## BS:5837 ARBORICULTURAL REPORT

ARBORICULTURAL SURVEY, IMPACT ASSESSMENT &  
METHOD STATEMENT

37 COMMONS ROAD  
WOKINGHAM  
BERKSHIRE  
RG41 1JJ

Ref: AIA/AMS 06414/ 2024

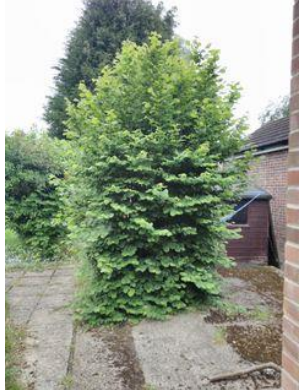
| Ref. | Species | Structure | Measurements | Spread | General Observations | Retention Category | RPA | Summary | Photo |
|---|---|---|---|---|---|---|---|---|---|
| T002 | Hazel<br>(Corylus avellana) | Tree | Height (m): 3.5<br>Stem Diam(mm): 300<br>Crown Clearance (m): 0<br>Life Stage: Mature<br>Rem. Contrib.: 20+ Years | N:1.5<br>E:1.5<br>S:1.5<br>W:1.5 | Mature coppice stool | C2 | Radius: 3.6m.<br>Area: 41 sq m. | Physiological Condition: Fair<br>Structural Condition: Fair<br>Public Amenity Value: Low | |

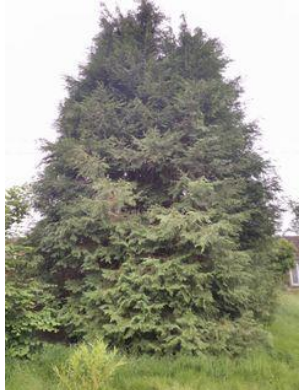
| Ref. | Species | Structure | Measurements | Spread | General Observations | Retention Category | RPA | Summary | Photo |
|---|---|---|---|---|---|---|---|---|---|
| T003 | Lawson cypress<br>(Chamaecyparis lawsoniana) | Tree<br>4 stems | Height (m): 9<br>4 stems, avg.(mm): 300<br>Crown Clearance (m): 0<br>Life Stage: Mature<br>Rem. Contrib.: 20+ Years | N:3<br>E:3<br>S:3<br>W:3 | Multistem from ground level previously topped at 4m. Multiple leaders in upper crown. Stems strapped together. Poor form. | C1 | Radius: 7.2m.<br>Area: 163 sq m. | Physiological Condition: Fair<br>Structural Condition: Physical Defect<br>Public Amenity Value: Moderate<br>Inspection Limitations: Low canopy | |

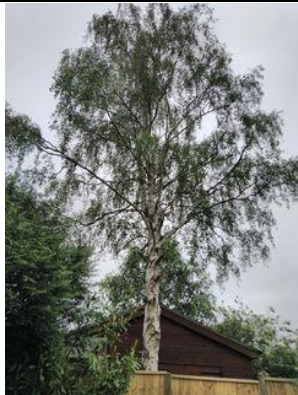
| Ref. | Species | Structure | Measurements | Spread | General Observations | Retention Category | RPA | Summary | Photo |
|---|---|---|---|---|---|---|---|---|---|
| T004 | Silver birch<br>(Betula pendula) | Tree | Height (m): 12<br>Stem Diam(mm): 350<br>Crown Clearance (m): 4<br>Life Stage: Mature<br>Rem. Contrib.: 20+ Years | N:4<br>E:4<br>S:4<br>W:4 | Offsite tree. Low overhanging branches cut back to trunk where they overhang garden of number 37. | B1 | Radius: 4.2m.<br>Area: 55 sq m. | Physiological Condition: Good<br>Structural Condition: Fair<br>Public Amenity Value: Moderate<br>Inspection Limitations: Access | |
