Loddon Garden Village - South

DESIGN RESPONSE

Prepared by:	Chris Shaw
Authorised by:	Leigh Abley
Date:	08 July 2025
Document Reference:	A392 – R067 LGV Observer Way RSA 2 Designers Response

Road Safety Audit – Loddon Garden Village - Observer Way Roundabout

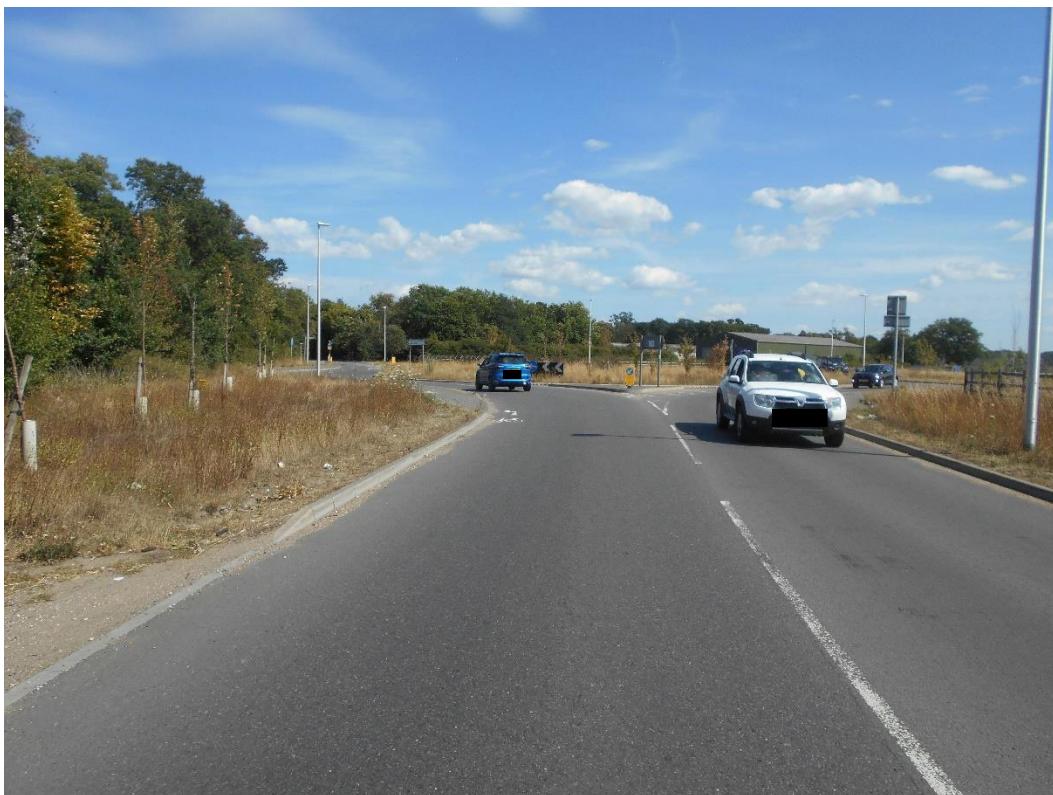
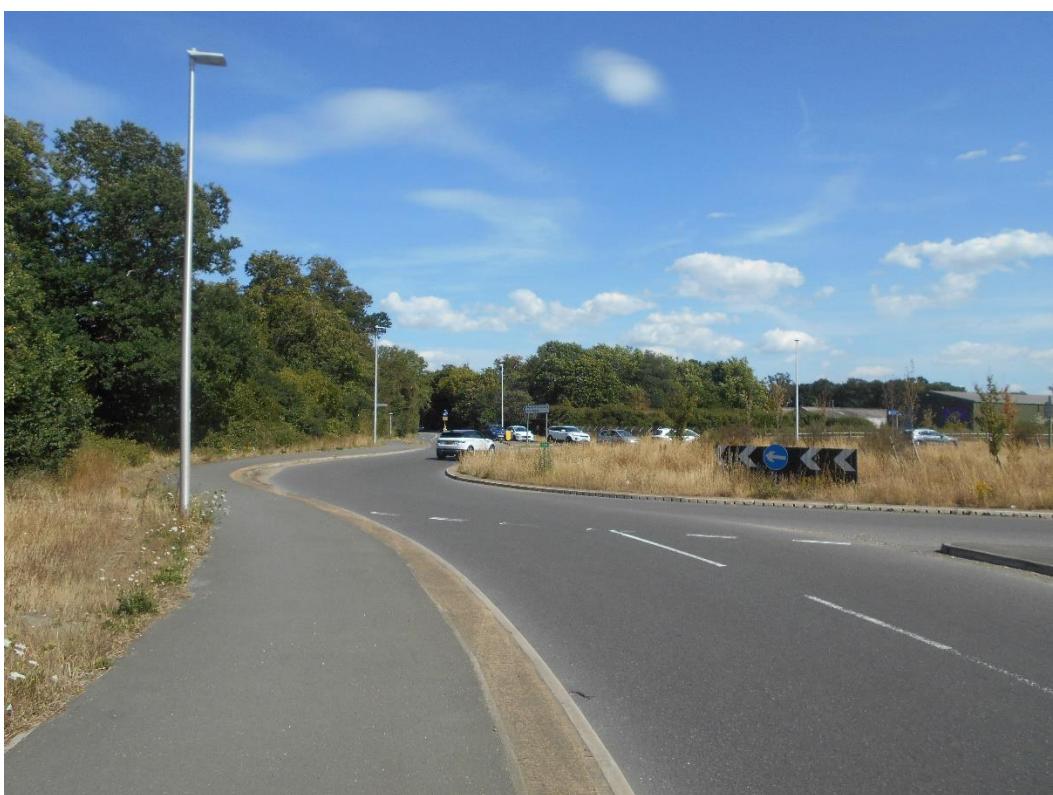
1.11 General views of site

Looking south-east on the A327. In the lower photo, the unclassified road continues ahead, and the proposed new road will join from the left, beyond the lamp column
