### **Resistograph Report**

**Oakfield Court, Wokingham**  
**RG41 2SW**

Date: 4<sup>th</sup> July 2025

Ref: TH 5320

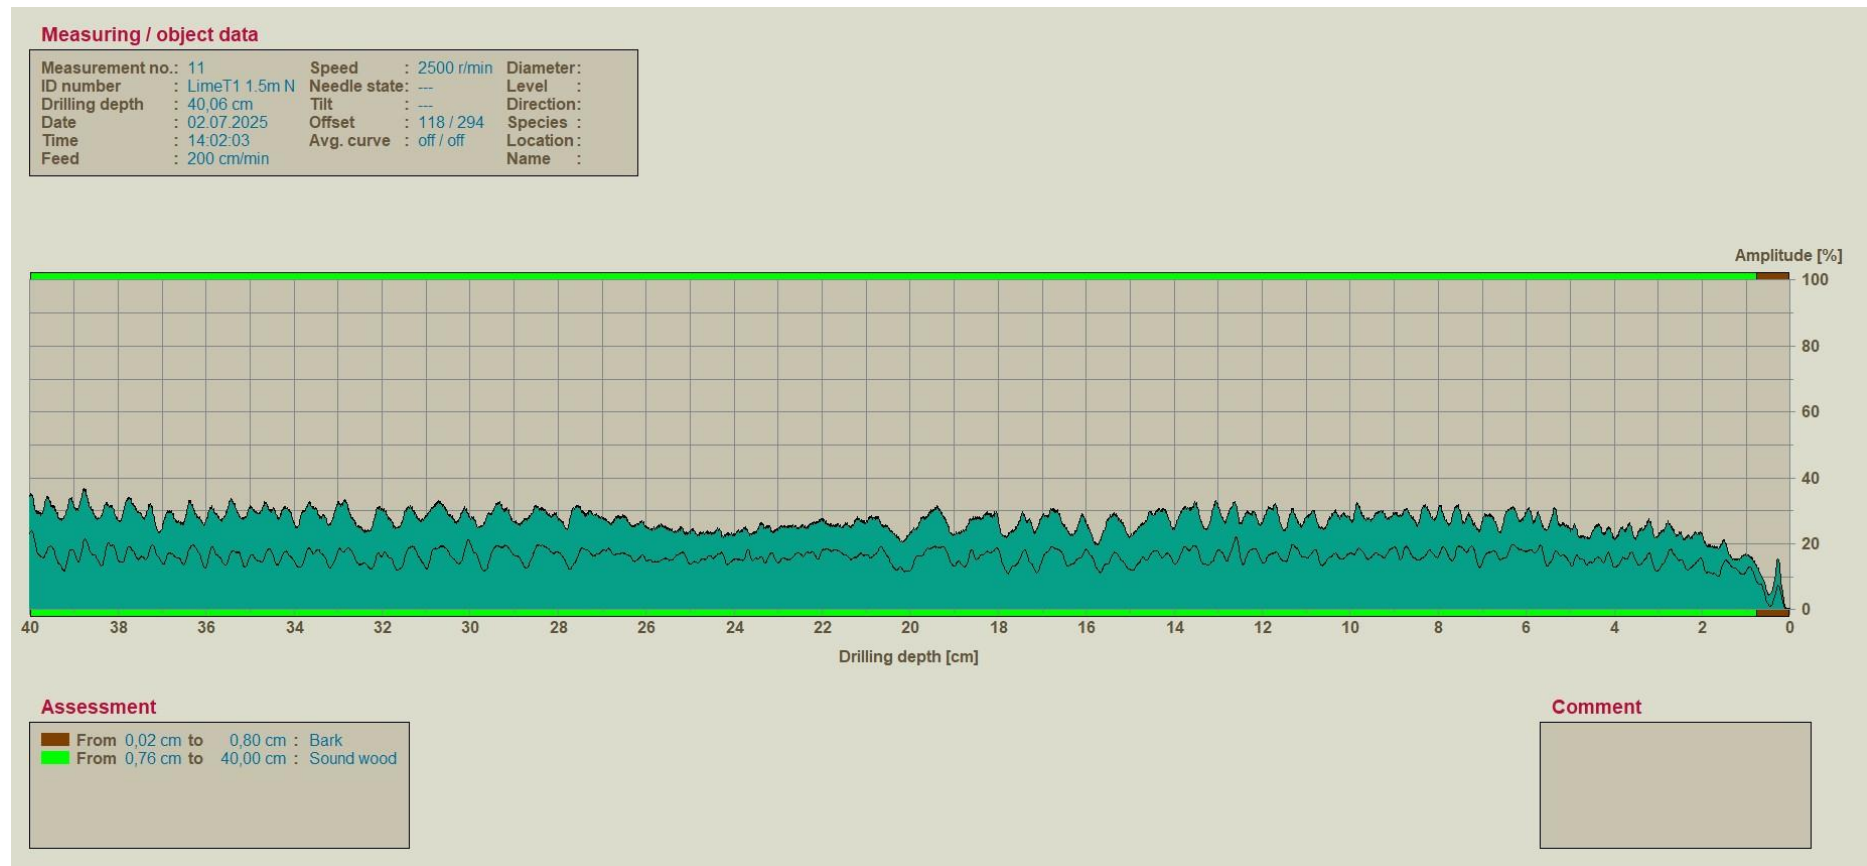
## Appendix 5-Readings

\* Note. The drill automatically extracted at 20mm, but when tested with a screwdriver, there was solid wood after about 40-50mm (the drill extracted because of the thin layer of decayed wood).

8.1 The resistograph test for Lime T1 showed that, although there is a large wound in the stem, the decay is superficial and there is barely any decay present.

8.2 The resistograph test for Lime T2 showed there was slightly more degradation than Lime T2, but that there was still enough sound wood to support it. However, there was further decay further up the stem / wound at about 4m above ground level (above the height I was able to test).

9.3 Lime T2 should be re-tested with a Resistograph about every 5 years to track the progress of the decay. It might be the case that a further reduction in height becomes necessary.
