Ref: LAS\_746  
Date: 05.06.24

**Site: Land adjacent to Warren Lodge Care Home, Finchampstead**

## **Arboricultural Statement**

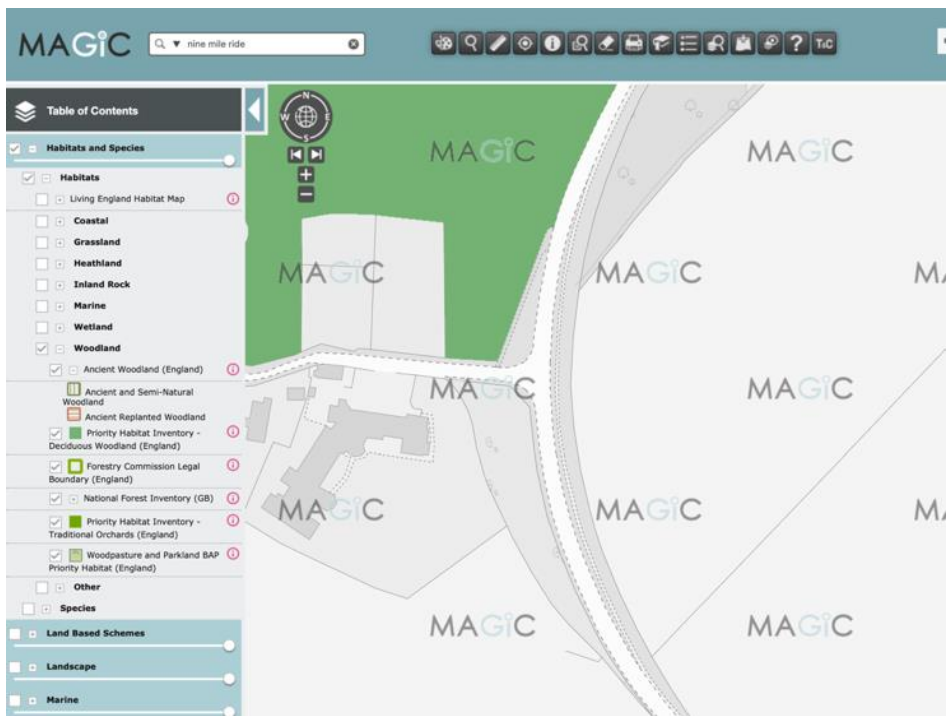
Fig 1: Extract of MAGIC maps showing location of any woodland designations. None shown covering the site.

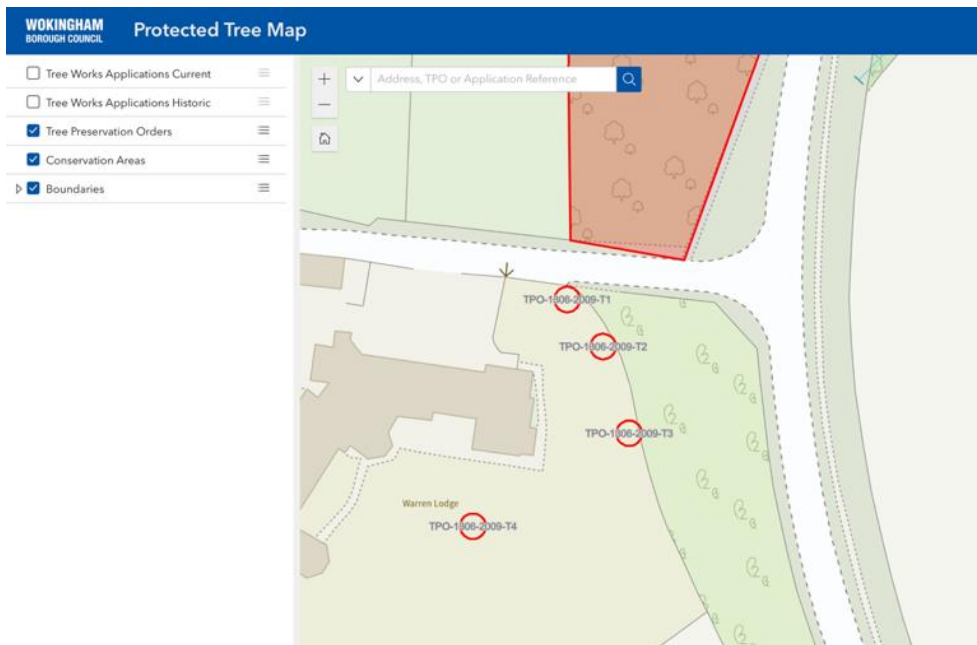
- 3.1 A review of Wokingham Borough Council's online TPO maps shows that the site is not within a Conservation Area. However it does show that three trees on the western boundary are subject to Tree Preservation Order (See Appendix 5, Figure 2 and 3.)

Figure 2: Extract of Wokingham Borough Council TPO maps. Conservation Area Constraints but three trees subject to a TPO.

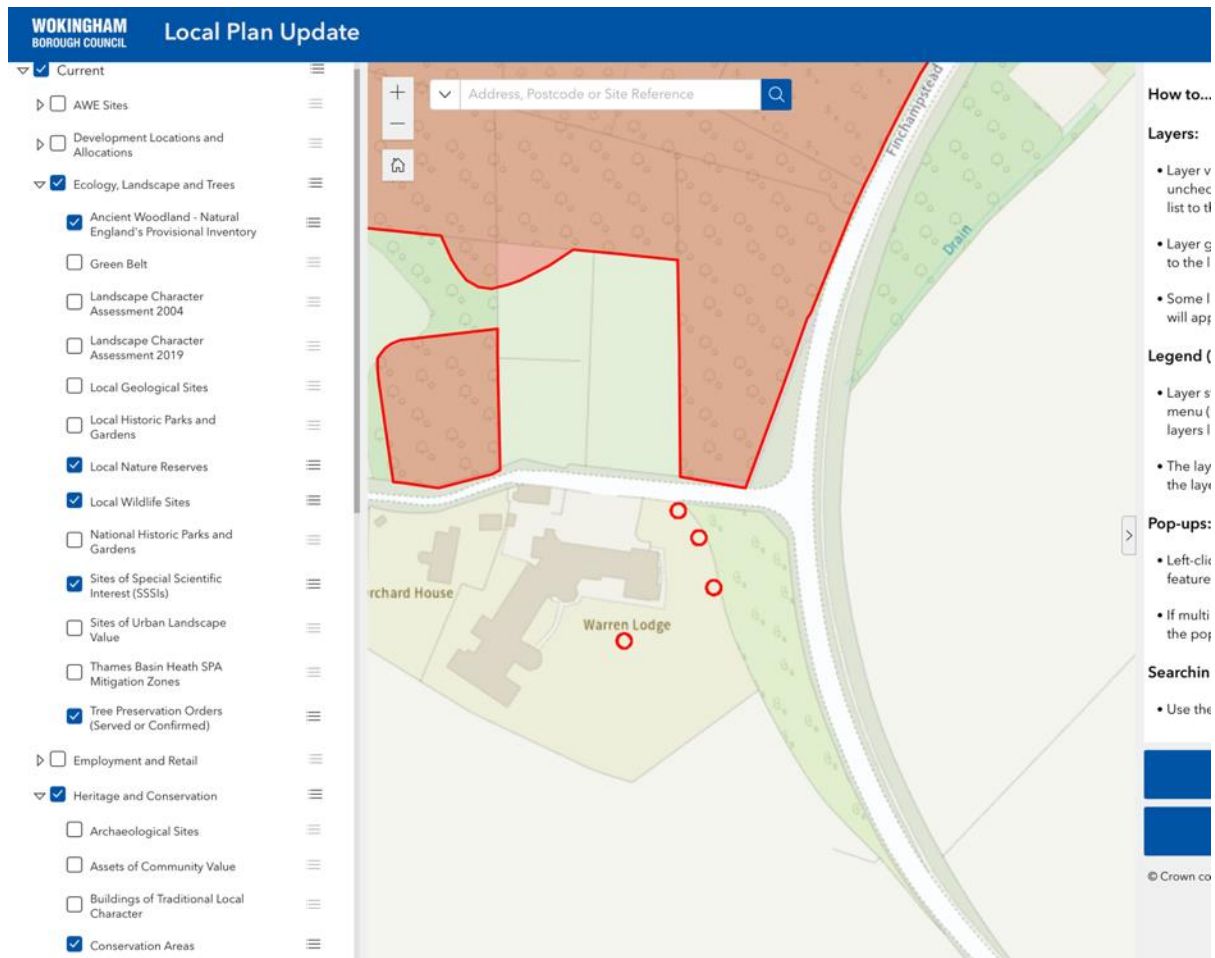
- 3.9 A review of the online DEFRA MAGIC maps and the Councils Proposals Maps shows that no ancient woodland, wood pasture, BAP woodland or any other woodland designation are within the site (See Appendix 5, Fig 1 and Fig 3).

Figure 3: Extract of Wokingham Borough Council Proposals Map showing ecology and tree constraints.
