**RE: Red oak tree at 16 Pound Lane, Sonning, RG4 6XE**

Thank you for your instruction to undertake an assessment of the red oak tree at the above site. You asked me to undertake a visual assessment of the tree and make comment on the damage caused to a nearby retaining wall. I duly visited on the 27<sup>th</sup> November 2024 and can now advise as follows.

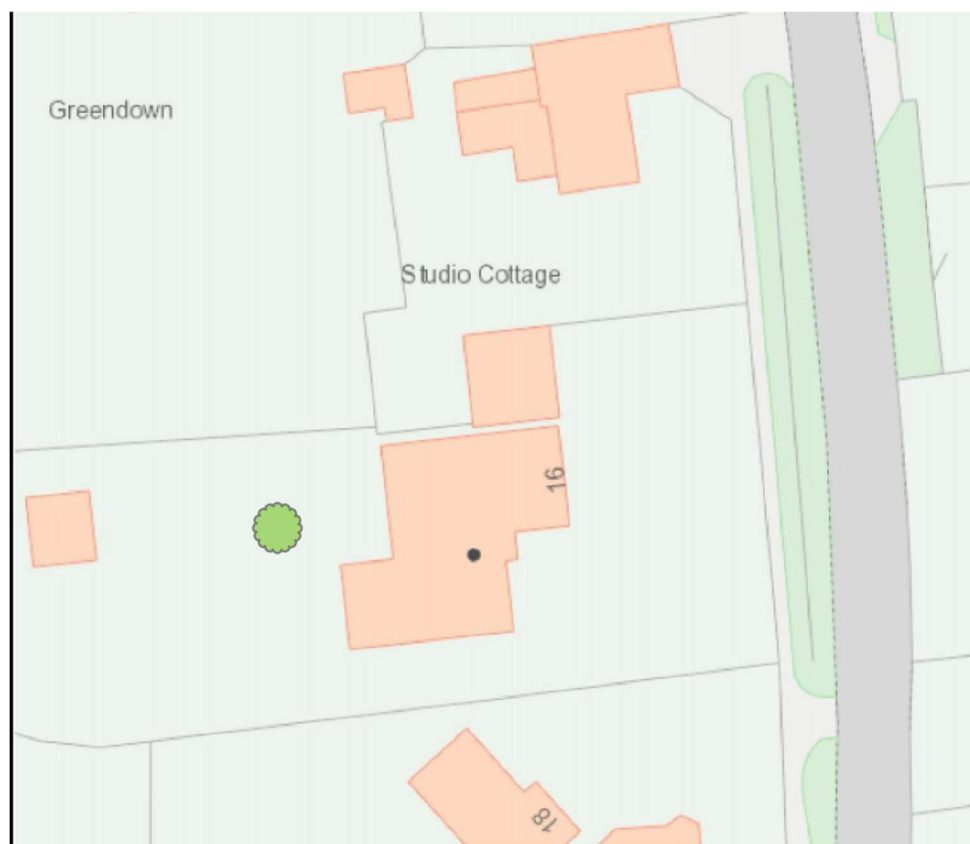
The tree sits in your rear garden as shown in the plan below:

The tree is located 8.5m from the nearest part of the house and 6.8m from the nearest part of the subject retaining wall as shown in the photo below. The wall is circa 1m tall.
