DUCKWORTHS
ARBORICULTURE

Arboricultural Supervision & Site Inspection

Location: Carnival Place, Wellington Road, Wokingham, Berkshire RG40 2AF

Date of visit: 4th March 2025

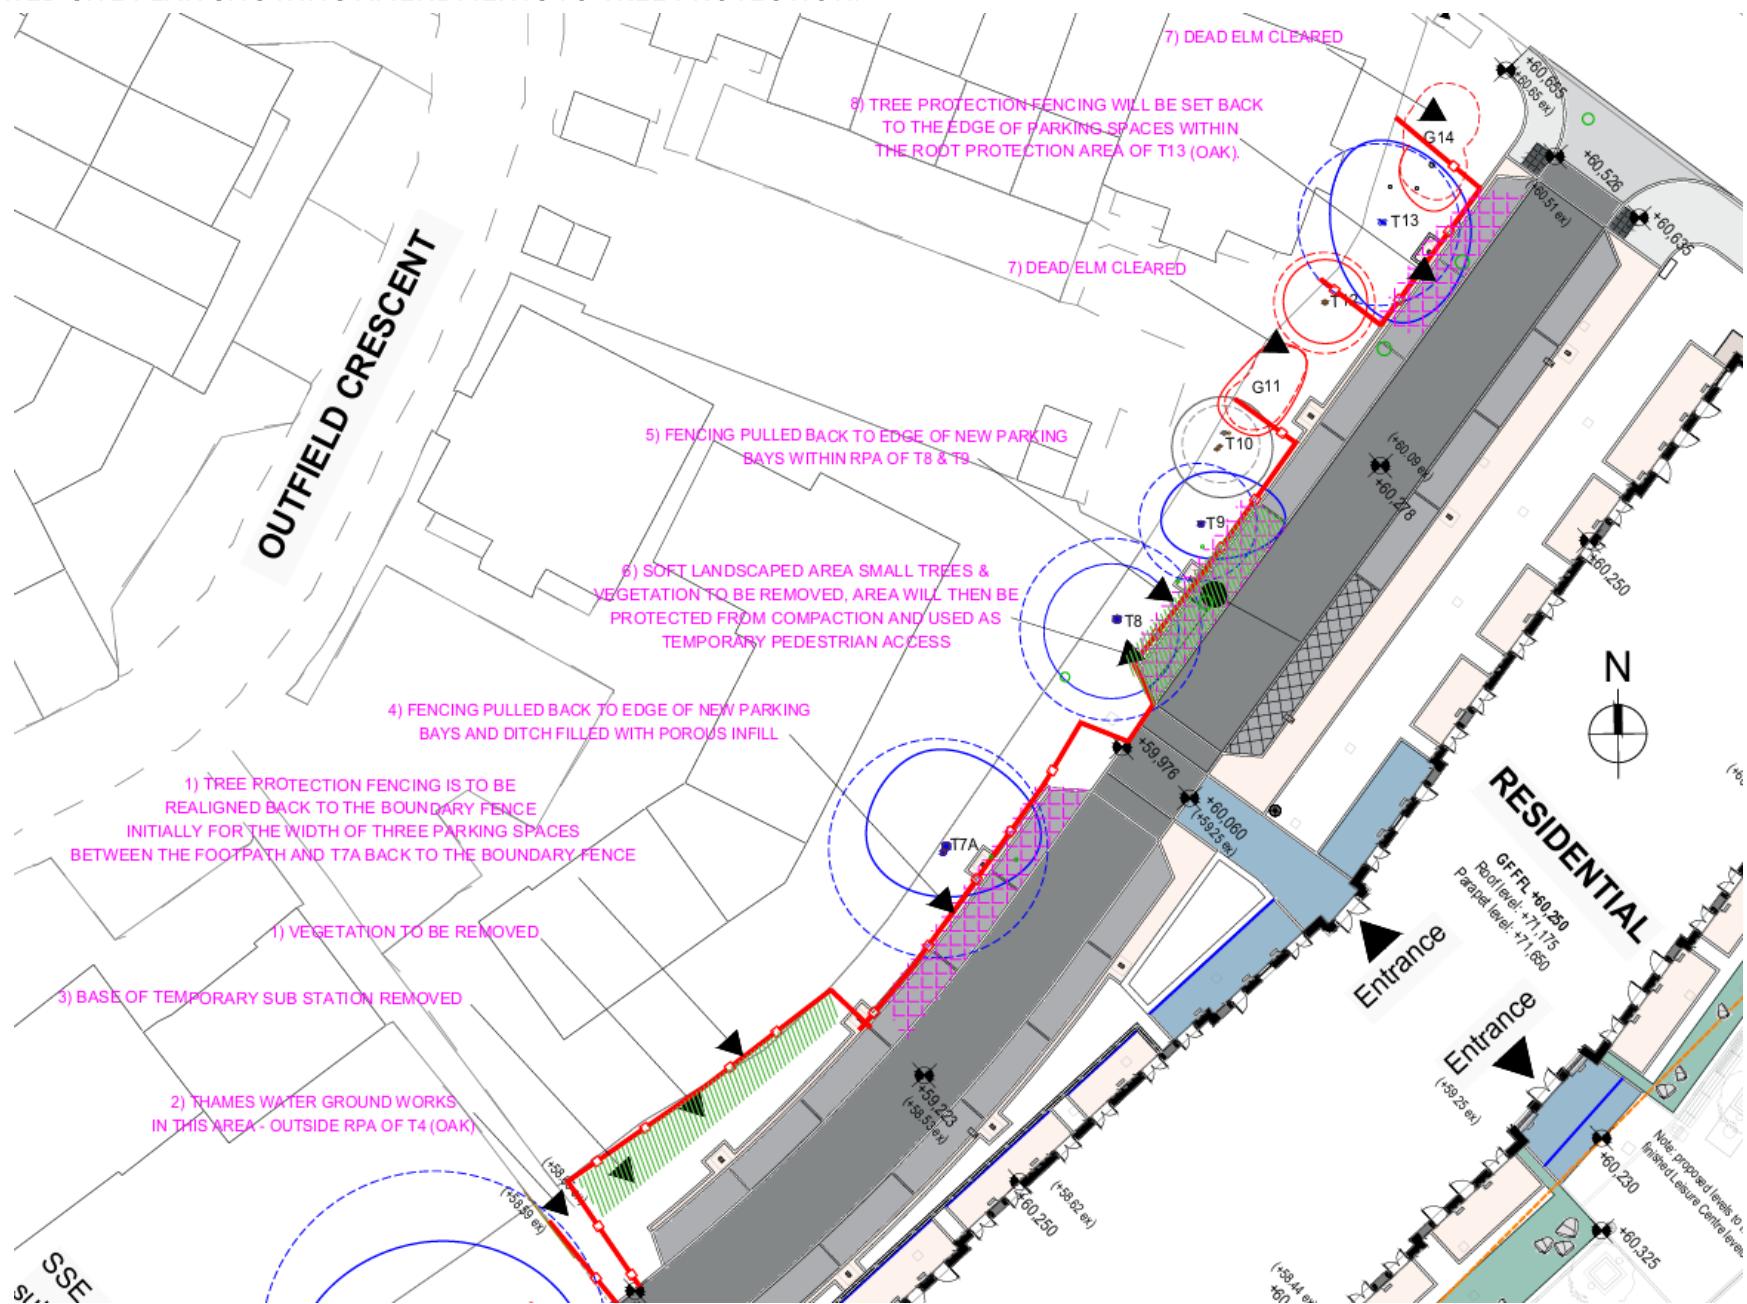
ANNOTATED SITE PLAN SHOWING AMENDMENTS TO TREE PROTECTION:

- Tree Protection Fencing has been removed along the northwest edge of the site but not reinstated as agreed in my previous report. In some areas the Heras fencing has been removed and replaced with crown barriers. These barriers do not meet the requirements of BS:5837 and The needs to be rectified within 7 days.

1. SD – Arboricultural Consultant will be returning to site within 2-3 weeks to review fencing / temporary ground protection and ensure it is correctly located and fit for purpose.
2. SD to write Part 2 of the AMS – further information required on the infill of the ditch.
3. Confirmation required as to whether a root barrier is required or necessary along the edge of the parking bays near to trees T8, T9 & T13. SD has advised that this would cause unacceptable severance to tree roots close to trees. Therefore, the recommendation is that the root barrier is not installed in these areas. The installation of a root barrier is possible within the RPA of T7A (Oak) as it can be installed within the porous ditch infill and as such will not require any excavation.
