**CCTV REPORT FOR: WEST WOOD  
LOWER WOKINGHAM ROAD  
CROWTHORNE  
BERKSHIRE  
RG45 6BY**

**Site Visit:** 30-Jan-25  
**Report Date:** 17-Feb-25

Address: **WEST WOOD, LOWER WOKINGHAM ROAD, CROWTHORNE, BERKSHIRE, RG45 6BY**

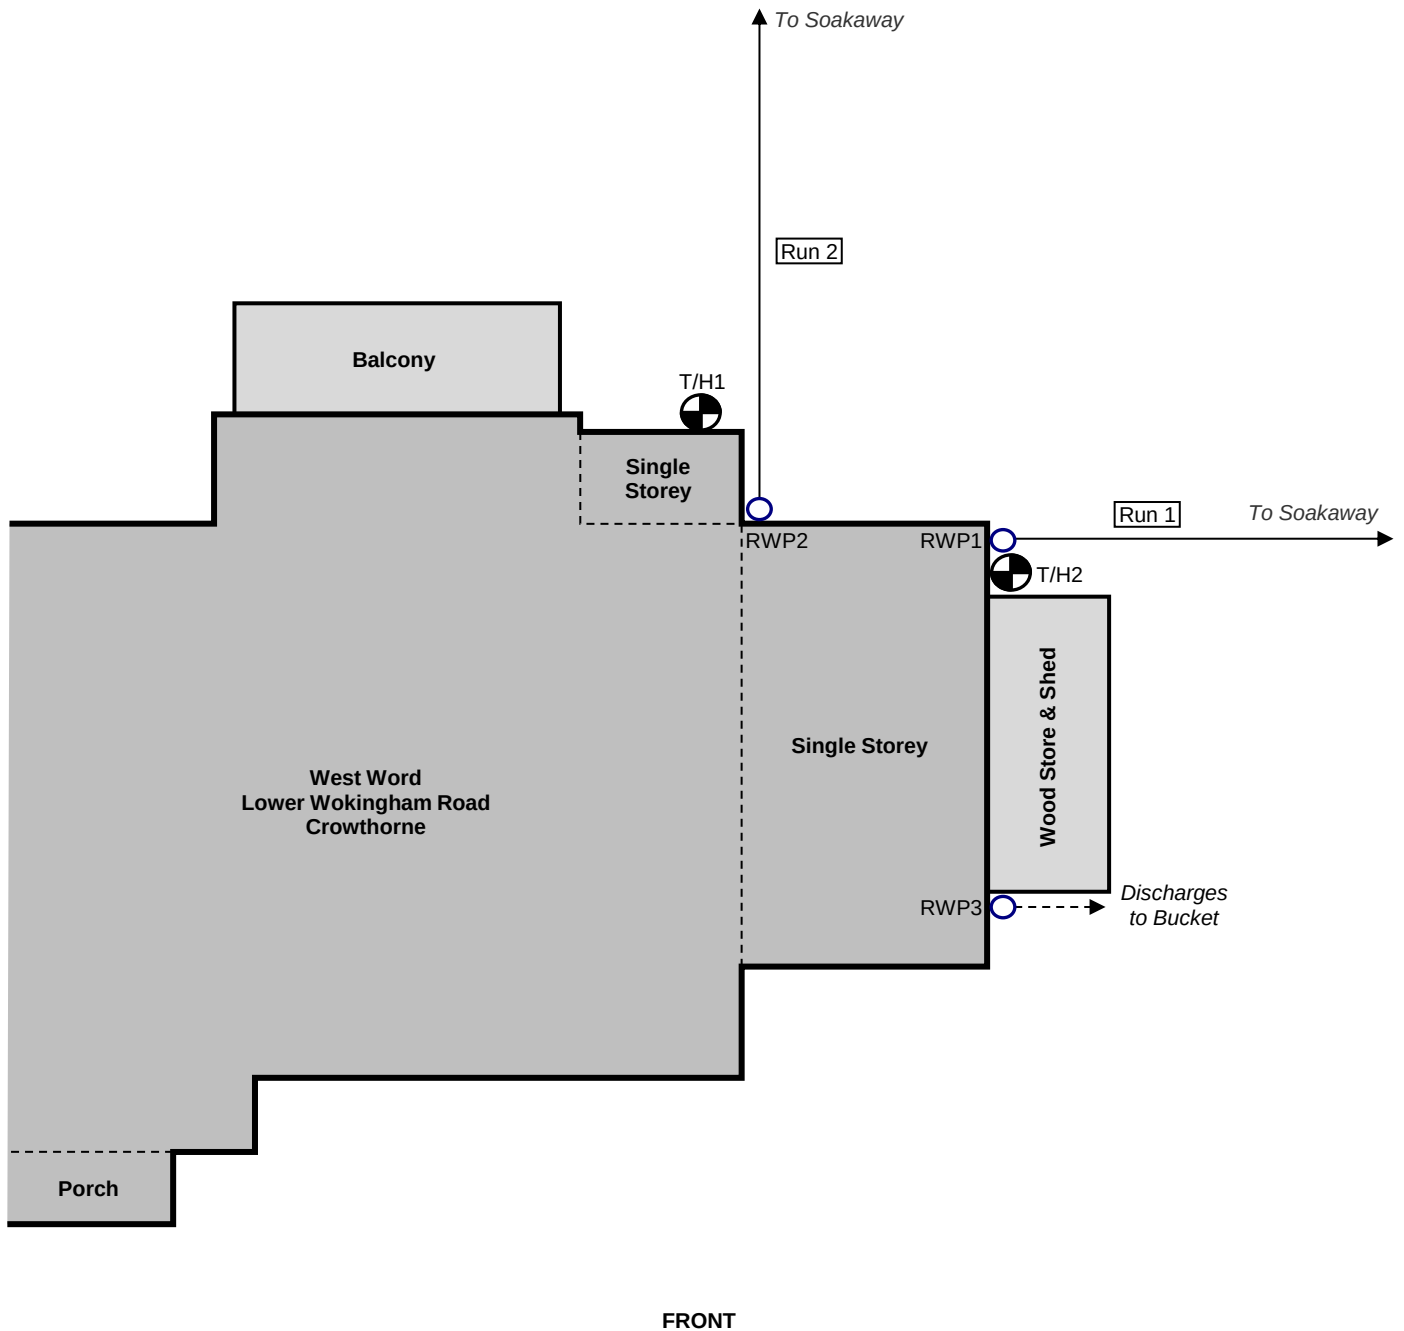
Minor accumulation of debris. No visible pipework defects.

There is a storm water down pipe on the front right corner of the main house. This runs above ground down the side of the wood store and discharges in to a large bucket.

The surveyed pipework is in good condition with no observed defects.

No recommendations are required.
