**Ashridge Farm, Warren House Road, Wokingham RG40 5QB**  
Historic recording of the farmyard buildings. Surveyed 30 06 2016.

## SUMMARY SHEET

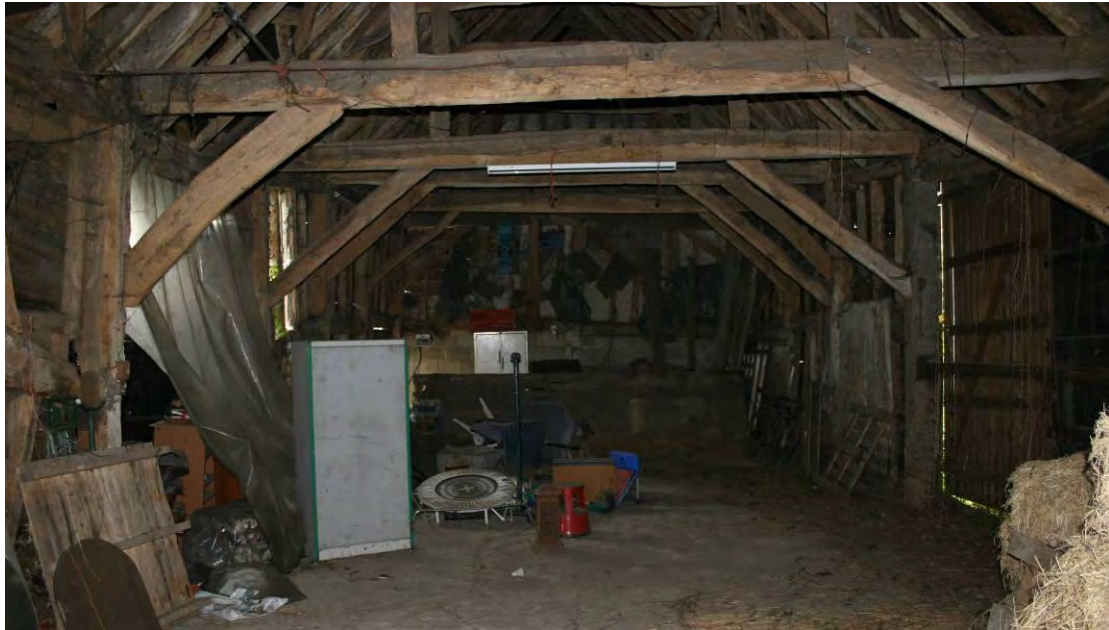
Looking E inside the Barn from the western end.

The Barn has 6 bays but it is immediately evident that Bay 1 (from the west) has been added. Truss 1 is morticed for studwork to form an end wall which has been removed to form the extra bay. The end wall is the brick wall described previously. The midstreys and porches are in Bay 3 giving an asymmetrical earlier building (i.e. the doors were not in the middle).

The walls are completely rebuilt with nailed, interrupted studwork or scantling studs. There are two sets of mortices. Curiously they are all round ended where they have been drilled but not cut square with a chisel to finish them.

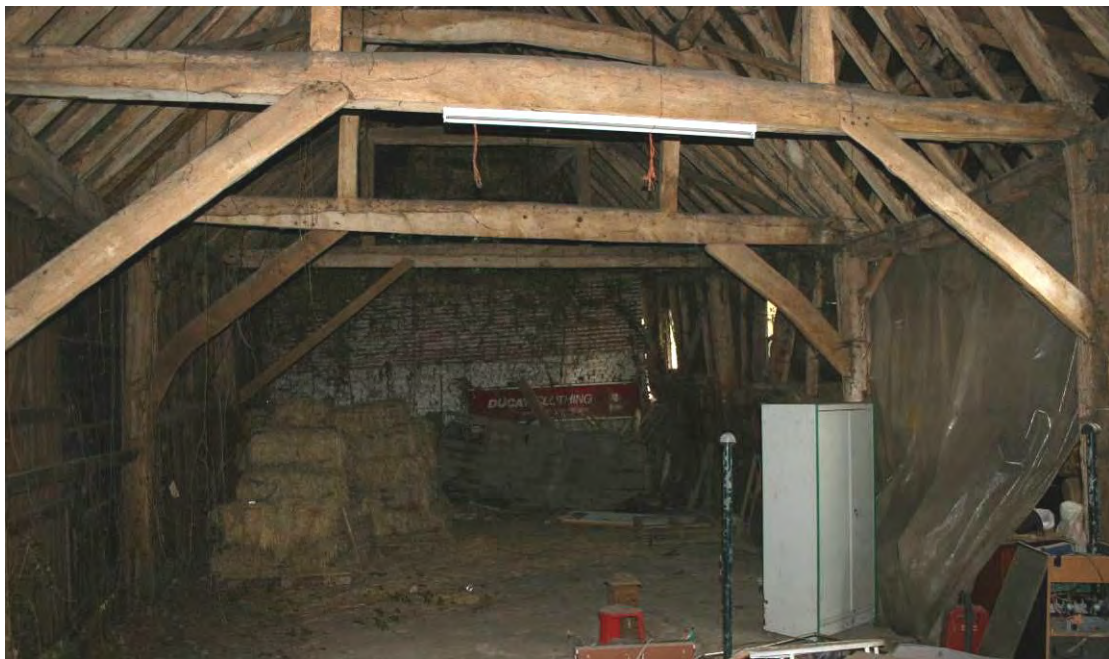
Looking W inside the Barn from the eastern end.

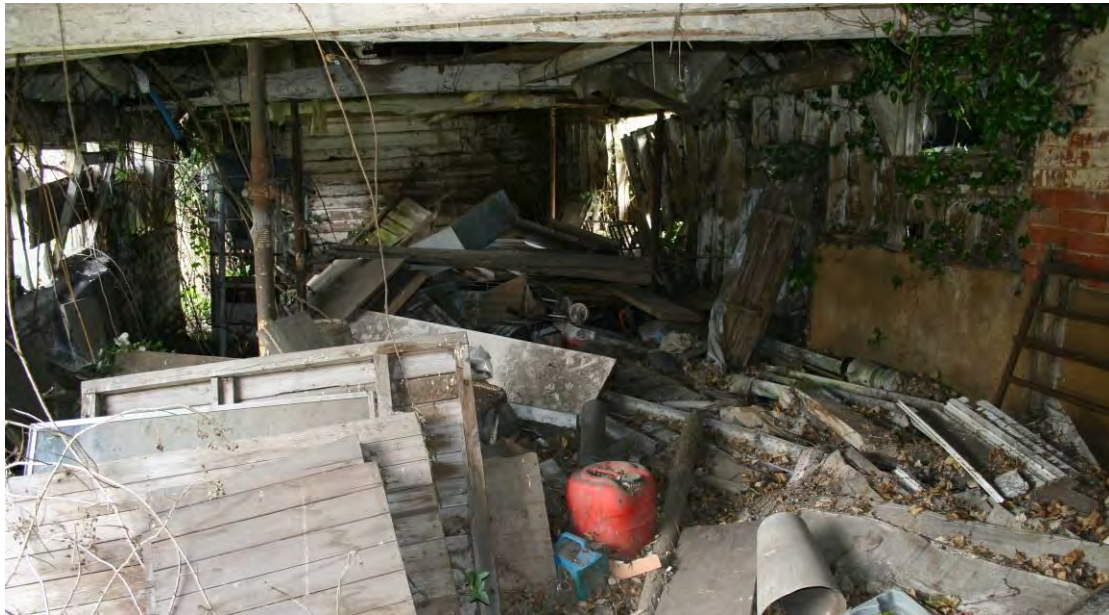
Looking N in the southernmost bay.

The Workshop has been formed by adjoining the Processing Shed with a LC19th timber link to a timber-frame with LC19th sawn softwood walls but an E-MC19th elm pitsawn roof structure with side purlins supported by raking struts. The southernmost bay has the common brick wall of the Processing Shed and a LC19th machine cut roof that meets the older roof at the first truss. Additional tie beams and struts have been added to improve the stability of the older roof of which many of the rafters are quarter poles.

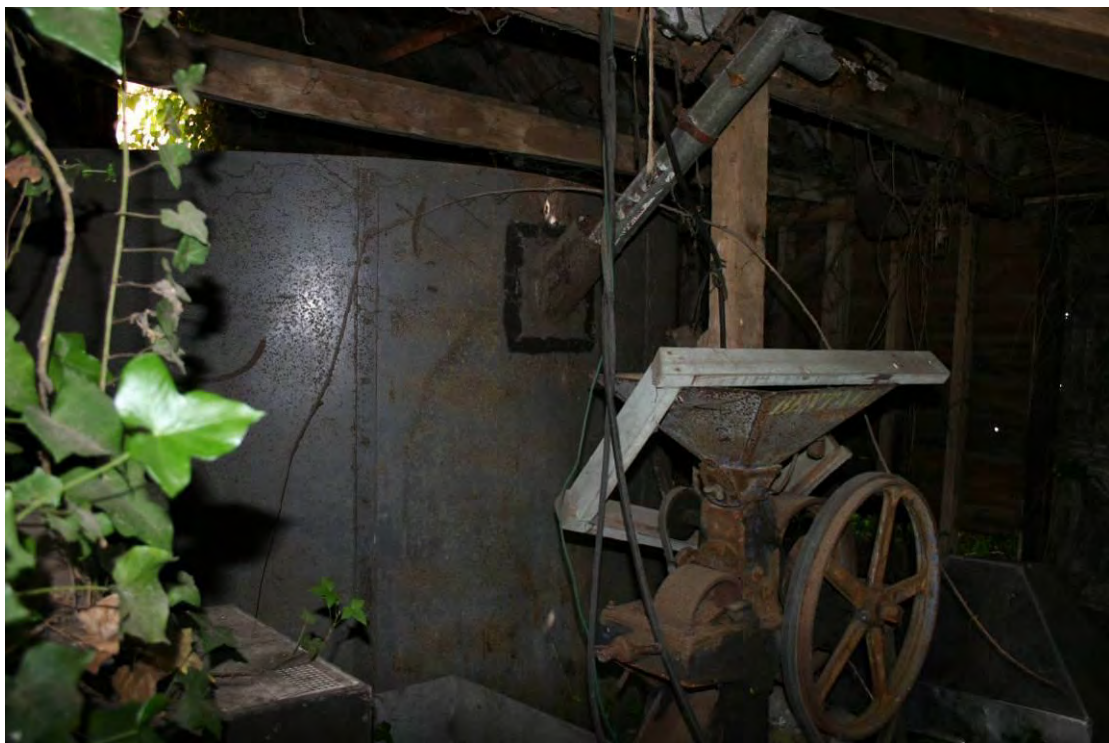
The grain silo and a Bentall's crusher grinder.

The northern room is equipped with machinery to produce cattle food. There is a large MC20th sheet steel cylindrical grain silo with an electrically powered auger to draw the grain up for delivery into a Bentall's crusher grinder. This machine crushes the grain in rollers to convert it into cattle cake. Close by is a Wrekin root cutter, also used to produce cattle food.

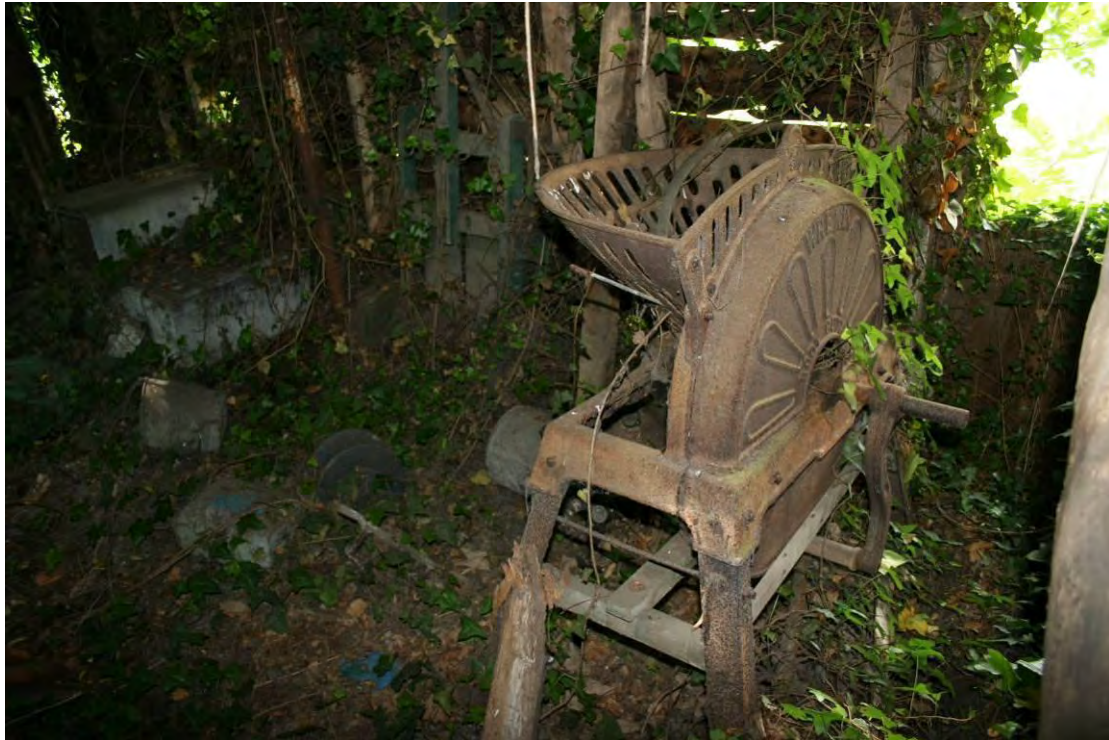
Detail of the hand driven Wrekin root (mangel) cutter. These are MC20th.
