# METHOD STATEMENT FOR REPAIR WORK TO BUILDINGS AT

## ASHRIDGE FARM, WOKINGHAM

Report by William Harrison

RED ROSE DEVELOPMENTS MARCH 2021

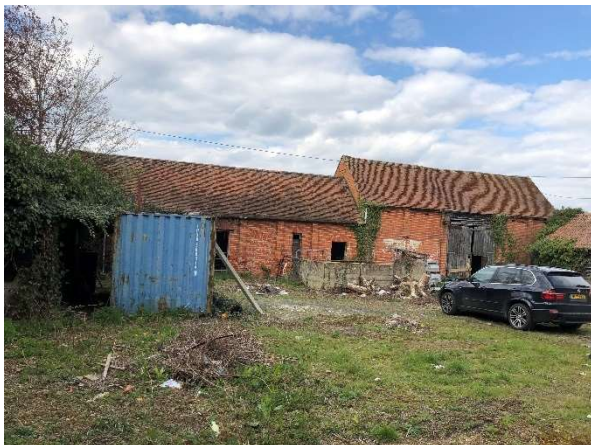
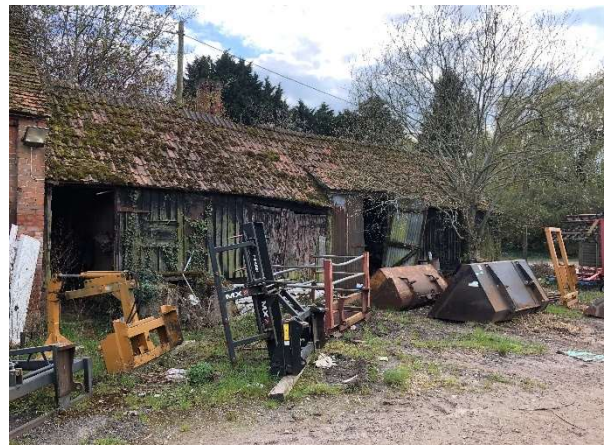
Figure 2: C19<sup>th</sup> Century South East elevation of Unit 1      Figure 3: C20<sup>th</sup> North West elevation of Unit 1

To the West lower section of Unit 1 there is a rough, partially broken up, concrete ground floor slab, previously used as timber framed stables and a garage. There is no sign of a visible damp proof membrane. The slab will have to be removed and replaced. The timber clad frame is sited on a small perimeter brick plinth that is partially collapsed in areas. It is unlikely that the structure has a much of a foundation due to the condition of the plinth. Tree roots around the building have destabilised much of the wall. Within the brick stables there is also a rough concrete slab which requires removing and replacing.

There are numerous spalled bricks that would need to be replaced locally, but in general the brickwork is in fair condition to the stables. All the brickwork will require repointing which will be completed in lime mortar, of matched colour and texture to the existing. There is structural cracking appearing where the external southern wall meets the eastern internal wall, likely due to the roof spreading. This will be repaired once the roof is repaired. The steel lintel over the main opening from the courtyard is not up to building regulations and has crudely been added in across two original windows, see image below, it has also been knocked causing a instability. The steel beam will be removed and replaced with a hidden lintel and brickwork made good above.

To the western elevation the walls and structure is constructed from softwood timber, partially sat on a brick plinth. The weatherboarding and timber structure is full of rot and in poor condition and requires total replacement. Like any modern shed once the roof tiles and cladding are removed what is left is an insubstantial softwood timber frame of no structural integrity.

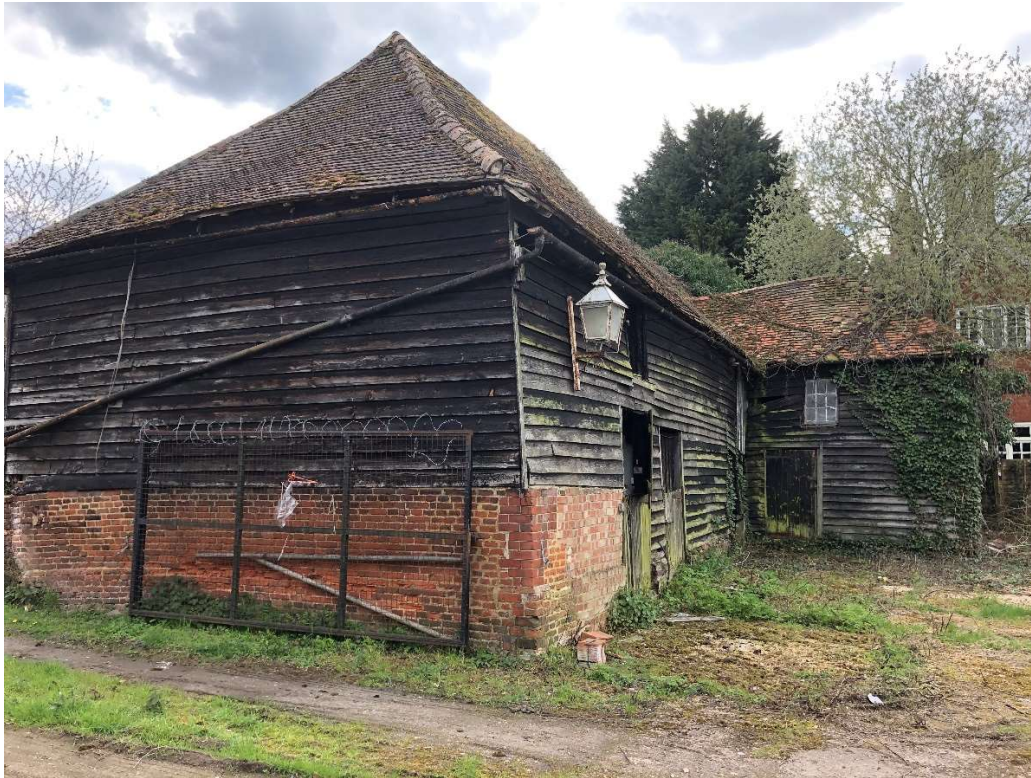
Figure 10: External East elevation of unit 5

The structural condition of the building overall is poor due to racking and movement, although the timber looks to be mainly free from decay. The timber itself is in fair condition and the vast majority can be repaired but due to all the movement many of the joints holding the structure together have snapped leaving it structurally unsecure. The roof has also racked over badly from its original position.

The external cladding to the main barn is black horizontal timber boarding onto timber uprights. Areas of the cladding have been replaced over the years and it will be removed to allow the repairs to be completed then replaced with larch, stained black, in keeping with the original fabric. The main barn doors have been replaced with softwood and are too large for the original opening. These will be replaced with a hardwood door of the same style and pinned open.

To the eastern elevation of the barn, the later extended bay 7, the wattle and daub panels have been infilled with brickwork and render. There is a high brick plinth where most of the original bricks have been repointed in cement have now blown. Subsidence has also left the South East corner structurally unsound, a range of modern bricks have been used to patch repair this corner of the barn. Cement render has also been used on the higher panels. Removing this render now would damage the timber wattle it is bonded to so it is sought to leave this in situ. All the modern bricks, cement and bricks in poor condition will need to be removed and replaced locally with a reclaimed match for the original handmade brick and pointed in lime mortar.

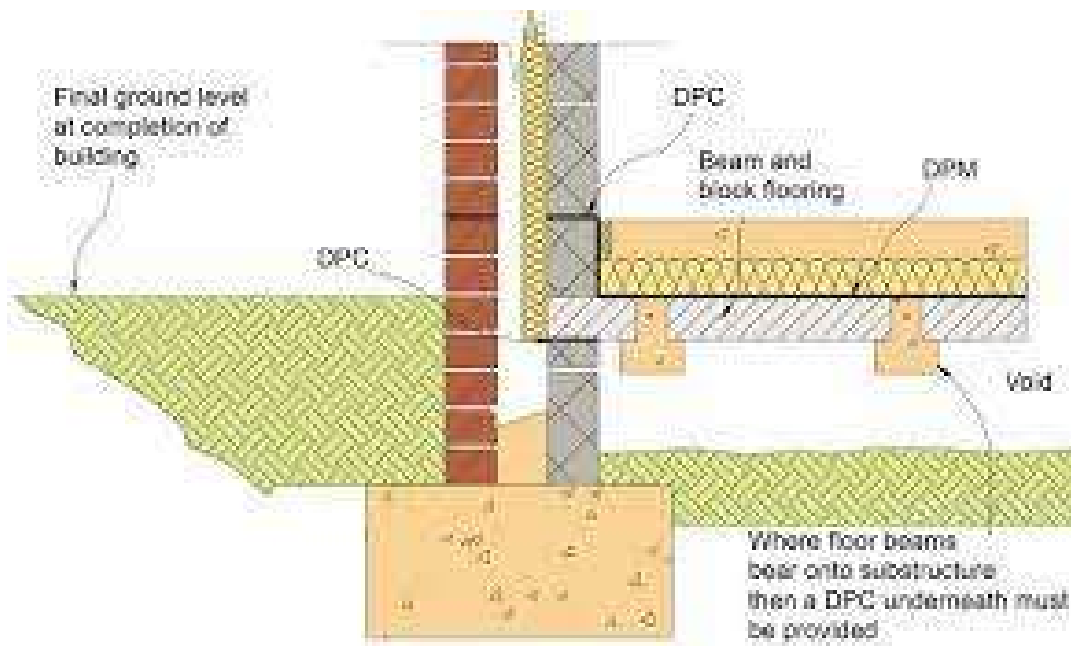
The only exception to the ground bearing slabs will be the western section of Unit 1 which will be completed in block and beam flooring, subject to the engineer's design. This is due to the proximity of two trees and a risk of clay heave.

Figure 14: typical block and beam detail proposed for Unit 1 West

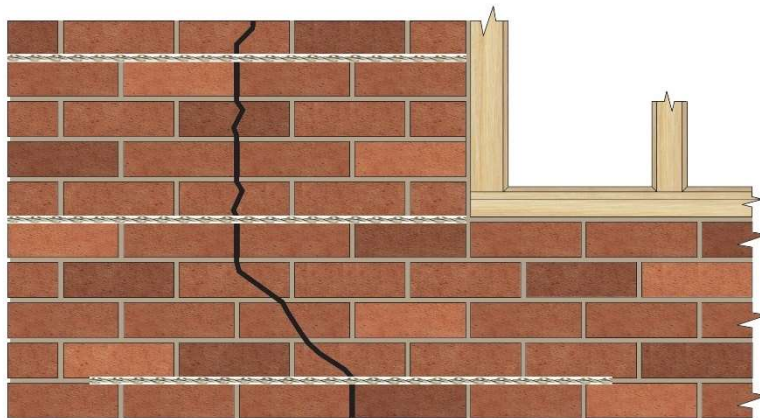
Where subsidence has taken place on the southeast corner a localised footing may be required on the corner to avoid this happening in the future. As the corner has cracked away approximately 0.5m in each direction this will be removed and rebuilt. Crack stitching may also be used, subject to the engineer's approval, in order to strengthen the corner and keep it aligned with the surrounding brickwork. This is done by inserting small metal rods into the joints, then covered by lime mortar.

Figure 21: Diagram above of crack stitching being used.

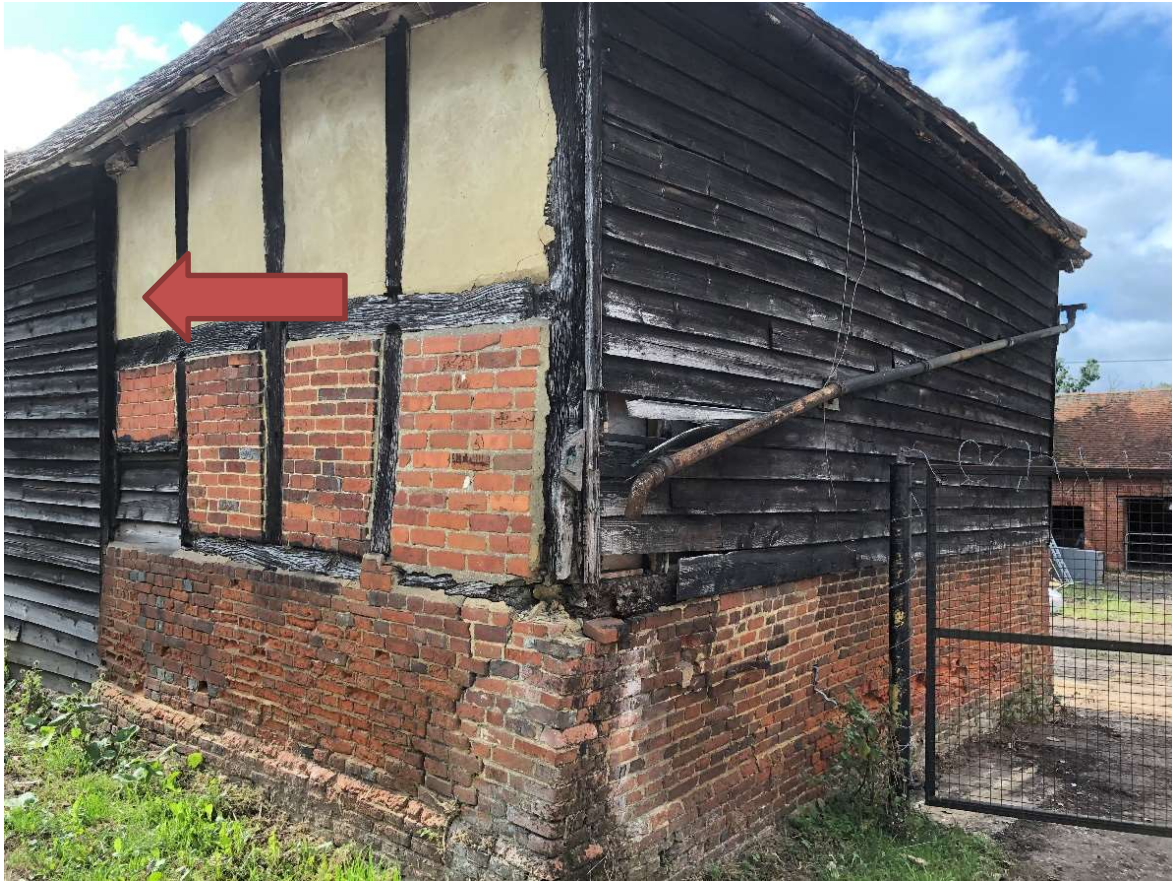
Where the new external build up adjoins the eastern bay 7 of the barn with the wattle and daub panels that are to be left exposed a timber board will be used at the junction to cap off the insulation area. This detail has already been used, see photo below, in the existing construction method and will only marginally be more pronounced. It has been used in this instance due to the brickwork protruding at the base of the wall and timber frame under the roof leaning inwards.

Figure 26: Unit 5 south east corner timber to brick junction detail

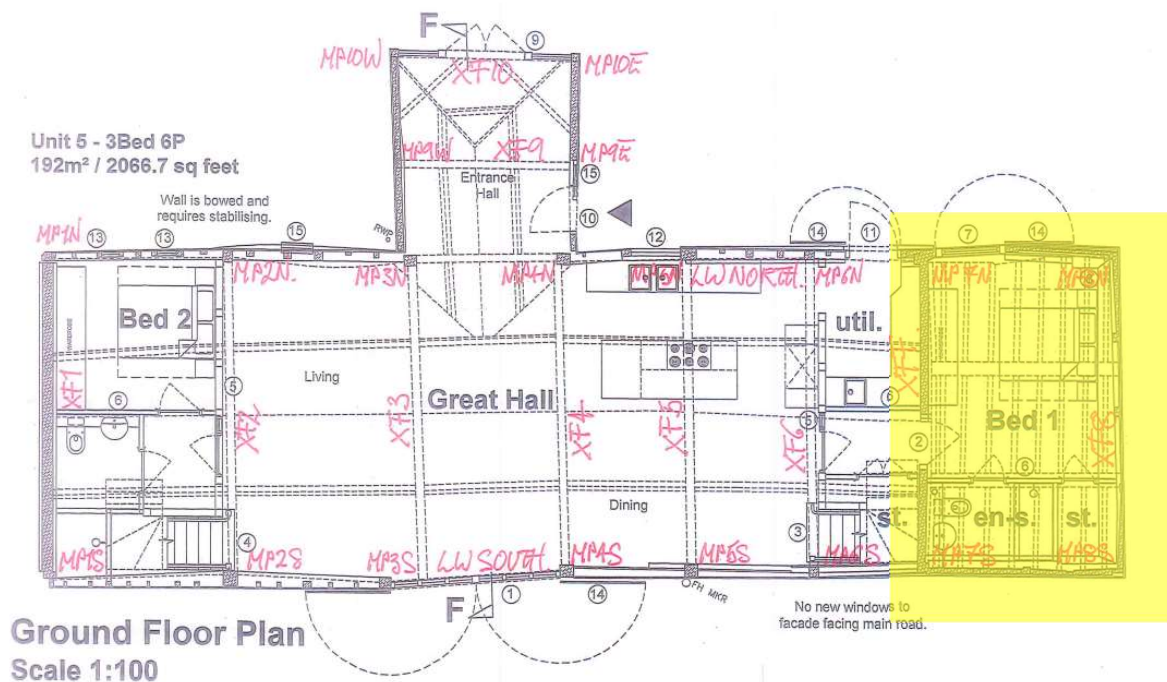
Figure 27: Unit 5 showing bay 7 to be left in situ highlighted

The end 17<sup>th</sup> century bay of the barn will be repaired in-situ, rather than removing it with the rest of the timber frame, in order to not disturb the wattle and daub panels internally and externally. Where the wattle and daub panels have been replaced with brickwork in the four bays below the wattle and daub it is proposed, subject to the conservation officer's approval, these are removed and replaced with new wattle and daub as originally intended. This will allow the timber frame to move and breathe, minimising any future rot. When the rest of the structure is removed for repairs a 'tin hat' protective temporary roof will be added over this section to aid in weather protection and a heavy gauge polythene draped over the exposed western side.

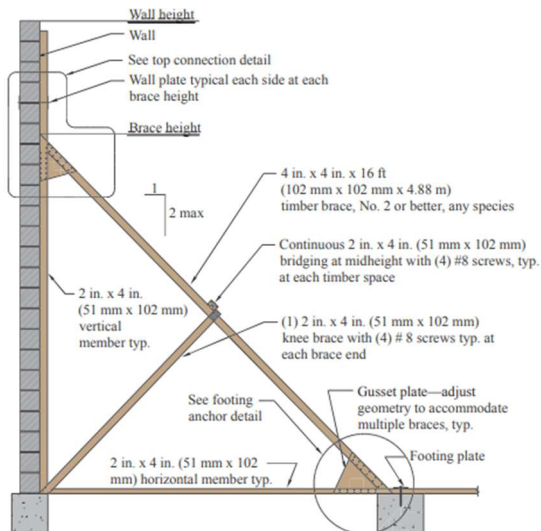
The brick wall to the western elevation must have previously replaced part of the timber frame to the barn and is predominantly covered by ivy so cannot be fully assessed from the outside but it appears in reasonable condition and will remain in situ. A structural studwork wall will be built inside of this wall to give it structural integrity. This will then be braced back to the concrete slab for rigidity. This will act as temporary support whilst the timber frame is removed and repaired but will stay in place permanently so that insulation can be added between the studs and plasterboard added to the face whilst not affecting the brickwork. Where the existing brick wall meets the historic timber frame it is not currently tied together and a gap is visible. Internally the new stud wall can be fixed all the way across into the existing timber to maintain the thermal integrity. Externally as the different materials will move independently the gap will be filled with rockwool and capped with a timber strip, NOT fixed into the brickwork, this will act as a movement joint.

Figure 32: Diagram of bracing to be used on unit 5 existing brick wall
