## OAK TREE BESIDE PUBLIC RIGHT OF WAY

TPO Number: 1886/2022

## **ASSESSMENT**

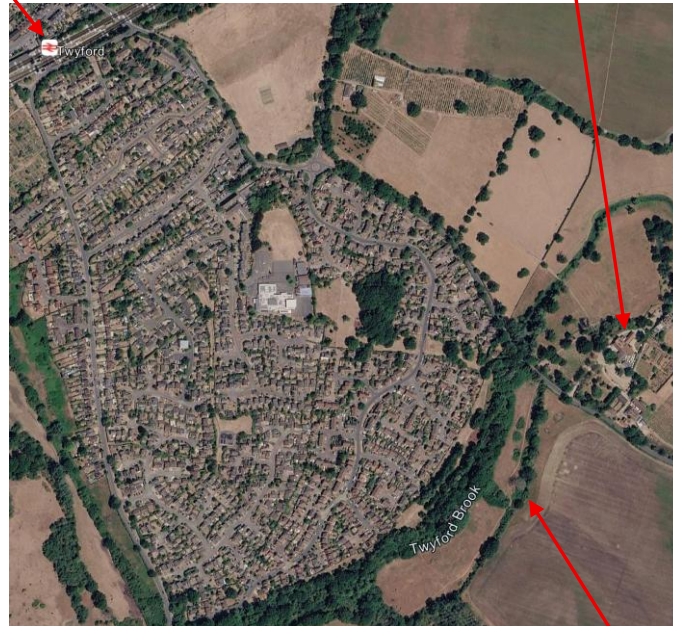
Morbund Oak Tree

The TPO tree in question (Number 1886/2022) is a native English oak (*Quercus Robur* / *Quercus Petraea*). This variety of tree typically maintains its green canopy well into October or November. However, when inspected on 24<sup>th</sup> September, in contrast to the surrounding oaks – which display robust foliage – this specific tree shows a total absence of leaf development. Because this is unlikely to be caused by standard seasonal change, and given its condition is completely at odds with its immediate neighbours, this is assessed as a moribund tree in terminal decline, with clear loss of structural integrity.

Clearly, the total lack of buds and its complete brittleness, with snapping twigs, is indicative of an ongoing problem. Crucially the vicinity of this tree – immediately beside a Public Right of Way (PRoW) – poses a safety hazard to the public.

It is a clear and apparent danger to the public in its current condition (which is only expected to deteriorate further). Therefore, it should have its upper boughs removed to avoid further dropping onto, or near to, the PRoW. This will also deter children from playing on, or in the vicinity of, the tree.
