## Preliminary Ecological Appraisal and Roost Assessment

71 London Road, Wokingham, RG40 1YA

26<sup>th</sup> November 2024

*Front and rear extensions with associated internal alterations*

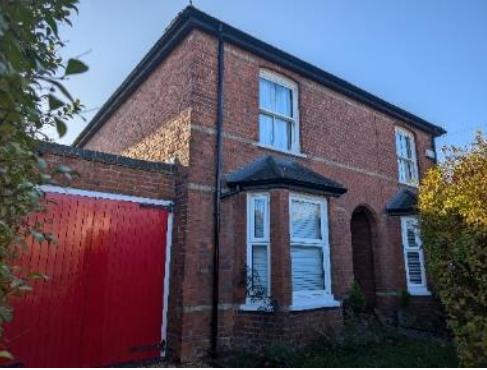
<p><b>Fig 2</b></p>
B1 – exterior	<p>The brick and mortar appear to be in good condition (Fig 3), leaving no gaps. The windows and doors appear to be tightly fitted (Fig 4), leaving no gaps. The eaves appear to be tightly fitted (Fig 5), leaving no gaps.</p>

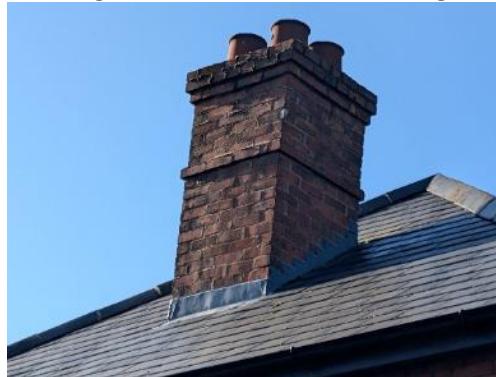
**Fig 6**

The lead flashing around the chimney appears to be tightly fitted (Fig 6), leaving no gaps. There are a small number of lifted roof tiles on the main section of the house (Fig 7), and the hip tiles do not appear to be tightly fitted (Fig 8), providing a suitable roosting location for crevice dwelling bat species.

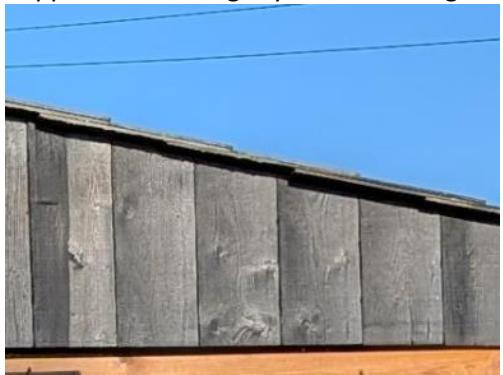
Fig 13

The lead flashing between the main house and the garage is lifted (Fig 12), providing a suitable roosting location for crevice dwelling bat species. It was not possible to fully assess the roof tiles on the garage without accessing the neighbouring property, however, the areas that could be observed appeared to be tightly fitted and in good condition (Fig 13).

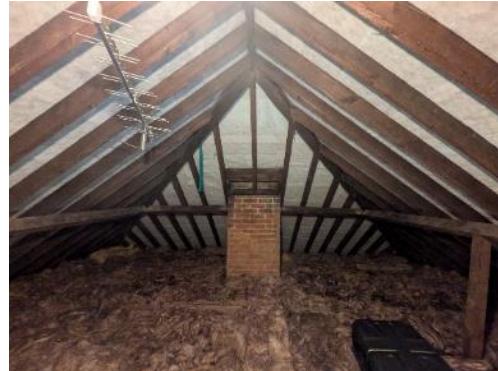
**Fig 14**

B1 – interior	<p><b>Limitations:</b> <i>The loft void within B1 is not boarded, with thick insulation covering the timber beams. Therefore, the assessment had to be completed from the loft hatch only. As the full loft void could be seen from the access point, this is not considered to be a major limitation.</i></p> <p><b>V1:</b> The loft void within B1 is lined with breathable membrane, insulated with mineral wool insulation, and there are timber beams throughout (Fig 14). The timber beams provide a suitable roosting feature for void dwelling bat species should they gain access to the loft void. There are some small areas of missing mortar on the chimney (Fig 15), however, these do not appear to</p>
---------------	--

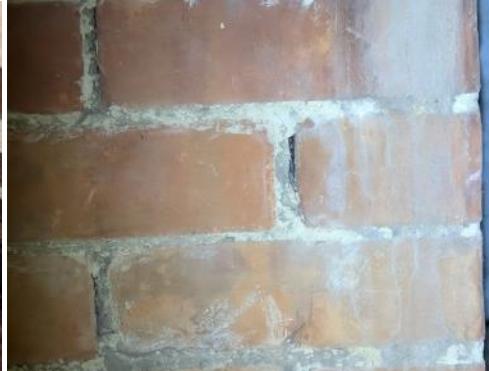
**Fig 15**

continue deep enough to provide a suitable roosting feature for crevice dwelling bat species. The roofing membrane is sagging in places (Fig 16), providing a suitable roosting location for crevice dwelling bat species. No light ingress or direct points of access were identified within V1, however, as there are lifted tiles externally bats may be able to access the loft void via the roof tiles and loosely fitted loft lining.

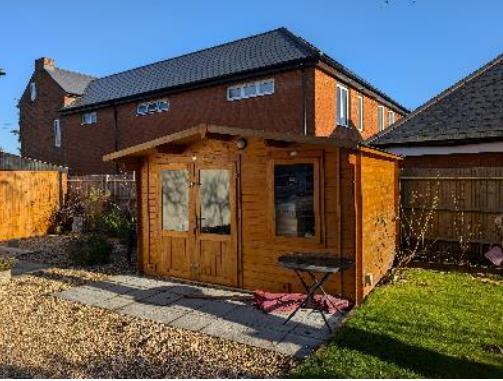
B2 - overview	<p>B2 is a cabin to the southeast of B1 constructed of timber with a gabled, bitumen felt roof (Fig 21), predominantly used for storage. There are windows and doors on the western elevation, along with a large area of overhanging eaves.</p>

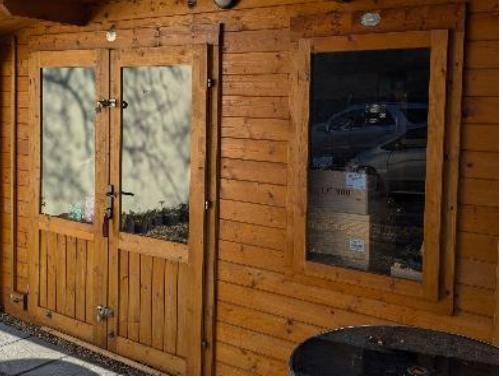
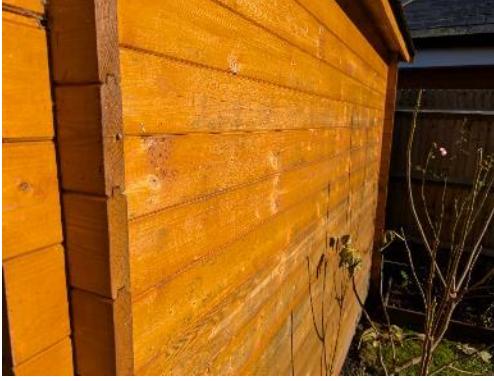
<p><b>Fig 22</b></p> <p><b>Fig 23</b></p> <p>The eaves, including the overhanging eaves to the west, appear to be in good condition (Fig 24), leaving no gaps. The bitumen felt roof appears to be tightly fitted (Fig 25), leaving no gaps.</p>

B2 – exterior	<p><b>Fig 21</b></p> <p>The windows and doors appear to be tightly fitted (Fig 22), leaving no gaps. The timber walls appear to be tightly fitted (Fig 23), leaving no gaps.</p>

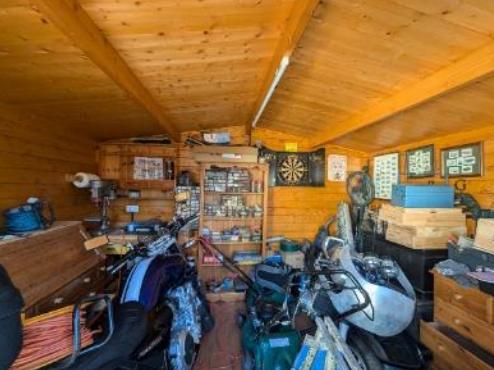
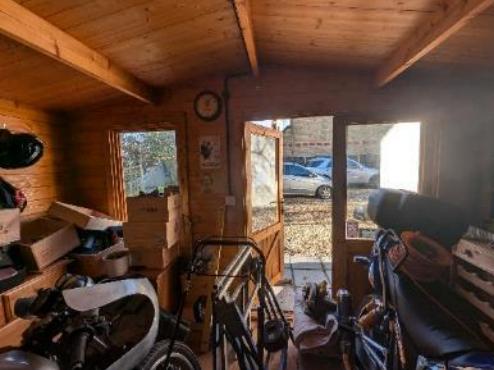
<b>Fig 24</b>	<b>Fig 25</b>
	No external roosting features or points of access were identified on B2.	
B2 – interior	<p>While the interior of B2 has timber roof beams (Fig 26) which could provide a suitable roosting feature for void dwelling bat species, the windows on the western elevation result in high levels of light within B2 (Fig 27), resulting in this being an unsuitable roosting location for void dwelling bat species. In addition, no roosting features suitable for crevice dwelling bat species were identified internally, nor were any points of access.</p>

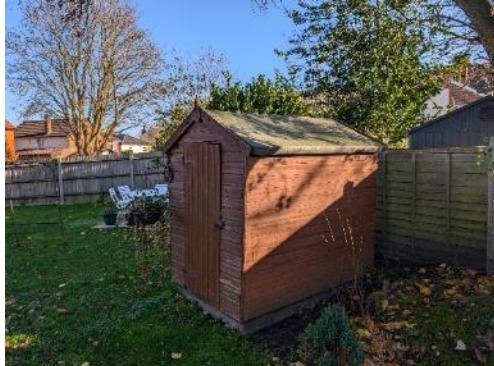
<p><b>Fig 28</b></p>
B3 – exterior	<p>The timber walls appear to be tightly fitted (Fig 29), leaving no gaps. The eaves appear to be in good condition (Fig 30), leaving no gaps.</p>

B3 - overview	<p>B2 is a small shed to the south of site constructed of timber with a gabled roof constructed of chipboard clad with bitumen felt roof (Fig 28), predominantly used for storage. There are no windows on B3, with one door on the northern elevation.</p>

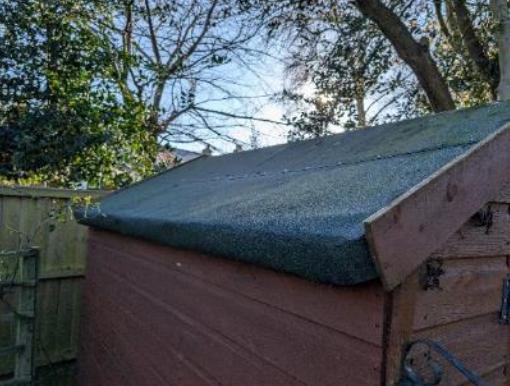
<p><b>Fig 29</b></p> <p><b>Fig 30</b></p> <p>The bitumen felt roof appears to be in good condition (Fig 31), leaving no gaps. The door does not close fully, even when locked (Fig 32), providing a potential point of access for void dwelling bat species.</p>
