Castleman's Cottage

Job No: 225131

Roof Repair: Tied Truss Works

225131 - MNP - XX - XX - SK - S - 4003

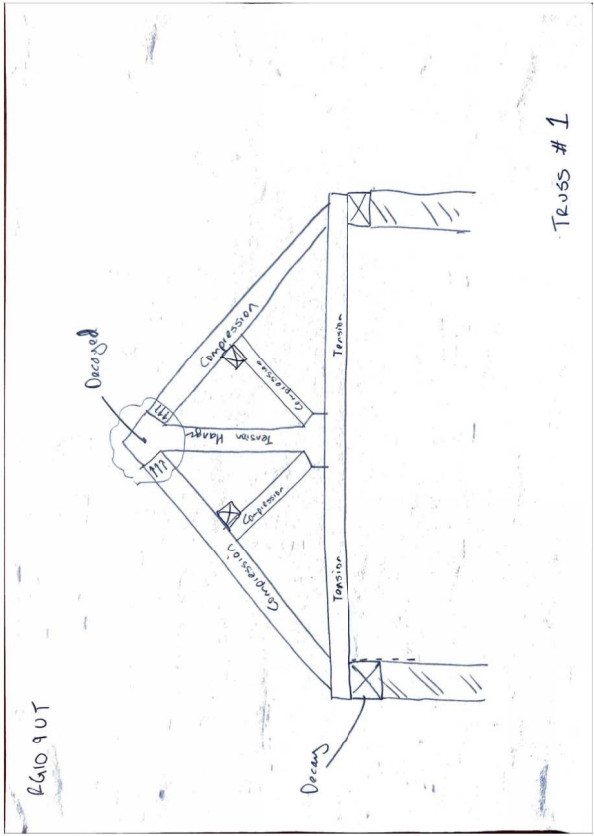
Indicative Side Elevation of a Tied Truss.

- The apex of the truss has decayed (water ingress through ridge intersection)
- The ability of the joint to transfer tensile force (from the central hanger post) to put compressive force into the principal rafter, has been adversely affected.

- After propping the truss from below.
- Reform the joint by cutting away the ends of the two rafters and the post
- Then splicing new ends on to a new replica (mortice and tenon) carpentry joint.
- Spliced connections to be scarf joints with lap length of 3 x depth (ie 300mm) for diagonals and 5x depth from the hanger (ie 500mm).
- Glue joists with Epoxy Resin (by Wessex Resins and Adhesives) and screw together to hold in place during curing.

- no need to prop the truss.
- Add 100mm wide x 5mm thick steel plates to each side and bolt through. Extend plates 500mm beyond decayed timber and use 5No M16 through bolts.
- Suggest applying ply template and drill through to ensure alignment of holes.
