**Castleman's Cottage**

Job No: 225131

**Roof Repair: Collared Truss Works**

225131 - MNP - XX - XX - SK - S - 4004

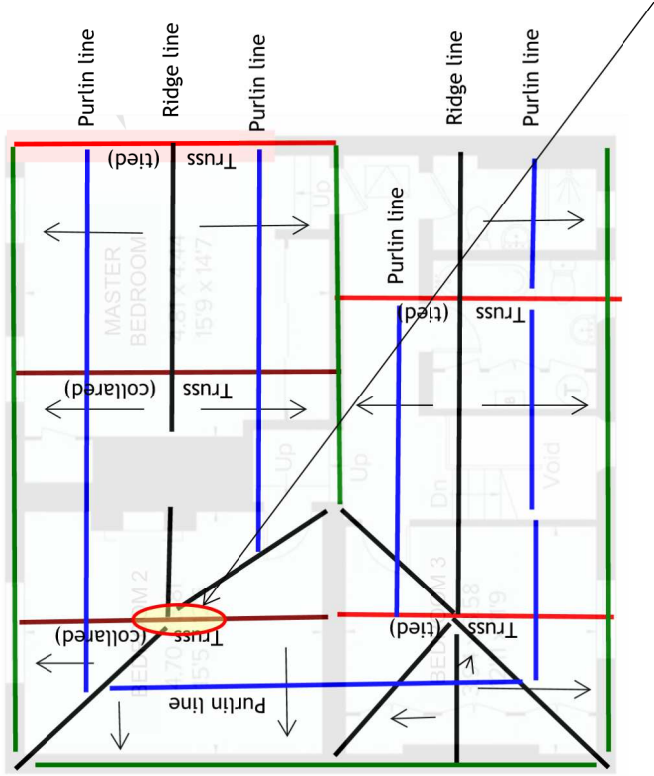
**Schematic layout of roof structure**  
(over 2nd floor layout)

**Problem**

- The apex of the collared truss has decayed (water ingress through ridge intersection)
- The ability of the joint to transfer compressive force from one rafter to the other has been adversely affected.
- NOTE: THE TRUSS RAFTERS ARE HIGHLY STRESSED IN BENDING AND SHOULD NOT BE CUT (on site, see bend at the collar as the rafter foot cantilevers)

**Proposed Remedial Works:**

- no need to prop the truss.
- Add 100mm wide x 5mm thick steel plates to each side and bolt through. Extend plates 500mm beyond decayed timber and use 5No M16 through bolts.

Note: Use of top and bottom plates allows retention of historic ridge seatings.
