# Geotechnical Survey Report

FSI Ref: 25253  
Issue Date: November 2022

Risk Address: 2 Greenside  
Crowthorne  
Berkshire  
RG45 6EX

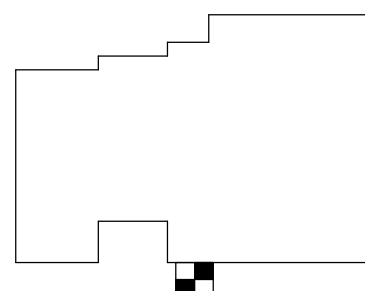
**Trial Pit Location:**

| Water Strikes | Sample and In Situ Testing | | | Depth (m) | Legend | Stratum Description | |
|---|---|---|---|---|---|---|---|
| | | | | | | <u>Foundation top-0.30m (Concrete construct projects 200mm with a thickness of 500mm)</u> | |
| | | | | | | <u>Foundation level-0.80m</u><br><u>Noted to contain hairlike-1mm roots at F/L</u> | |
| | | | | | | <u>Noted to contain hairlike-6mm roots at 1.50m</u> | |
| | | | | | | <u>Noted to contain hairlike-8mm roots at 2.00m</u> | |

Remarks: Borehole closed at 3.00m.  
Borehole noted to be dry on completion.

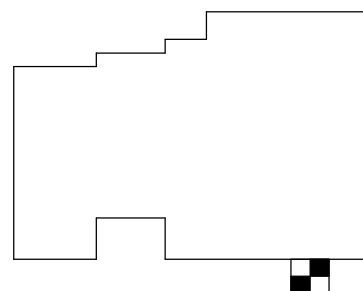
**Trial Pit Location:**

| Water Strikes | Sample and In Situ Testing | | | Depth (m) | Legend | Stratum Description | |
|---|---|---|---|---|---|---|---|
| | | | | | | <u>Foundation top-0.26m (Concrete construct projects 170mm with a thickness of 550mm)</u><br><u>Clay noted to become grey in colour at 0.30m</u> | |
| | | | | | | <u>Foundation level-0.81m</u><br><u>Noted to contain hairlike-1mm roots at F/L</u> | |
| | | | | | | <u>Noted to contain hairlike-5mm roots at 1.50m</u> | |
| | | | | | | <u>Noted to contain hairlike-8mm roots at 2.00m</u> | |

Remarks: Borehole closed at 3.00m.  
Borehole noted to be dry on completion.
