**ADDENDUM ARBORICULTURAL REPORT**

**SUBSIDENCE CLAIM**

**2 Greenside**

15 November 2024

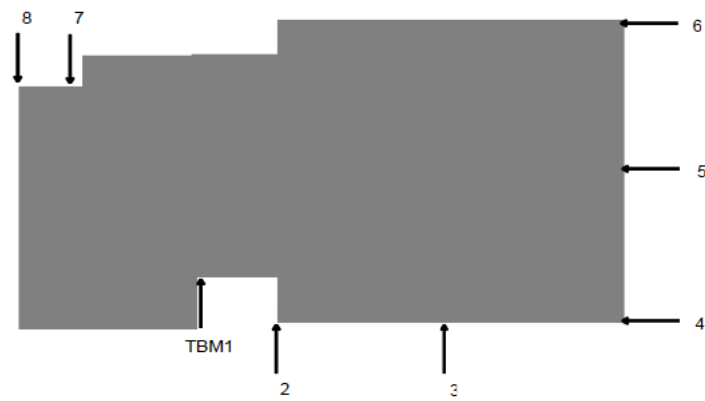
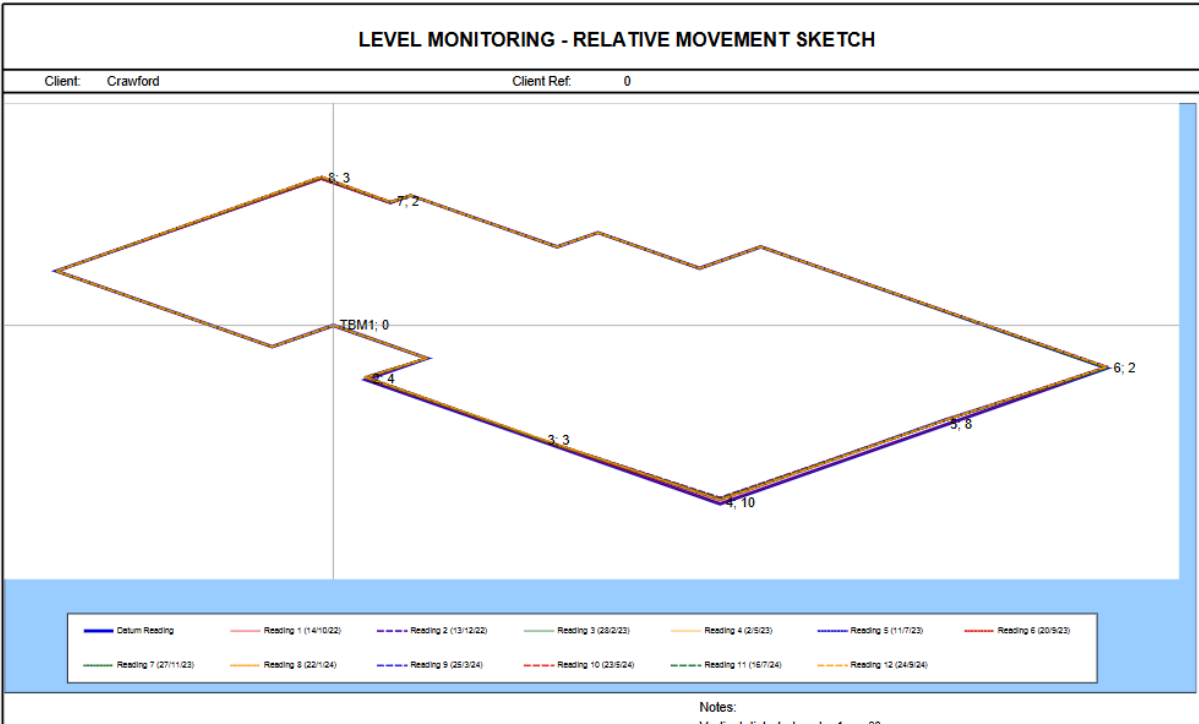
FRONT.

The level monitoring indicates a clear seasonal and cyclical pattern of movement consistent with root induced clay shrinkage with the greatest amplitude of movement being consistent with the location of Oak T4 being the main cause of the movement to the front / front right of the building.
