# SJ Stephens Associates

## Re: Tree at 4 Lake View

DRAWING TITLE  
TREE SURVEY

DRAWING NUMBER  
1536-01

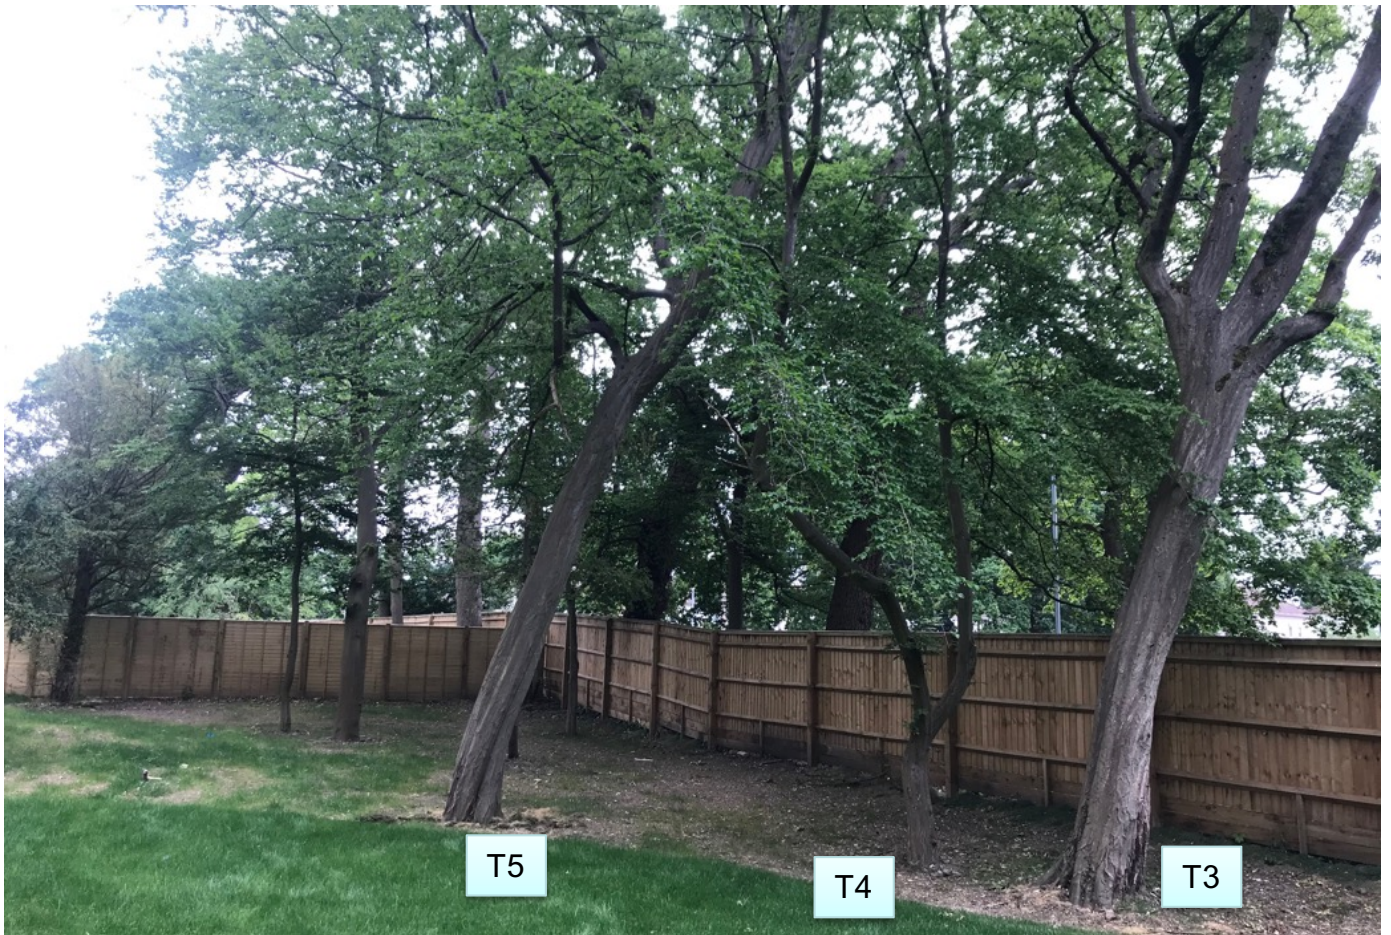
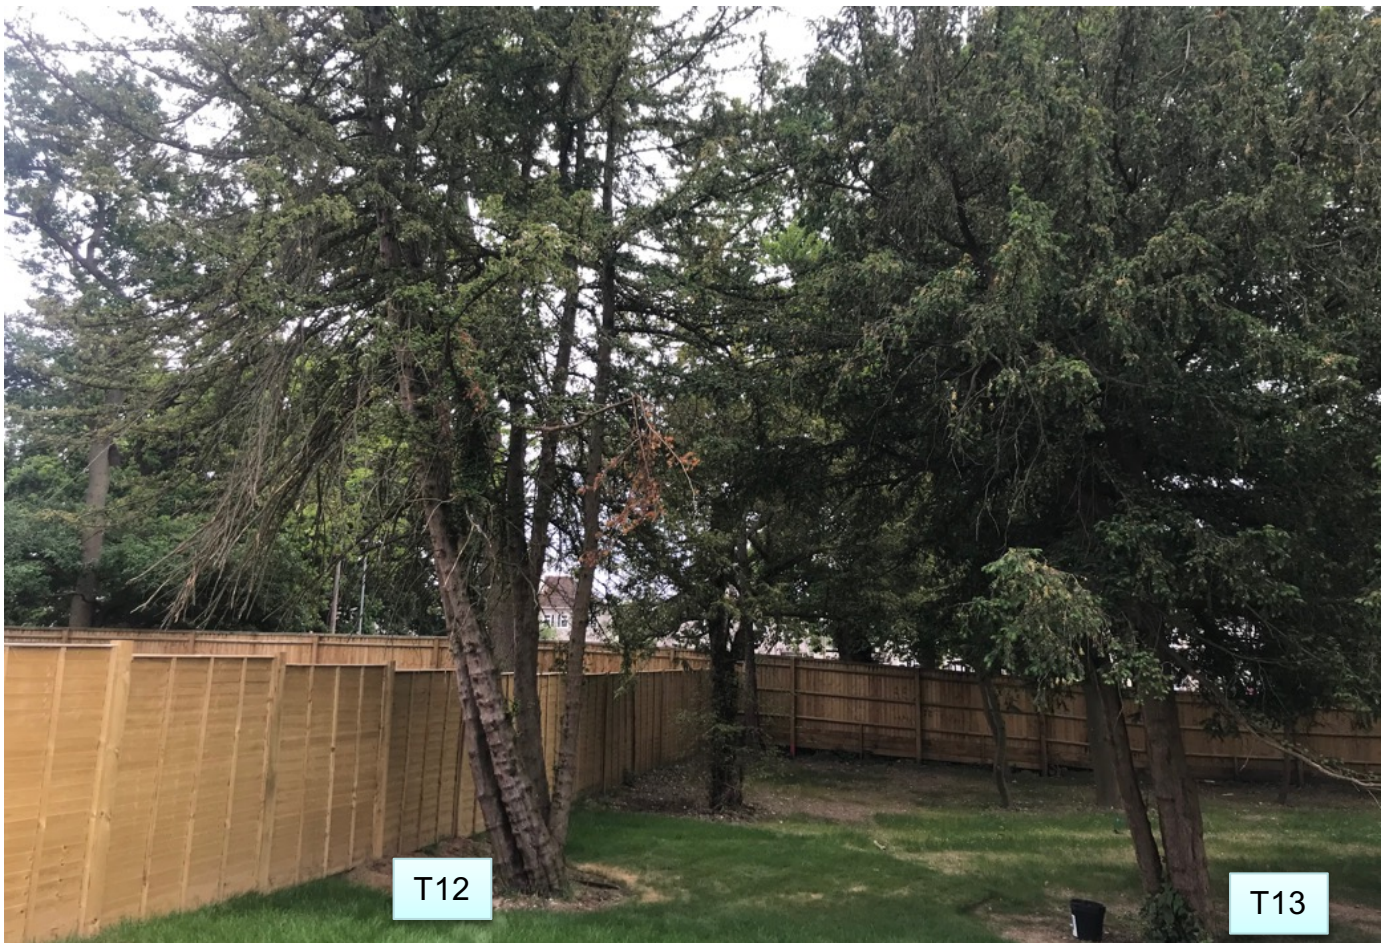
There are 15 trees in the back garden, including yew, beech and hornbeam. These are of mixed quality and it is proposed that lower-quality trees are removed to allow better quality trees to develop, to open up the garden and the to allow additional new tree planting around the perimeter. Nine trees are proposed for removal including T3 a mature hornbeam, leaning over the Waterloo Road, which is showing basal decay and should be removed to reduce safety risks.

The garden has recently been soiled and turfed/seeded by the developer. Soil levels have been raised around the stems of some trees which is likely to lead to basal decay and failure. For retained trees, soil levels should, therefore, be reduced to underlying ground levels around the base of retained trees and graded up to current levels.
