# ARBORICULTURAL IMPACT ASSESSMENT

(INC. TREE SURVEY TO BS 5837:2012)

PROJECT - Land off Church Lane, Shinfield

DOC. REF - P4225-AIA01 V1

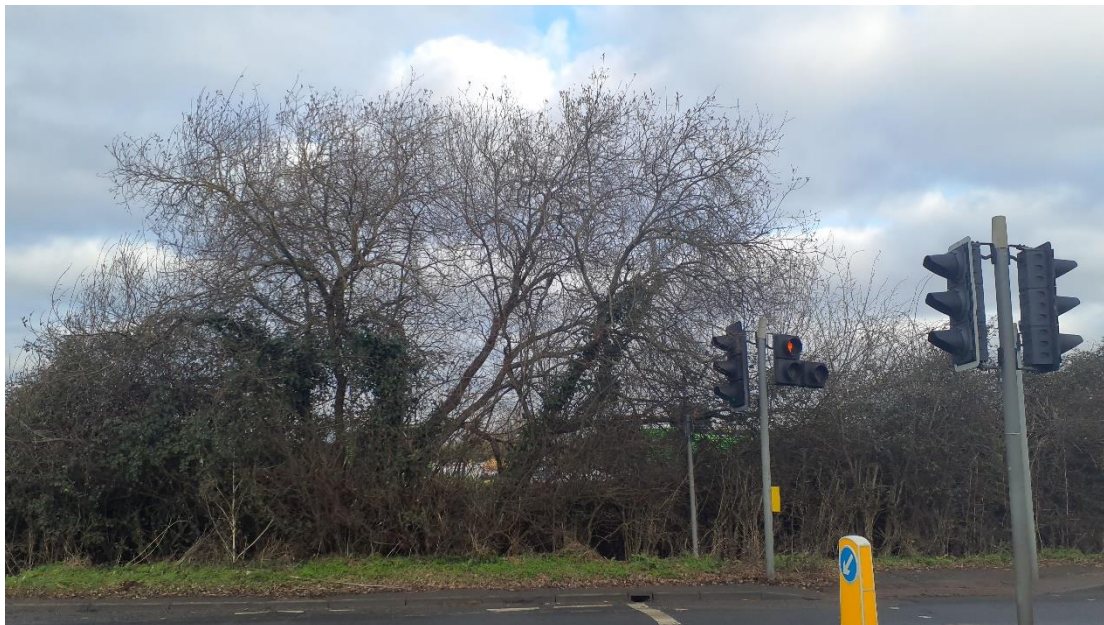
Figure 1 – The south-western corner of the site, pictured from the south. From left to right, G1, T2 and T1 are visible.

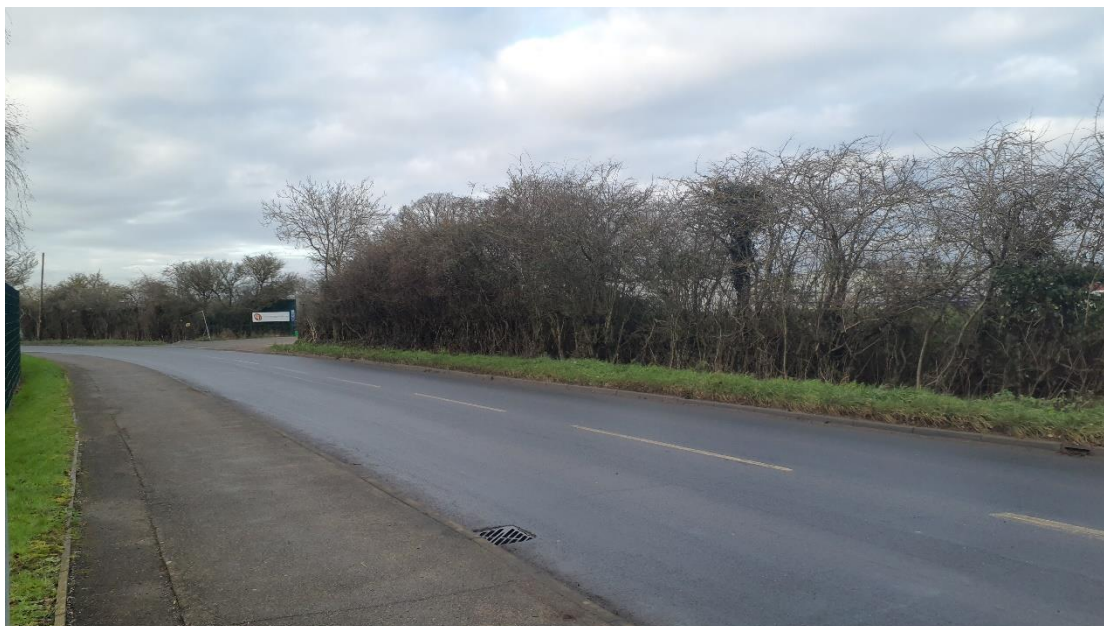
| <b>Impact Appraisal &amp; Mitigation</b> | During the initial installation of the site compound, surfacing was placed within the RPAs of T4, T10, T11, T12, T13, and T14. This is believed to have occurred between 2018 and 2020, resulting in significant root loss and soil compaction within the RPAs of some trees. These impacts are likely the primary cause of their declining vitality. |

Figure 2 – The southern boundary of the site, pictured from the south-east. T4 is visible just to the right of the site entrance, with G1 extending along the verge to the right of the entrance.

As the compound is proposed to remain for another 8 years, measures should be implemented to mitigate the damage and prevent further harm to the affected trees.

- Existing surfacing is to be removed from within the affected RPAs under arboricultural supervision.
- A 0.5m<sup>2</sup> grid will be marked out within the extended rooting area of the tree. At each grid point, an auger or airspade will be used to excavate a 75mm x 400mm deep hole (taking care not to damage roots >20mm diameter).
- The holes will then be filled with a mix of the following (or similar): John Innes No 3 Soil (50%); Organic compost (40%); Slow release fertiliser (5%); Biochar (5%).
- In addition to the above, and to improve, distribute the nutrients added to the holes, and to decompact the existing soil within the tree's rooting area, mixed earth worm colonies will also be introduced to the soil.

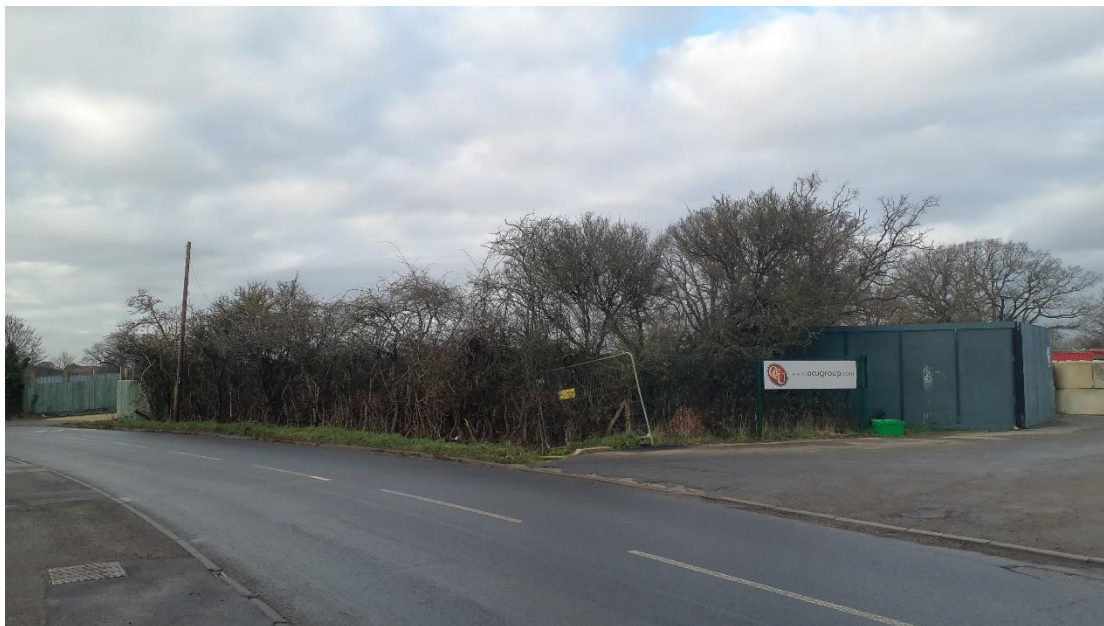
*Figure 3 – The southern boundary of the site, from the entrance to the south-western corner. T5 is visible by the entrance, with G2 running along the verge and T6 visible to the left of the telephone pole.*

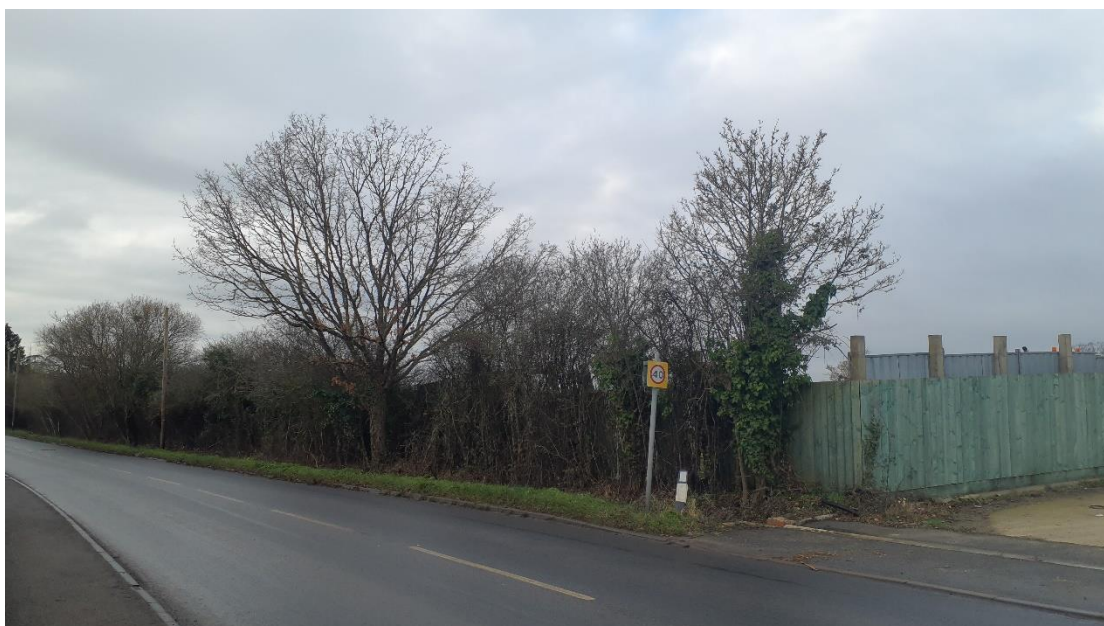
*Figure 4 – T7 and G3. While these trees have been included in the survey, they do not border the OCU Group owned compound.*

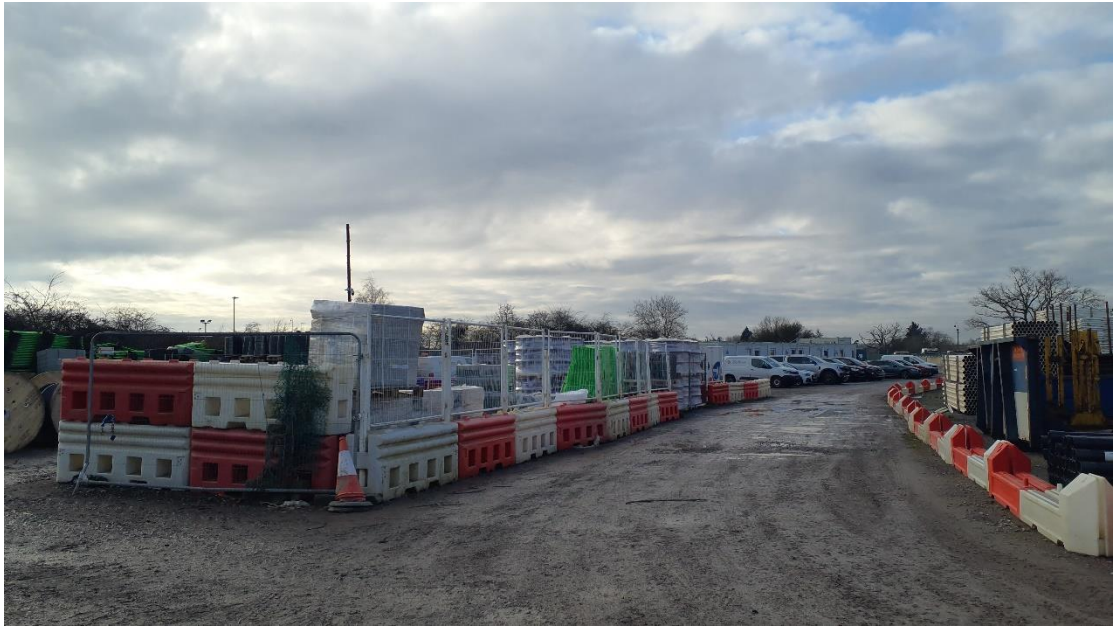
*Figure 5 – The southern boundary, pictured from the north-east. T4 can be seen right of centre.*

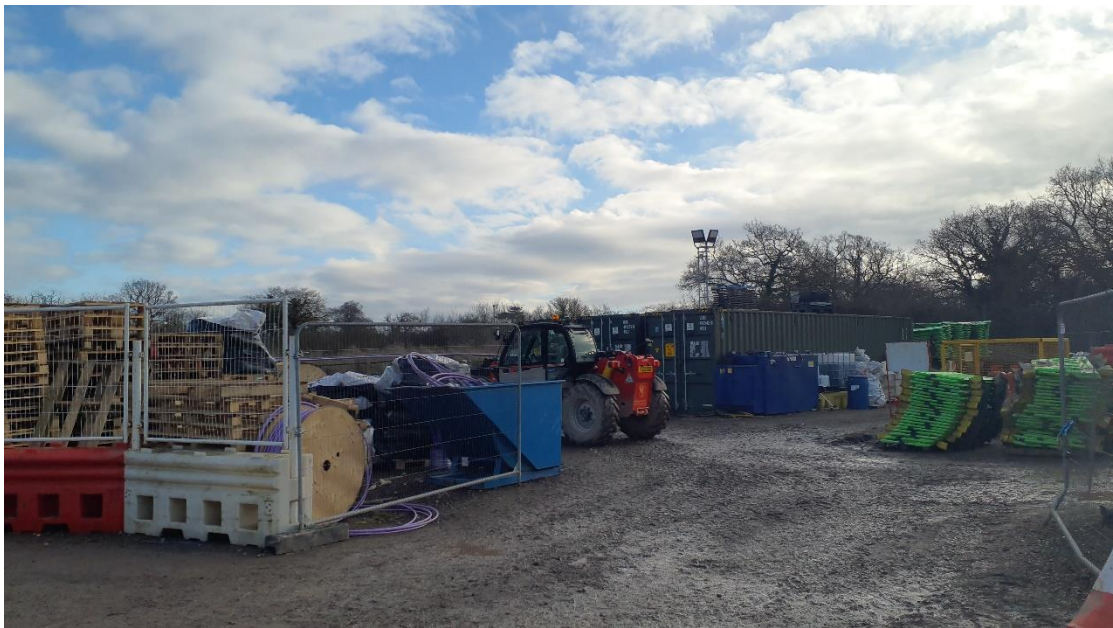
*Figure 6 – The south-eastern corner of the compound, pictured from the north-west. The trees visible to the right are not close enough to the compound to be affected by its retention.*

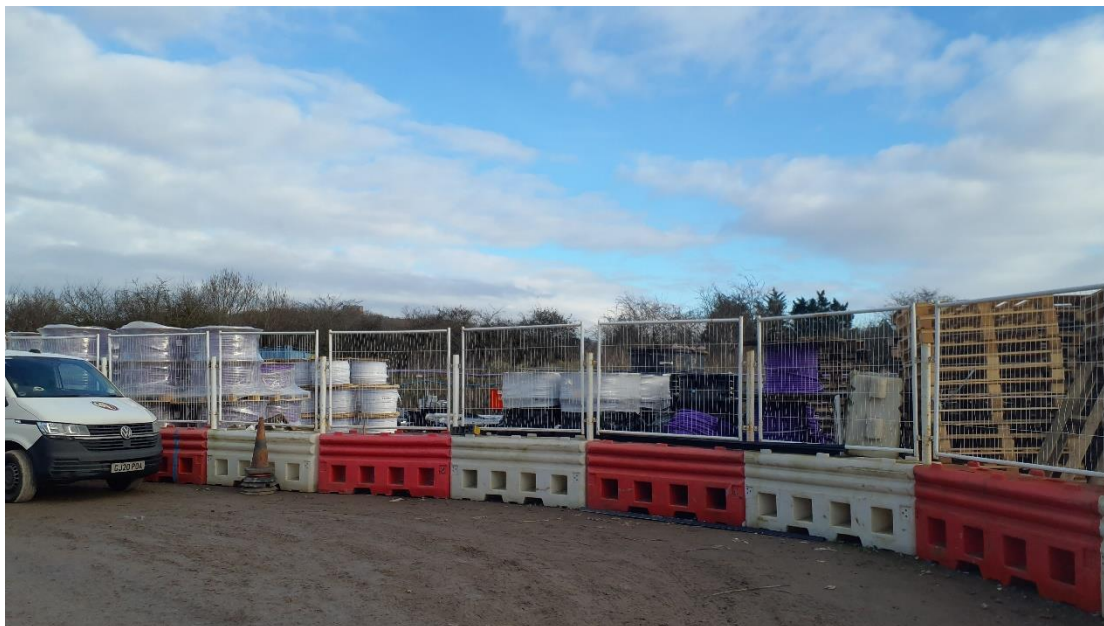
Figure 7 – The eastern boundary of the compound, pictured from the west. No trees or groups are close enough to the compound to be affected by its retention.

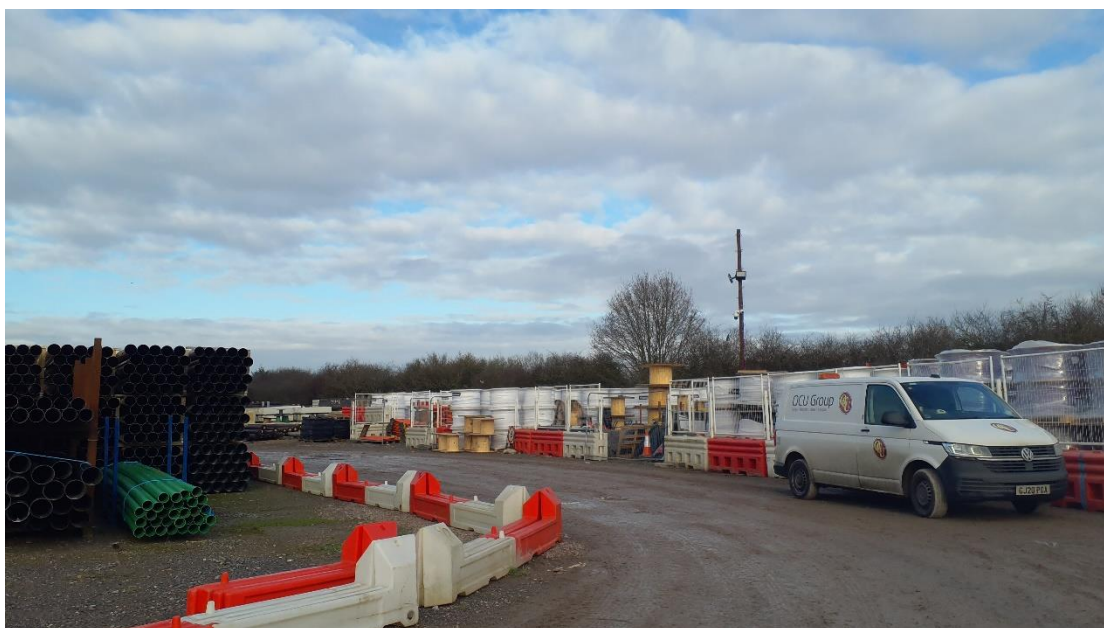
Figure 8 – The eastern boundary of the compound, pictured from the south-west. T8 can be seen centre frame. No trees in this picture are close enough to the compound to be affected by its retention.

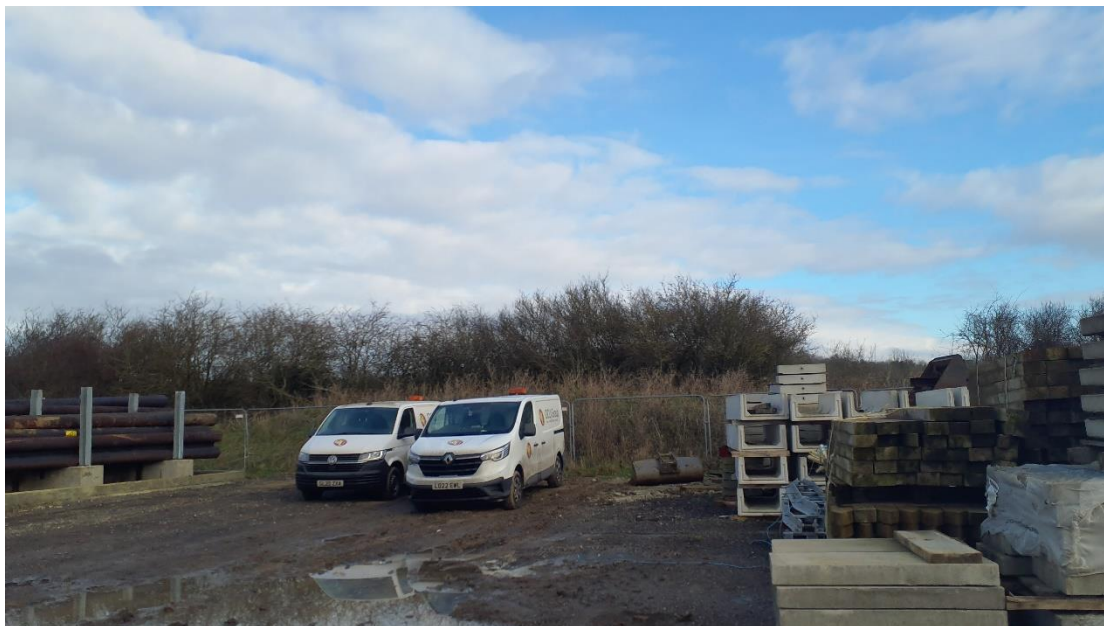
*Figure 9 – The north-eastern corner of the site, pictured from the south-west. No trees pictured are close enough to the compound to be affected by its retention.*

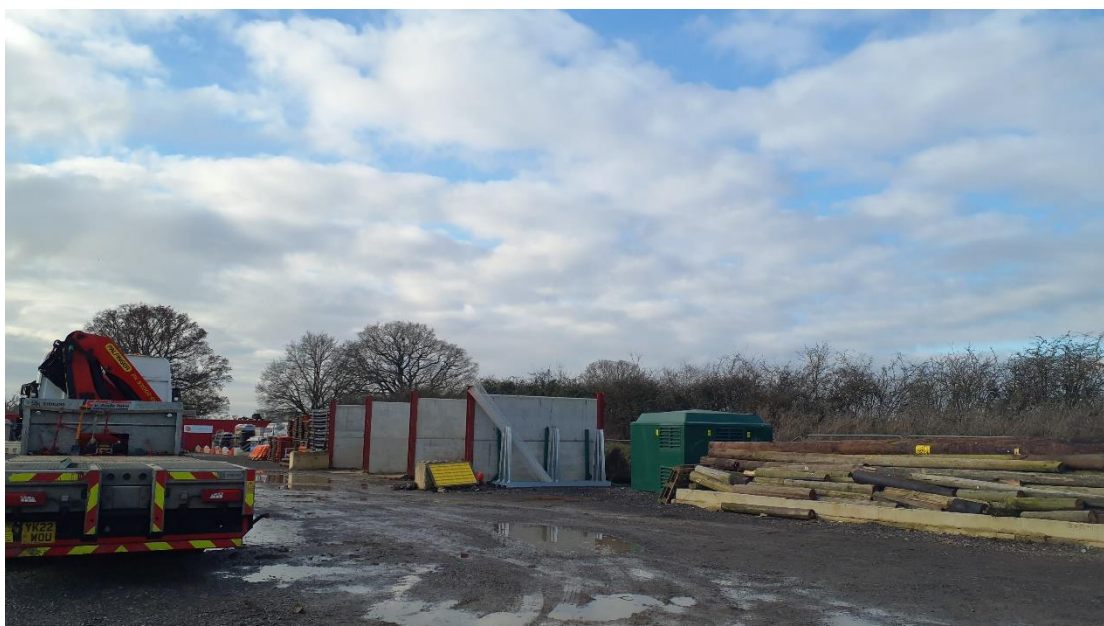
*Figure 10 – The northern boundary of the site, pictured from the south-east. T9 can be seen left of centre. T11 can be seen left of frame. No trees to the north of the compound are close enough to be affected by its retention.*

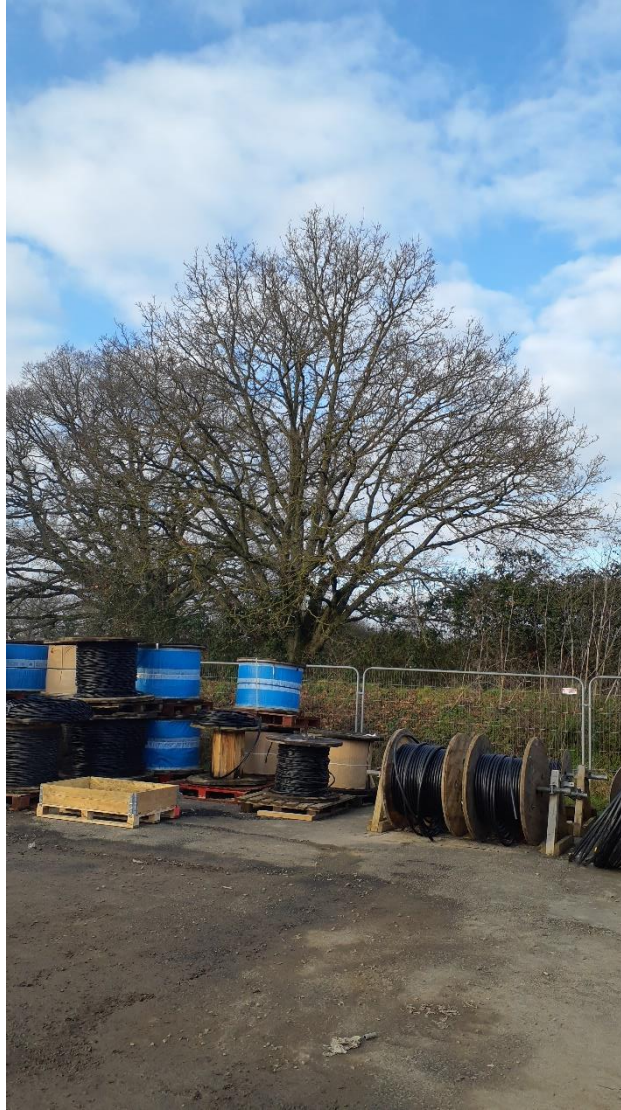
*Figure 13 – T9, pictured from the south-east.*
