Meadow Cottage  
18, Primrose Lane  
Winnersh  
Wokingham  
RG41 5UR

Structural Inspection  
of the rear chimney stack

Clive Hudson Associates  
Consulting Structural & Civil Engineers

April 2026  
Project Ref: 267040

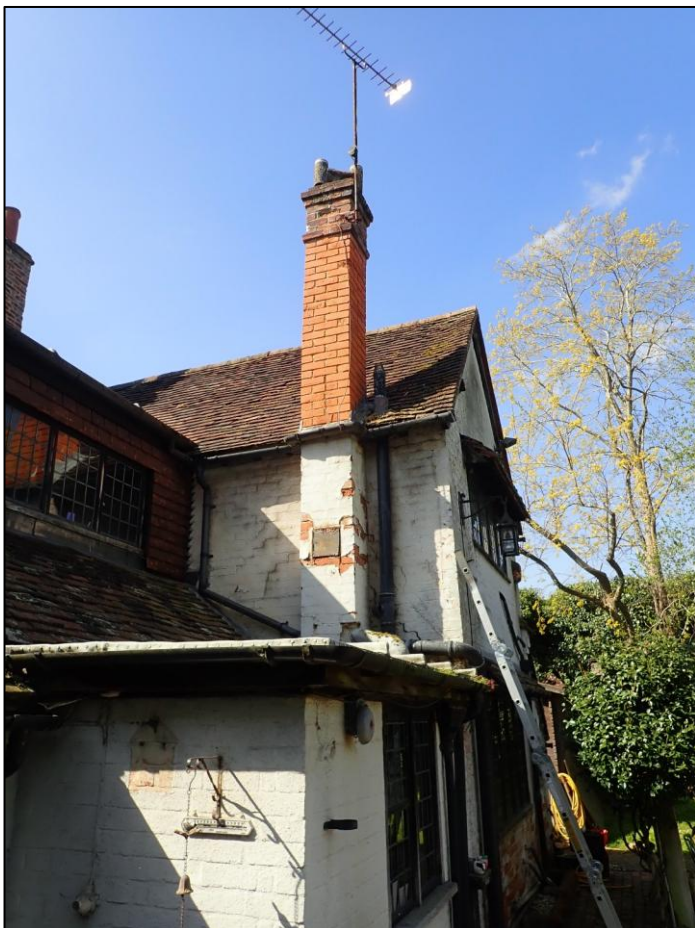
The chimney stack inspected is located on the east elevation of the two-storey rear extension, on the north-west corner of the property (Fig. 4).

Figure 4. View of the chimney stack at the rear of the property.

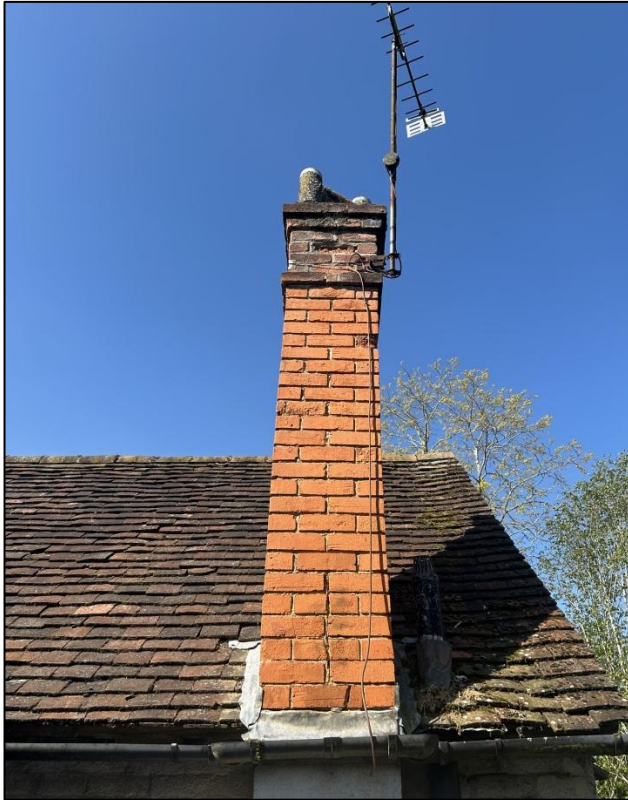
Figure 7.  
View of the east face of the  
stack above the eaves.

- vi. Above the eaves, the mortar is set back (recessed) from the face of the brickwork which, while it is not a structural defect in itself, is a poor detail as it exposes the brick arises and the mortar to rain, frost, and wind-driven moisture. Although a detailed inspection of the masonry above the eaves was not possible, limited access from the flat roof indicated sections of the mortar were very friable, and the low-level inspection hatch was found to contain loose mortar dust and brick

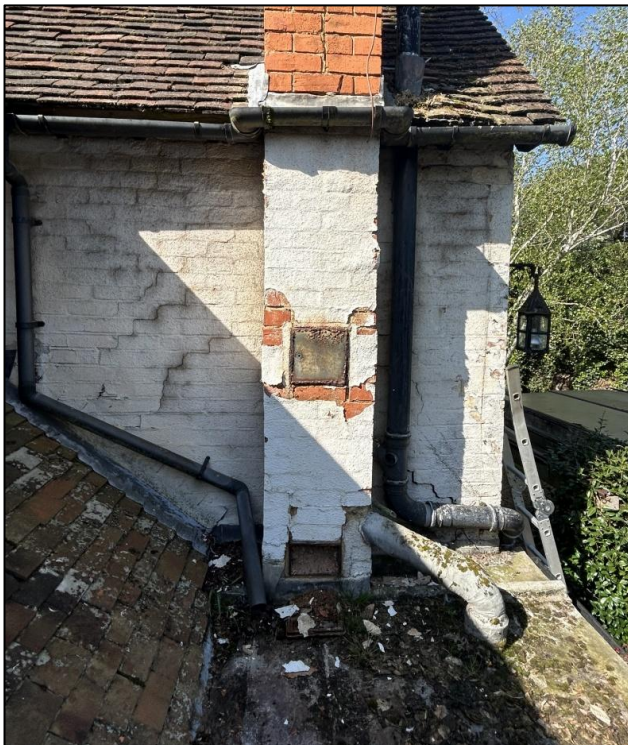
Figure 8.  
View of the east face of the  
stack below the eaves.

fragments (Fig.17). This indicates ongoing weathering and deterioration of the stack, consistent with the vulnerability created by the recessed joints and the inappropriate use of modern masonry paints below the eaves. If the stack were to be retained, then we would recommend that repairs are undertaken. Subject to a more detailed inspection of the bed joints above the eaves, it is likely that it would be necessary to dismantle the stack first before rebuilding it if it were to be retained.
