## ARBORICULTURAL REPORT

TREE CONDITION SURVEY & MITIGATION STRATEGY

WATERLOO COTTAGE  
BATH ROAD  
KNOWL HILL  
WOKINGHAM  
BERKSHIRE  
RG10 9UP

Ref: 06408/2024 0.3

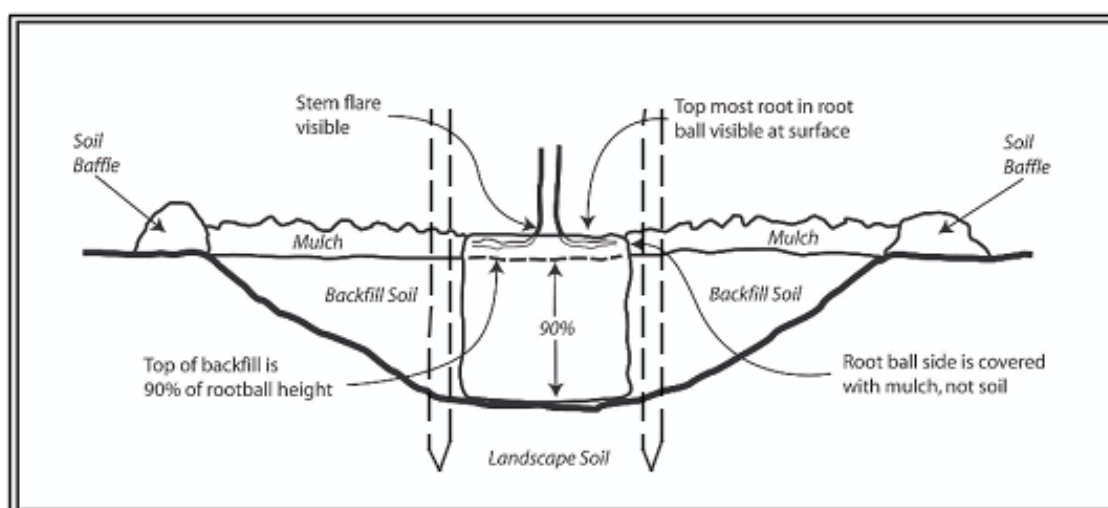
Figure 8. Tree Planting Pit specification

The width of the planting pit will be a minimum of one and a half times as large as the root-ball/container and up to a maximum of two times as wide, if the soil is very compacted. This means that a root-ball of 40cm wide will be planted in a hole at least 60cm wide. The soil backfilled into the planting pit will consist of 1/3 organic matter (well rooted manure or other compost) with 2/3 existing soil.

The standard trees (with a clear stem to 2m) will be staked with two stakes and a cross bar set as low down the tree as possible to allow for canopy and stem movement whilst supporting the structural function of the root system.
