# Subsidence Tree Report

## For William Hunt Consulting

**Property:** South Lodge, Wellington Court, Spencers Wood, RG7 1BN

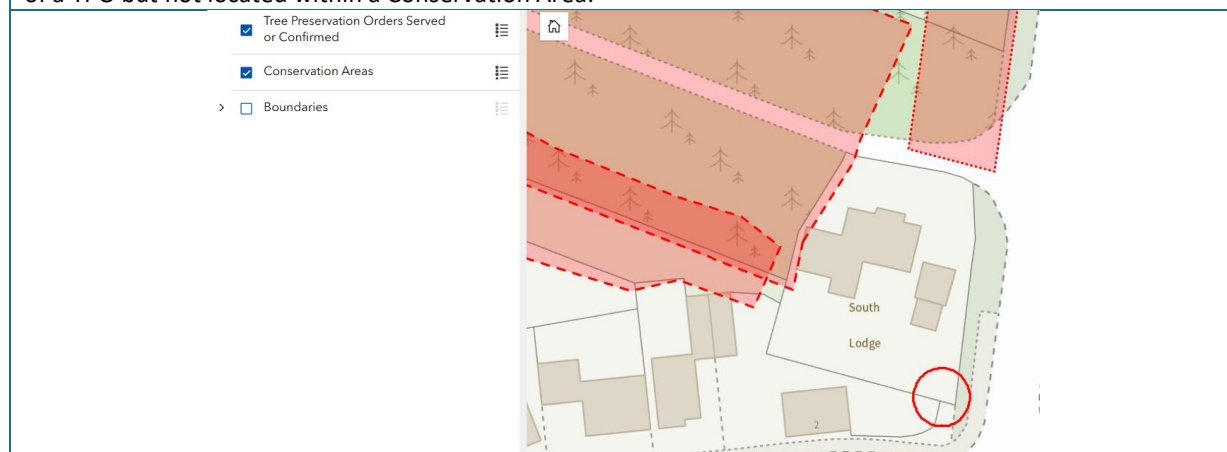
**Fig 1 – Trees referenced as T1, T2, T3, T5 & T6 within this report appear subject to a TPO. The property and trees are not located within a Conservation Area.**

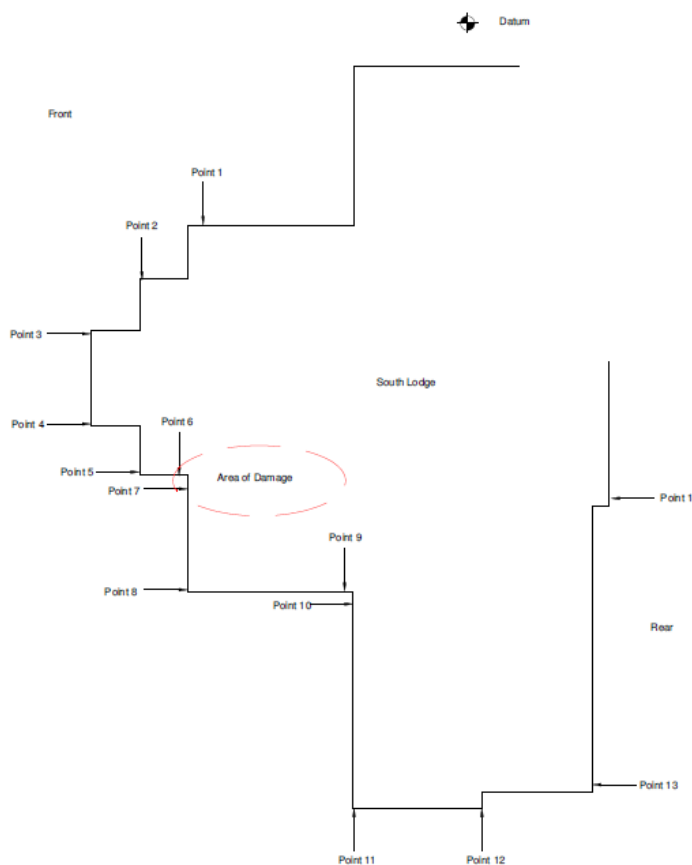
5.14 Level monitoring is available monitoring for the period 17.11.2015 to 26.9.2017. 5 sets of readings are available for 7 locations. The readings are made relative to a deep datum.

**Fig 4 – Advised level monitoring locations.**
