## BS:5837 ARBORICULTURAL REPORT

ARBORICULTURAL SURVEY, IMPACT ASSESSMENT &  
METHOD STATEMENT

37 COMMONS ROAD  
WOKINGHAM  
BERKSHIRE  
RG41 1JJ

Ref: AIA/AMS 06414/ 2024

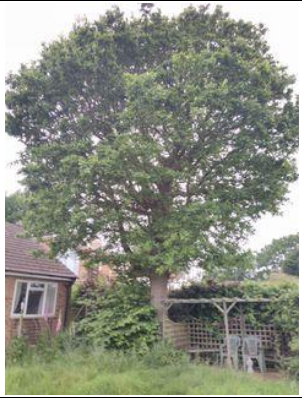
| Ref. | Species | Structure | Measurements | Spread | General Observations | Retention Category | RPA | Summary | Photo |
|---|---|---|---|---|---|---|---|---|---|
| T001 | Pedunculate oak<br>(Quercus robur) | Tree | Height (m): 10<br>Stem Diam(mm): 540<br>Crown Clearance (m): 3.5<br>Life Stage: Mature<br>Rem. Contrib.: 40+ Years | N:5<br>E:4.5<br>S:5<br>W:5 | Base and lower trunk obscured by dense vegetation. Small tree with compact canopy maintained by regular pruning. | B1,2 | Radius: 6.5m.<br>Area: 133 sq m. | Physiological Condition: Good<br>Structural Condition: Fair<br>Public Amenity Value: Moderate<br>Inspection Limitations: Dense vegetation | |

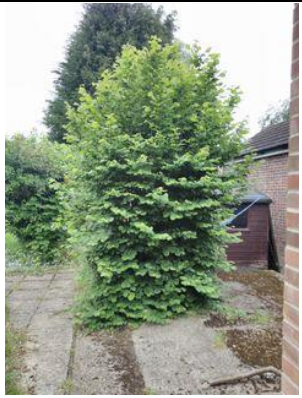
| Ref. | Species | Structure | Measurements | Spread | General Observations | Retention Category | RPA | Summary | Photo |
|---|---|---|---|---|---|---|---|---|---|
| T002 | Hazel<br>(Corylus avellana) | Tree | Height (m): 3.5<br>Stem Diam(mm): 300<br>Crown Clearance (m): 0<br>Life Stage: Mature<br>Rem. Contrib.: 20+ Years | N:1.5<br>E:1.5<br>S:1.5<br>W:1.5 | Mature coppice stool | C2 | Radius: 3.6m.<br>Area: 41 sq m. | Physiological Condition: Fair<br>Structural Condition: Fair<br>Public Amenity Value: Low | |

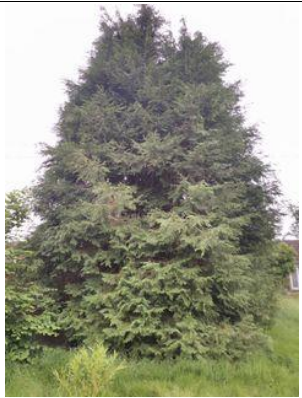
| Ref. | Species | Structure | Measurements | Spread | General Observations | Retention Category | RPA | Summary | Photo |
|---|---|---|---|---|---|---|---|---|---|
| T003 | Lawson cypress<br>(Chamaecyparis lawsoniana) | Tree<br>4 stems | Height (m): 9<br>4 stems, avg.(mm): 300<br>Crown Clearance (m): 0<br>Life Stage: Mature<br>Rem. Contrib.: 20+ Years | N:3<br>E:3<br>S:3<br>W:3 | Multistem from ground level previously topped at 4m. Multiple leaders in upper crown. Stems strapped together. Poor form. | C1 | Radius: 7.2m.<br>Area: 163 sq m. | Physiological Condition: Fair<br>Structural Condition: Physical Defect<br>Public Amenity Value: Moderate<br>Inspection Limitations: Low canopy | |

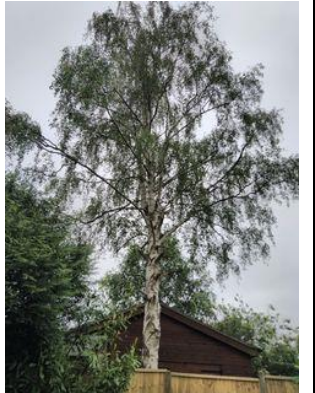
| Ref. | Species | Structure | Measurements | Spread | General Observations | Retention Category | RPA | Summary | Photo |
|---|---|---|---|---|---|---|---|---|---|
| T004 | Silver birch<br>(Betula pendula) | Tree | Height (m): 12<br>Stem Diam(mm): 350<br>Crown Clearance (m): 4<br>Life Stage: Mature<br>Rem. Contrib.: 20+ Years | N:4<br>E:4<br>S:4<br>W:4 | Offsite tree. Low overhanging branches cut back to trunk where they overhang garden of number 37. | B1 | Radius: 4.2m.<br>Area: 55 sq m. | Physiological Condition: Good<br>Structural Condition: Fair<br>Public Amenity Value: Moderate<br>Inspection Limitations: Access | |

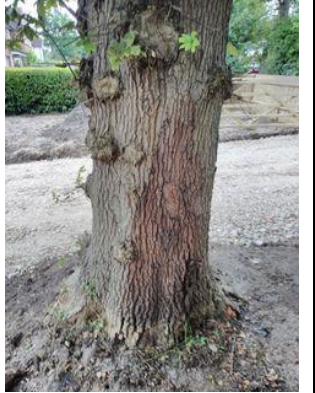
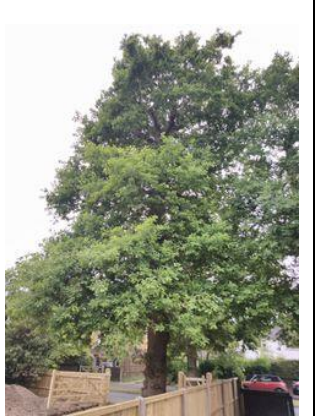
| Ref. | Species | Structure | Measurements | Spread | General Observations | Retention Category | RPA | Summary | Photo |
|---|---|---|---|---|---|---|---|---|---|
| T005 | Pedunculate oak<br>(Quercus robur) | Tree | Height (m): 11<br>Stem Diam(mm): 650<br>Crown Clearance (m): 2<br>Rem. Contrib.: 20+ Years | N:3.5<br>E:3.5<br>S:3<br>W:3 | Offsite tree. May be affected by current grounds works at front of neighbouring property. Canopy formed of mature epicormic growth on trunk. Foliage dense, good vitality. | B1 | Radius: 7.8m.<br>Area: 191 sq m. | Physiological Condition: Good<br>Structural Condition: Fair<br>Public Amenity Value: Good<br>Inspection Limitations: Access | |
