# CASTLEMANS COTTAGE ROOF REPAIRS

**Planning Portal Reference: PP-13905061**

**BCS Reference: 25/0784/OTHBN**

This document forms part of an application for listed building consent sought for the repairs to the existing second storey tiled roof.

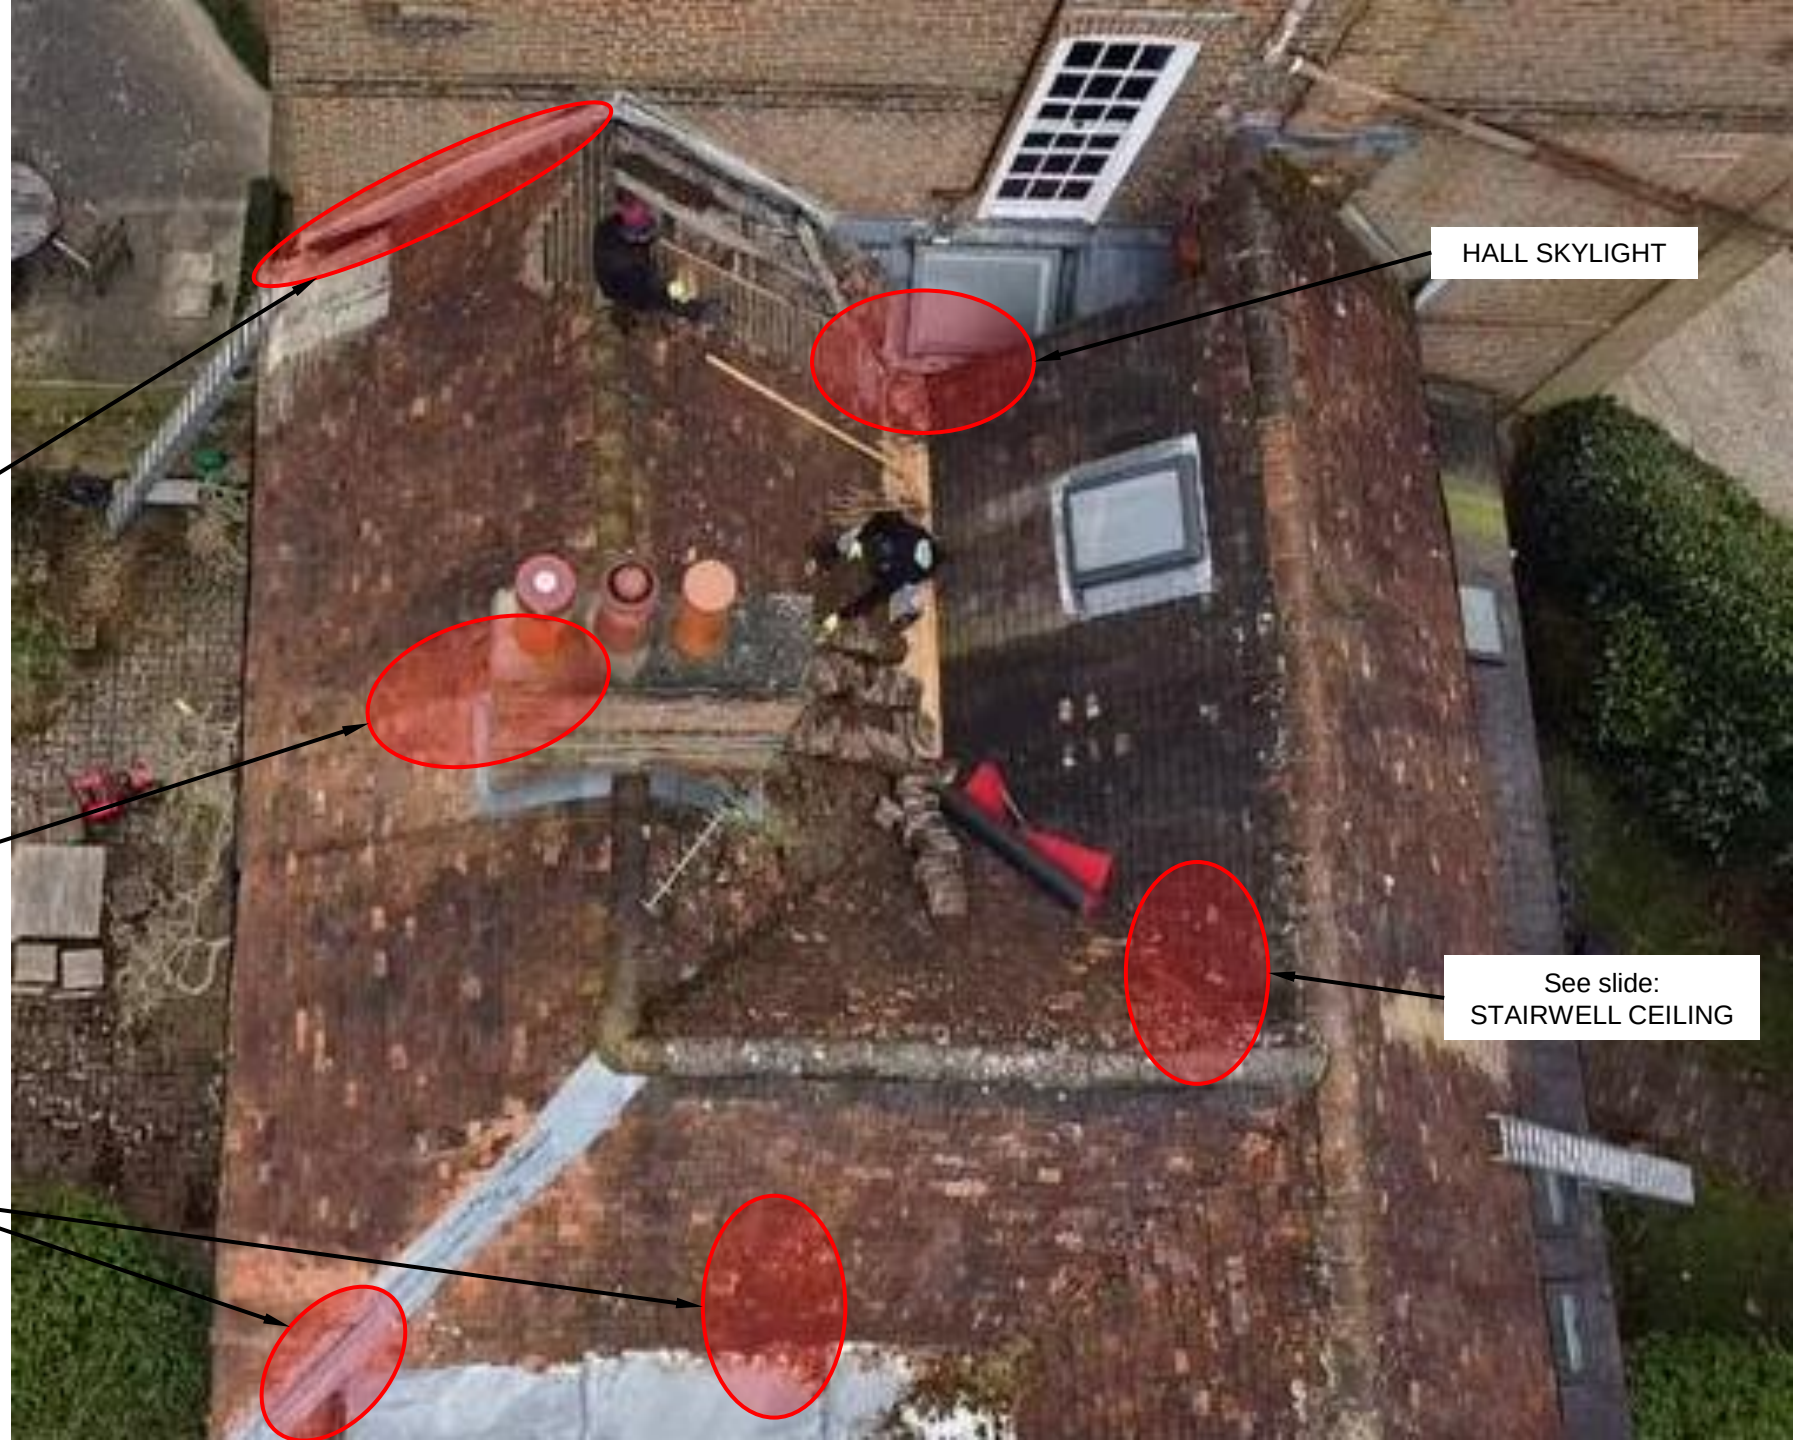
# MAP SHOWING LOCATIONS OF WATER INGRESS

INDICATES REGION WHERE SIGNS OF  
WATER INGRESS ARE VISIBLE ON  
INTERNAL DECOR

See slide:  
MASTER BEDROOM  
ABUTTING WALL TO CASTLEMANS HOUSE

See slide:  
MASTER BEDROOM  
CHIMNEY BREAST

See slide:  
BEDROOM 2

HALL SKYLIGHT

See slide:  
STAIRWELL CEILING

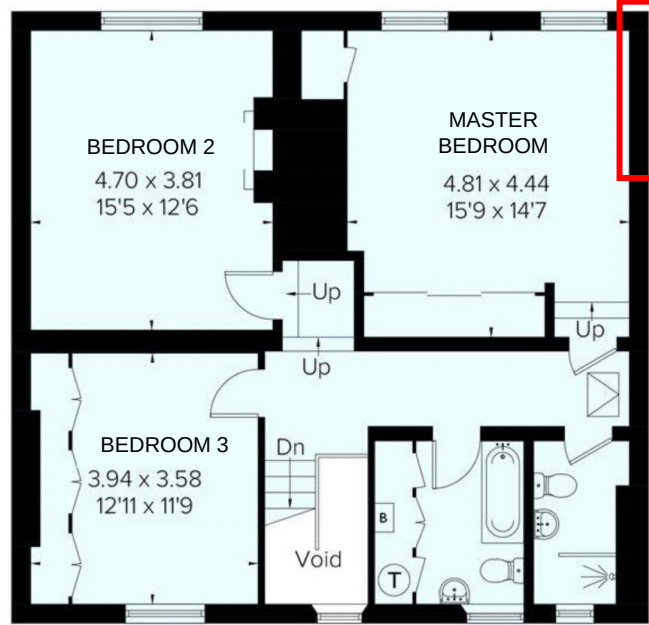
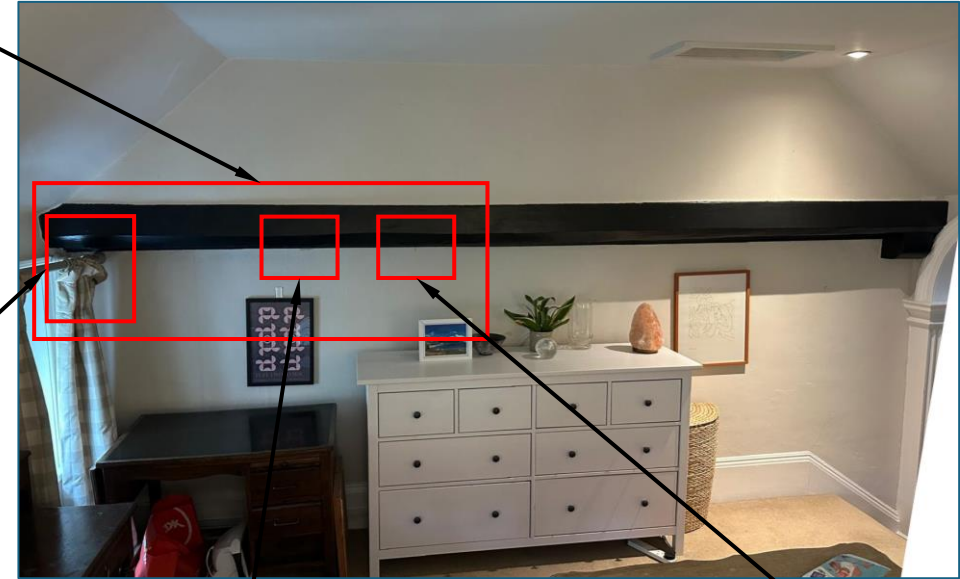
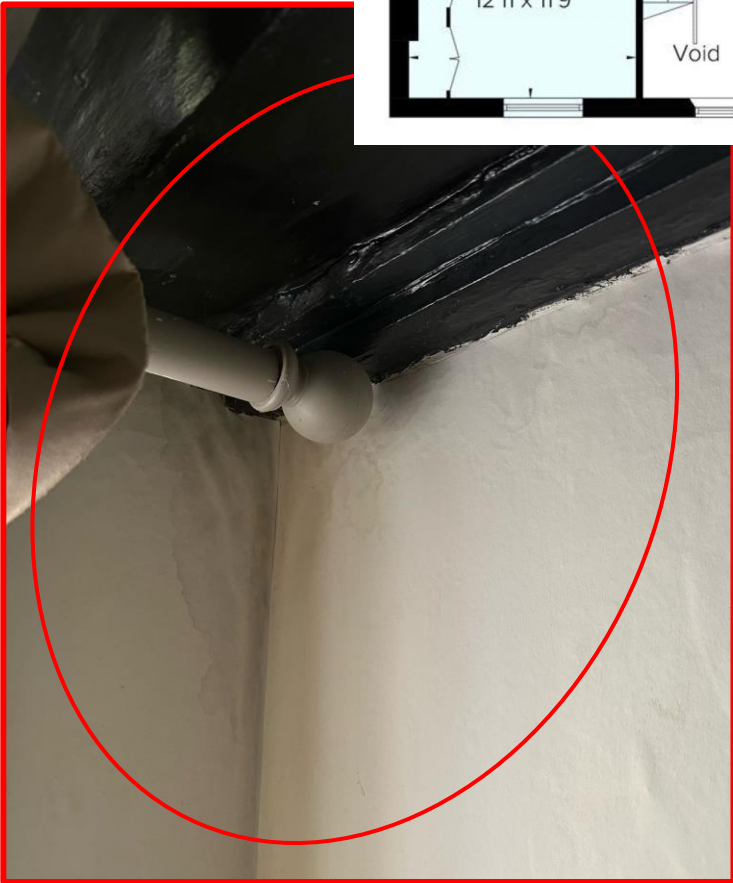
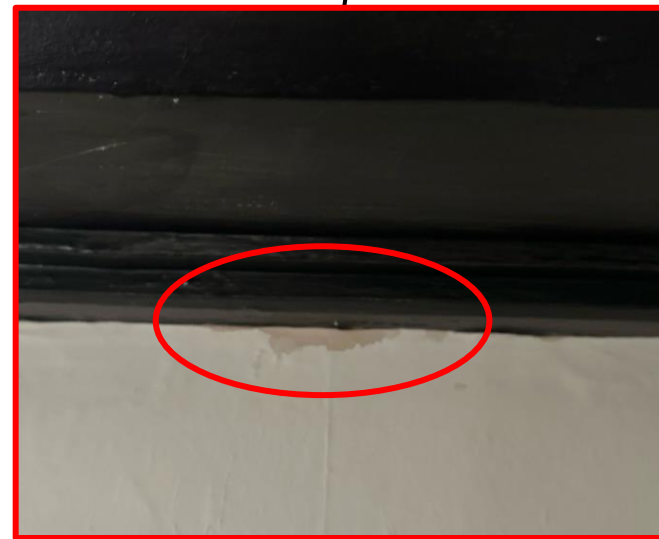
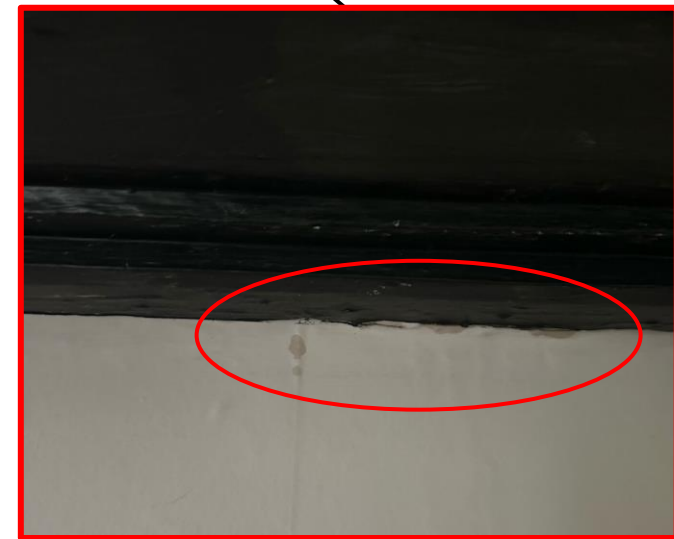
# MASTER BEDROOM ABUTTING WALL TO CASTLEMANS HOUSE

STAINING ON WALL  
CAUSED BY IMPROPER FLASHING/JOINT DETAIL TO  
ABUTTING WALL  
PROPOSED STEPPED LEAD FLASHING WITH  
SOAKERS (TO MATCH EXISTING DETAIL ON  
CHIMNEY)

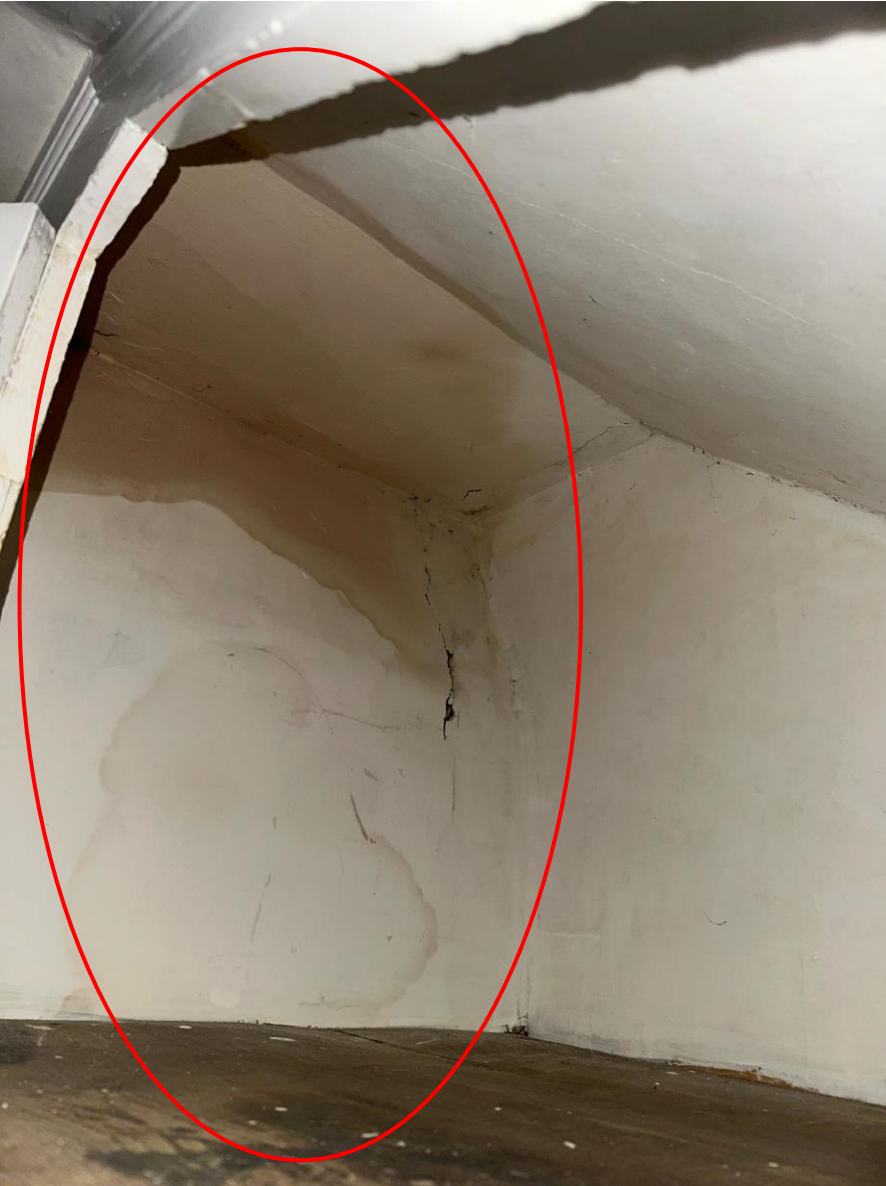
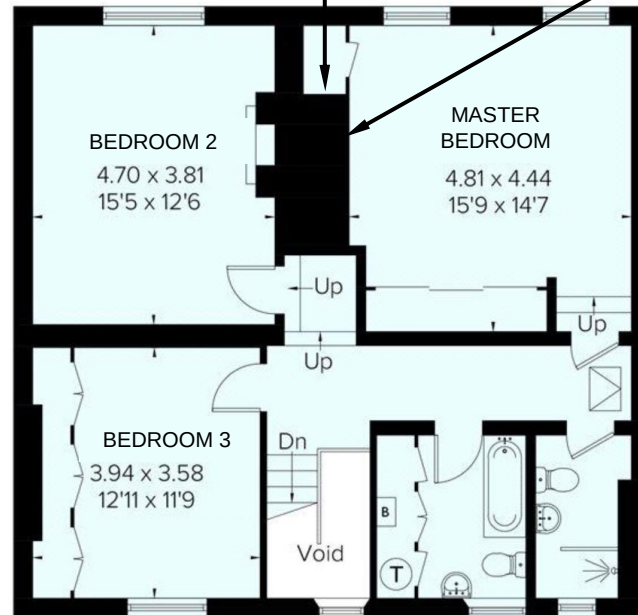
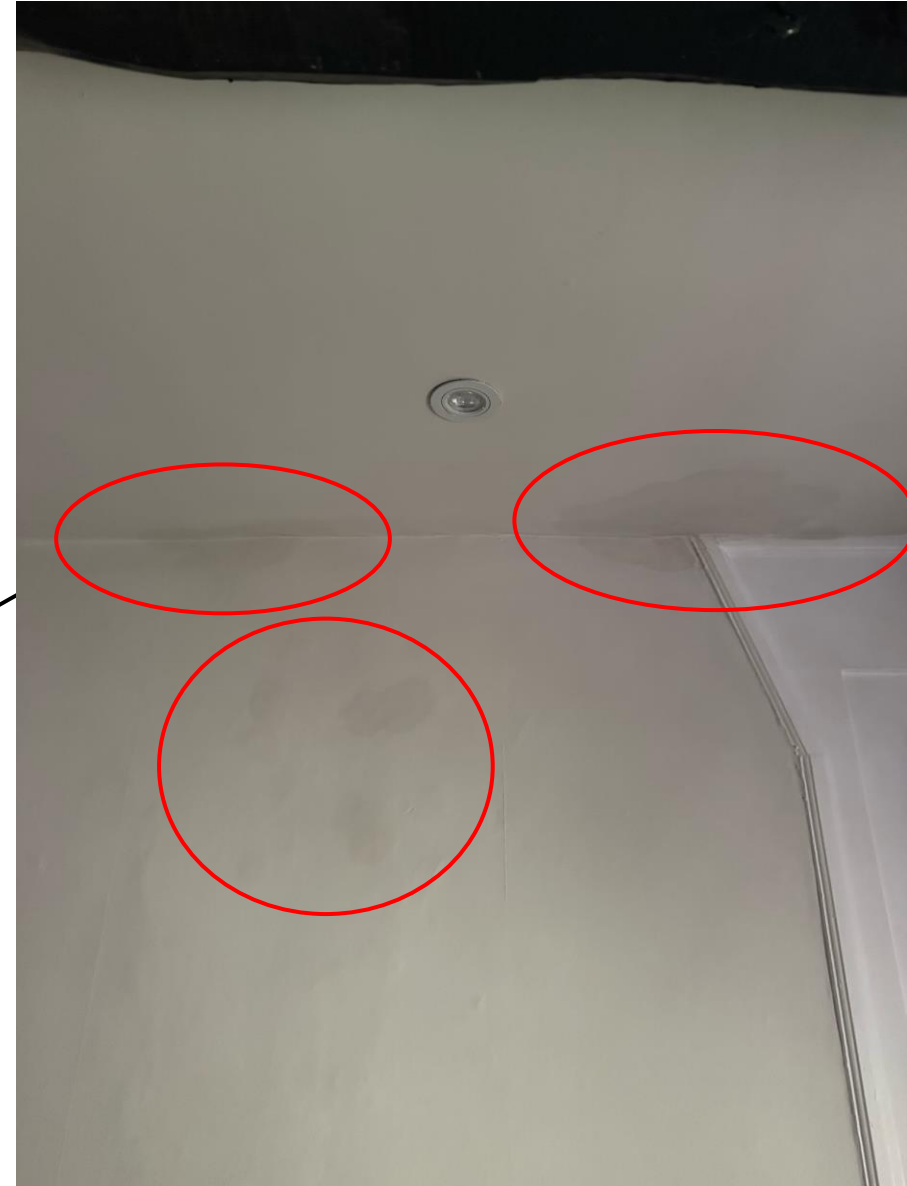
# MASTER BEDROOM CHIMNEY BREAST

CEILING TIMBERS DAMP, CHIMNEY BRICKWORK IN  
LOFT SPACE DAMP/DISINTEGRATING  
CAUSE LIKELY IMPROPER FLASHING DETAIL, HOLE  
IN FELT, BROKEN TILES  
PROPOSED STEPPED LEAD FLASHING WITH  
SOAKERS AND BREATHABLE FELT  
FIGURE 2.1 / PAGE 21

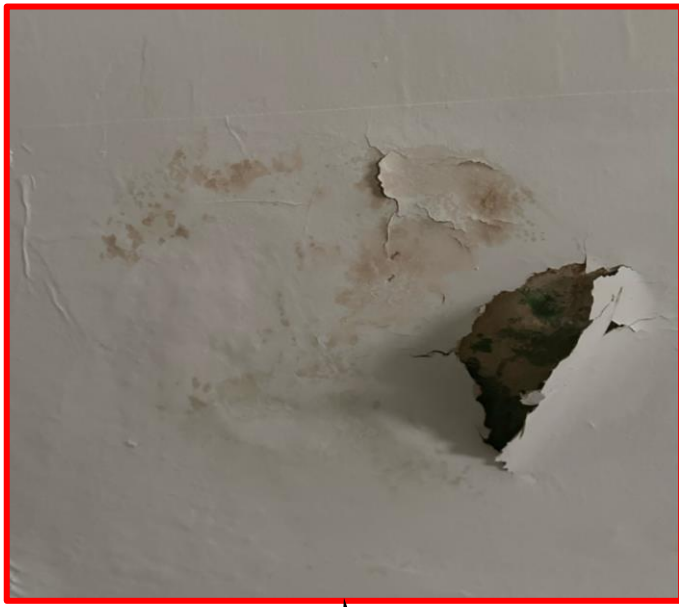
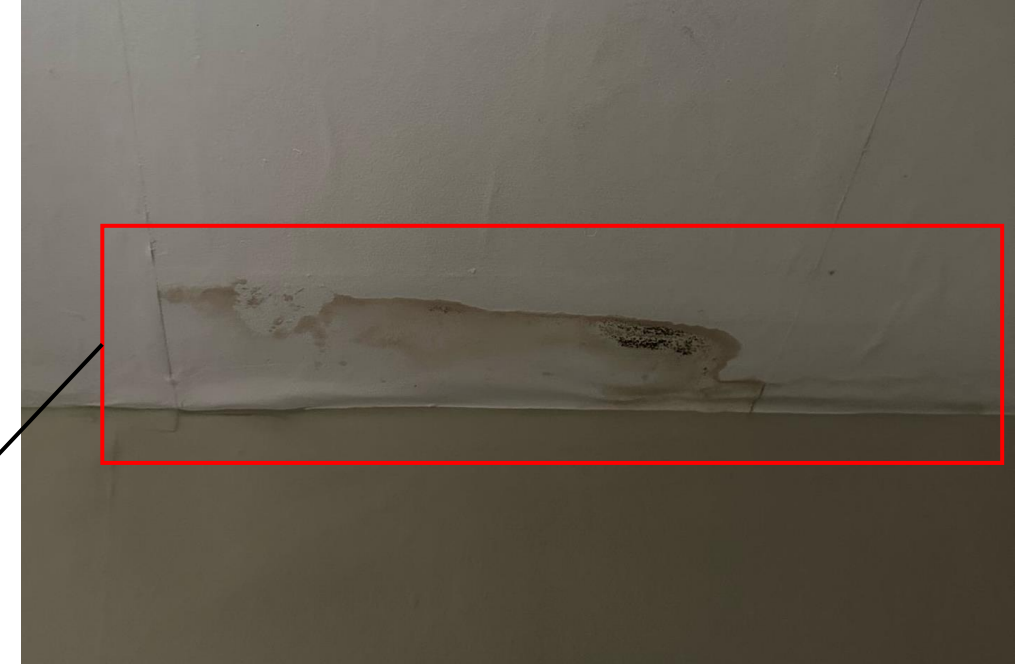
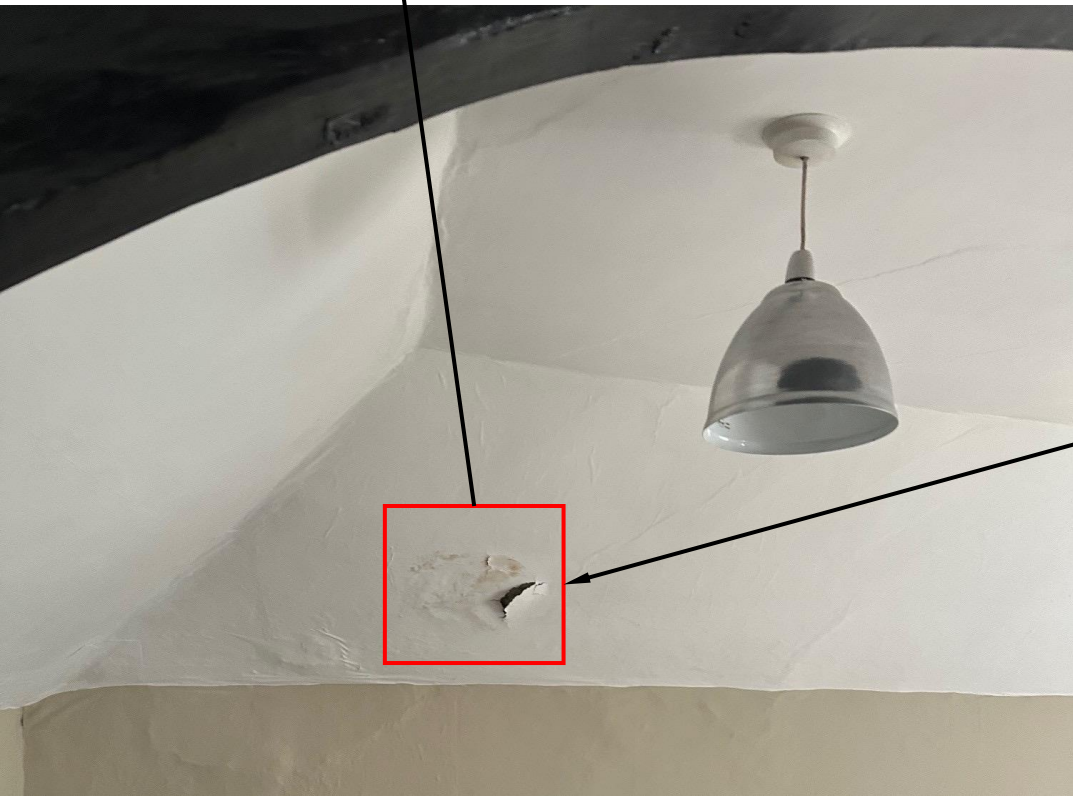
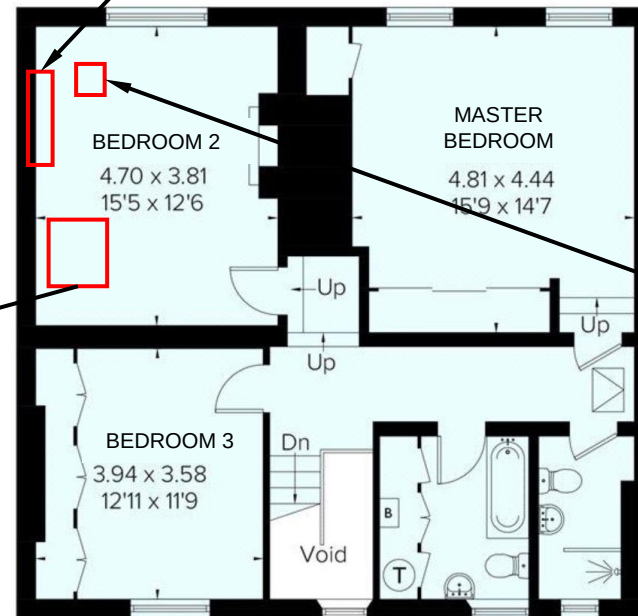
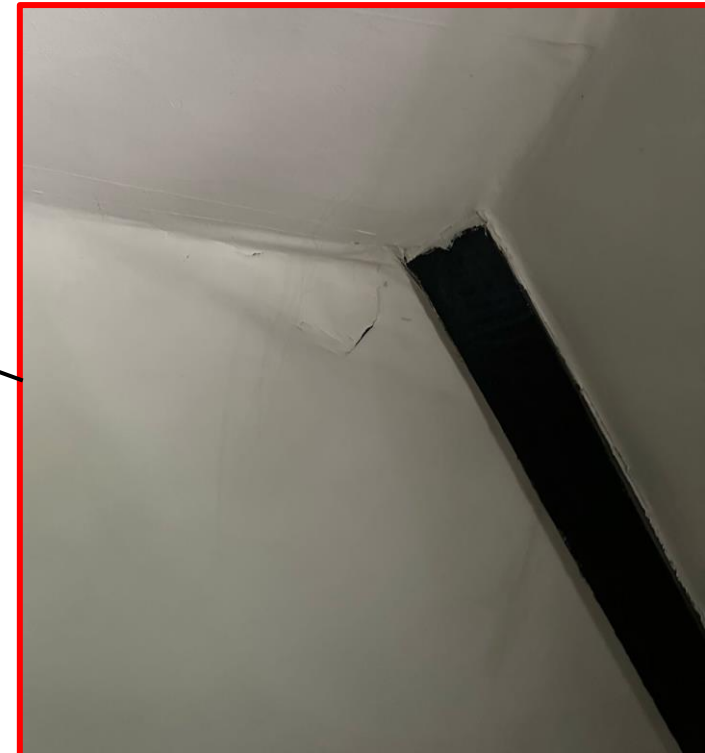
## BEDROOM 2

CEILING STAINED AND DISINTEGRATING  
CAUSED BY BROKEN TILES, LOOSE RIDGE TILES,  
FAILED FELT  
PROPOSE BONNET TILES TO BE INSTALLED ON HIP  
MIMICKING NEIGHBOUR'S HIP OPPOSITE  
FIGURE 3.1 / PAGE 22

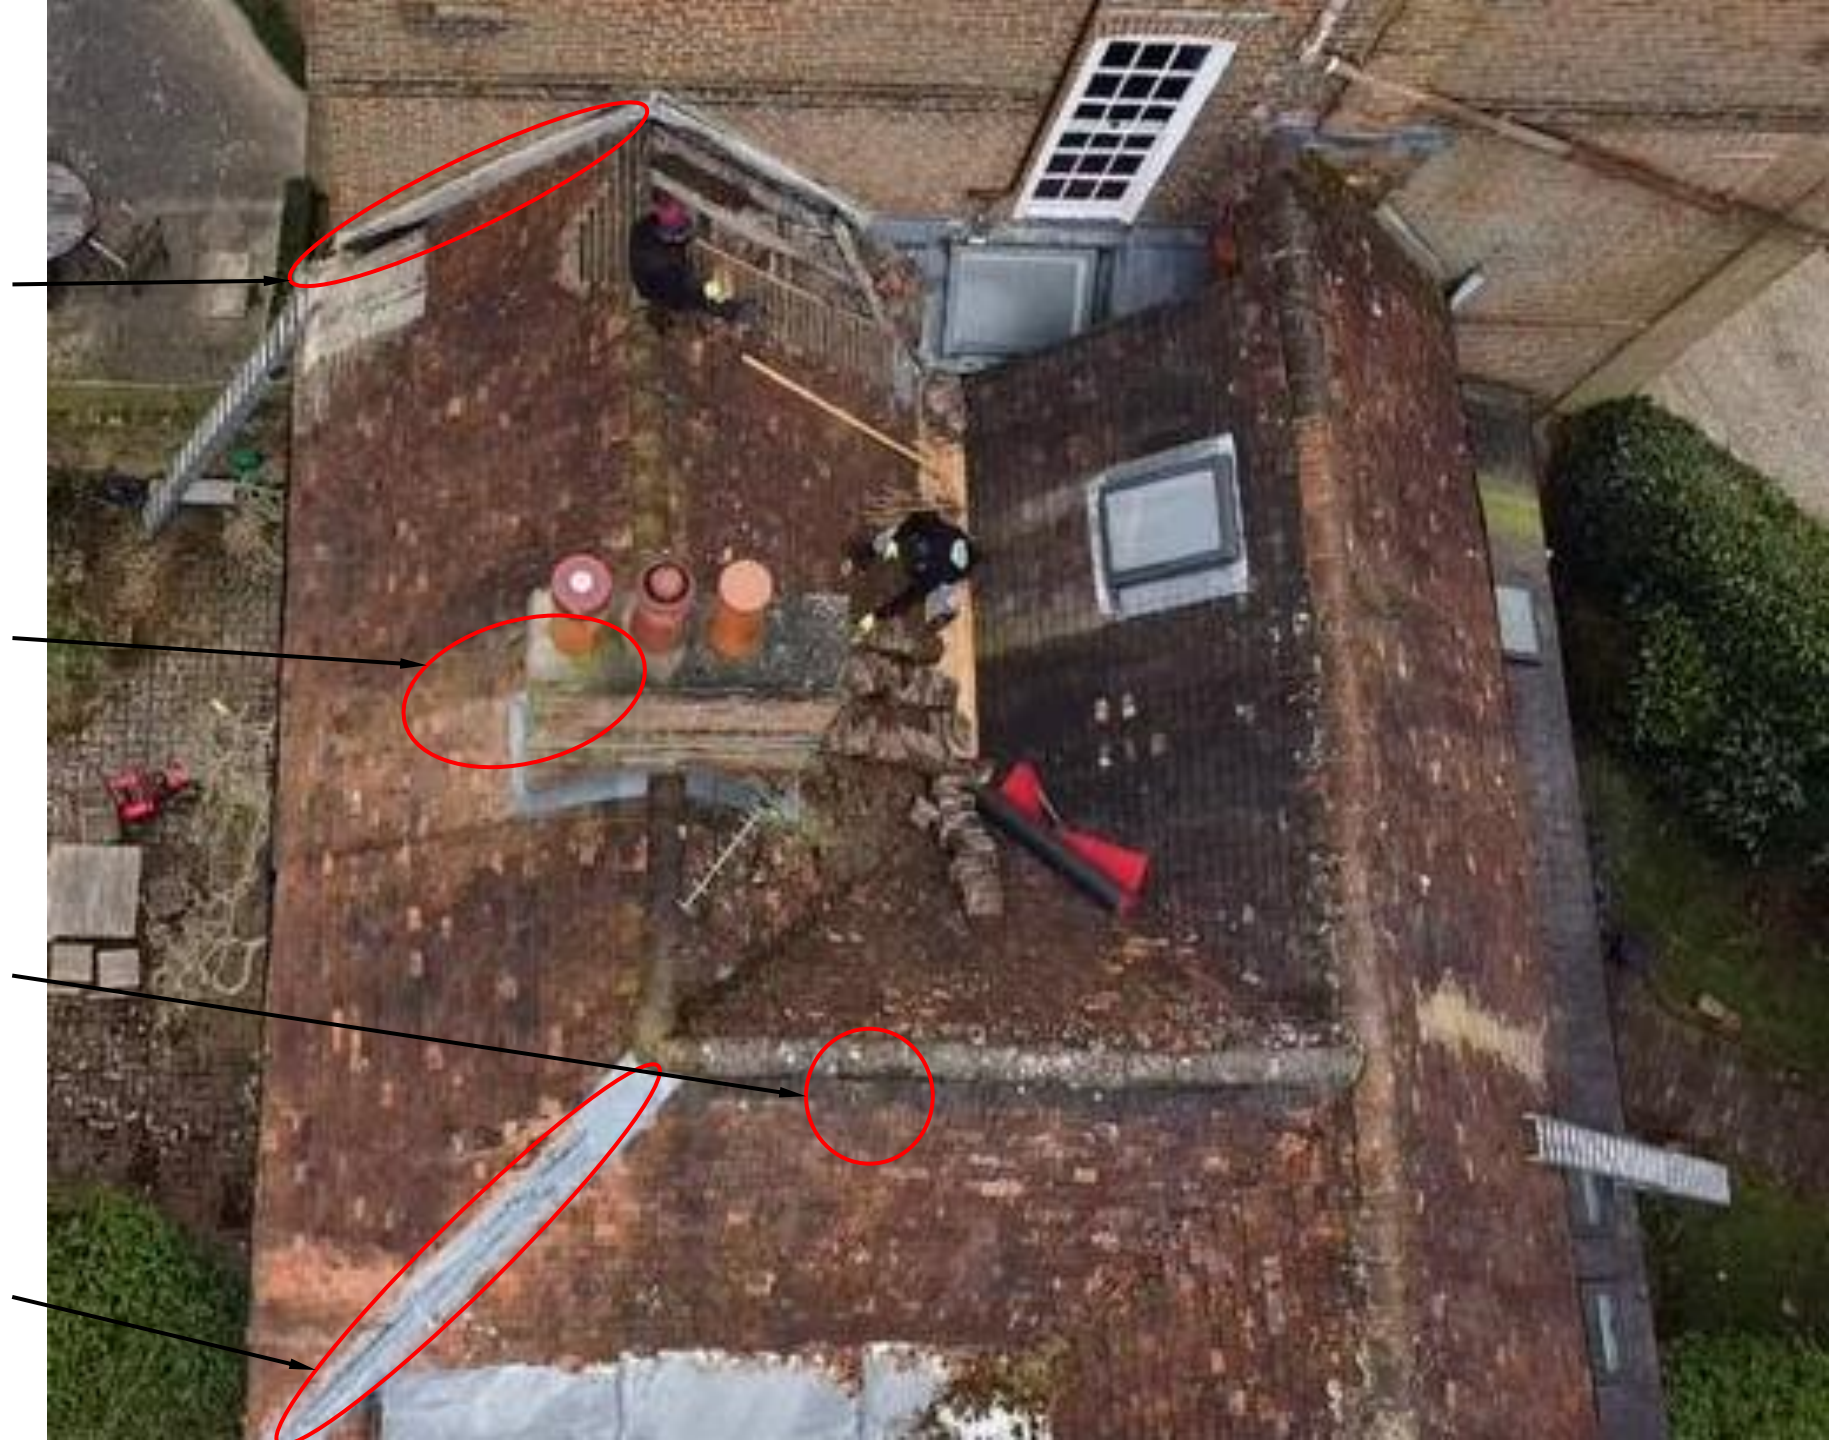
# DEFECT MAP

STAINING ON CEILING  
CAUSED BY DISLODGED/BROKEN TILES AND  
DEGRADED LEAD HIP CAP WITH CRACKS AND NAIL  
HOLES  
PROPOSE RIDGE TILES TO BE INSTALLED ON HIP  
FIGURE 4.1 – 4.3 / PAGES 23 - 25

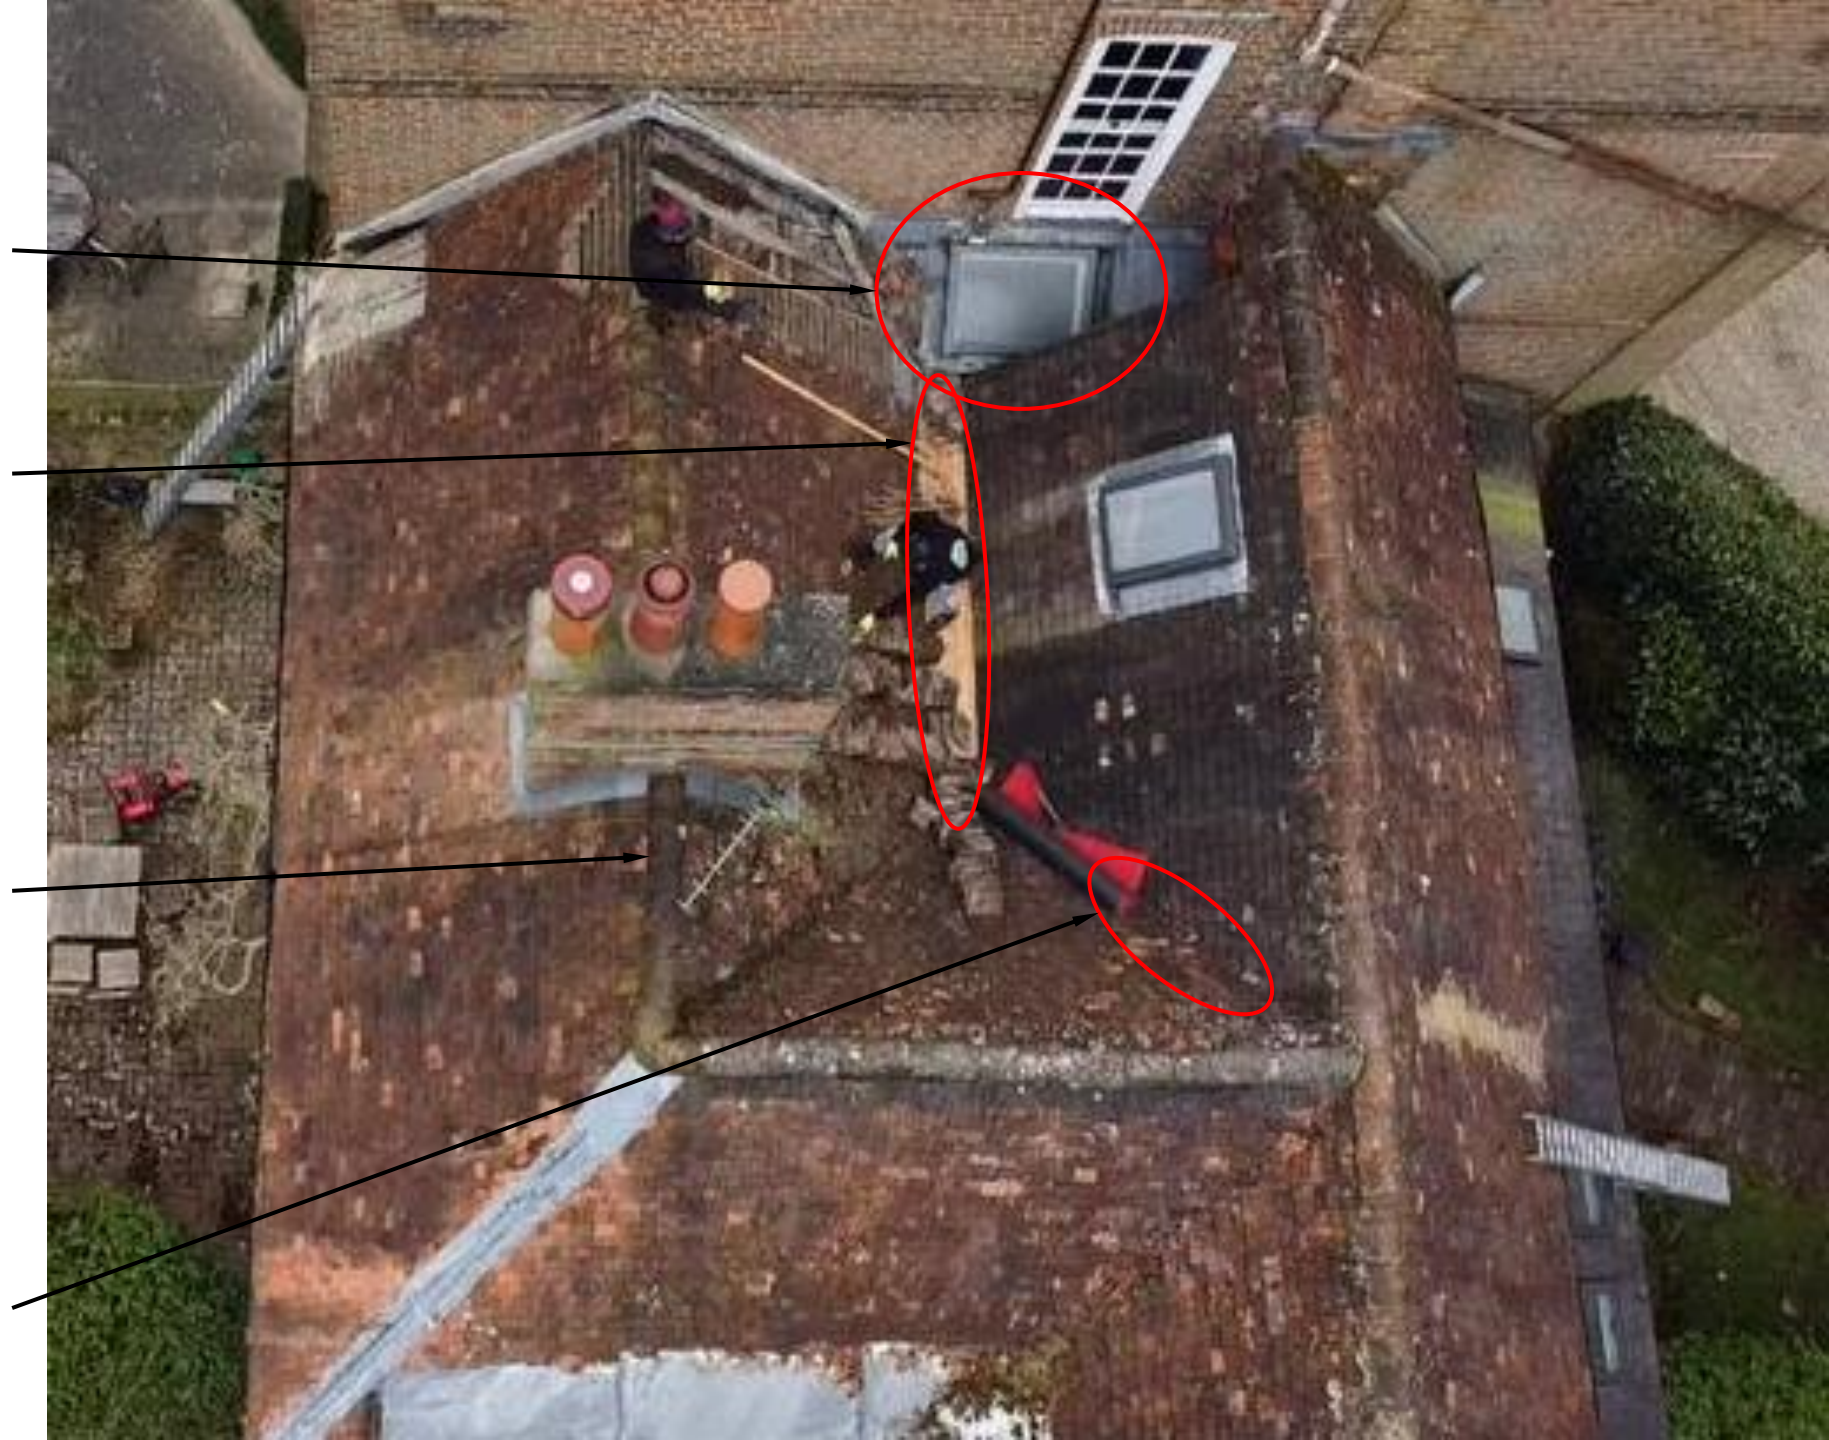
# DEFECT MAP

STAINING ON SKYLIGHT FRAME  
CAUSED BY DEGRADED AND DAMAGED LEAD  
FLASHING SURROUNDING SKYLIGHT  
PROPOSE RENEW FLASHING  
FIGURE 5.1 / PAGE 26

TIMBER BOARDS UNDER LEAD ROTTEN  
CAUSED BY FELT UNDERLAPPING LEAD  
PROPOSE TO OVERLAP FELT ONTO LEAD AND  
REPLACE ROTTEN BOARDS WHERE NECESSARY  
FIGURE 6.1 / PAGE 27

RIDGE BOARDS, RAFTERS, TRUSSES AND WALL  
PLATES IN VARYING STATES OF DECAY  
TIMBER AFFECTED BY INSECT DAMAGE, DRY ROT,  
DAMP ROT AND BLACK MOULD  
CAUSED BY LOOSE RIDGE TILES (100%  
AFFECTED), IMPROPER FLASHING DETAILS,  
DEGRADED/DAMAGED LEAD, DISLODGED/BROKEN  
TILES, HOLES IN FELT  
PROPOSE REINSTATING STRUCTURE BY  
STRENGTHENING EXISTING AND REPLACING  
MEMBERS AS NECESSARY, RE-COVERING WITH  
BREATHABLE FELT, NEW BATTENS AND  
REINSTALLING THE EXISTING TILES, PROPER  
INSTALLATION OF CLAY RIDGE AND BONNET TILES  
WITH LIME MORTAR, PROPER STEPPED FLASHING  
DETAIL WITH SOAKERS AND LIME MORTAR  
FIGURES 7.1 – 7.13 / PAGES 28 - 40

STAINING ON CEILING  
CAUSED BY COLLAPSED VALLEY AND HOLE IN  
FELT  
PROPOSE REINSTATING STRUCTURE, FELT AND  
VALLEY TILES

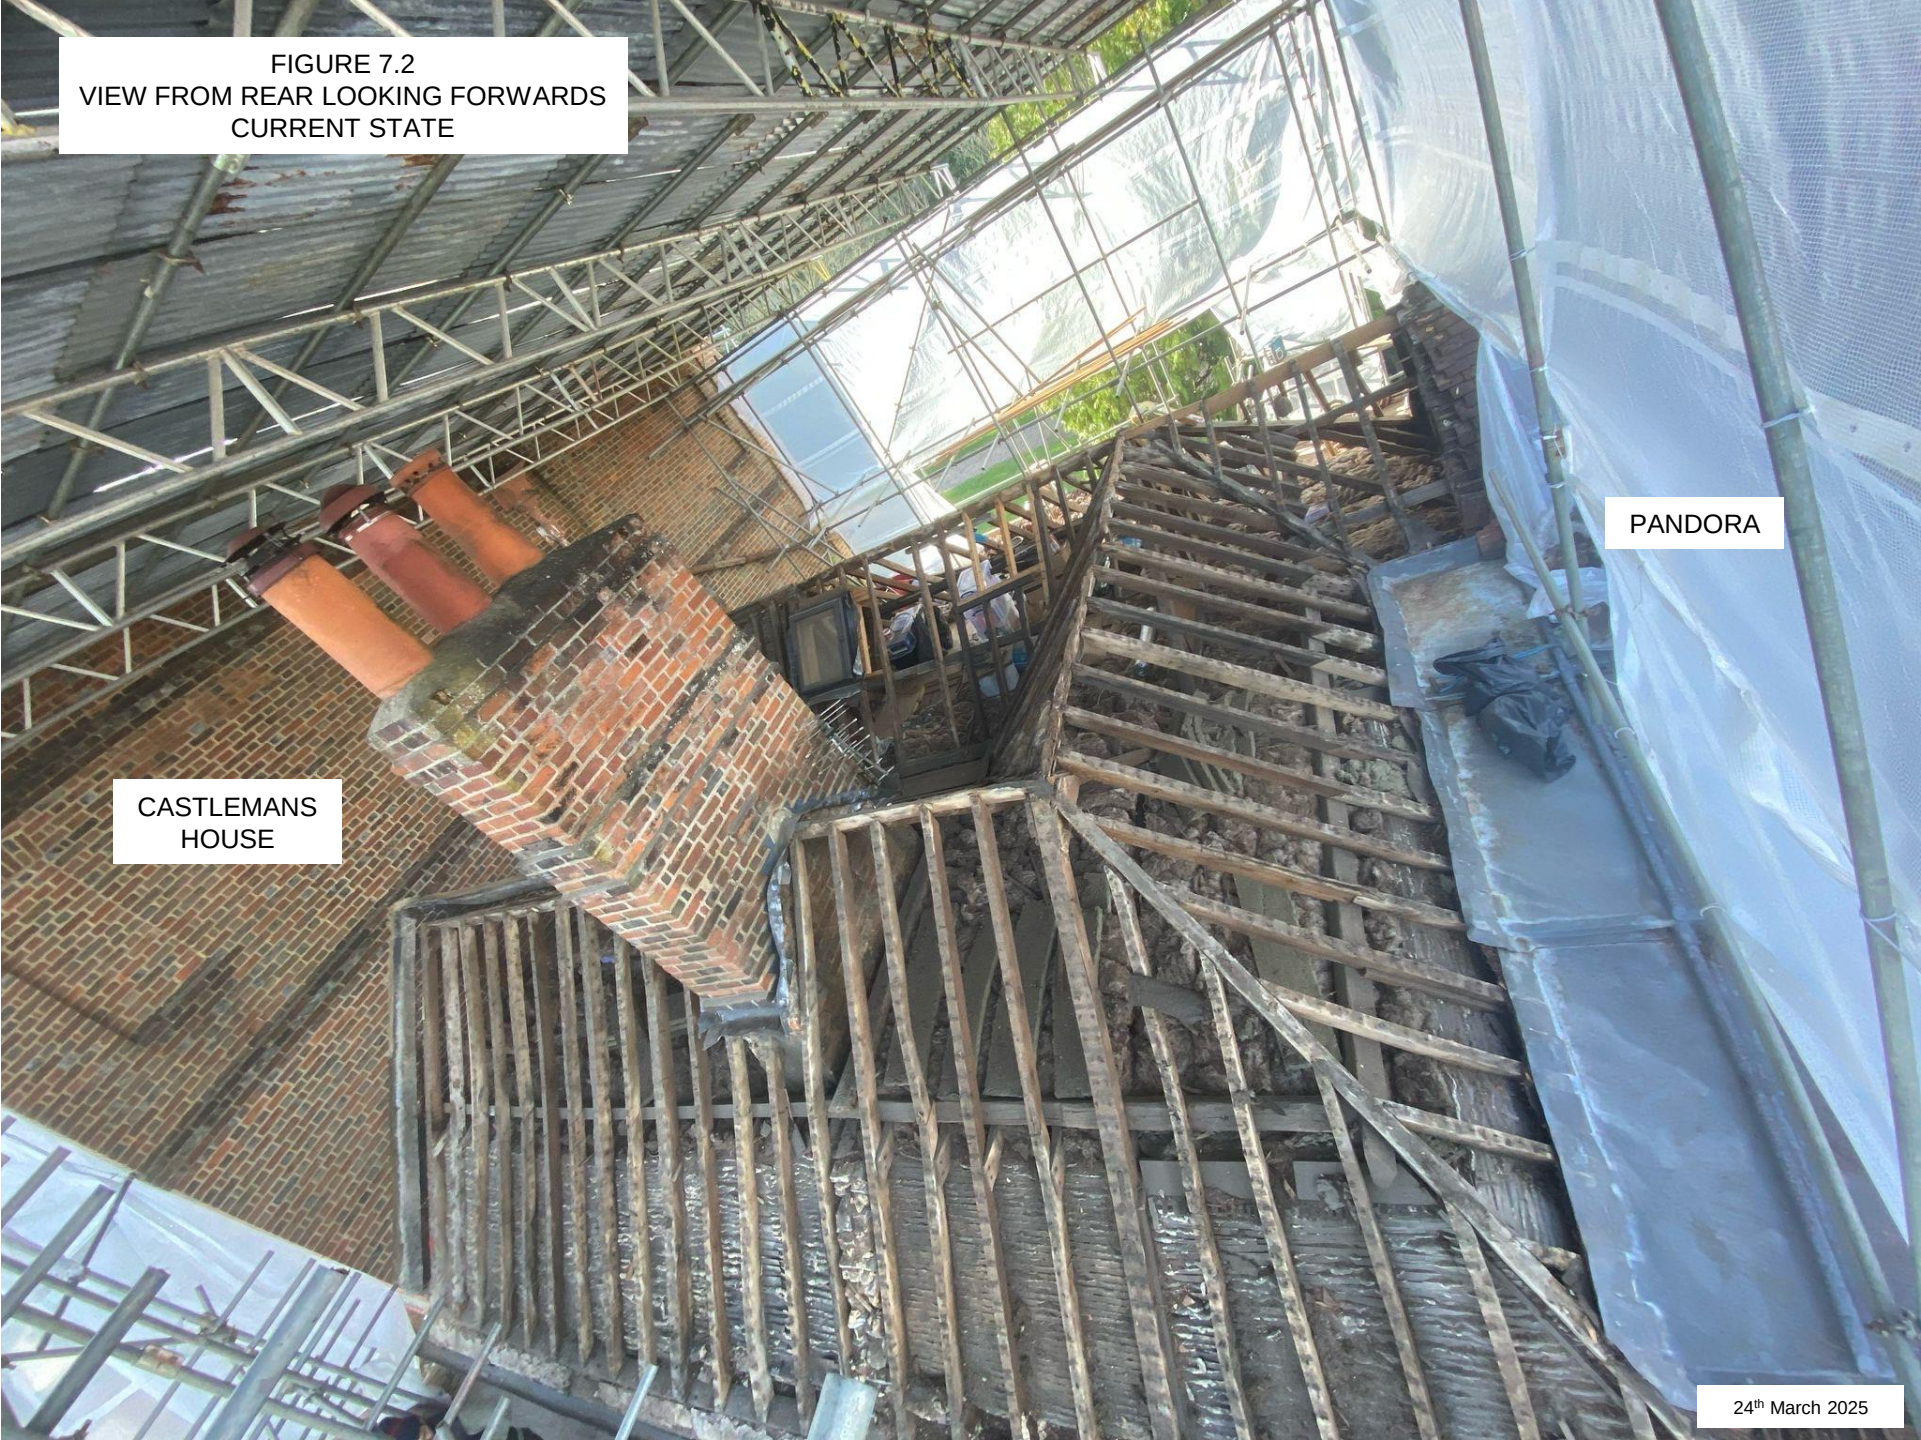
FIGURE 7.3  
TYPICAL CONDITION OF RIDGE BOARD AND RAFTERS  
VIEW LOOKING REARWARDS  
CURRENT STATE

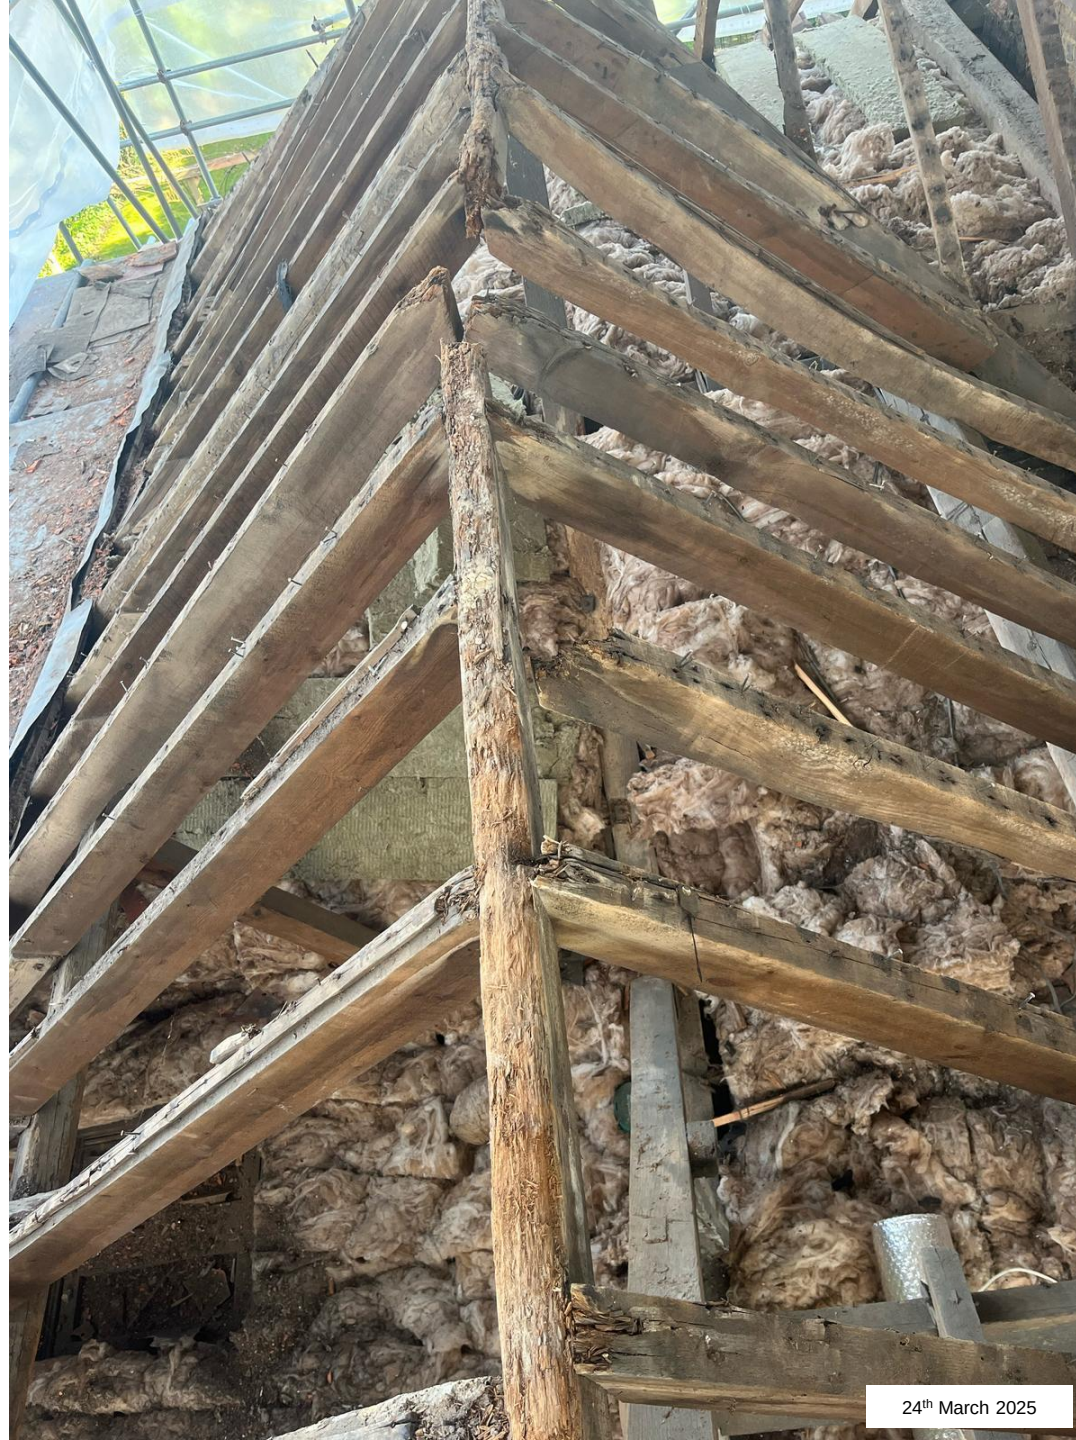
FIGURE 7.4  
TYPICAL CONDITION OF RAFTERS, DECAYED AND OUT OF POSITION  
VIEW LOOKING REARWARDS  
CURRENT STATE
