# CASTLEMANS COTTAGE ROOF REPAIRS

**Planning Portal Reference: PP-13905061**

**BCS Reference: 25/0784/OTHBN**

This document forms part of an application for listed building consent sought for the repairs to the existing second storey tiled roof.

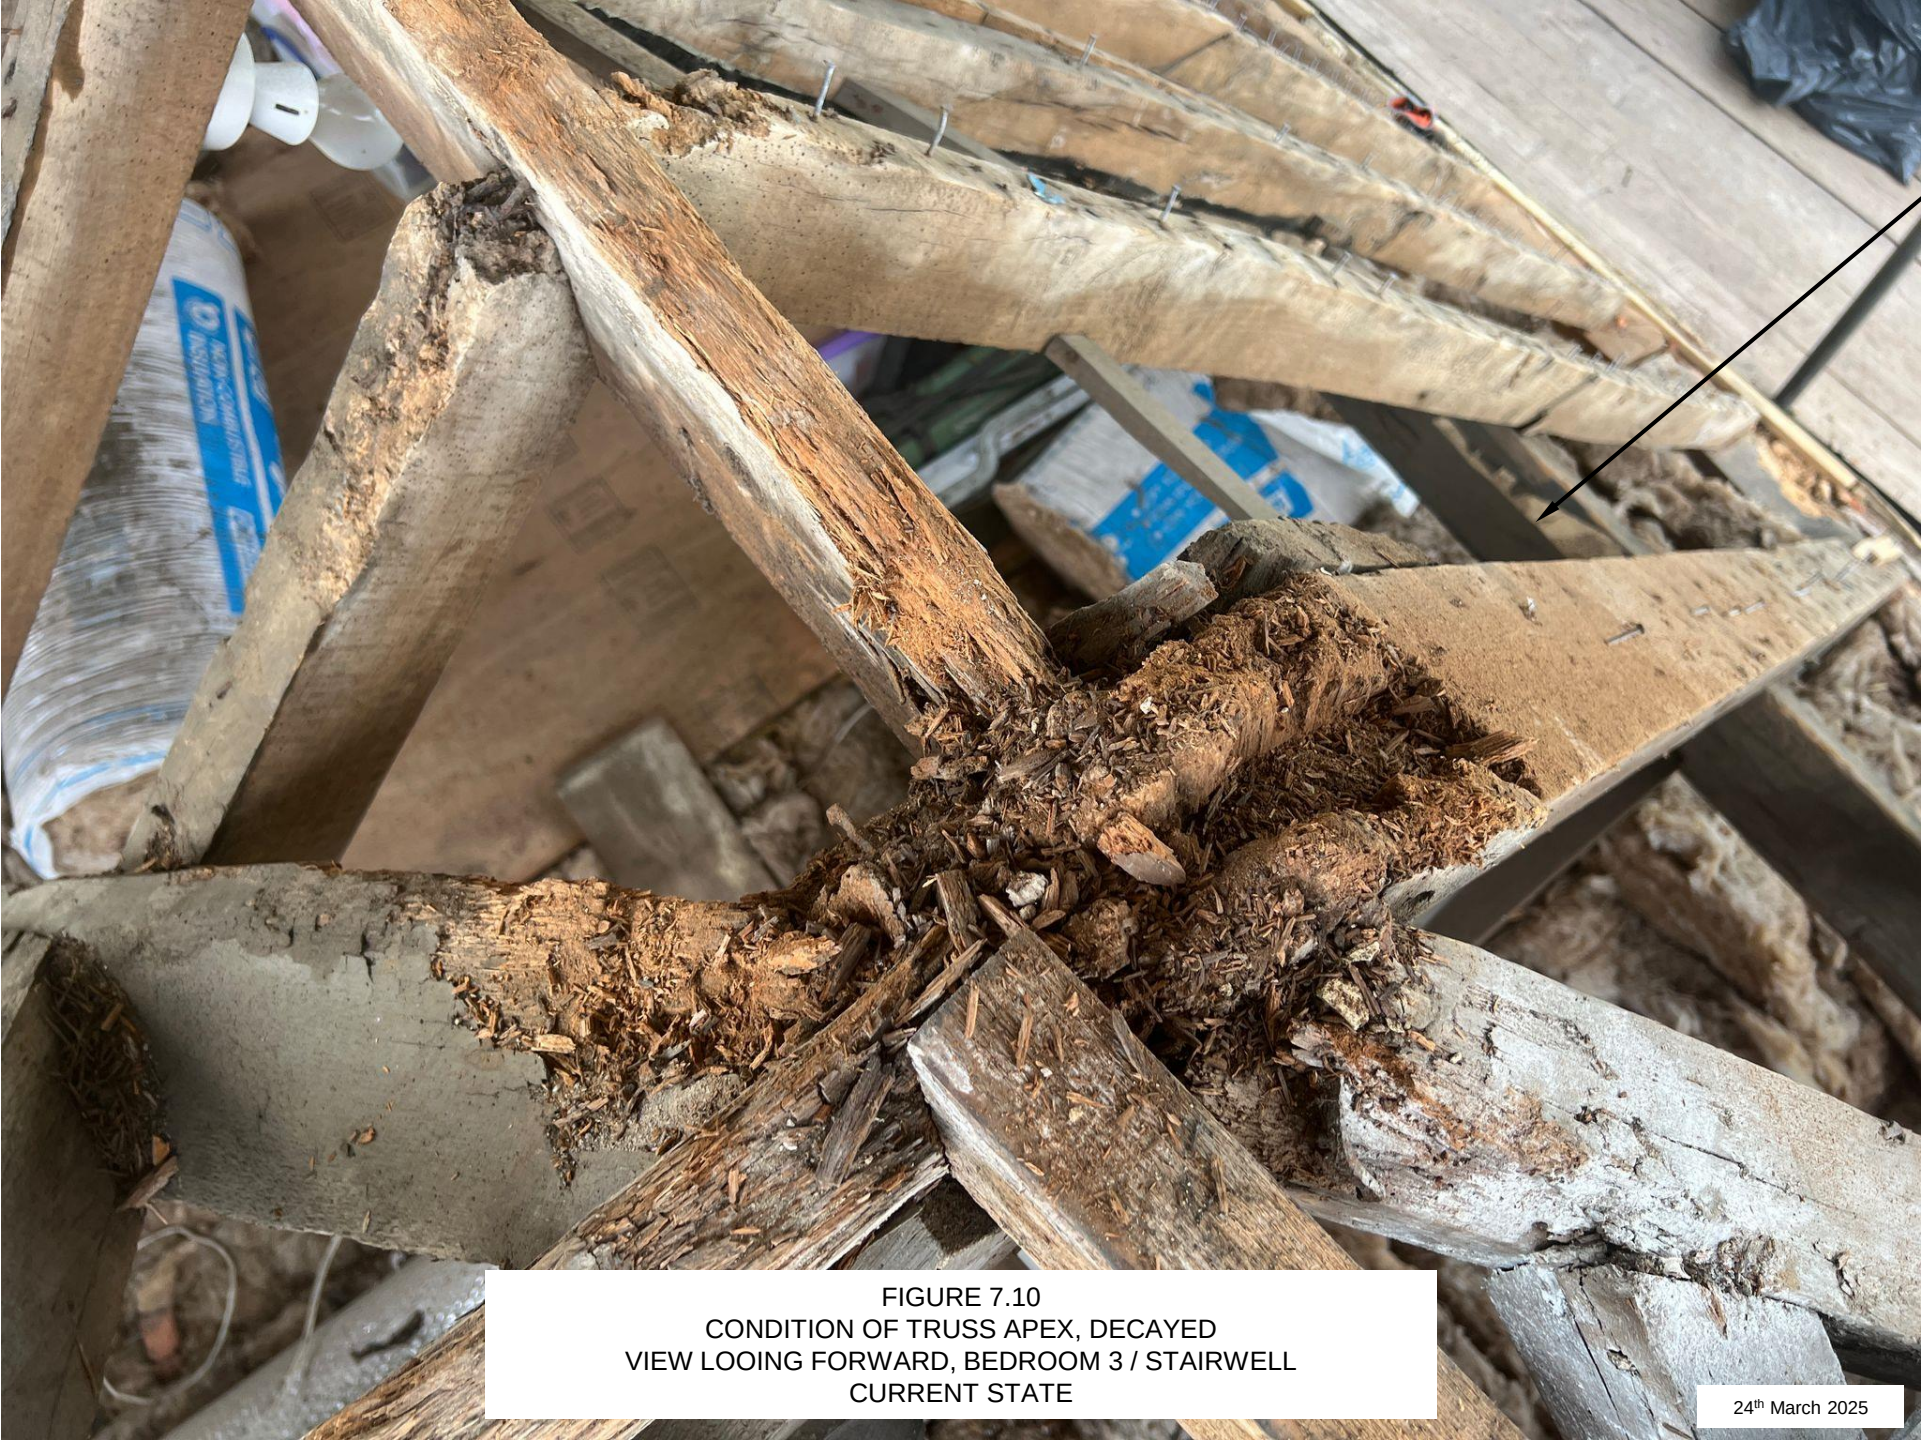
RIDGE BOARDS, RAFTERS, TRUSSES AND WALL  
PLATES IN VARYING STATES OF DECAY  
TIMBER AFFECTED BY INSECT DAMAGE, DRY ROT,  
DAMP ROT AND BLACK MOULD  
CAUSED BY LOOSE RIDGE TILES (100%  
AFFECTED), IMPROPER FLASHING DETAILS,  
DEGRADED/DAMAGED LEAD, DISLODGED/BROKEN  
TILES, HOLES IN FELT  
PROPOSE REINSTATING STRUCTURE BY  
STRENGTHENING EXISTING AND REPLACING  
MEMBERS AS NECESSARY, RE-COVERING WITH  
BREATHABLE FELT, NEW BATTENS AND  
REINSTALLING THE EXISTING TILES, PROPER  
INSTALLATION OF CLAY RIDGE AND BONNET TILES  
WITH LIME MORTAR, PROPER STEPPED FLASHING  
DETAIL WITH SOAKERS AND LIME MORTAR  
FIGURES 7.1 – 7.13 / PAGES 28 - 40

FIGURE 7.10  
CONDITION OF TRUSS APEX, DECAYED  
VIEW LOOING FORWARD, BEDROOM 3 / STAIRWELL  
CURRENT STATE
