# MEMORANDUM

| <b>Application No.</b> | 260979 | <b>Site Visit Made:</b> | Yes (12/05/26) |
| <b>Address:</b> | The Old Cottage, Pearson Road, Sonning, RG4 6UH. | | |
| <b>Proposal:</b> | Application for submission of details to comply with Condition 4 (structural repairs method statement) of listed building consent 232278 dated 09/01/2024. | | |

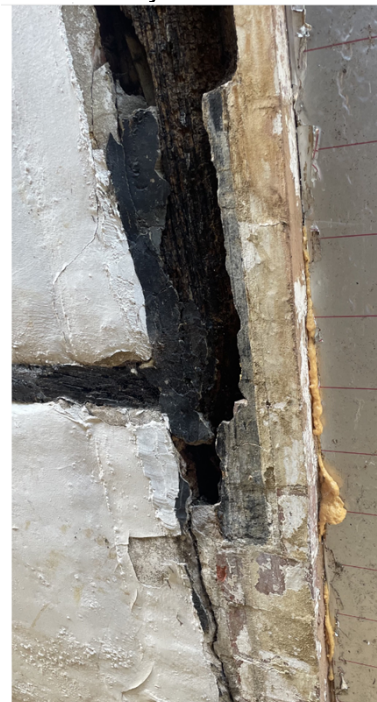
Remains of lower portion of southern principal post.

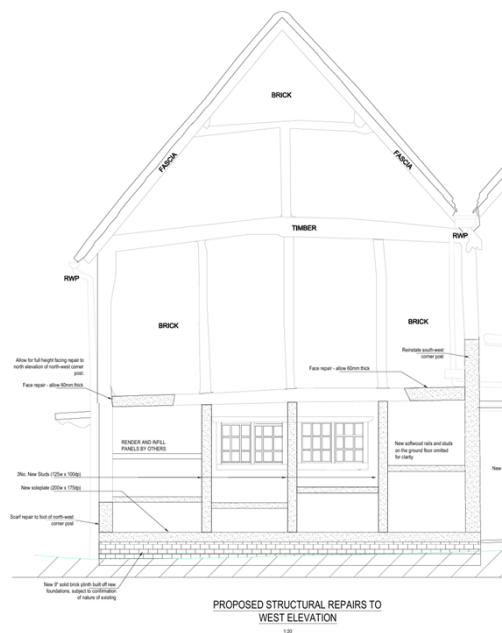
Extract from Heritage Revival Method Statement – here it should be noted the braces at first-floor level previously hidden under the cementitious render finish have now exposed along their lengths (along with directly adjacent brick infill) as a result of the render covering them. Furthermore, removal of the existing render covering for the southern principal post appears shows the lower portion severely eroded rather than having been historically removed.

West Gable End – phot shows the braces have now been exposed
