**Damaged Structures  
(within the attached outbuilding)  
Method Statement & Justification for Replacement**

15/01/25

Sussex Lodge

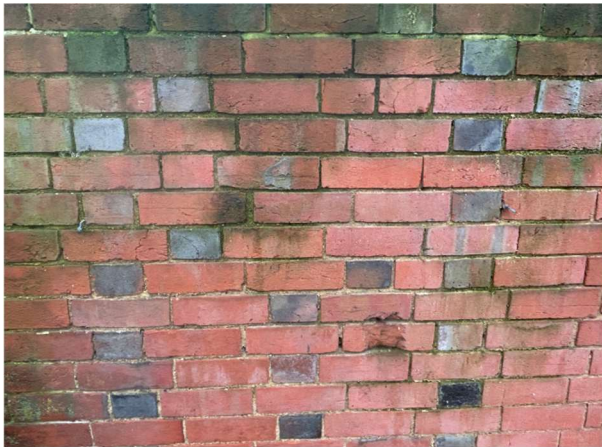
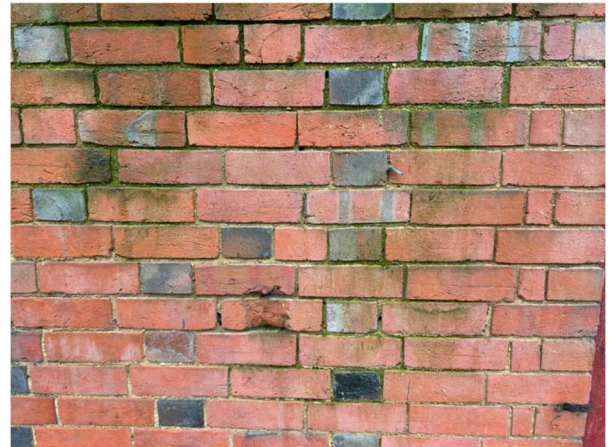
Examples of original brickwork

The east elevation to the outbuilding has proved to be more damaged than originally thought. In addition to the new openings for the window and glass doors (approved by applications 223175 & 223176), there were large areas where repairs/re-instatement were required, which would leave a relatively small area of fully untouched original brickwork.

With this in mind the end finish and structural integrity would benefit significantly from approaching the whole wall in one go rather than a patchwork of repairs amounting to somewhere in the region of 90% of the original wall being affected.

A - Saw-tooth band - most of the saw-tooth band was in poor condition and required replacing

B - Cracks internally and externally - areas of diagonal cracking, significant vegetation/root damage, making good historic repairs

C - Blown bricks - to be replaced/turned

The section of wall was carefully dismantled brick by brick and stacked for re-use, before re-building with the same brick bond and combination of burnt and non-burnt headers.

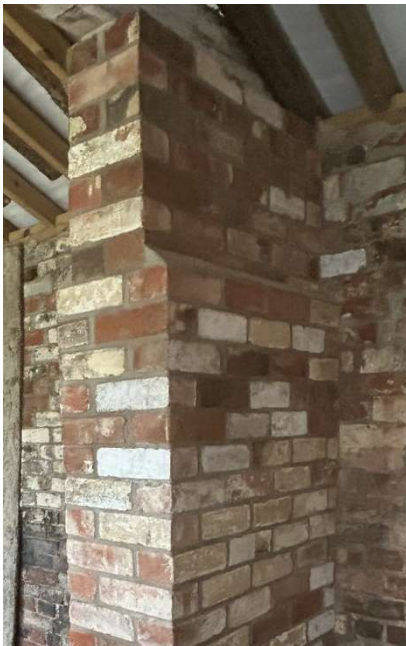
The existing nib, although looking substantial, lacked any bonding between the three brickwork 'skins' that the base of the nib was made up of, and lacked any form of foundation, as well as being undermined by rodent activity. In addition, the top single skin section of brickwork was off vertical.

With this nib needed to be the structural support for the beam and roof above, it was re-built, allowing for a fully bonded pier at the base and although still narrower at the top, an increase to 9" brickwork providing a better support for the beam.
