1App TPO 2026 1 Kerris Way Specification Plan Photos (where applicable) and Reasons (where applicable)

- Tree Work: Application for Consent for tree works to trees subject to a Tree Preservation Order.
- 
- Your Reference: TPO REF: TPO 197/ 1980 A9
- 
- From : Future Tree

- In reference to Site: Site adjacent to 1 Kerris Way, Lower Earley, RG6 5UW
- On behalf of: The Homeowner
- 
- Please find enclosed a copy of the specification for the intended tree work at the above address.

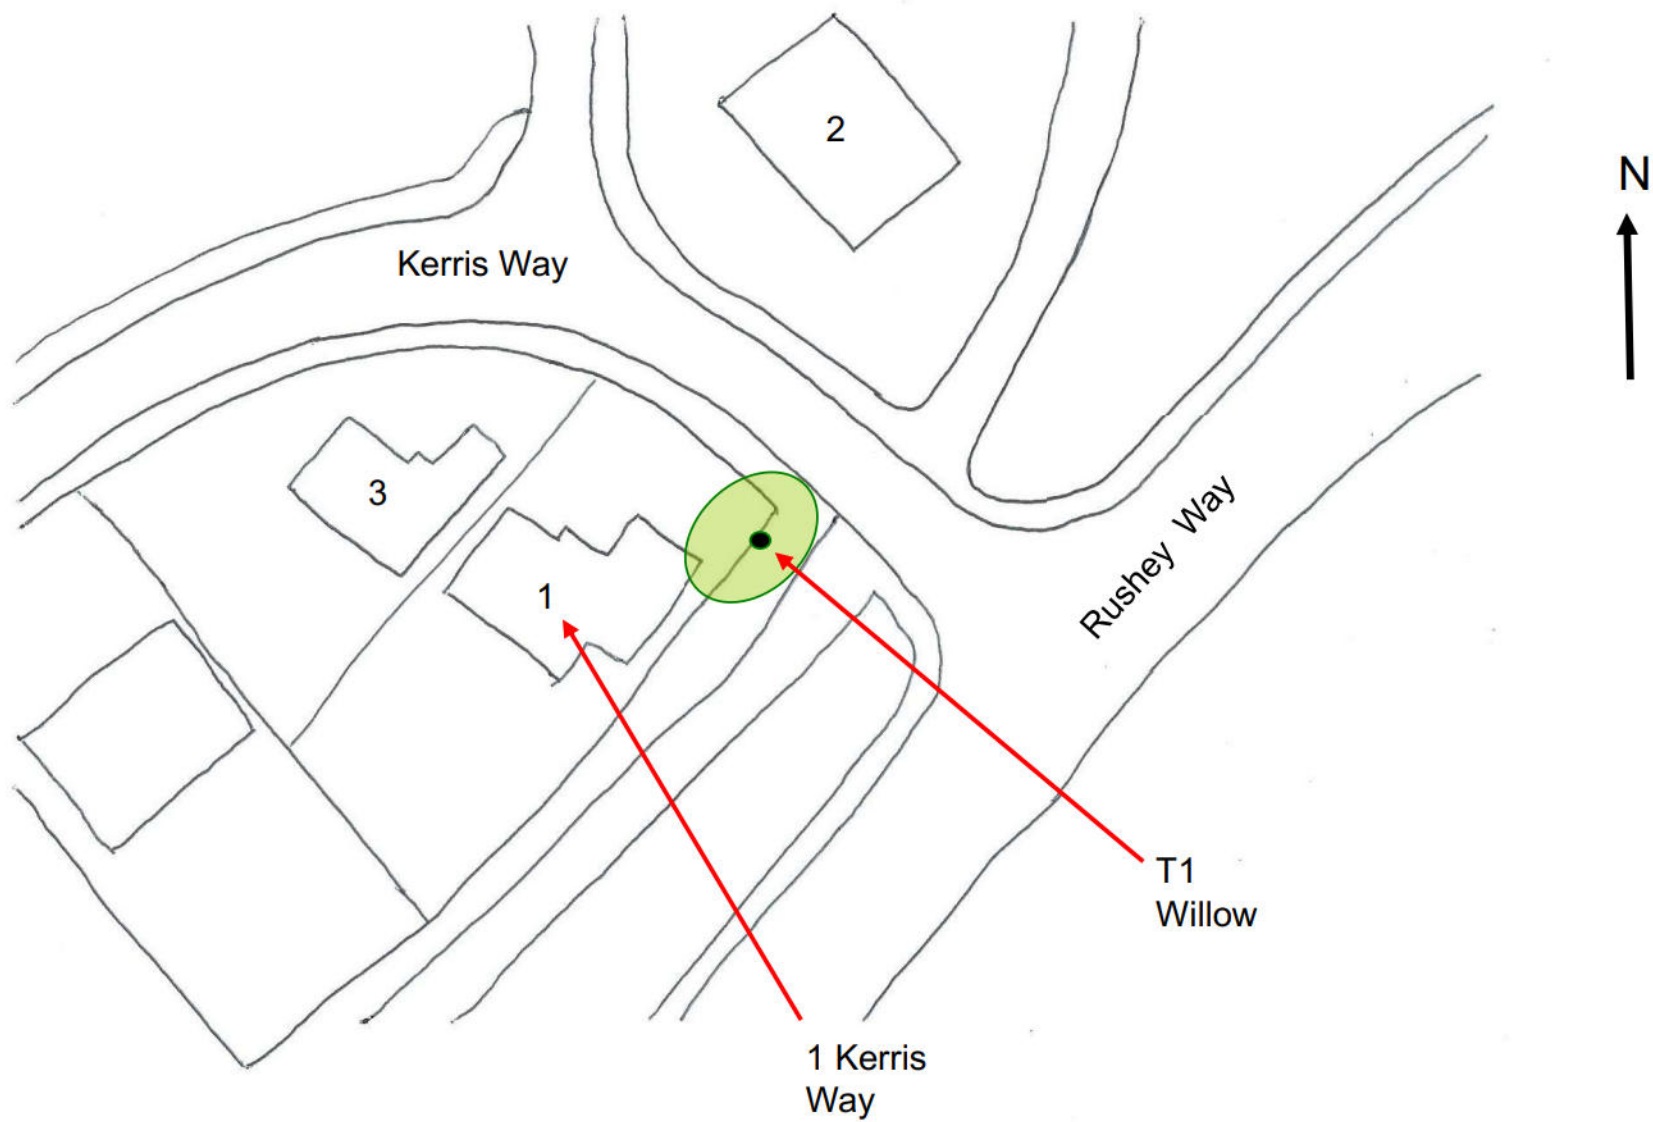
Sketch Plan: Site adjacent to 1 Kerris Way, Lower Earley, RG6 5UW

- **Tree Number:** T1 **Location:** Refer to site Plan. **Tree Species:** Willow
- **Discussion:** The Tree grows on Municipal land under the management of Wokingham Borough Council.

- The tree consistently sheds debris across the seasons such that the use and enjoyment of the property is compromised.
- That damage may be sustained to the vehicles parked below is foreseeable.

- The root system of the tree has evidently caused subsidence to the block paving surface of the drive with significant undulations being plain to see. As yet, no evidence of subsidence to the house has been reported, although issues with tree related subsidence have occurred within Lower Early since clay soils are a feature of the area.

- It is reasonable to anticipate that if one of more of the elongated limbs were to fail it would be likely that cars may be parked underneath, and that persons may be at risk.

- All work specified to be conducted in accordance with B.S.3998:2010. Tree Work- Recommendations with pruning being made back to suitable growth points within the canopy. No cuts to be made at the unions with the main stem.
