# Tree Assessment and Compensation Strategy

**Lodge Road, Hurst**  
**04 June 2025**

| Project No: | Report No. | Date | Revision |
|---|---|---|---|
| 16452 | R05 | 04 June 2025 | a |

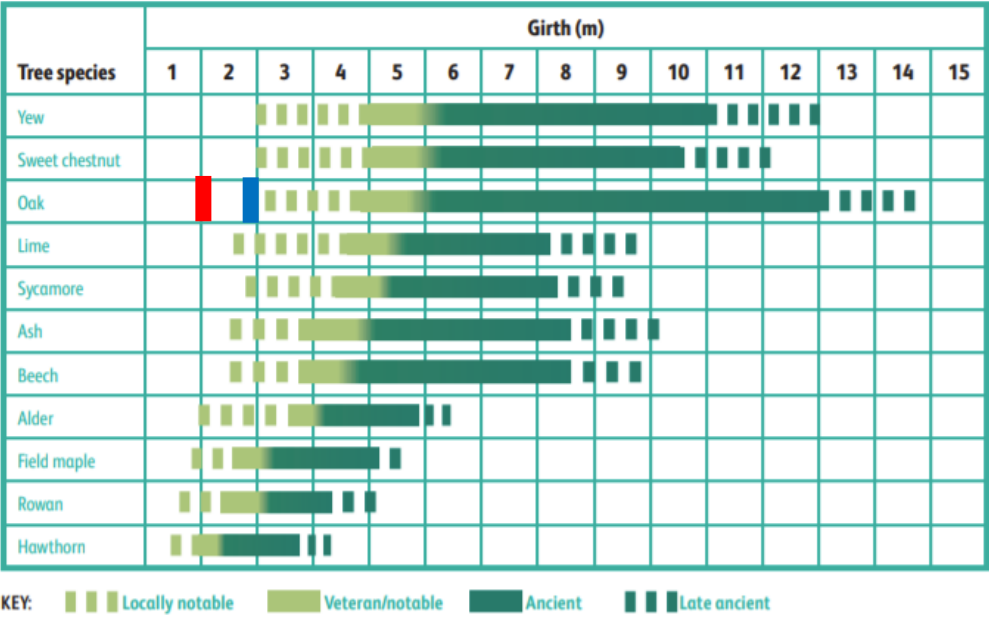
- 2.24. Tree T85 had a stem size measured at 700mm diameter which does not represent a large size compared to others of the same species. The stem diameter of tree T86 was measured at 944mm (the combined diameter of the three stems) which is considered to be a mature size; however, this is not large relative to the species. The stem diameter of both trees is measured smaller compared to adjacent trees T14 and T70 which have stem diameters of 1350mm and 1210mm respectively. They are several other oak trees on the site that have larger stem diameters compared to trees T85 and T86. These include veteran trees T32 (1680mm), T33 (1900mm), T44 (1350mm), T47 (1350mm), T52 (1300mm), as well as a number of mature (non-veteran) trees. A full list of stem diameter recordings can be found in the submitted Tree Survey Schedule (Report Ref. 16452 R01a dated 2nd July 2024).

- 2.25. The stem sizes of the trees can be compared to established thresholds to determine whether it is of a size capable of veteran status. It is not sufficient in accordance with the NPPF criteria for a tree to be a typical mature example of the species and be a veteran. The “Ancient and other veteran trees: further guidance on management”<sup>6</sup> by Lonsdale, presents an illustration of oak trees as they progress from Locally Notable, Veteran / Notable and Ancient and Late Ancient life stages as a function of their size. Whilst not clear cut, the threshold figure for veteran/notable status for girth size in oak trees according to Lonsdale, shown at Figure 1 below, is approximately 4.6m - 4.8m. The stem girth size is 2.2m for tree T85 and 3m for T86, falling well below the veteran threshold.

**Figure 6. Extract of chart of girth in relation to age and developmental classification of trees (Fig. 13) of Ancient and other veteran trees: further guidance on management (Lonsdale, ATF 2013). Red marker illustrates girth of tree T85 and blue marker illustrates girth of tree T86.**

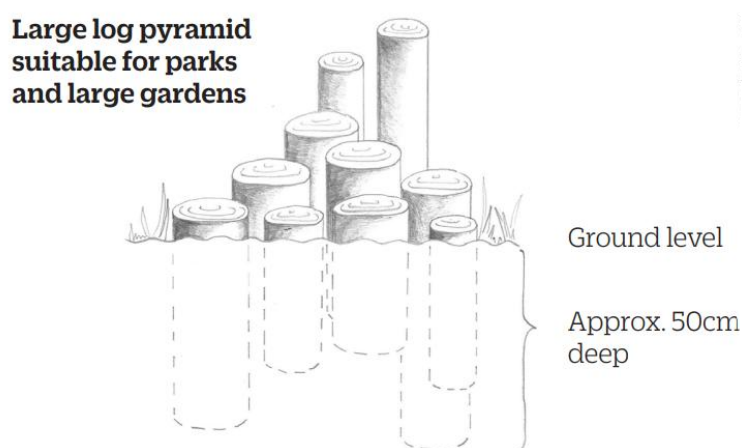
**Figure 17: Illustration of log pyramid for saproxylic invertebrates such as stag beetle. Taken from People's Trust for Endangered Species – Build a log pile for stag beetles<sup>12</sup>**

3.25. The creation of new saproxylic log pyramids will provide additional breeding opportunities for stag beetle within the site boundary; the location will be determined as a matter of detail; however, it's envisaged that this will be in the north and north-west of the site in retained grasslands. Creation of log pyramids should be created using the following methodology, and shown in Figure 17:

- Bury logs vertically in a pyramidal shape to an approx. depth of 50 centimetres (cm) or greater;
- Logs should be at least 30 cm in circumference with the bark still attached and from broadleaved trees such as oak; and
- Position in a partially shaded location.

3.26. The wood used to create the log pyramids should be sourced from the wood on site, such as from tree T48.

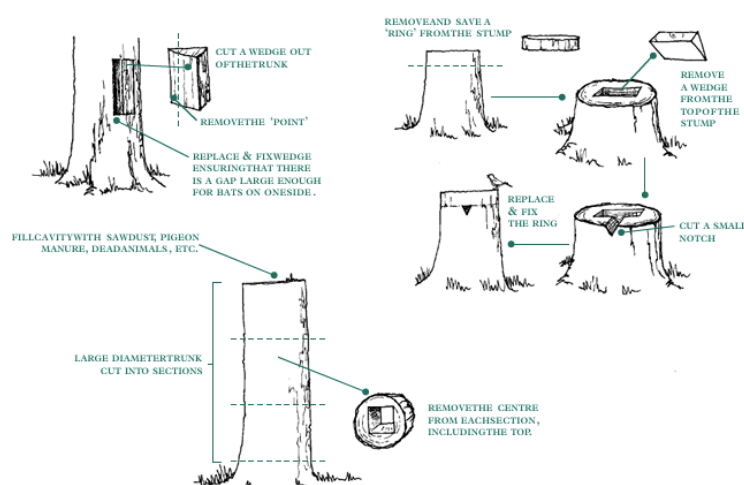
Figure 179. Suggestions for design of artificial cavities (Source – Veteran trees: a guide to good management, ATF)

- 3.29. Opportunities for veteranisation are considered appropriate for trees T45, T46 and T49 as this will have a beneficial impact towards the adjacent veteran trees. This will involve pollarding and creating cavities and holes in the stems of tree T45, and creating sections of dead wood, artificial limb failures, and decay holes in the canopy of trees T46 and T49. A detailed specification for veteranisation will be determined as a matter of detail and included within an AMS secured by condition.

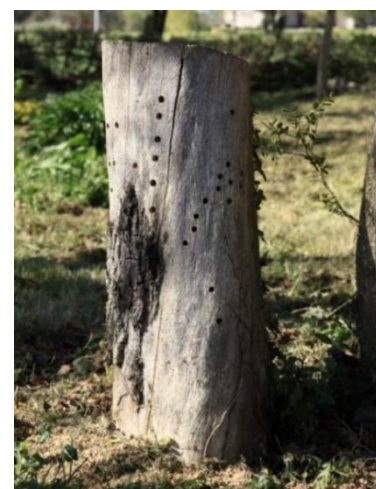
Figure 168. Example of artificial drilling in section of dead stem (Source – unknown).

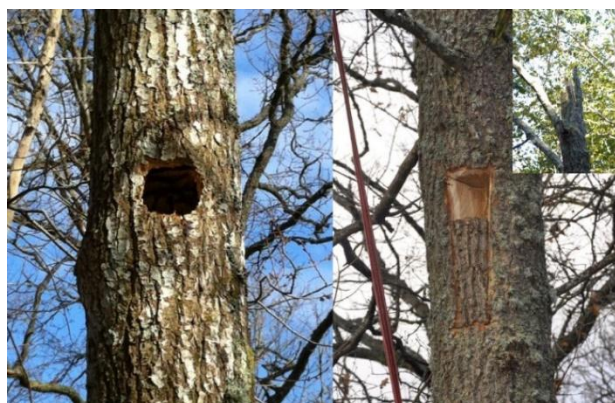
Figure 20. Example of artificial holes and cavities in tree canopies (Source - Arboricultural Association)

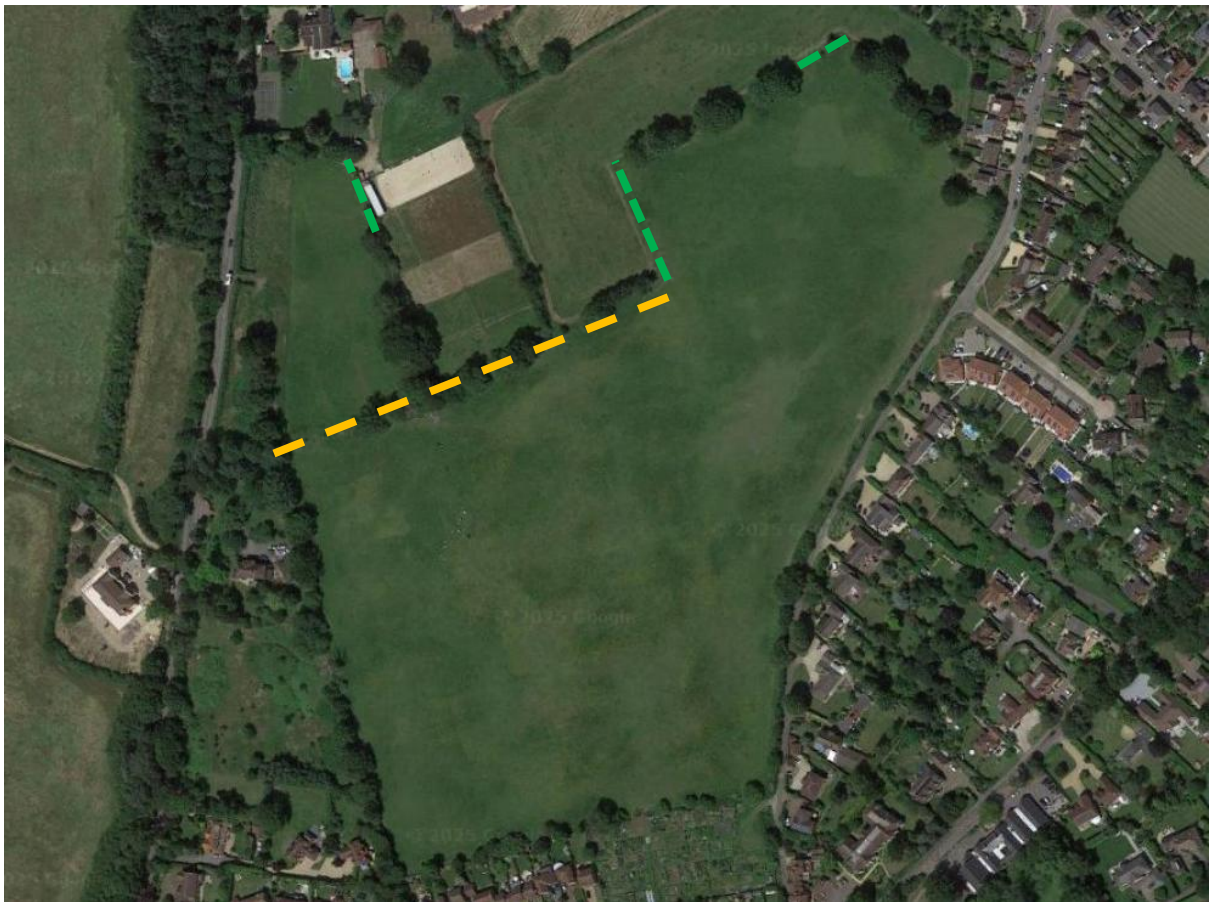
**Figure 2118. Location of degraded hedgerow / tree line (yellow dash) and location of key green links proposed b existing mature and veteran canopy cover.**

- 3.31. The Illustrative Masterplan for the proposed development provides the initial strategy for new tree planting across the site. Key items on the plan include retained and enhanced vegetation across the boundaries, a new community orchard, parkland planting which frames a common located between the two development parcels, and tree planting along the main access road and street scenes. In addition to the planting, the existing space between T14 and T70 will be kept as a dark corridor, with a bat-sensitive lighting strategy expected to be conditioned. A "Species Specific Enhancement and Ecological Permeability" strategy is also expected to be conditioned, as noted in the Memorandum from the WBC Ecology Officer. Overall, the extent of tree planting will provide a site-wide improvement in terms of tree canopy cover and its connectivity. Figure 21 below illustrates where new tree planting is proposed which will have a notable benefit in terms of linking existing groups of mature and veteran canopy cover.
