**Lime Trees, 2 Ruscombe Road, Twyford, RG10 9JS**

**WINDOW HISTORY AND DETAILS OF REPLACEMENT**

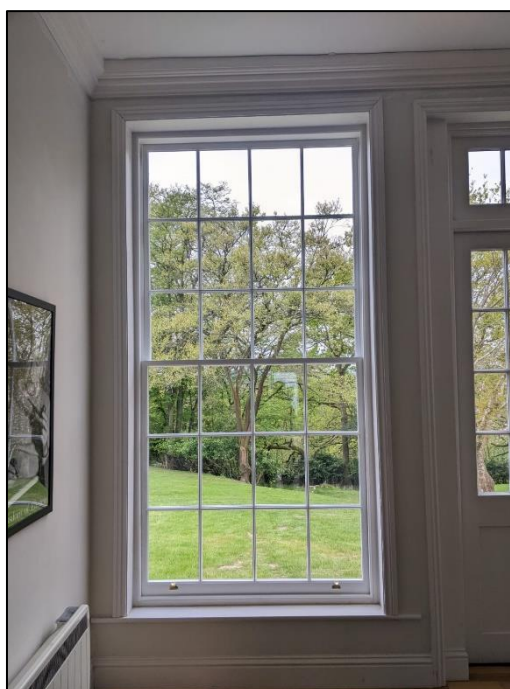
*Photograph 4 – An example of the traditional timber, double glazed sashes installed*

The works are to be completed by a specialist company, which advocates making traditional timber, double glazed sashes, which are fitted into the original frame, which they fully restore. The process involves carefully removing strategic parts of the existing frame in situ. Their own manufactured timber components are installed within the existing window frame, made from a mixture of hardwood and Accoya rot resistant timber. New rot resistant timber double glazed sashes are hung by waxed cotton sash cord over premium metal wheel pulleys, with lead counterbalance weights. On completion the window aims to match the existing as much as possible. The slim profile glazing has an overall thickness of 14mm. The detailed section through the full height of the window is attached as Appendix I. An example sash window installed is shown in **Photograph 4**. The new window is indistinguishable from the original frame. This specialist company protect all aspects of the original frame. The box frames, sills and door frames, including the thresholds are therefore maintained with only the window casement units and the exterior doors being replaced.

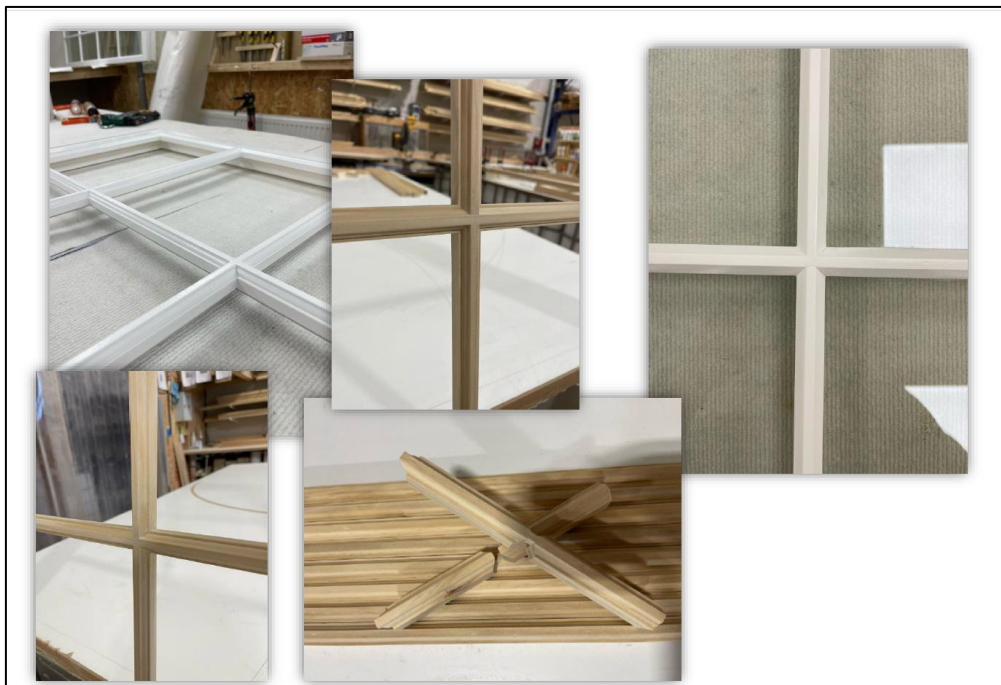
An example of the glazing bars are shown in **Photograph 5**, with the glazing bars of the original dwelling underneath it for direct comparison (**Photograph 6**). We would argue that the proposed new glazing bars are within an acceptable level of variance from the original and would actually provide a renewed, clearer moulding profile. It is clear from **Photograph 6**, that due to the age of the windows some of the glazing profiles are clearly damaged and beyond repair.

*Photograph 5 – A collage of the proposed glazing bars to the new windows with painted and unpainted views*
