## **Planning Application Structural Report**

Bird Place  
Henley Bridge  
Henley-on-Thames  
Berkshire  
RG9 2LN

03 April 2025

25-2795

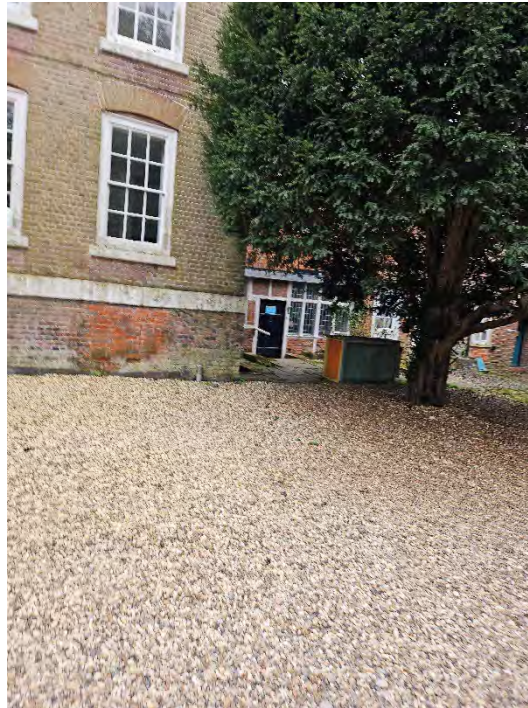
**P7 Front right corner – proximity to yew tree**

The mitigation measures will probably be dependent upon the removal of the yew tree which is likely to have been influential in the movement caused at the front.

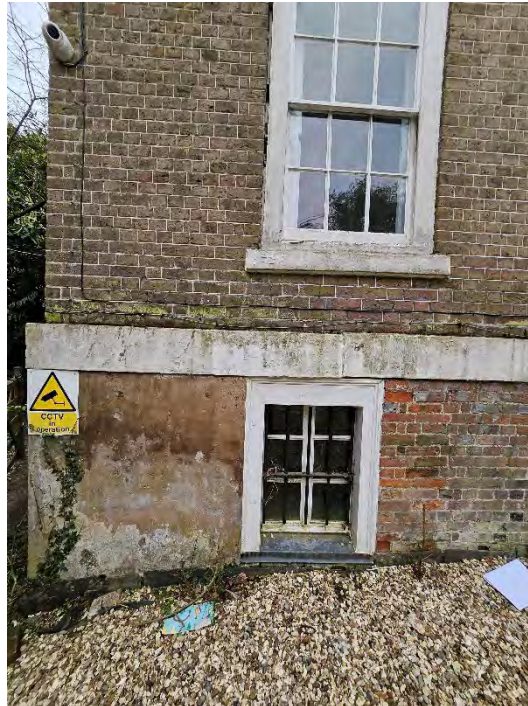
**P35 Left-hand corner - movement above basement window**

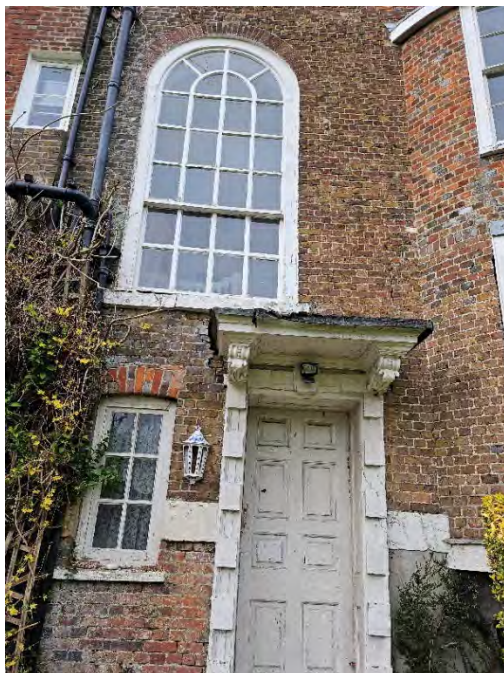
In relation to this, further investigation will be necessary to determine the cause of the movement and appropriate rectification. It is likely that the lintel may be of timber and this would have been sensitive to moisture causing wet rot decay. The risk in relation to this is water penetration from above together also with the canopy roof over the doorway.

**P43 Displaced brickwork above door**

Opening up will be necessary to determine the cause and appropriate measures to be taken.

- d) Drainage investigations should be undertaken including CCTV to review the condition of the underlying drainage around the building.
- e) In relation the rear hallway, it is recommended that the lintel over the rear doorway be opened-up to check its condition. The floor also may need to be lifted in the landing to check the condition of the wall. It will be prudent to locate a trial hole close to this position.

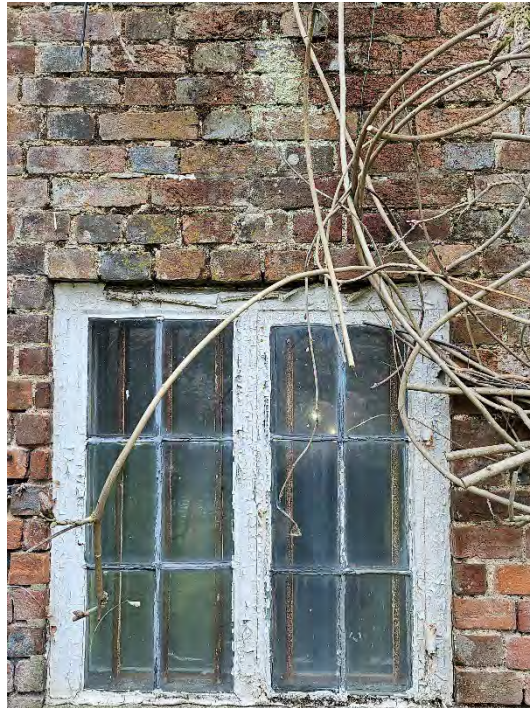
**P45 Rose Cottage – rear.  
Displaced brickwork above window.**

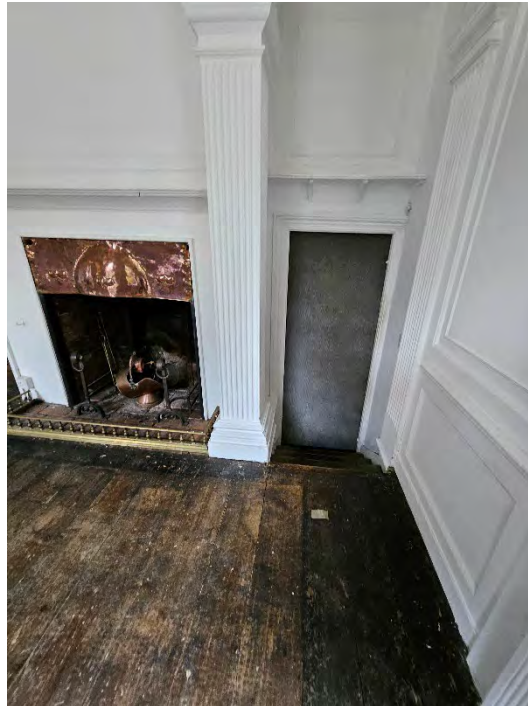
**P59 Link access to Rose Cottage – stairs beyond**

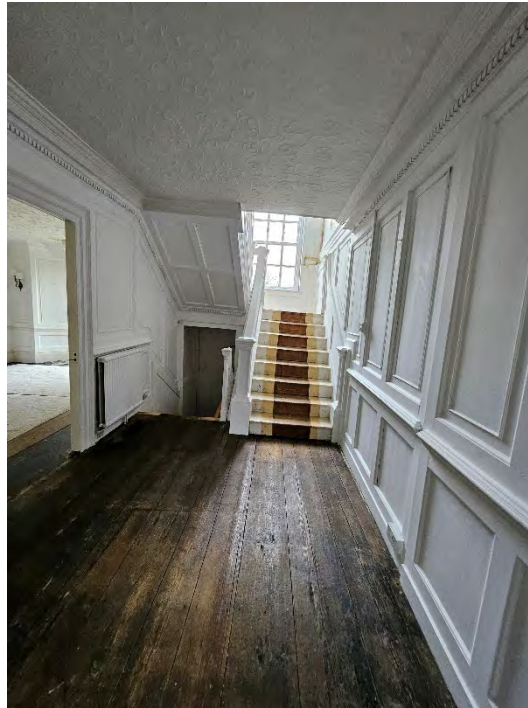
**P61 Central hallway – view to rear stairs**

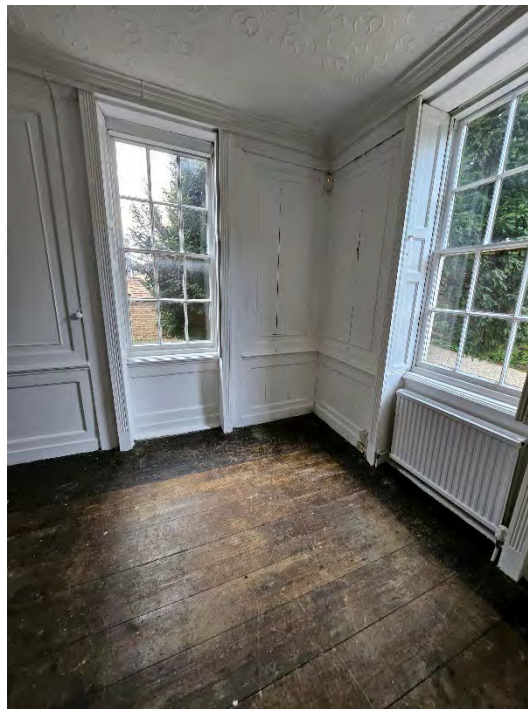
**P64 View to front right-hand corner**

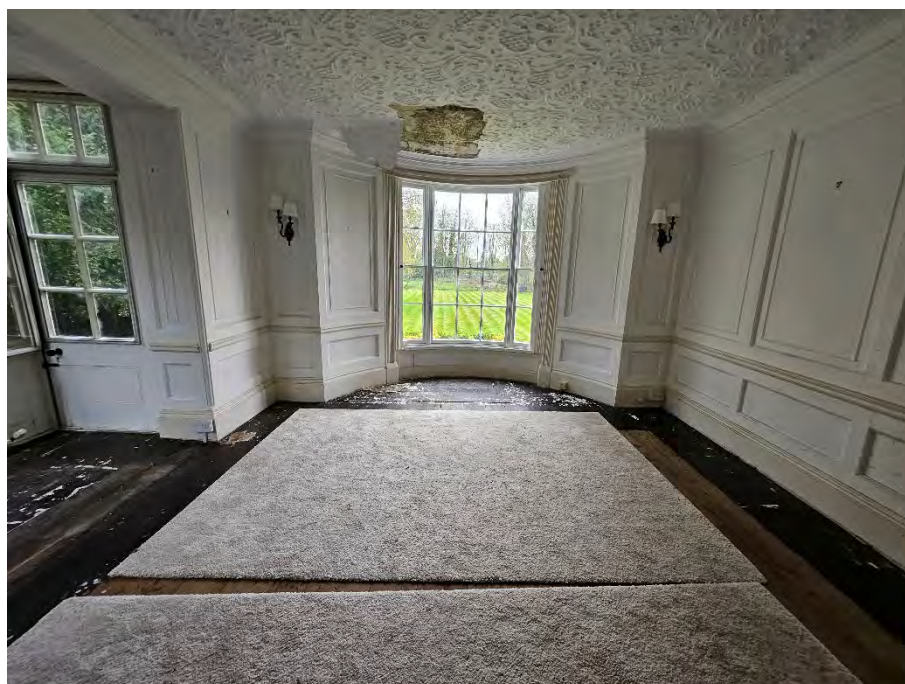
**P66 Ground floor – rear left-hand room – view rear**

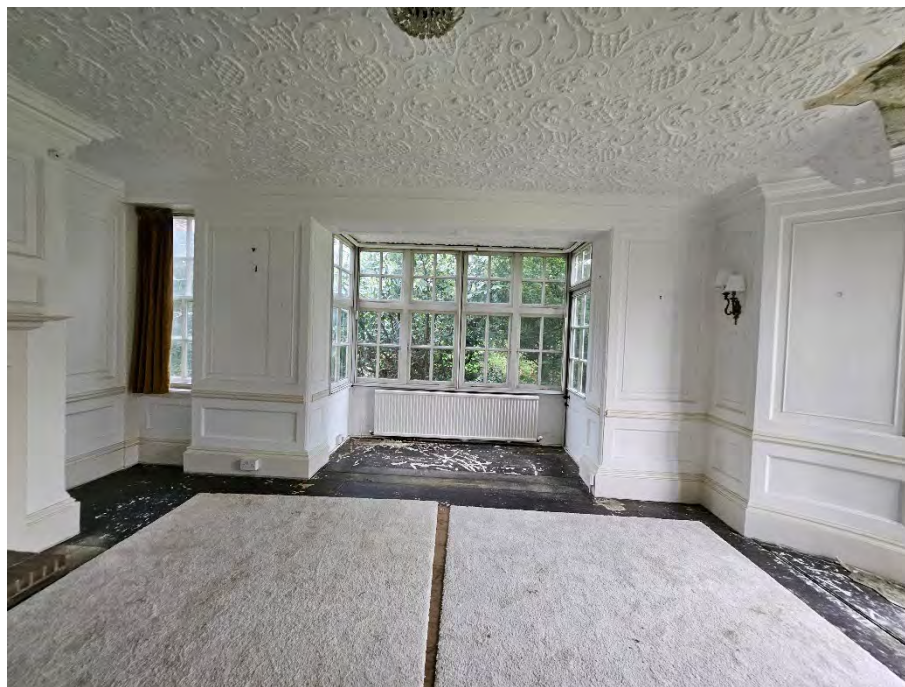
**P67 Ground floor – rear left-hand room – view east**

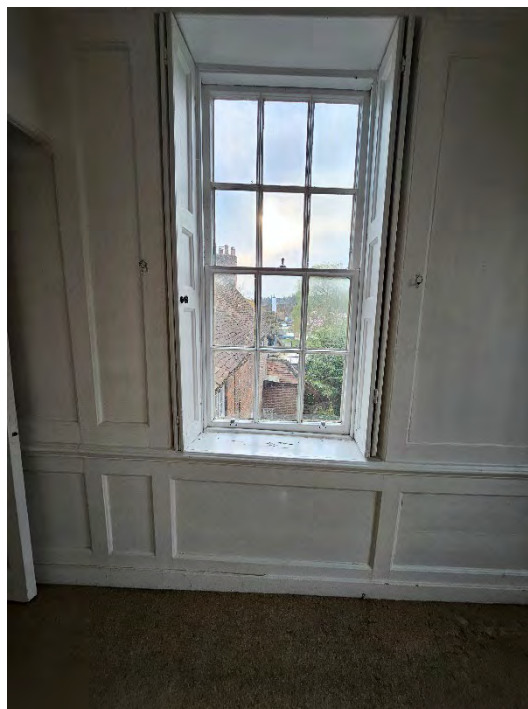
**P74 First floor – right-hand gable – settlement to wall**

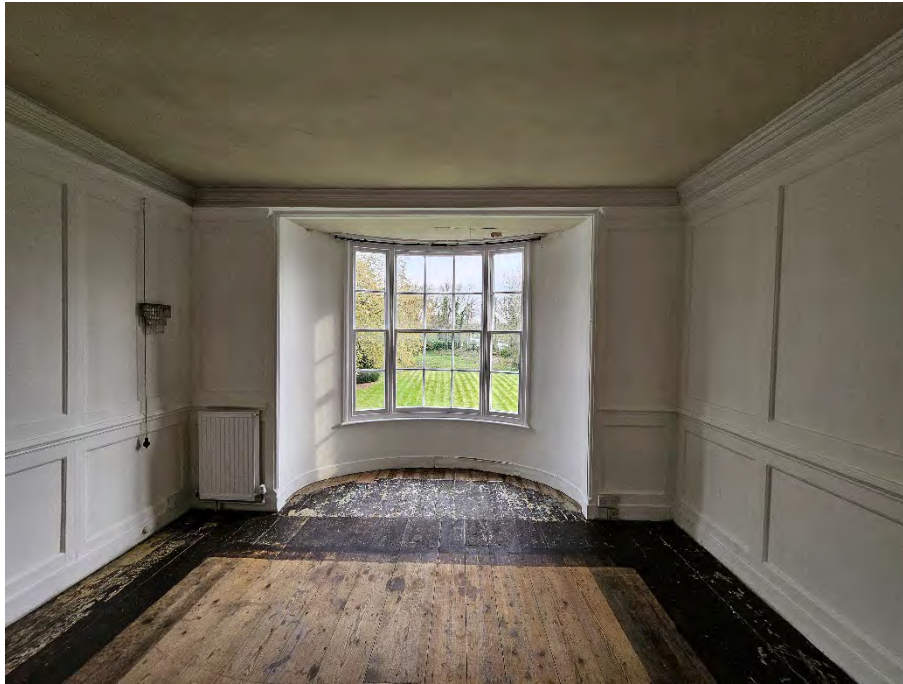
**P75 Rear left-hand bedroom – first floor – bay window**
