# **DETAILED TREE HAZARD ASSESSMENT**

Mill Green  
Wargrave  
Berkshire  
RG10 8EU

**April 2024**

Addendum to Duckworths Arboriculture Report (Tree Condition Survey)

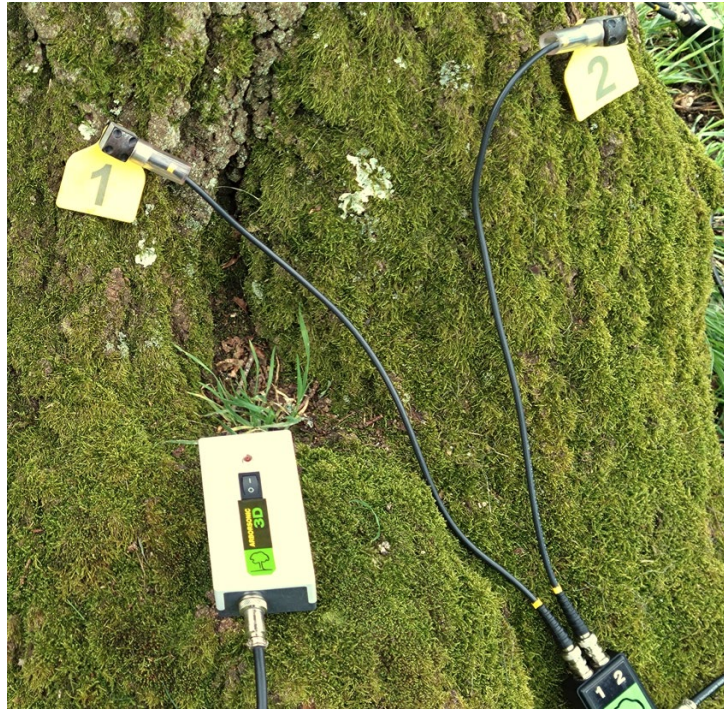
The wood at the two test levels appears to be solid, with no obvious signs or decay or any hollowing.

The likelihood of the tree failing at the trunk base as a result of the noted features is low.
