Clarke Webb Ecology Limited

GTO House

Proposed replacement of storage shed with new barn

Ecological Appraisal

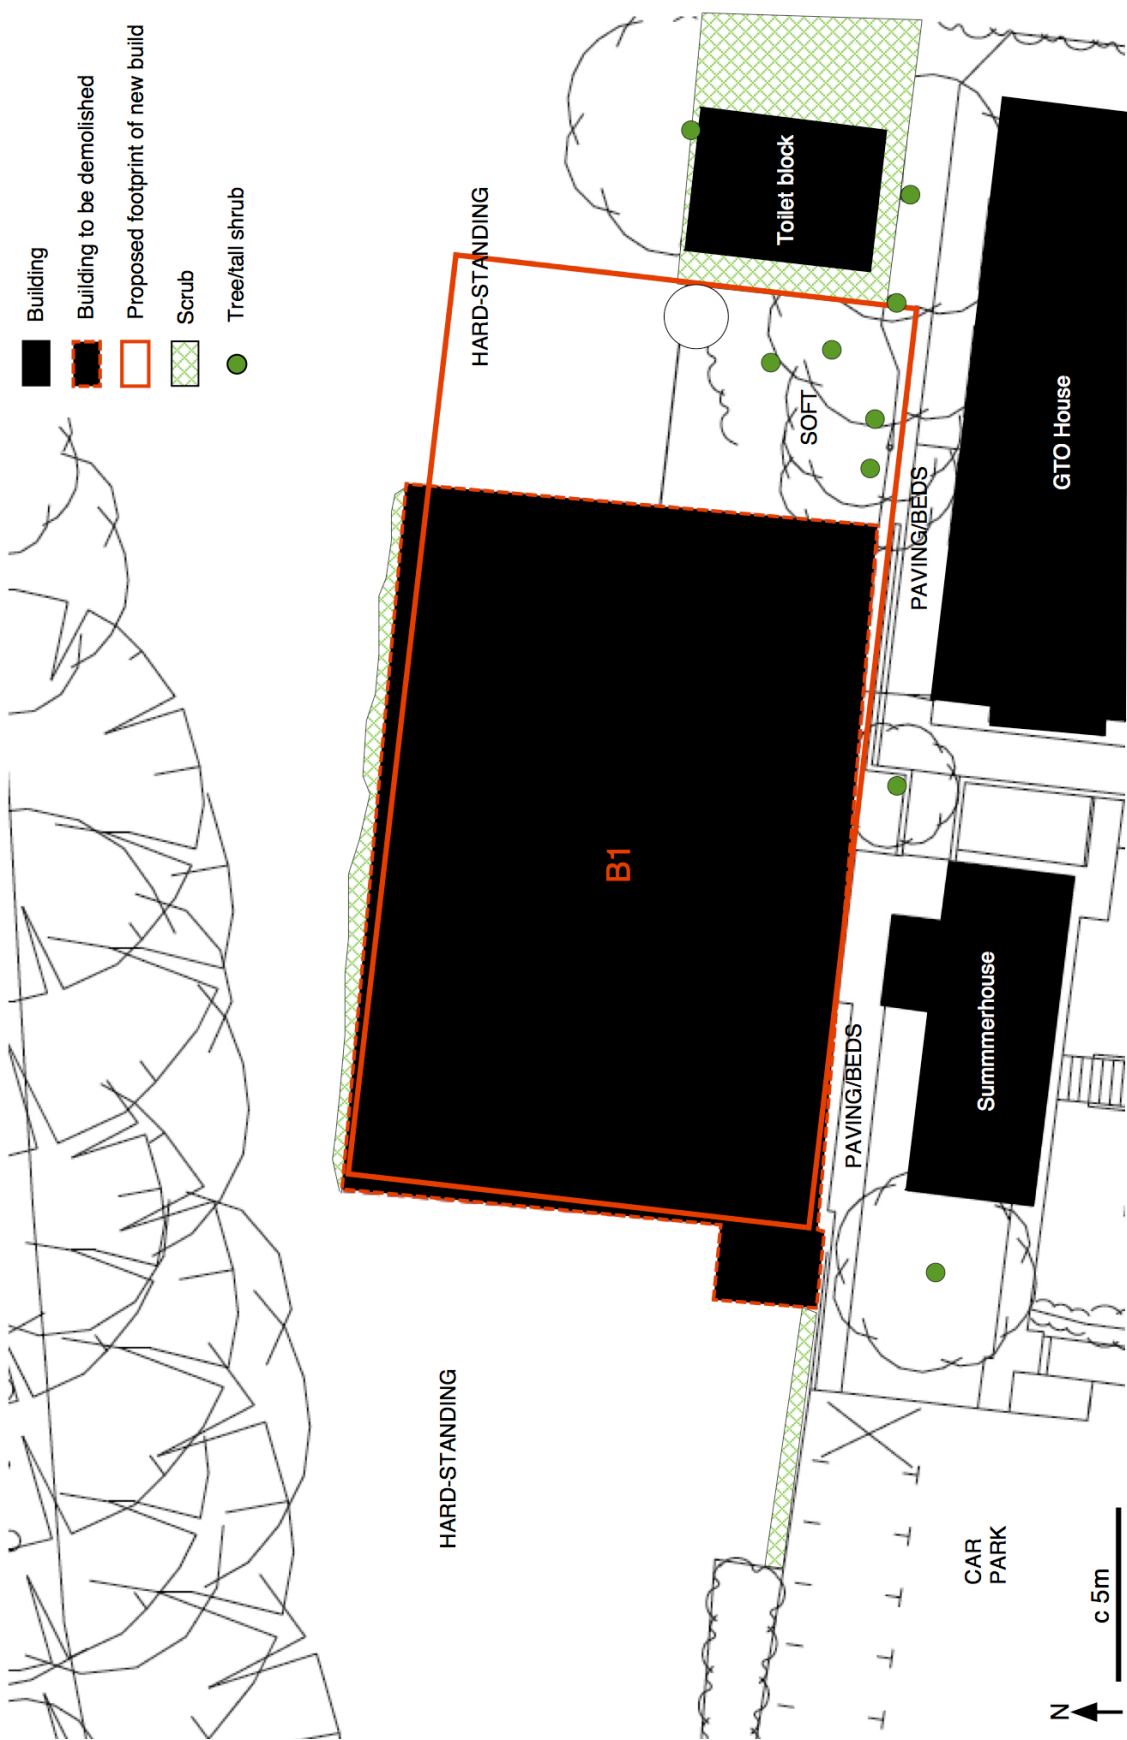
Figure 2. Site plan.

- 1.2 A satellite image of the site location can be found at Figure 1, site plan at Figure 2 and photographs of the site at Figure 3.
- 1.3 The building to be demolished (B1, Figure 2) is a large, single-storey storage shed. The lower c 1 m of three of the four external walls are brick or block-work. The remainder of the walls and the roof are of single-skin corrugated tin supported by a metal-frame. The interior is a single large void other than a small entrance lobby protruding at the southwest corner (with a mono-pitched plywood roof) and a small internal toilet block in the southeast corner. The building is in a state of disrepair and is currently used for the *ad hoc* storage of cars/car parts.

- 3.4 No evidence was found during daytime survey/assessment for any use of building B1 or affected/overlooking trees/shrubs by bats.
- 3.5 Notwithstanding the above, and with reference to the Bat Survey Guidelines, the following table summarises the potential suitability of the buildings, trees/shrubs, habitats and other relevant features for use by bats:

- 3.8 No evidence was found for use of building B1 by Barn owls.

- 3.9 No evidence was found for birds having nested recently within or upon building B1. There is a small risk of common birds nesting in denser vegetation (trees, shrubbery, scrub, Ivy) upon or adjacent to the site.

- 4.3 No evidence was found for use of the site as a roost by bats. All buildings/trees/shrubs present were deemed to be of negligible potential suitability for use as roosts. With reference to the Bat Survey Guidelines, no further bat roost survey is therefore warranted.
