# **URS REFURBISHMENT**

## **UNIVERSITY OF READING**

# **DESIGN & ACCESS STATEMENT**

Our ref: 435-ACG-W033-ZZ-RP-A-1906

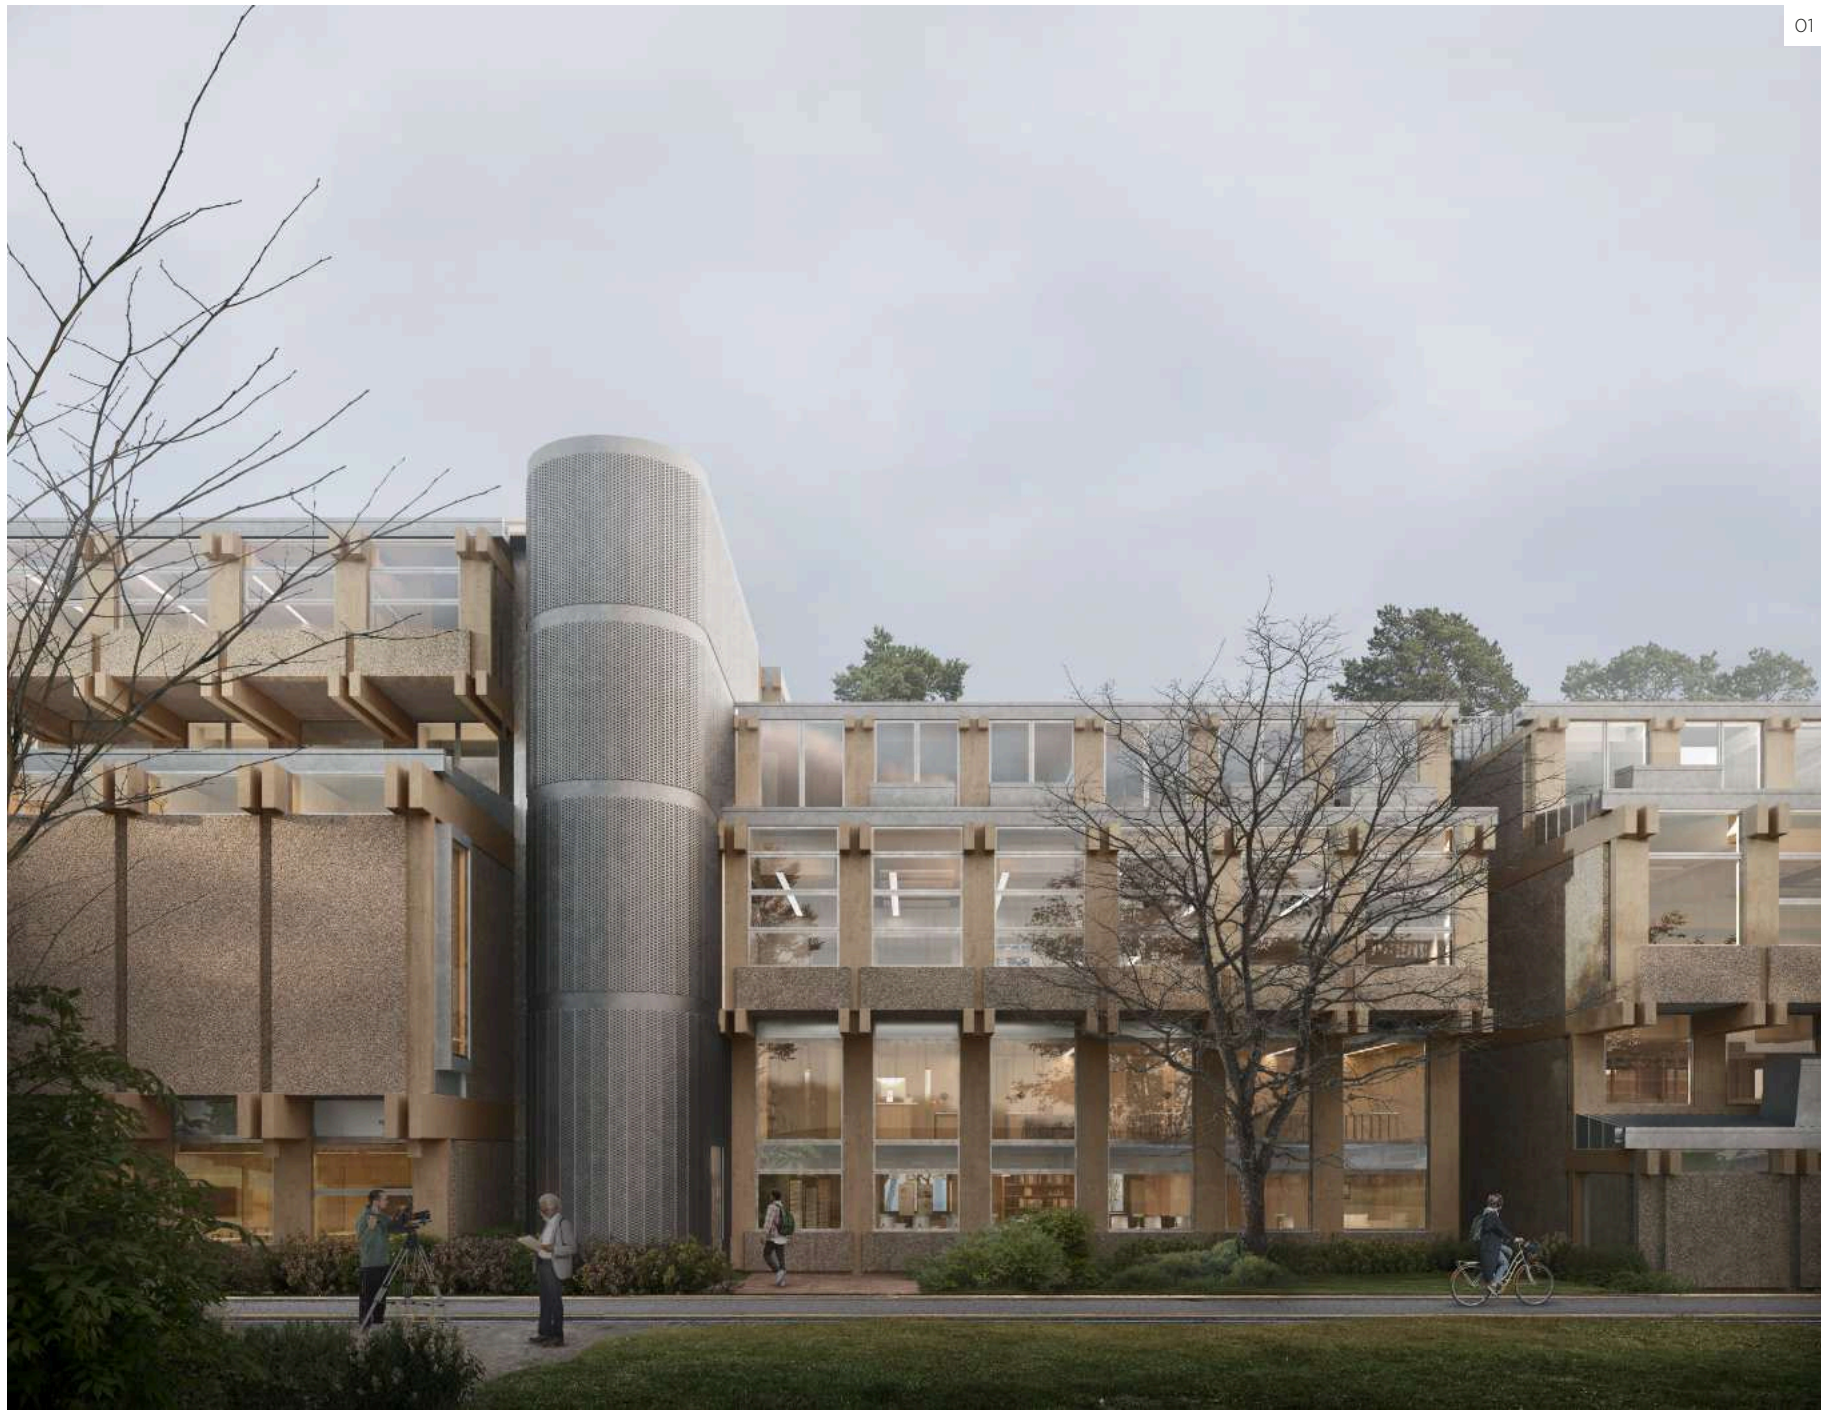
01 Exterior image of the southern facade of the URS Building.

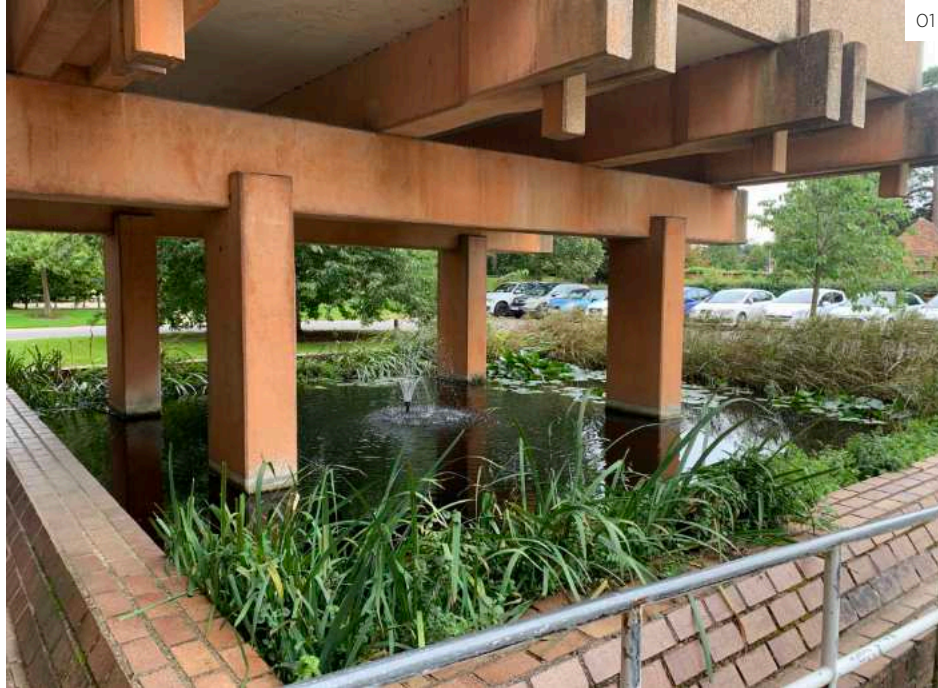
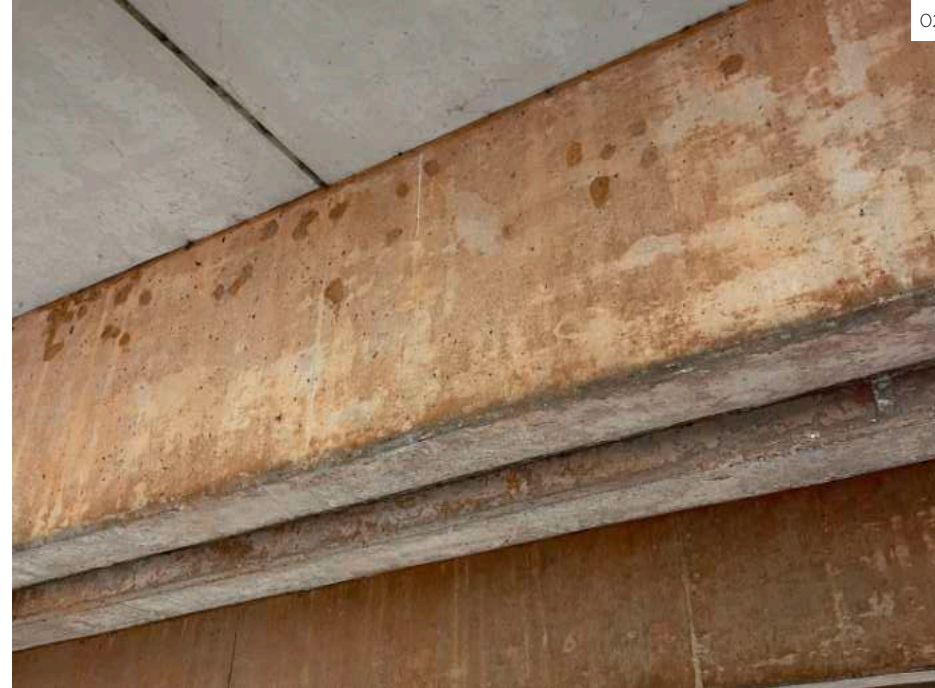
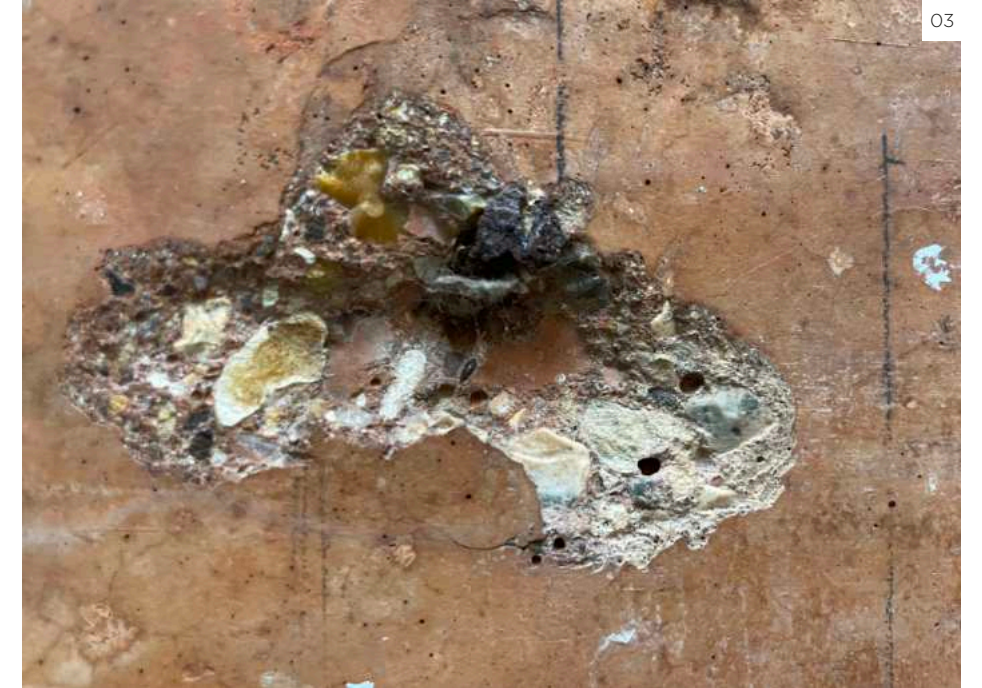
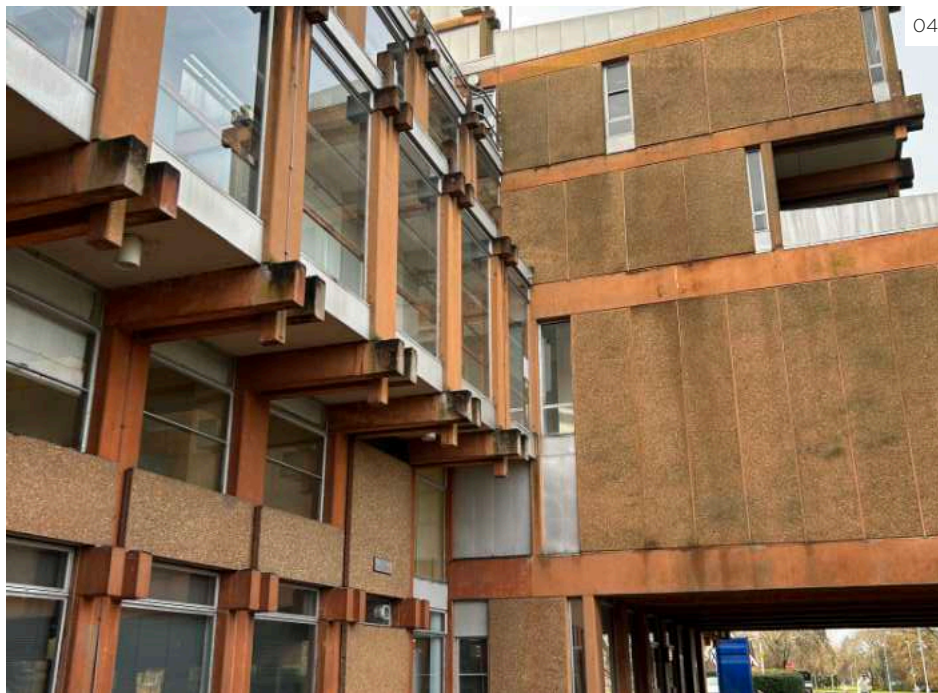
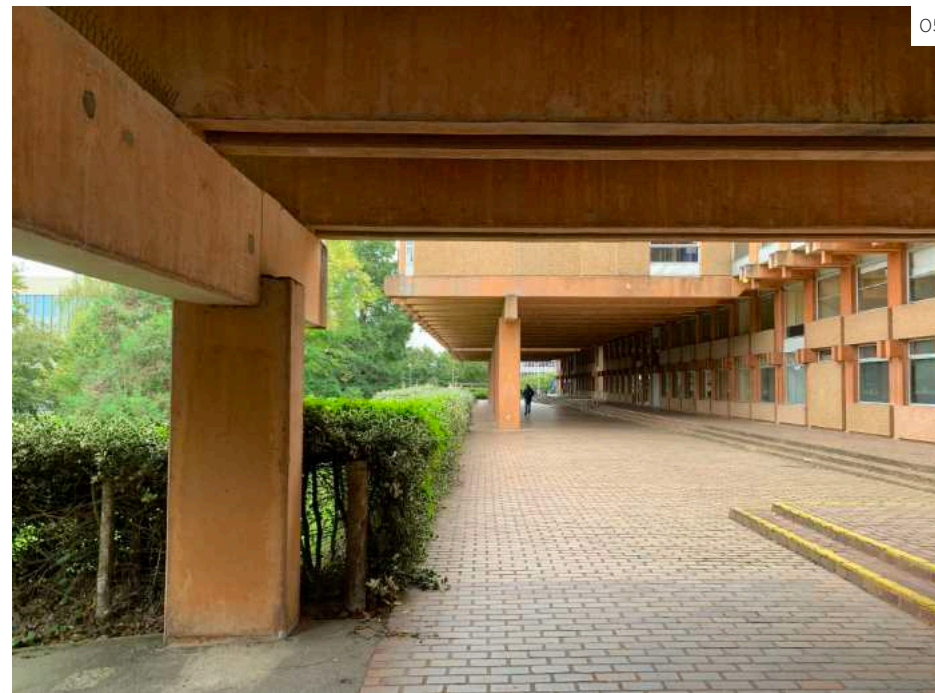
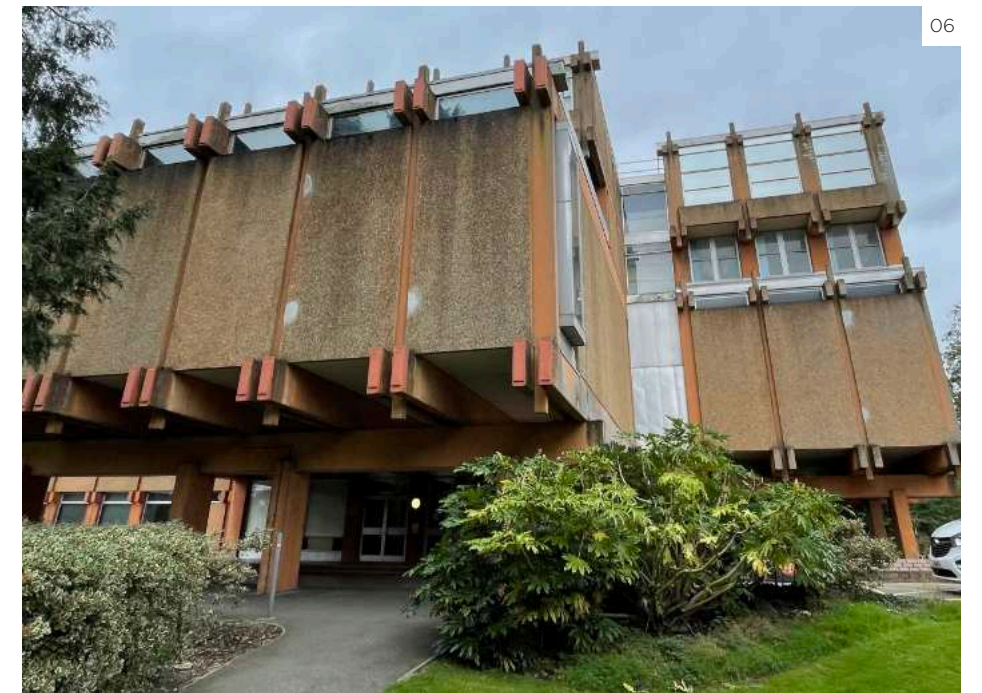
- 01 Fishpond.
- 02 External structural concrete beam condition.
- 03 Fault/damage in existing concrete beams.

- 04 North-west first floor overhang.
- 05 Public right of way running beneath northern overhang.
- 06 Patched repairs of concrete pre-cast panels.

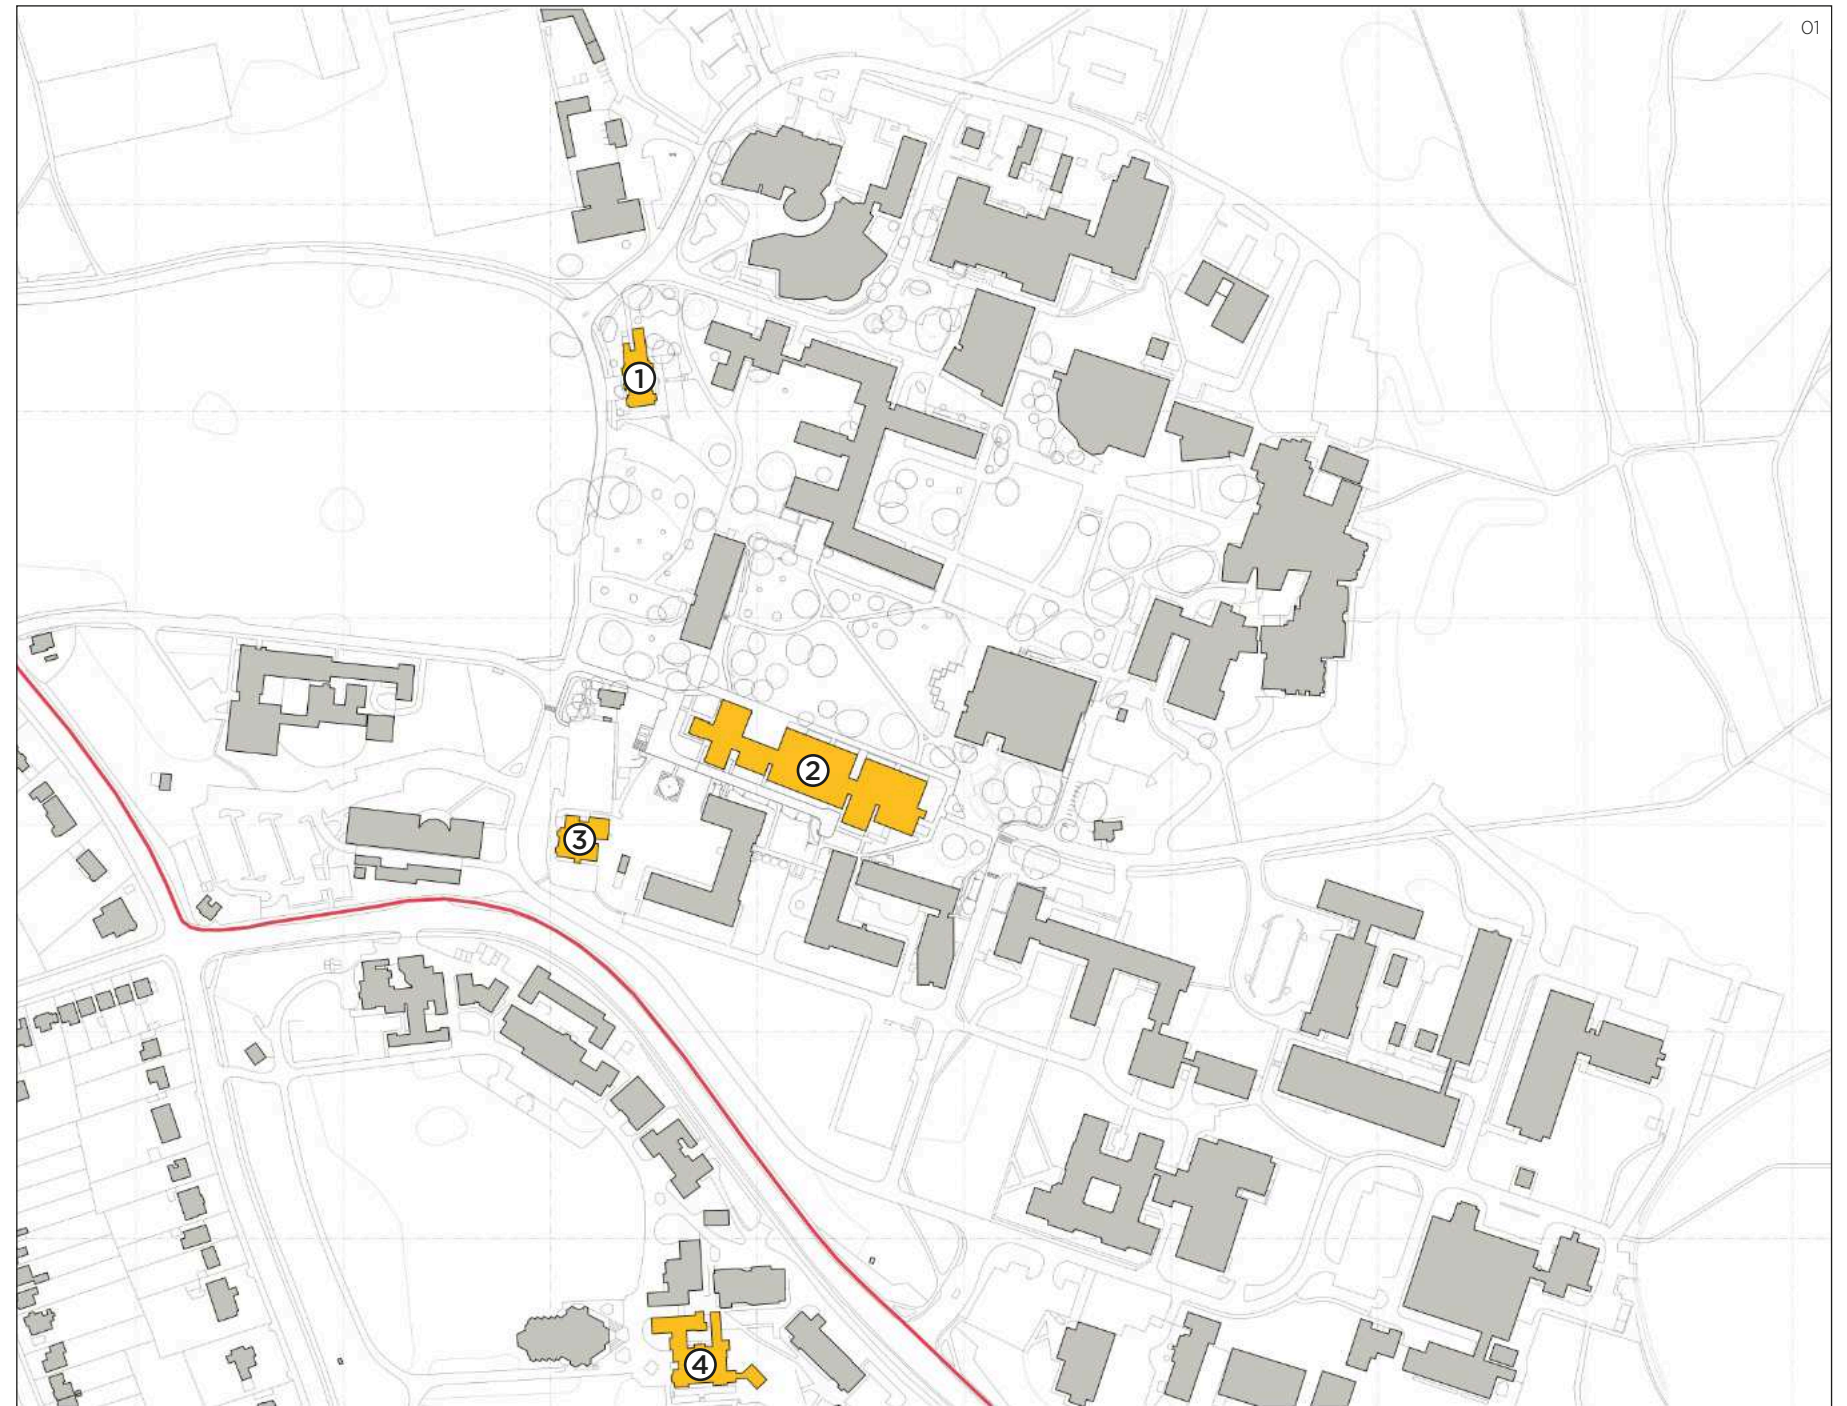
01 Annotated site plan with listed buildings highlighted in yellow (nts).

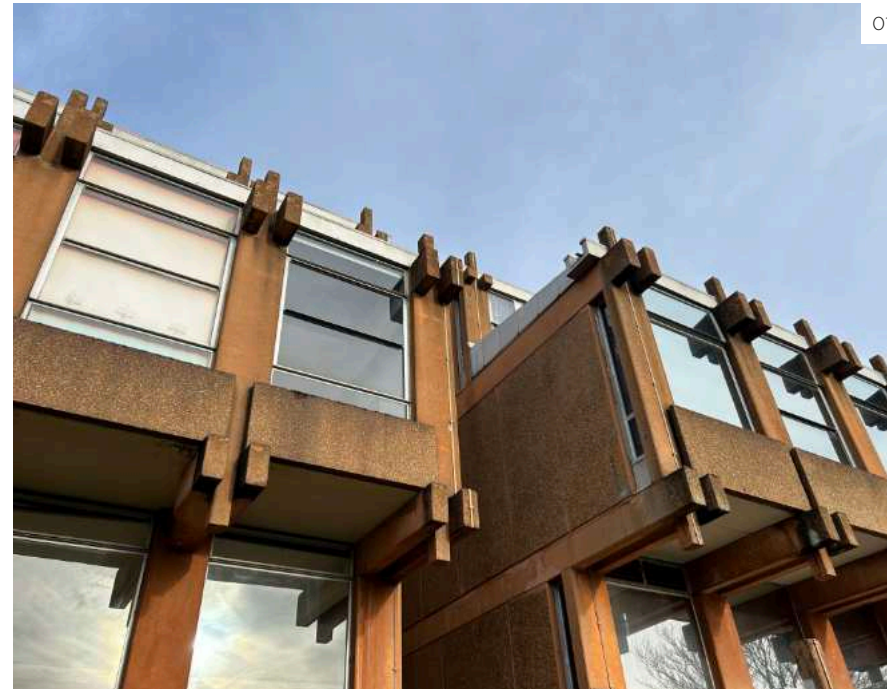
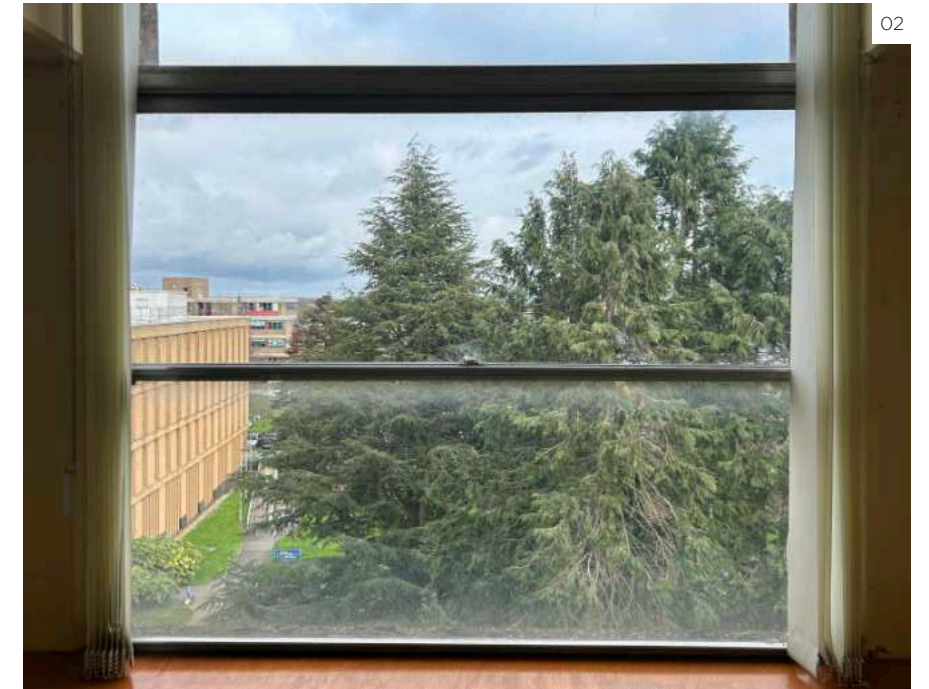
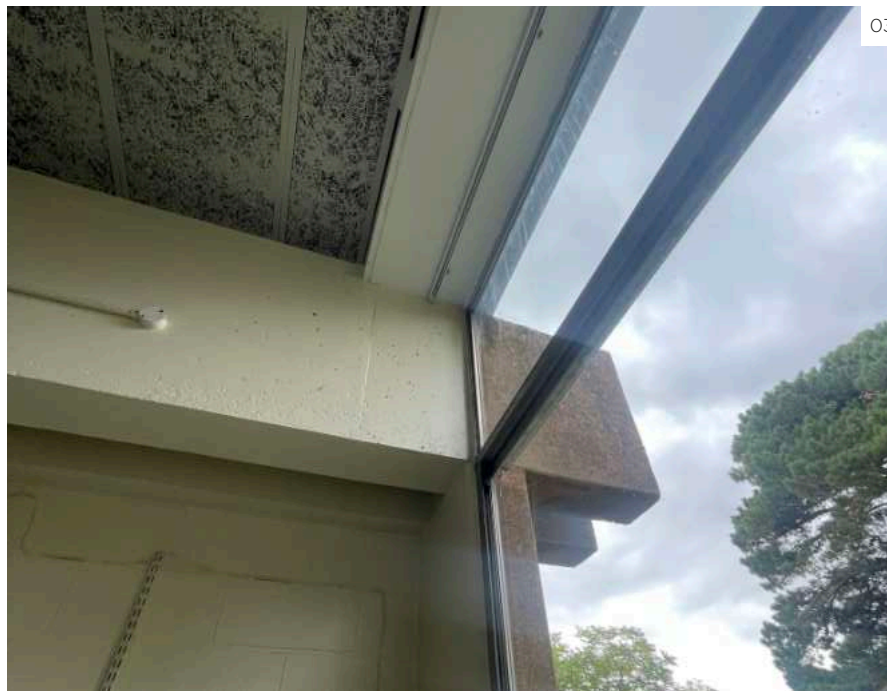
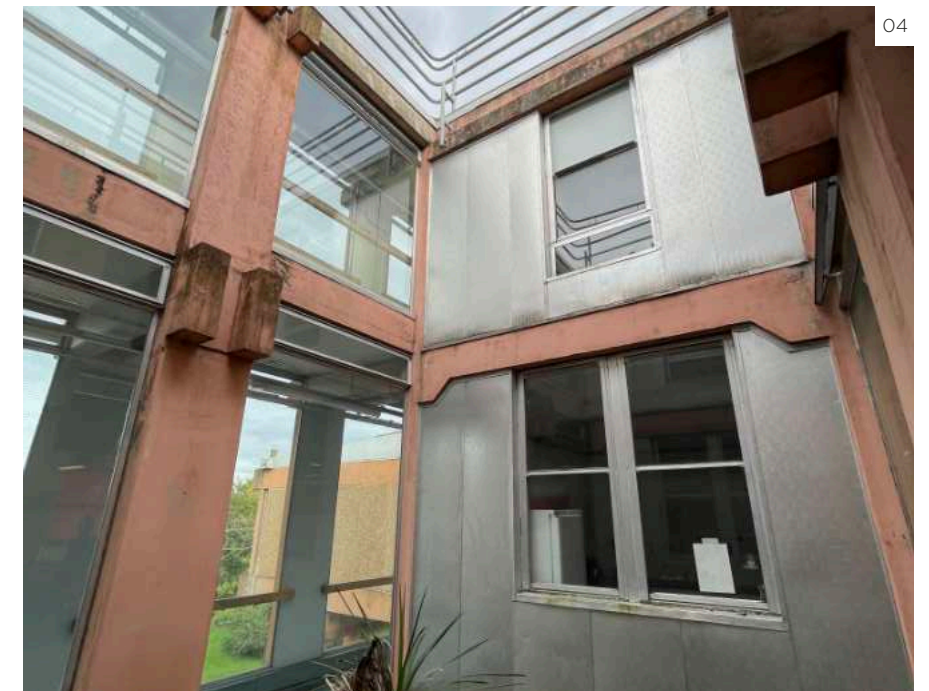
- Existing windows are single glazed aluminium framed. Frames are not thermally broken.
- Manufacturer is identified as Luxfer on original drawings.
- Window fenestration patterns vary on a floor by floor basis. While there are clear fenestration patterns, some areas seem to fall outside the general strategy. Fenestration patterns are further analysed in the coming pages.
- Key heritage and planning drivers include the slim window section widths and the general fenestration pattern making across the building.
- It is not felt that the original material used (mill finished aluminium) is significant in terms of heritage. Its is likely that new aluminium windows would be powdercoated, therefore alternative materials could be proposed.

- 01** Exterior photo of existing glazing on south facade.
- 02** Interior photo of existing glazing on north facade.
- 03** Interior photo of existing glazing on north facade.
- 04** Photo of internal courtyard glazing.

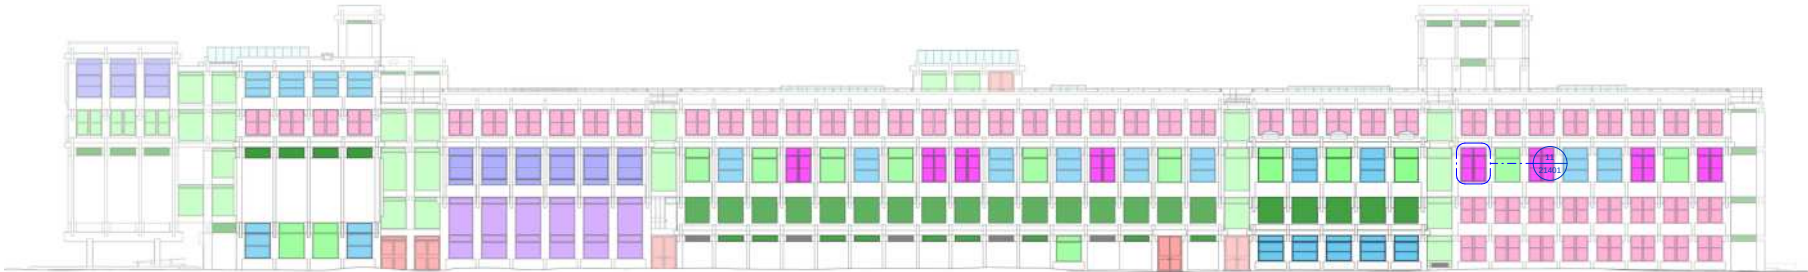
- 01 Annotated south elevation showing existing window fenestration patterns.
- 02 Annotated south elevation showing proposed window fenestration patterns.

In some areas we have chosen to deviate from the existing patterns where there is good reason. For example, where very large fixed single panes of glass are now replaced by a window with an additional transom at guarding level, to enable additional opening lights to increase ventilation. Another example, rooms with MVHR kit that do not have access to clear roof space above will instead integrate a louvre into the window configuration. This can be seen on the south facade, where we have proposed Active Travel space.

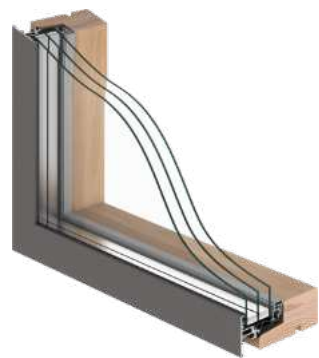
- Proposed window replacement - timber/aluminium composite.
- Face Width = approx. 50/100mm.
- Glazing = Up to 44mm (triple).
- Typically used as open outward. The external finish is powder-coated aluminium, which will be a close match to the original mill finish.

01 Composite window detail image.

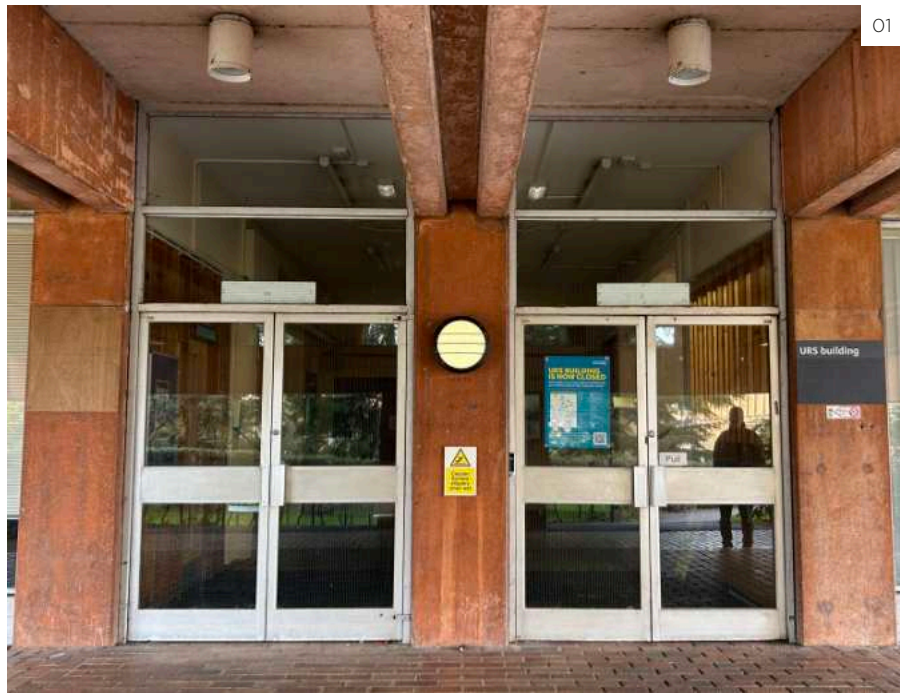
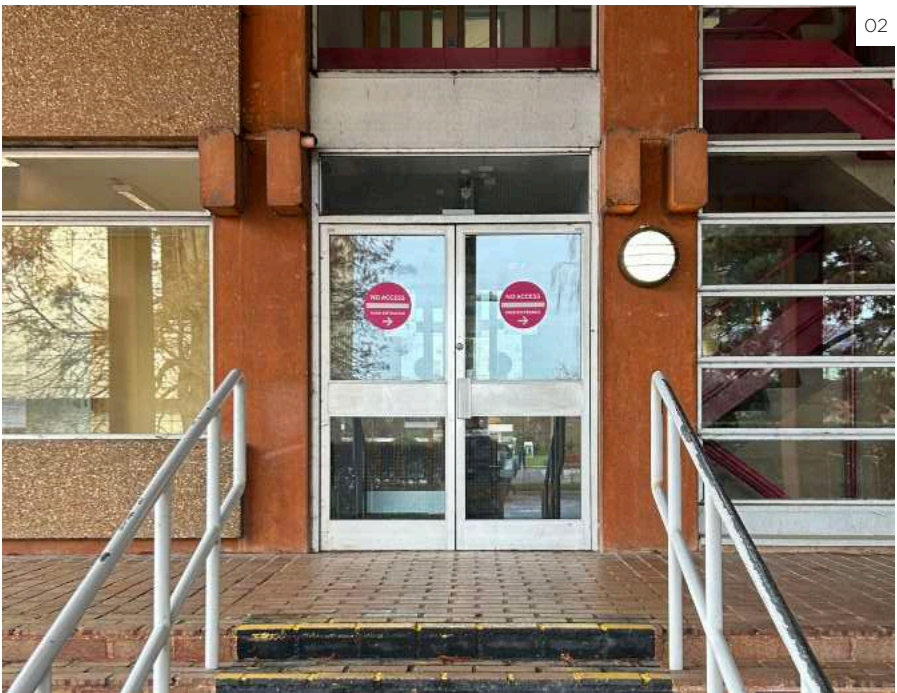
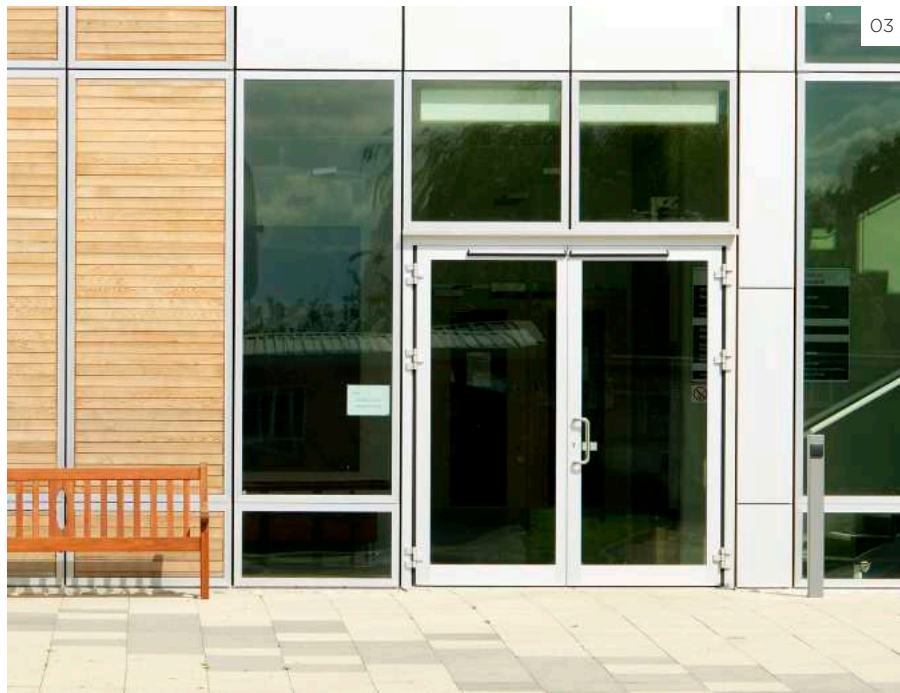
- Proposed external doors will be commercial grade aluminium doors. These doors need to deal with a lot of traffic.
- Maximise transparency.
- Improved entrance accessibility, with power-operated doors.
- Inviting, clear entrance route.
- Triple glazing, so improved thermal performance.

01 Existing main entrance doors.  
02 Existing secondary entrance doors.  
03 Aluminium commercial door precedent image.  
04 Aluminium commercial door product image.

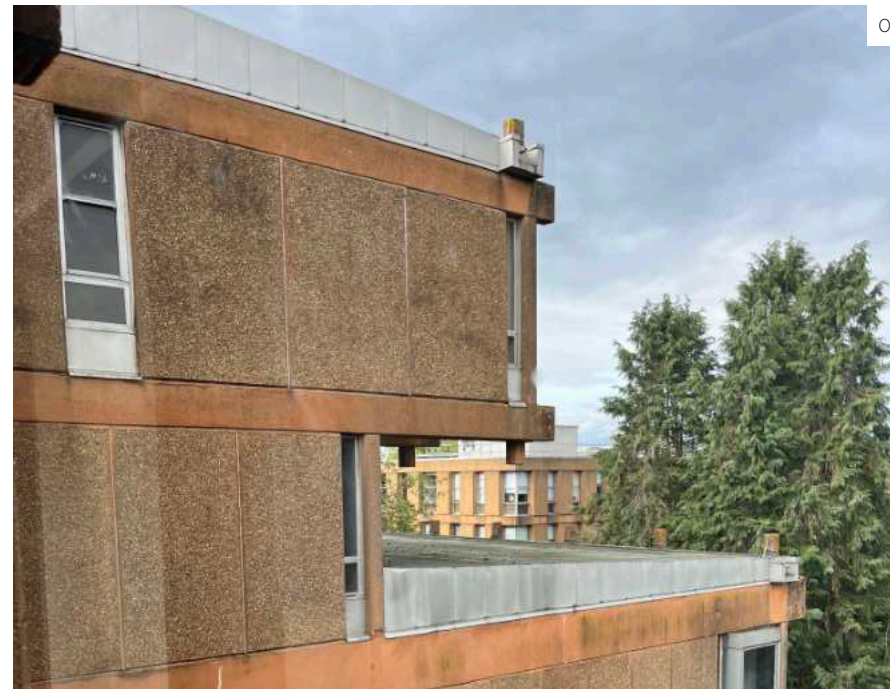
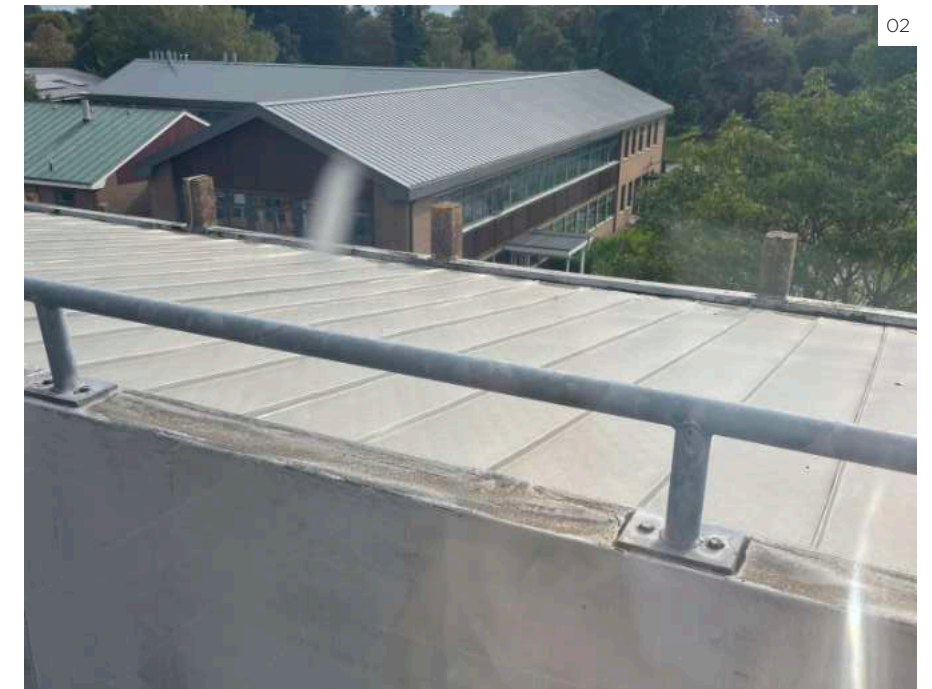
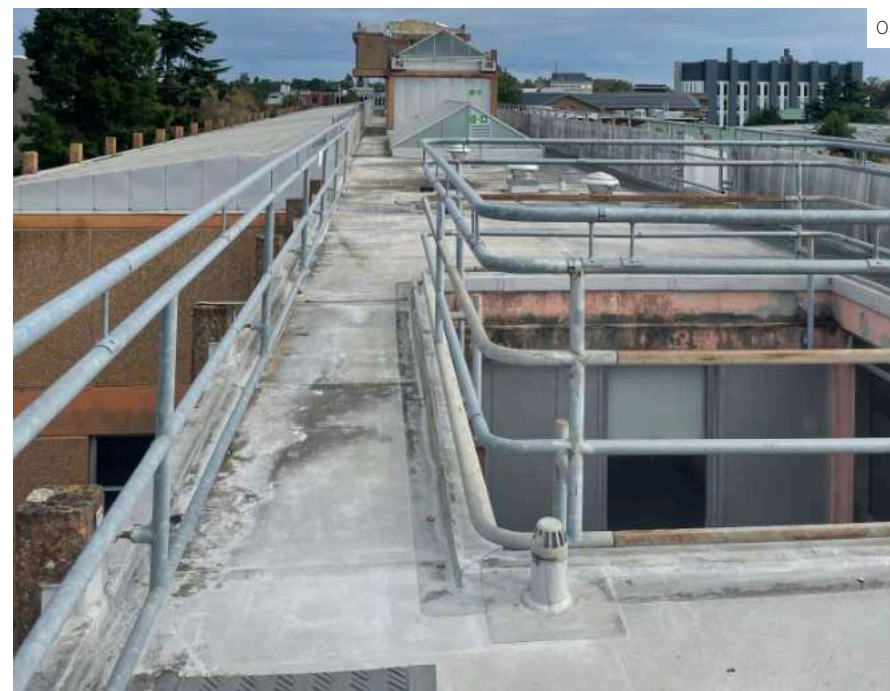
- Original drawings indicate felt over screed, over woodwool deck.
- It looks like the roof has been recovered, probably overlaid with single ply membrane and additional insulation.

The existing roof is in a poor state, leaks, and has caused damage to the structure below. Therefore, the planning application proposes a full roof replacement.

- 01 Existing pitched roof standing seam.  
02 Existing pitched roof.  
03 Existing flat roof and handrails.  
04 Existing roof gutter.

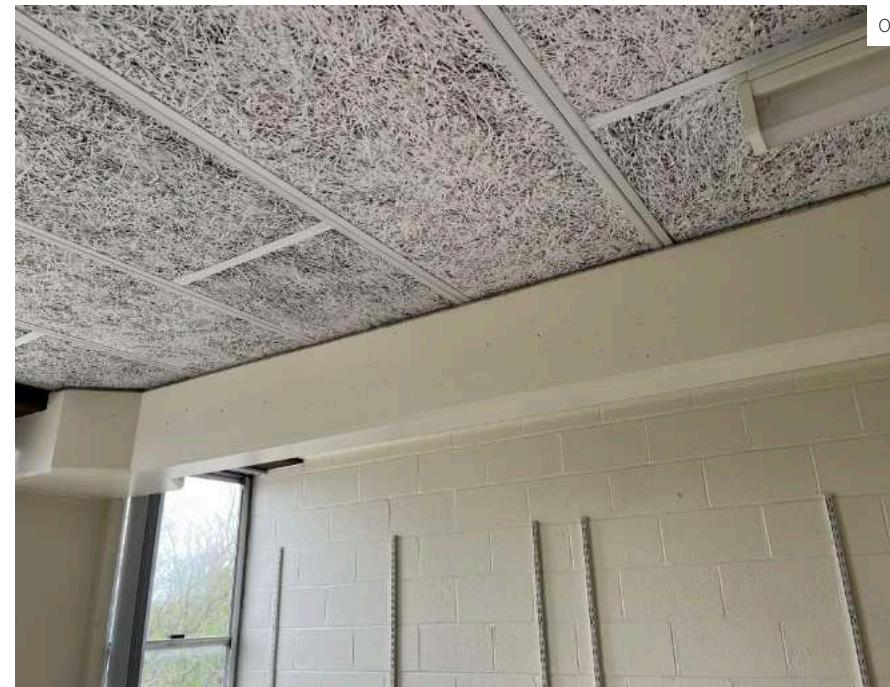
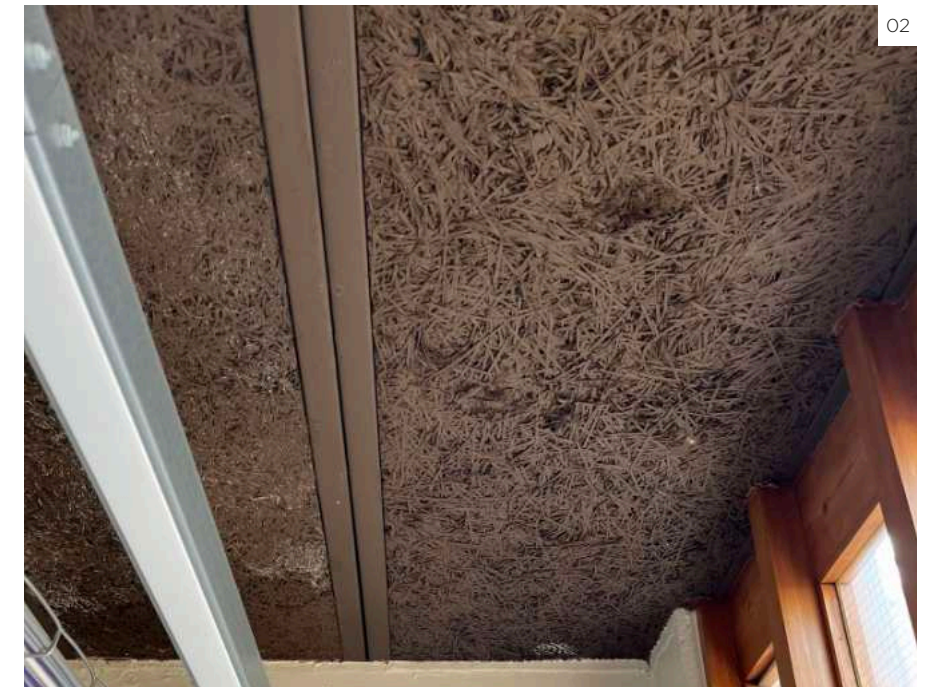
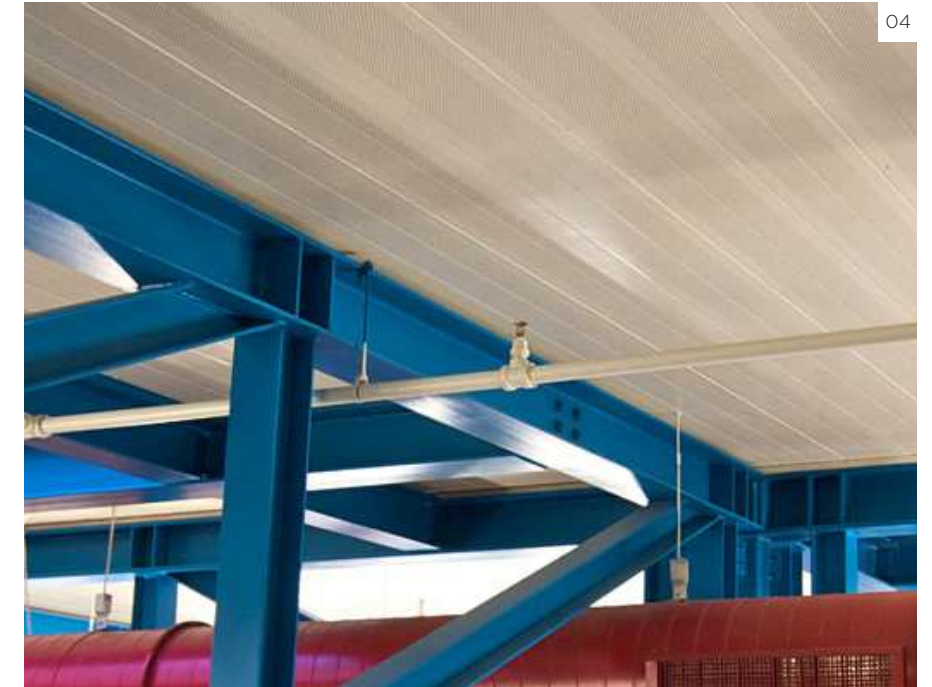
- Existing roof deck structure consists of framed woodwool slabs for both the pitched and the flat roof areas.
- The intention is a full roof replacement, which includes the existing woodwool roof deck slabs.
- There are no modern direct replacements for woodwool structural decks.
- Woodwool is a very light deck, its replacement must not overload the buildings structure.
- Full replacement allows much improved insulation levels to be achieved.

- Replacement needs to be lightweight, capable of significant thermal efficiency while remaining slim and to have a generally flat soffit.
- Proposal is a structural metal linear tray deck, with acoustic perforations, spanning between the existing concrete structural beams.
- The deck would be flat and have a 600mm linear grid as per the woodwool.
- While clearly not the same materiality as a woodwool slab, the perforations will add texture to the soffit as well as helping acoustic attenuation.
- Significant levels of mineral wool insulation can be incorporated.
- Overall build up increases but the thickness increases downwards so not effecting the gutter and verge line.

- 01** Existing woodwool panel roof deck.
- 02** Existing woodwool panel roof deck.
- 03** Detail image of proposed perforated metal tray deck.
- 04** Indicative precedent image of perforated metal roof deck.

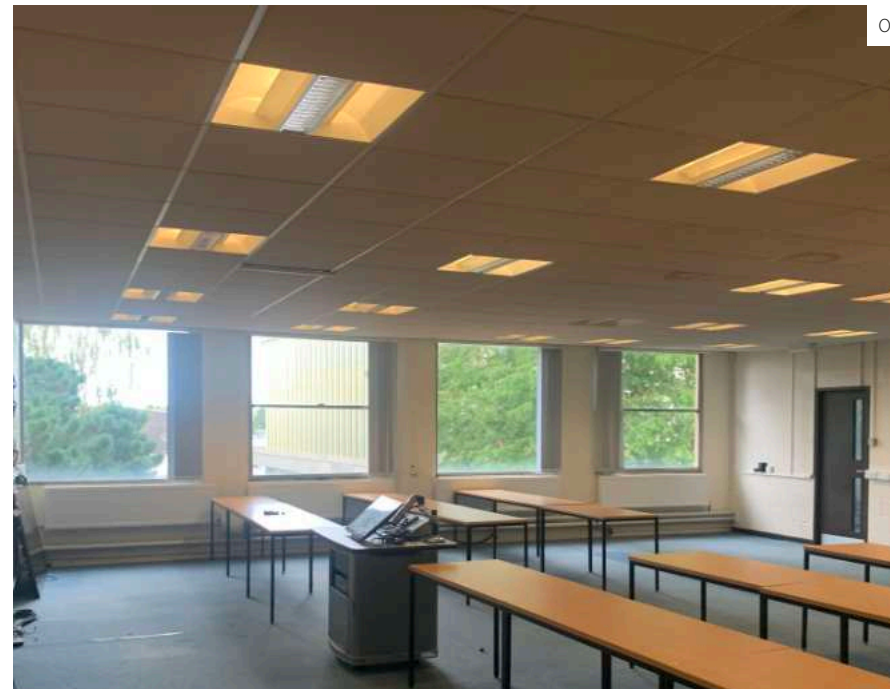
01 Existing suspended ceilings in the classrooms.

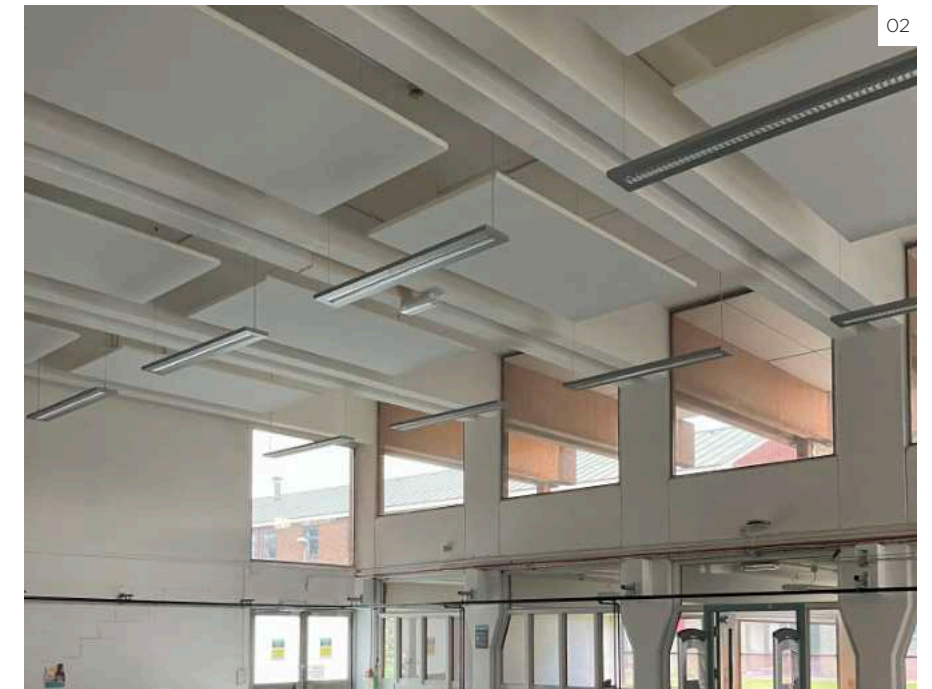
02 Existing suspended acoustic baffles.

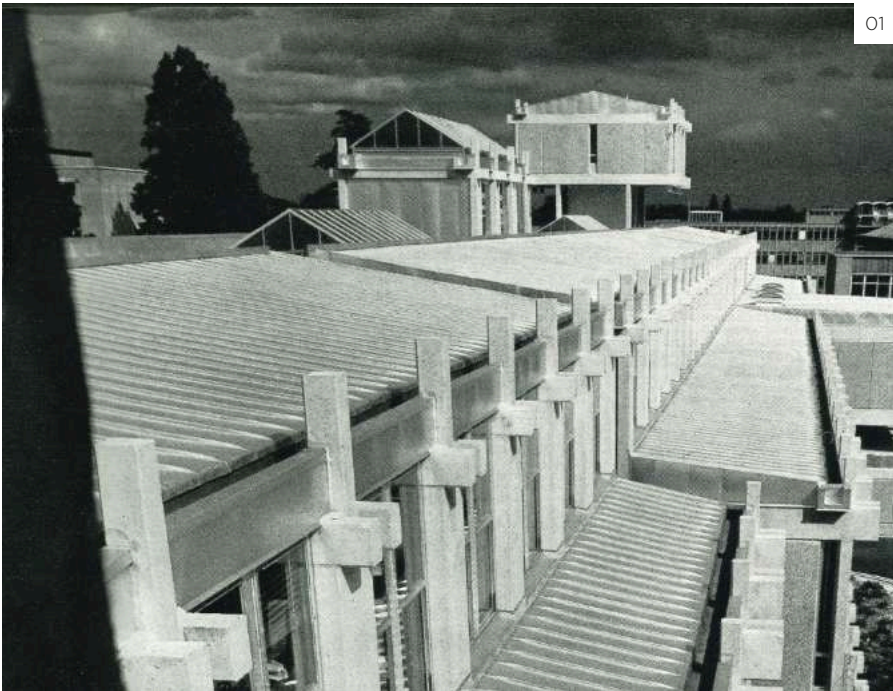
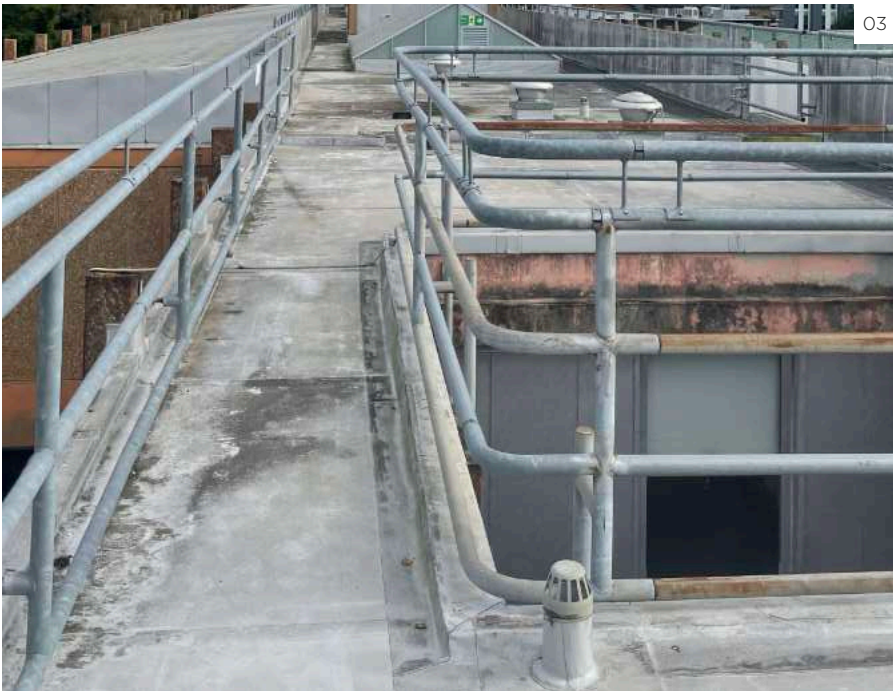
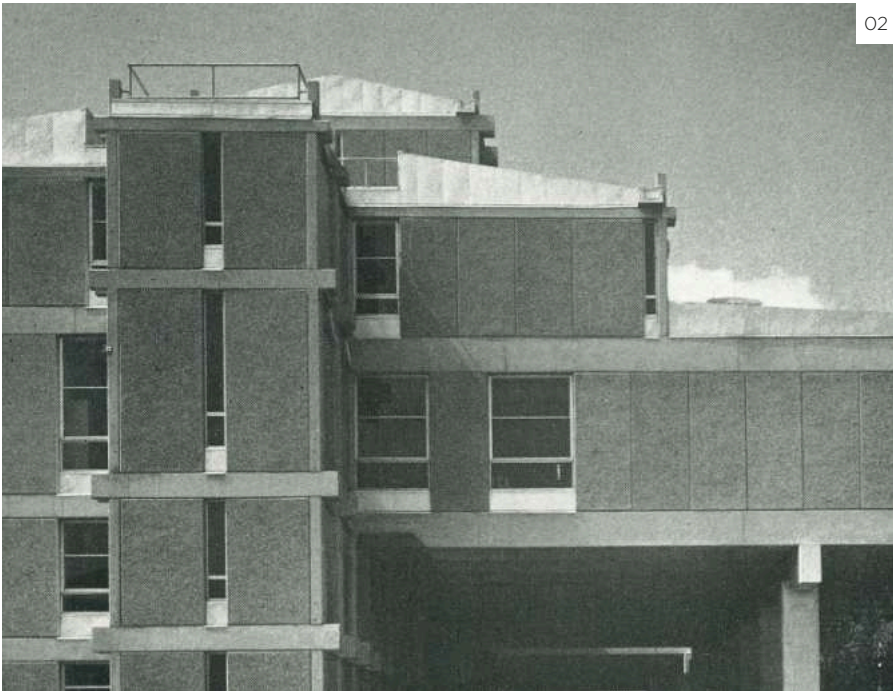
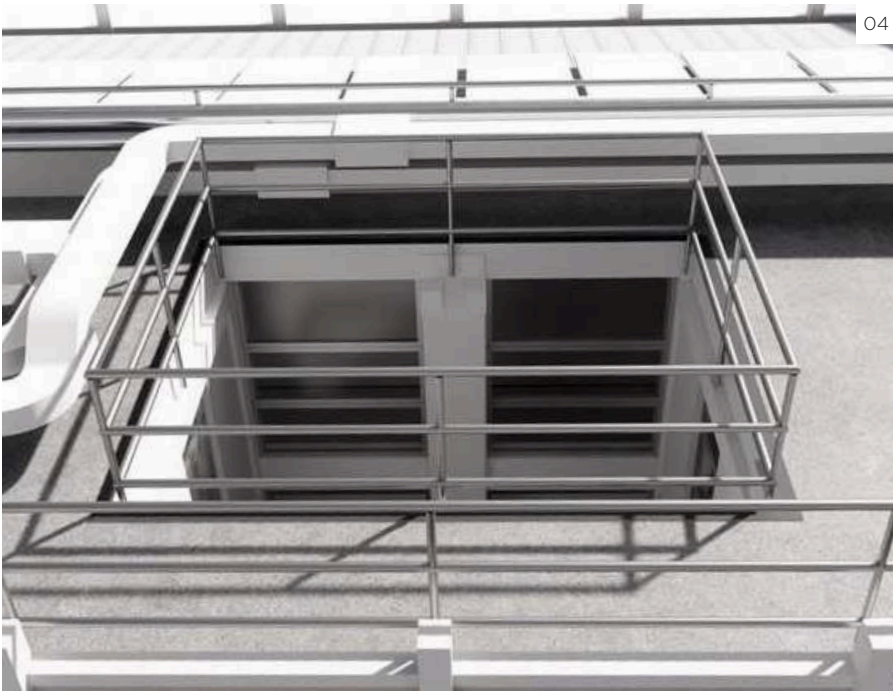
**01** Image of the original roof handrail system, taken from the November 1973 issue of the Architectural Review magazine.

**02** Image of the original roof handrail system, taken from the November 1973 issue of the Architectural Review magazine.

**03** Existing roof handrail.

**04** Indicative visual of proposed roof handrail system.

- As the existing handrails are both in a poor state and heavily modified from original, it is proposed to remove and replace these with a more sympathetic design.
- Tubular steel guarding will be silver in colour, to tie in with the roof and window frames.
- Guarding height and design will be compliant with current regulations, which will require a rail along the upstand edge, but this will be set back to align with the full height guarding.
- Existing roof fixing points will be reused where possible.
