# **URS REFURBISHMENT**

## **UNIVERSITY OF READING**

# **DESIGN & ACCESS STATEMENT**

Our ref: 435-ACG-W033-ZZ-RP-A-1906

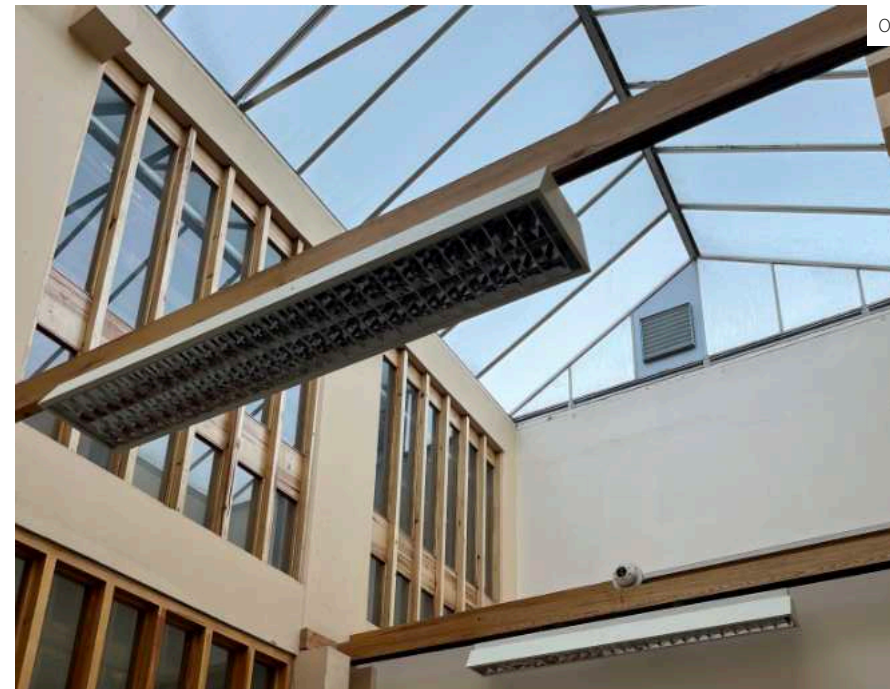
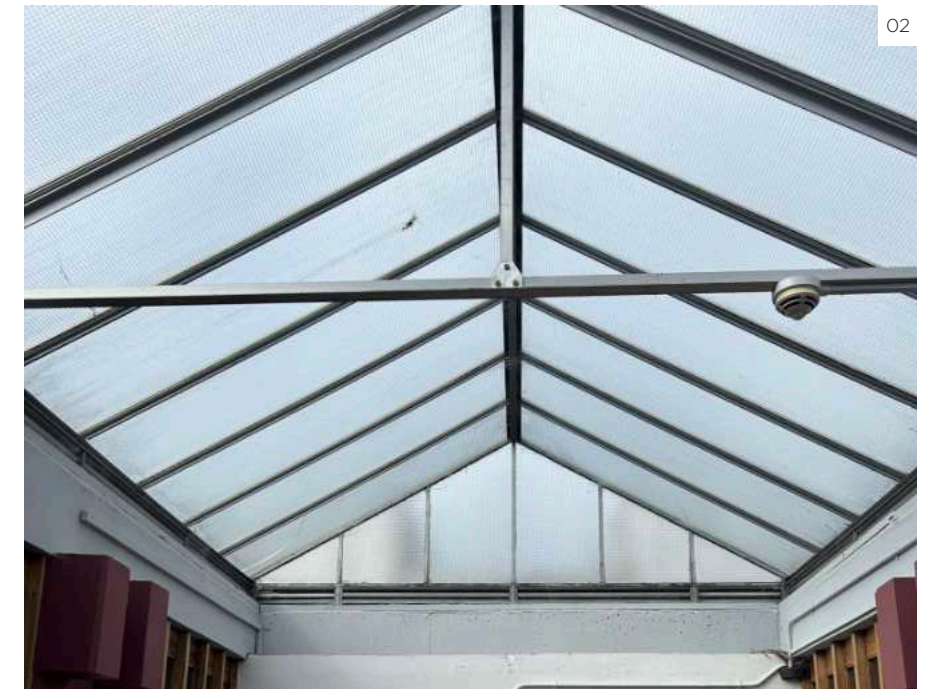
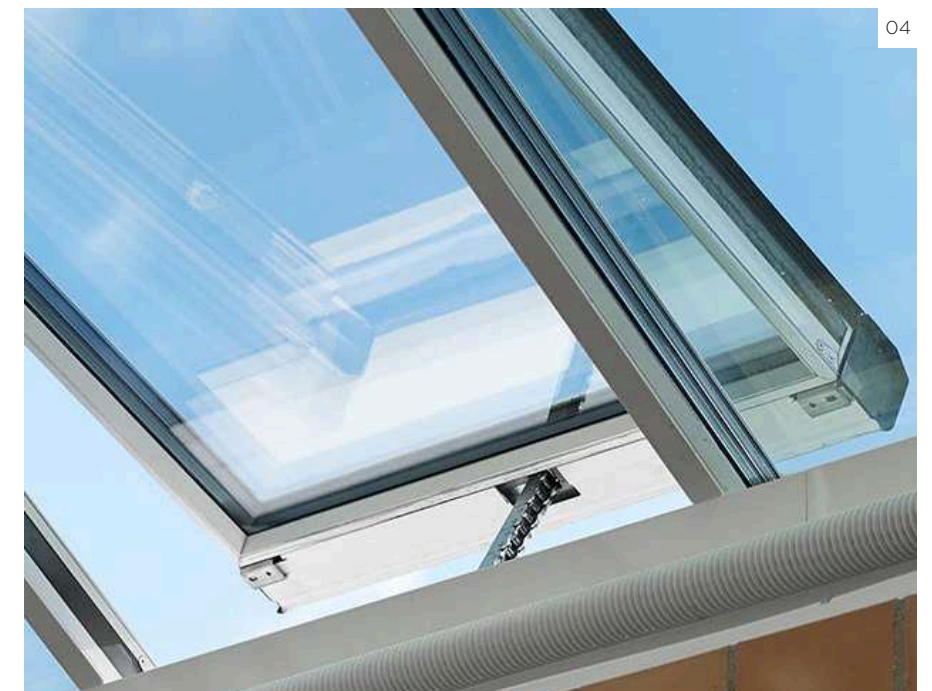
- 01 Existing roof lantern in atrium space.  
02 Existing roof lantern above stairwell.  
03 Proposed aluminium roof lantern.  
04 Proposed aluminium roof lantern.

- Existing glazing panels are Georgian Wire glass.
- Single glazed window panes, so poor thermal performance and inevitable condensation issues.
- Subject to both water and air leaks.

- Proposed roof lantern will be 'new dual pitched aluminium' system, matching the pitch and modules where possible.
- Replacing the roof lanterns presents an opportunity to also provide ventilation for cooling and smoke vent, through automatic openable panels - approximately 10% will be openable.
- Triple glazing throughout to improve thermal performance.

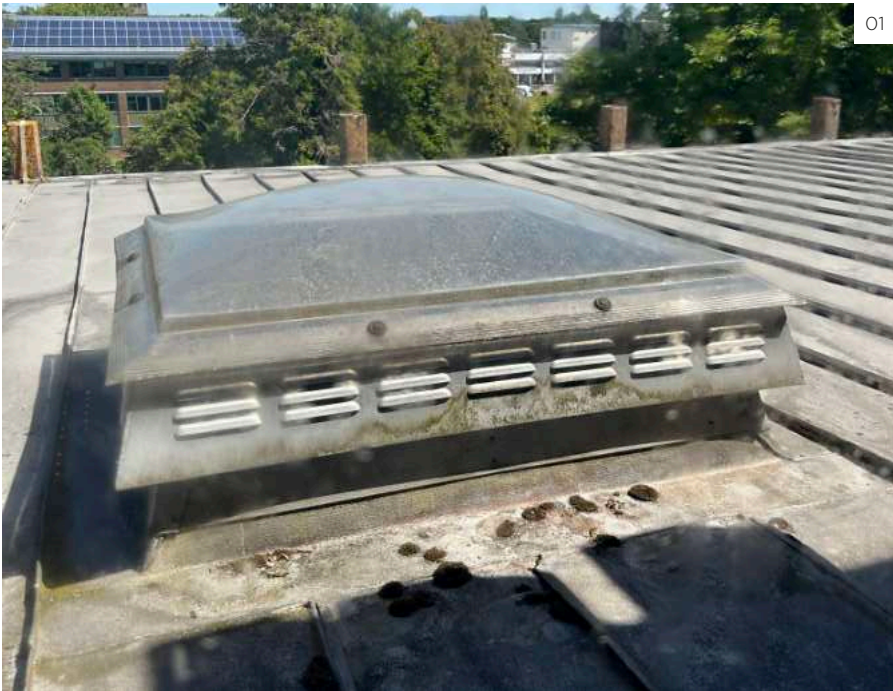
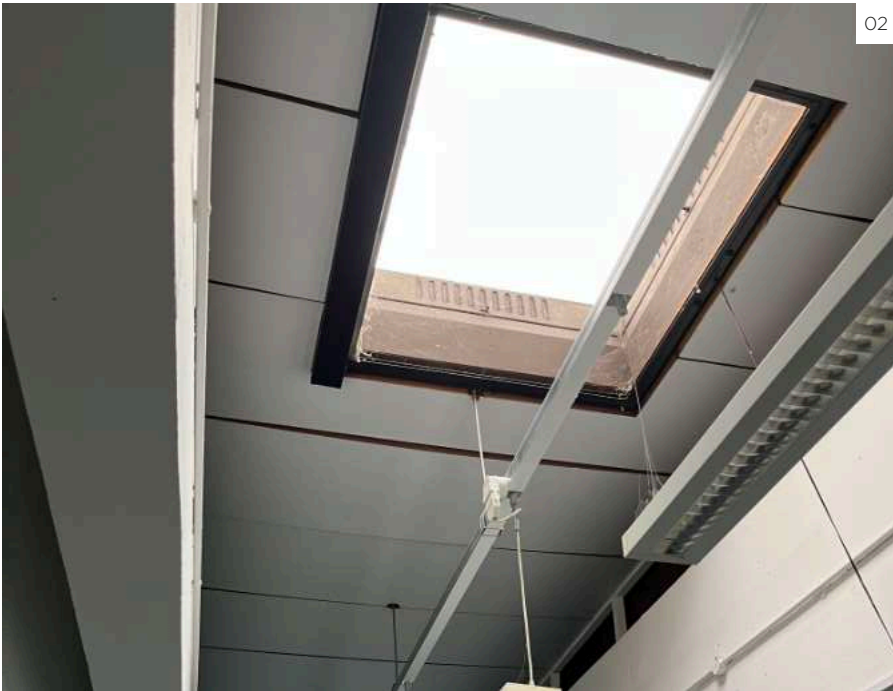
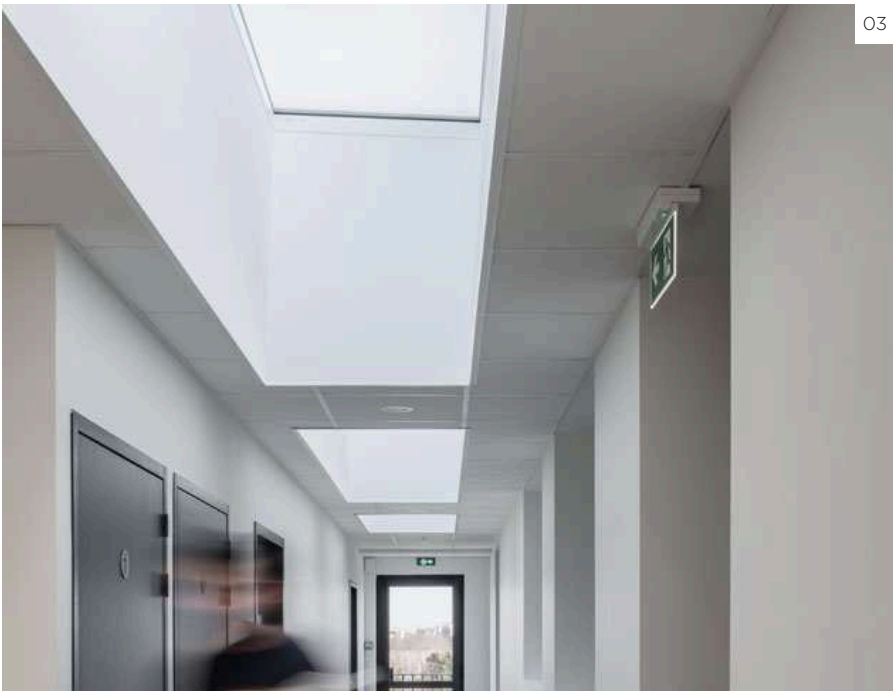
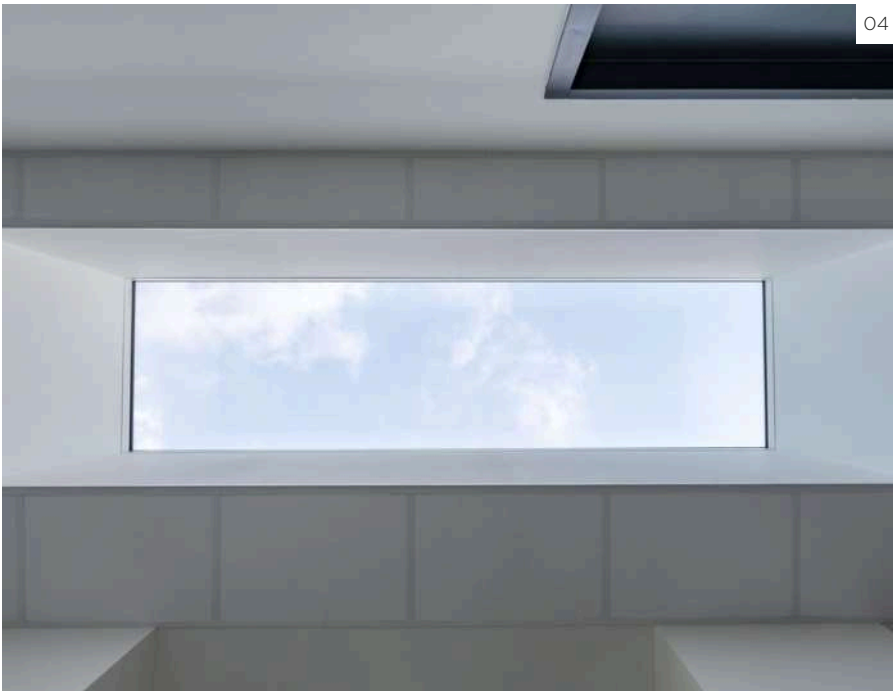
01 Existing roof light.  
02 Existing roof light in classroom space.  
03 Proposed roof light precedent.  
04 Proposed roof light precedent.

- Rectangular shape to fit between concrete beams, reducing the need for trimming structure.
- Proposed dimensions of approximately 800mm x 2000mm.
- Triple glazing, so improved thermal performance.

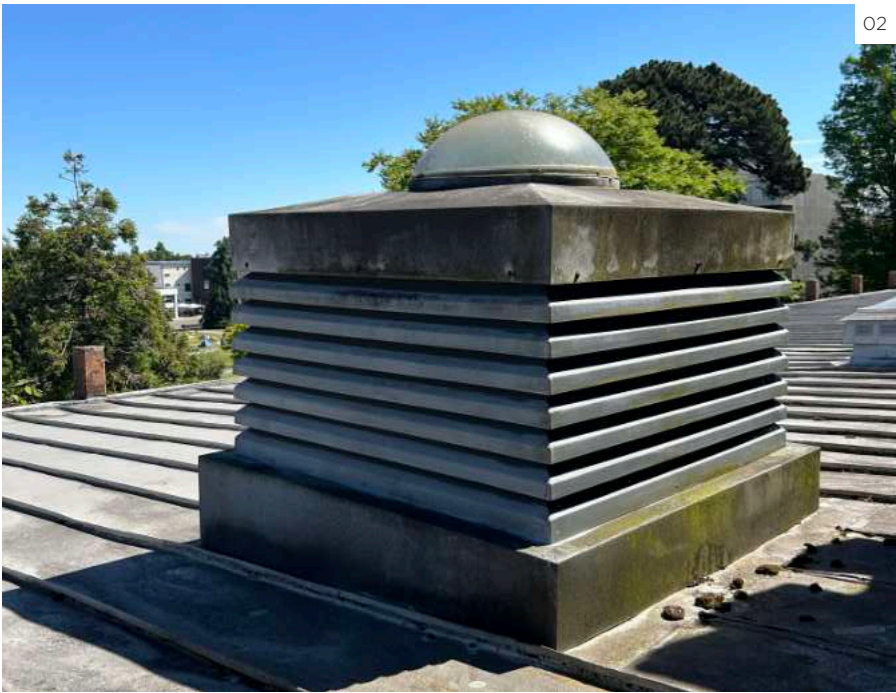
**01** Indicative 3D model of proposed cowls.  
**02** Existing roof cowl.  
**03** Precedent image of proposed roof cowl.

- The proposed development will require a comprehensive strategy for ventilating the building. This requires new roof ventilation cowls on the roof.
- The cowls will be formed in a similar material to the roof finish.
- Locations are illustrated on the roof plan drawings.

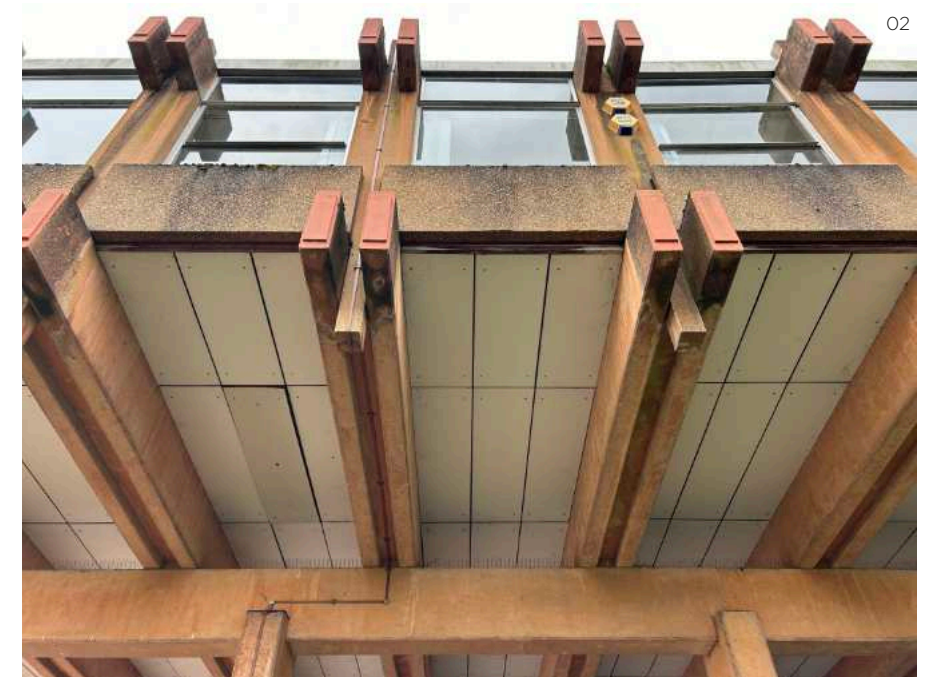
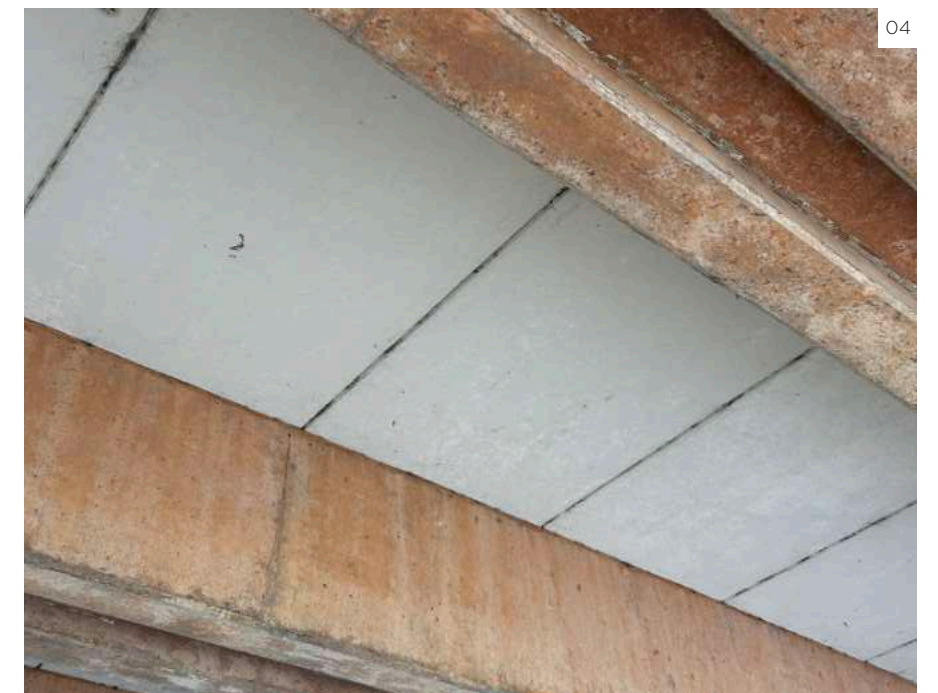
- 01 Existing soffit overhang with cladding panels.  
02 Existing soffit overhang with cladding panels.  
03 Existing soffit overhang - exposed.  
04 Existing soffit overhang - exposed.

- Removal of existing soffit boards, to expose original concrete deck.
- Thermal improvements will instead be achieved by introducing a new thermal concrete screed to the internal flooring. This has the benefit of fully reducing the thermal bridges through the beams, as well as being considerably lighter than the original screed being replaced, which is also at end of life.
- By insulating internally and removing the ill fitting soffit panels we allow the beams to be fully expressed passing beneath the building.

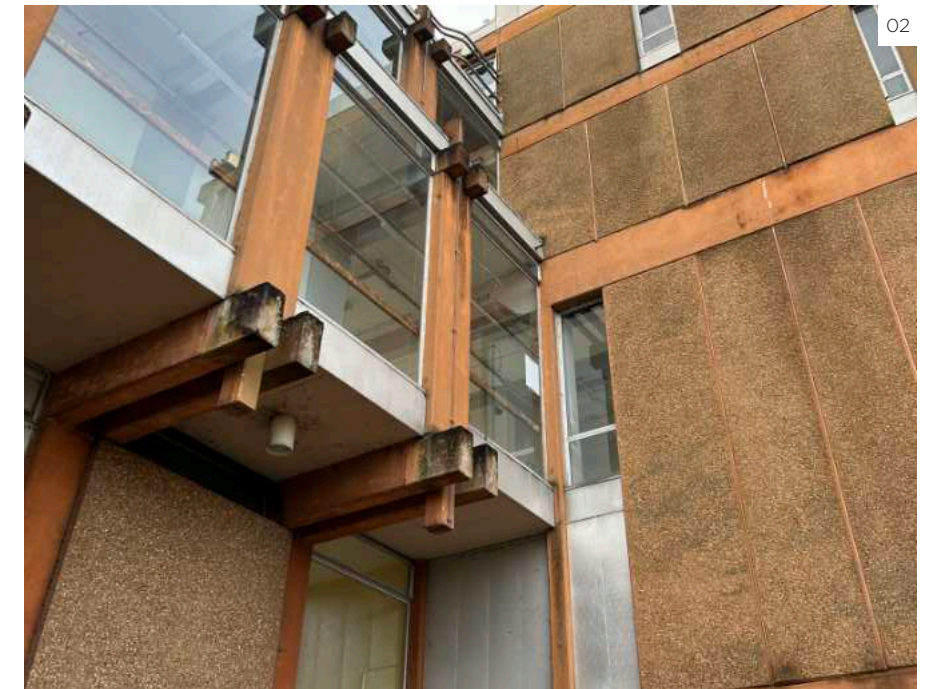
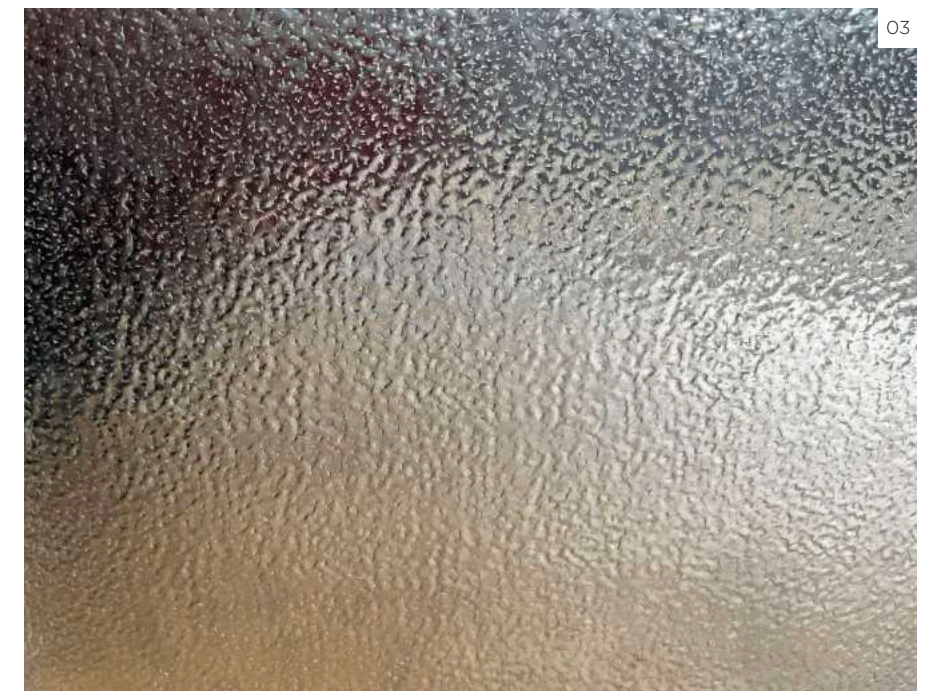
- 01 Existing aluminium facade panels on east-end of building.
- 02 Existing aluminium facade panels beneath windows.
- 03 Replacement aluminium sheeting where required-textured mill finish (will oxidise over time).

- The proposal seeks to retain all existing aluminium cladding panels in principal.
- The cladding will be lightly cleaned and inspected. In some cases the aluminium material may have existing damage or it may be impossible to remove the existing windows without causing damage. If this occurs, the intention is to replace the cladding with a 'like for like' textured aluminium sheet from the same source as the roof sheeting.

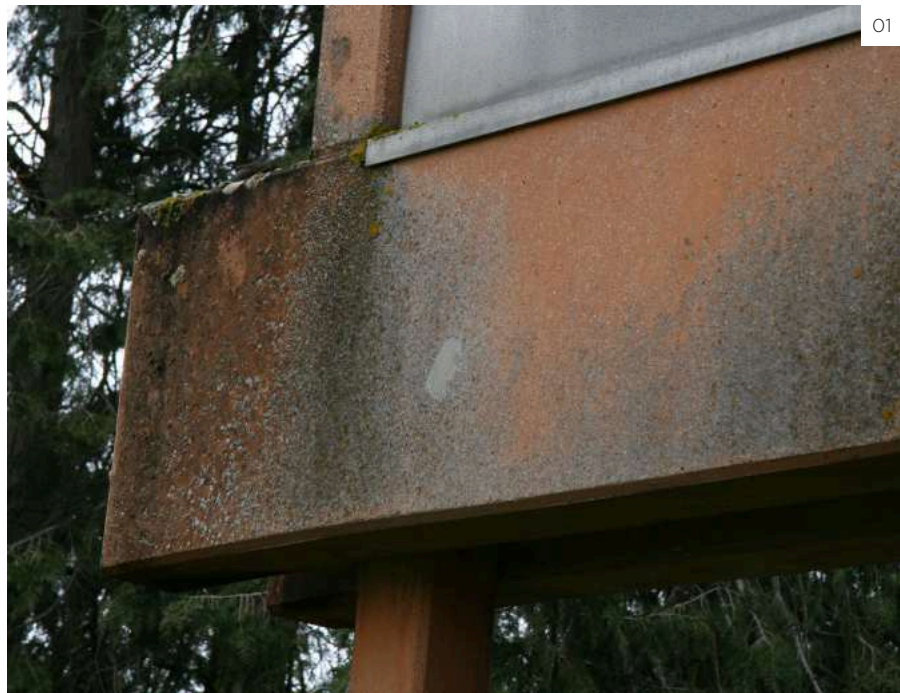
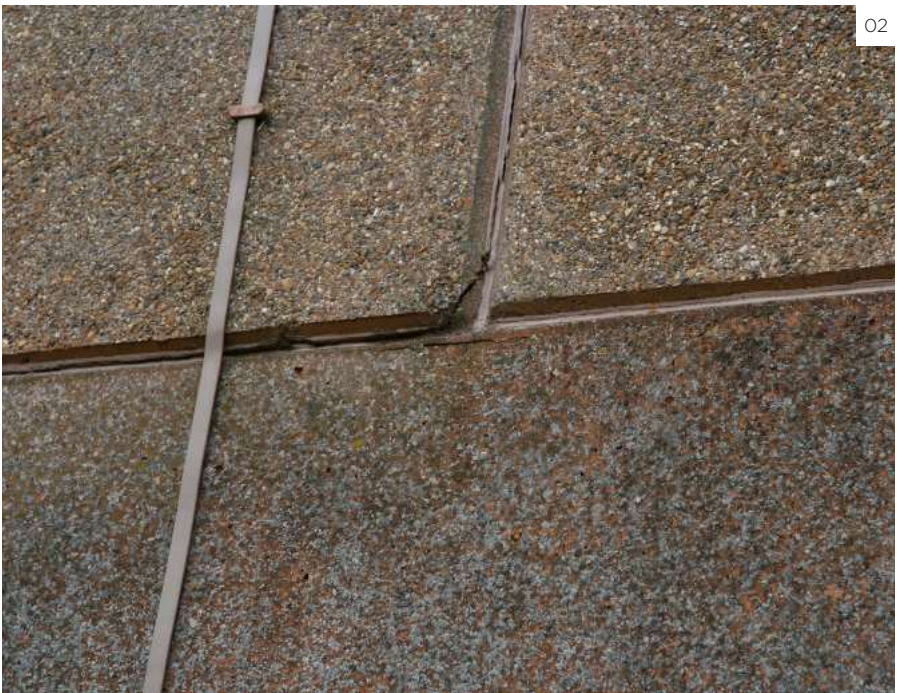
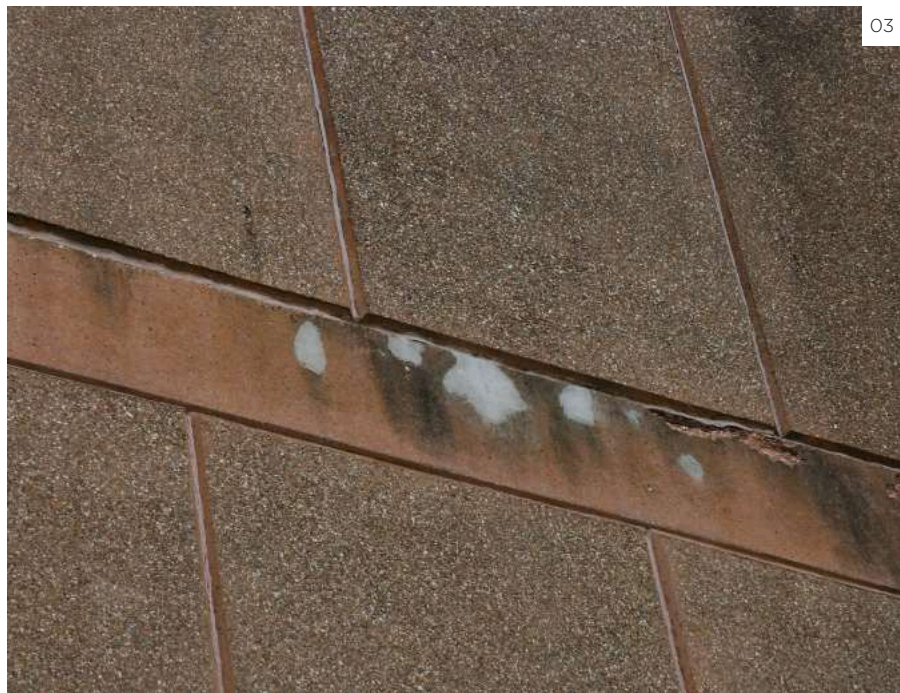
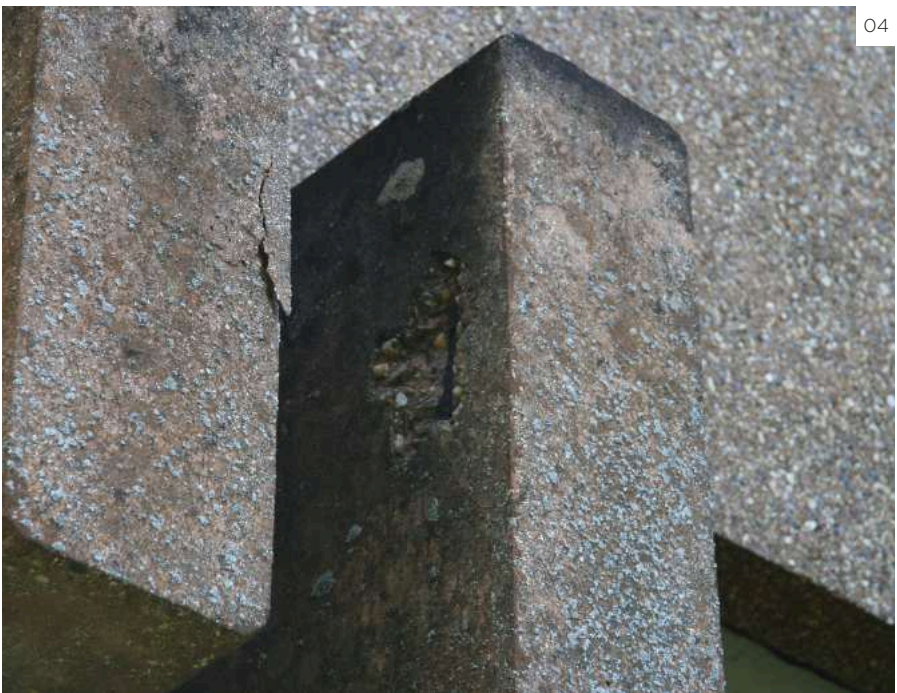
- 01 Weathered concrete beam.
- 02 Pre-cast concrete panel cracking.
- 03 Temporary concrete repair patch repairs.
- 04 Chipped concrete, showing the rebar beneath.

The range of defects identified in Purcell’s report, and illustrated here, include cracking and spalling of concrete, corrosion of reinforcement, poorly matched historic repairs, displacement of pre-cast panels, various types of staining and surface deposits. Recommended repairs include cast in-situ concrete repairs, hand-placed mortar repairs and sensitive cleaning.

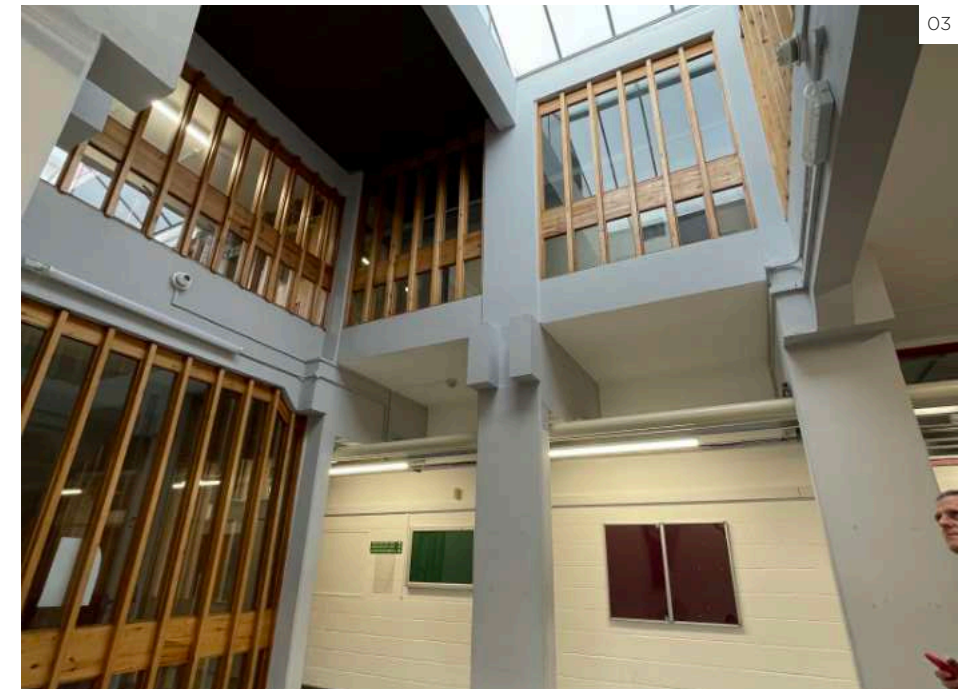
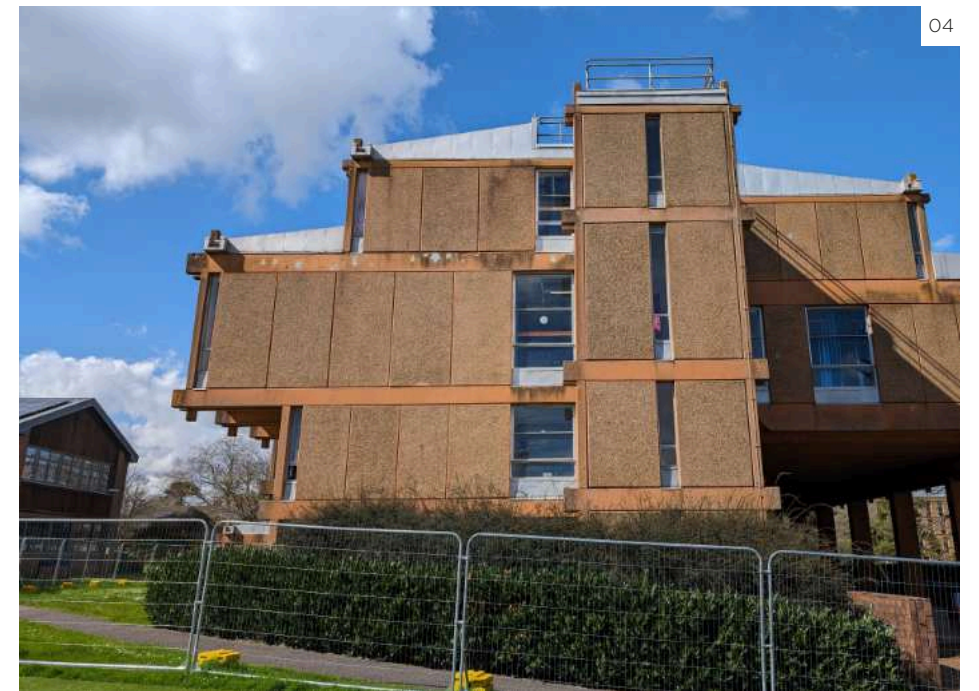
- 01 North facade recess near main entrance.
- 02 South facade recess.
- 03 Internal lightwell.
- 04 East facade/elevation.

Two out of three existing internal stairs will be upgraded with lobbies to improve their capacity. In addition, two new additional stairs are needed to comply with current fire escape regulations. They also provide opportunity to add new lifts to the building to improve accessibility.

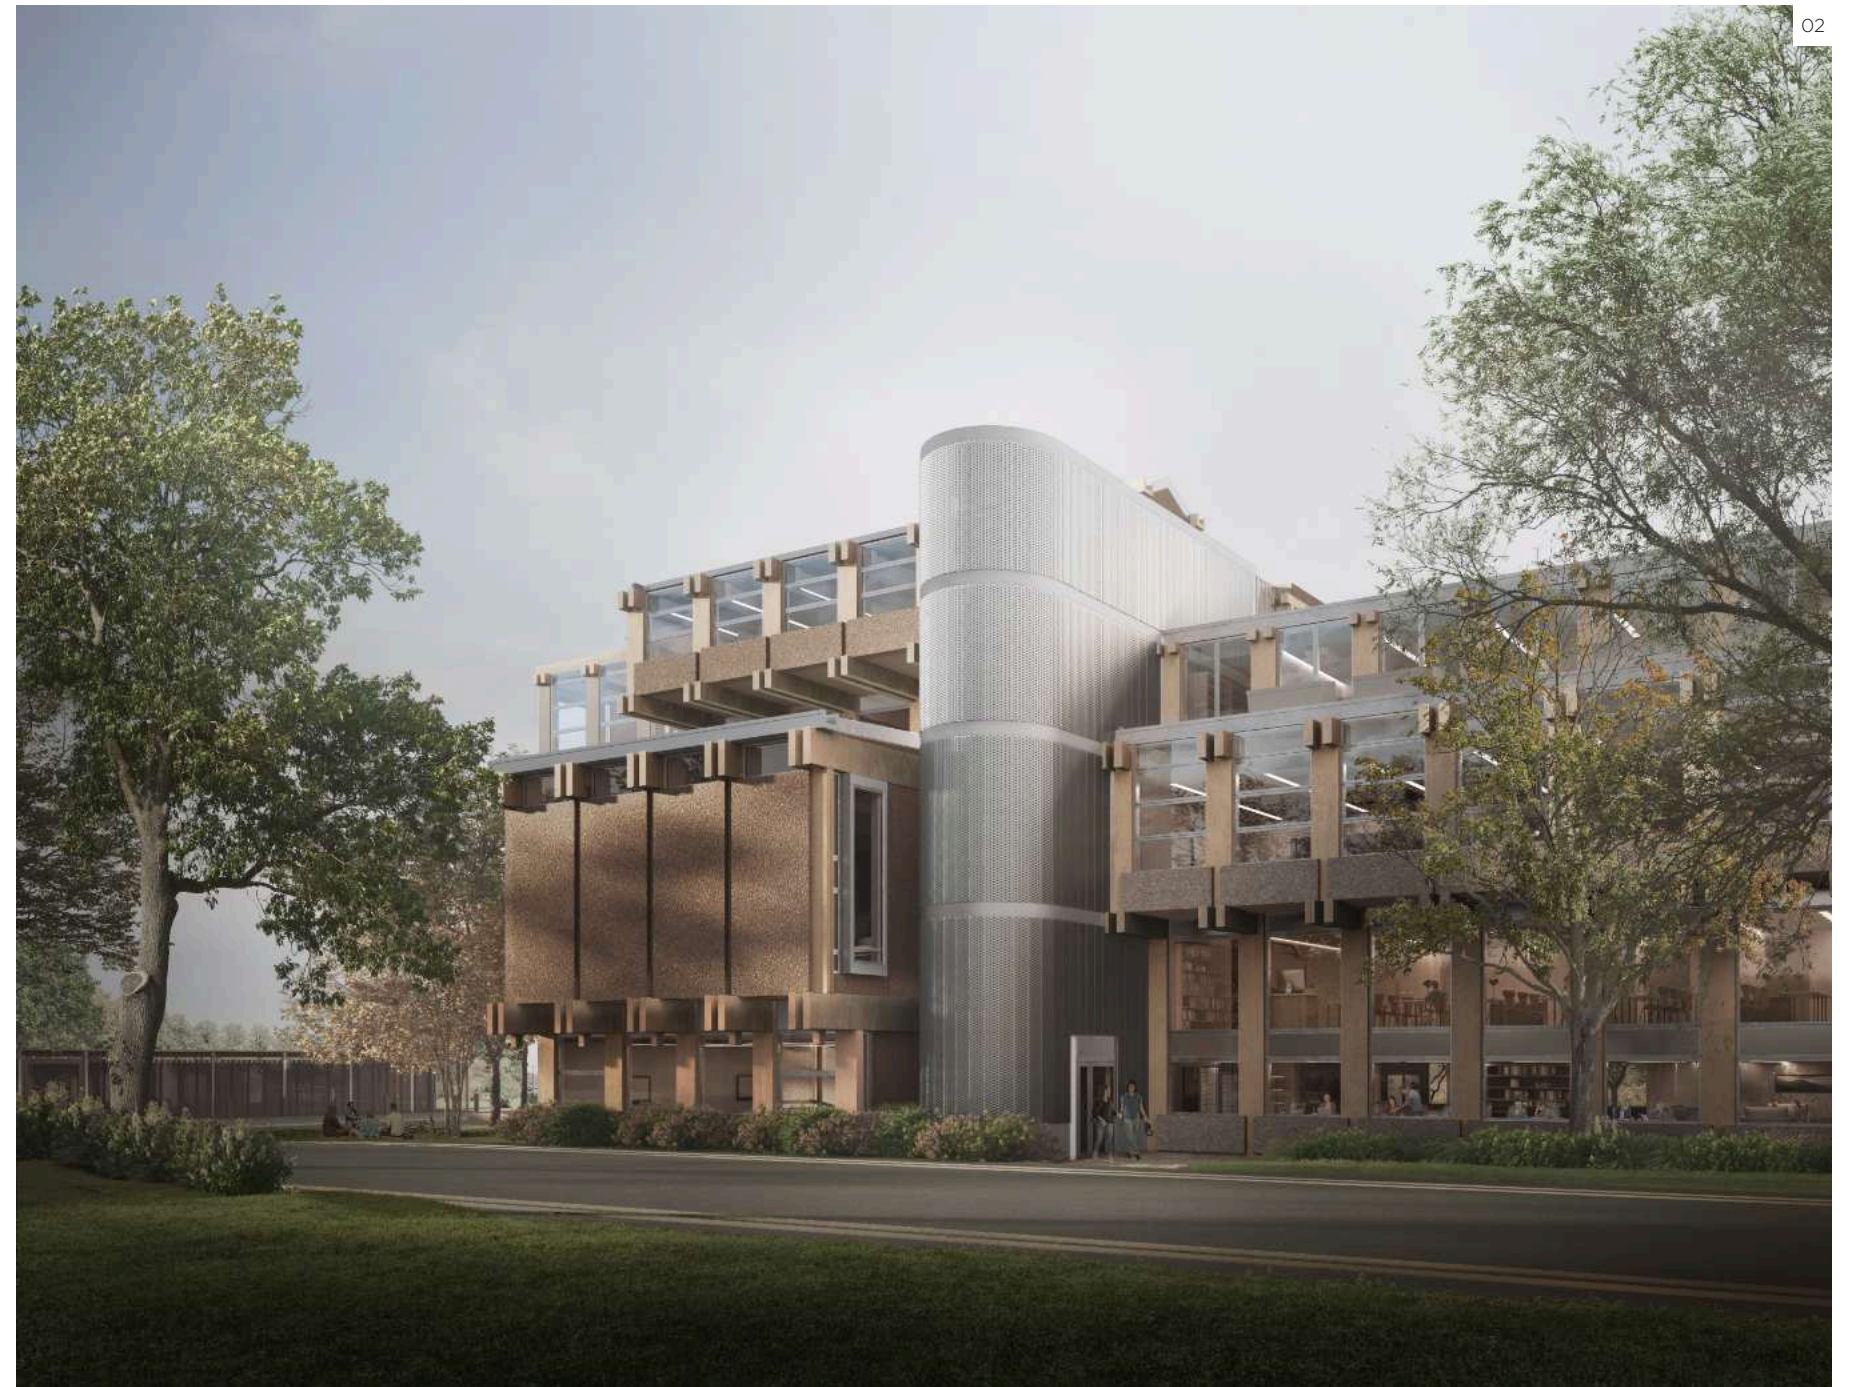
The proposed material choice for the stair cores will be perforated aluminium panels. The perforations respond to the existing 'textured' aluminium cladding, which is used across the building as a secondary material to the primary concrete elements. As seen with the existing textured aluminium, the perforations read as a solid material from a distance, which reveals detail on approach.

The banding of the new stair envelope will tie in with the existing floor levels.

- 01** Ground floor plan showing the proposed external stair core locations (nts).  
**02** Indicative view of new external stair core on the south facade.

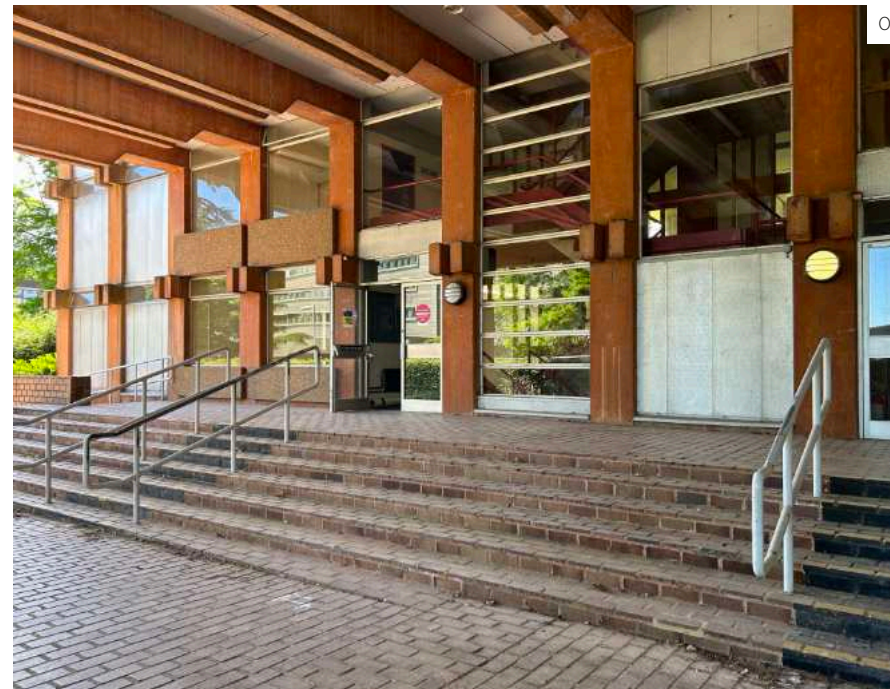
- 01 Photo of existing east entrance.
- 02 Photo of existing paving damage.
- 03 Photo of existing paving near the main entrance and pond.
- 04 Photo of existing main entrance (during asbestos removal works).

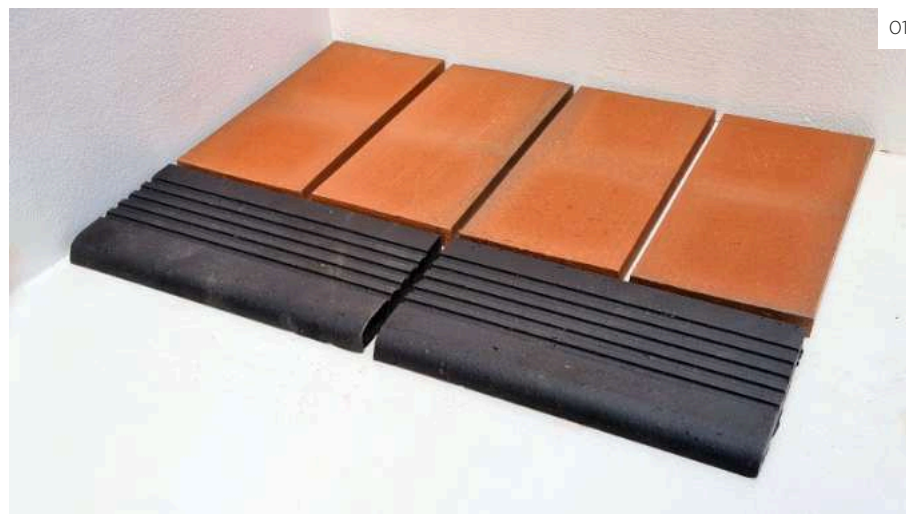
01 Precedent image of Anthracite Black Quarry step tread tiles.

- Paving will be steam cleaned and re-grouted.
- The surfaces will be treated with a clear coating to help improve anti-slip, but that does not alter the colour of the original tile.
- To improve grip and step visibility we will be removing the existing paving along the stair nosing and replacing with an 'Anthracite Black Quarry' step tread. These tiles should be a direct replacement for the red quarry tiles, which will improve visual contrast and are ribbed for safety.
- Width = 215mm / Height = 102mm / Thickness = 15mm of proposed 'Anthracite Black Quarry' step tread tile.
- The existing tiles removed from the step nosings will be used to repair and replace broken/damaged paving tiles in other areas of the undercroft and the pond perimeter wall.

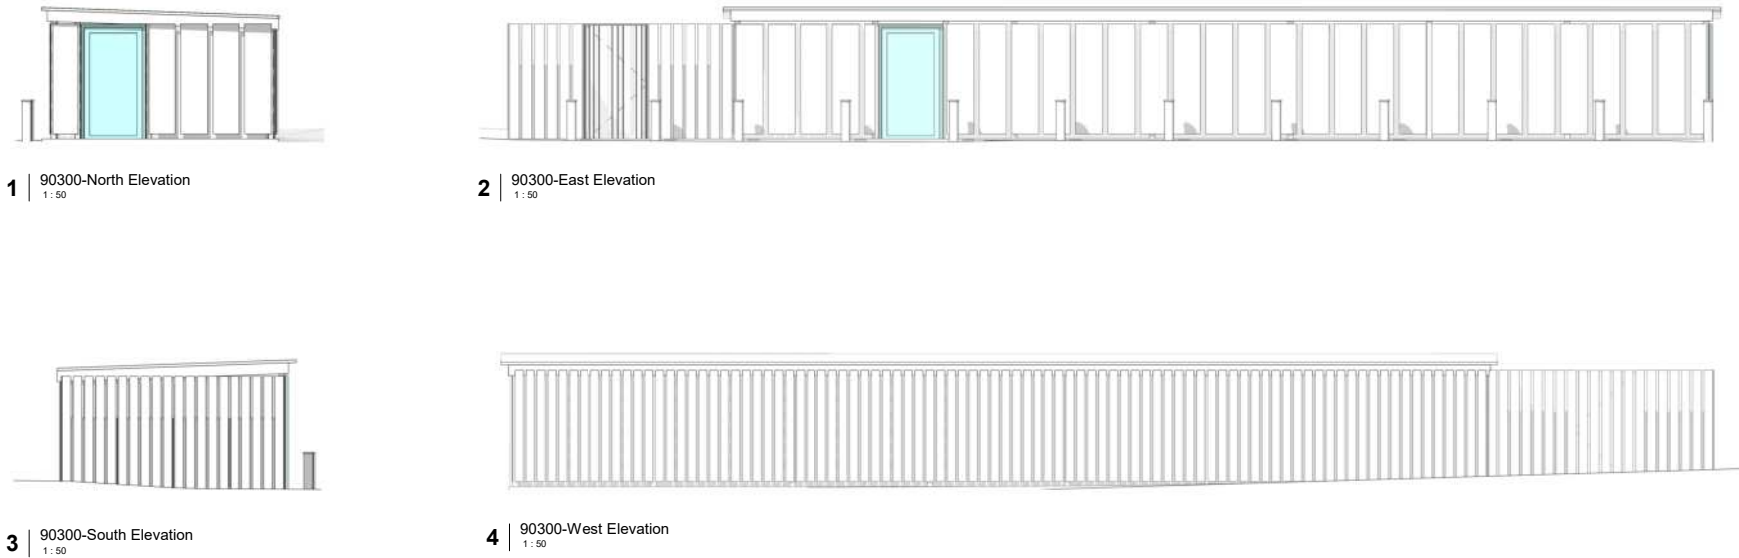
- 01 Photo of existing area with 10 vehicle parking spaces.
- 02 Elevations of proposed bin and bike store (nts).
- 03 Floor plan of proposed bin and bike store (nts).

- Existing space consists of approximately 10 vehicle parking spaces.
- Steel post structure with laminated glass and timber slat facade.
- Laminated glass at exposed sides of shelter for safety and security reasons, and timber slats around the back of the bike shelter and bin store.
- Structure stands at approximately 2500mm high.
- Overall footprint approximately 107m<sup>2</sup>.
- Capacity for 8 euro-bins and 36 bikes on Sheffield stands.
- The existing building has no dedicated waste storage collection area, with bins often left on the road. Our BREAAAM assessment needs a dedicated and secure bin area. The chosen location is close to the neighbouring building's bin space.

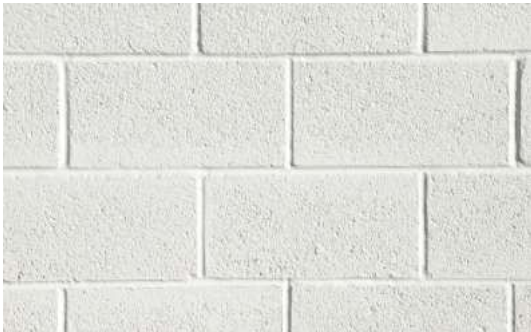
## WHITE PAINTED BLOCKWORK

Exterior walls will require new insulation over the existing blockwork and classroom wall linings will require acoustic plasterboard linings. Other areas of exposed blockwork will be plastered over for visual continuity, after door openings will be expanded to accommodate new accessible door sizes.

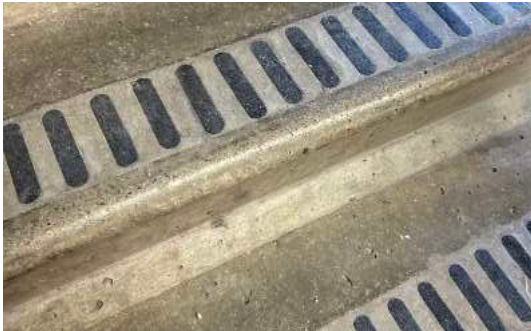
## CONCRETE STAIR CORES

Existing stairs were precast with inlaid nosing, which will be refurbished.

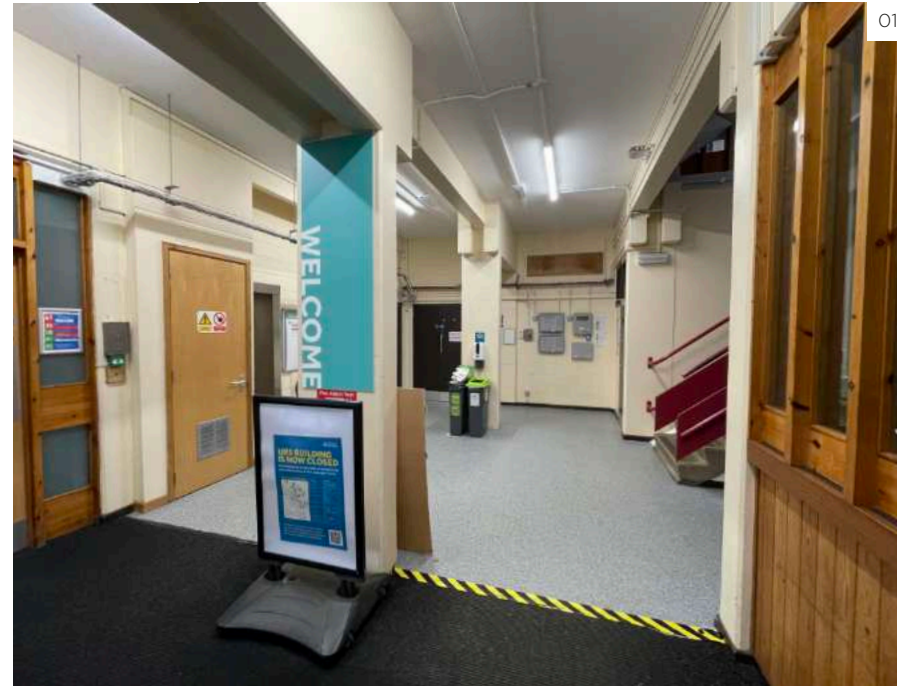
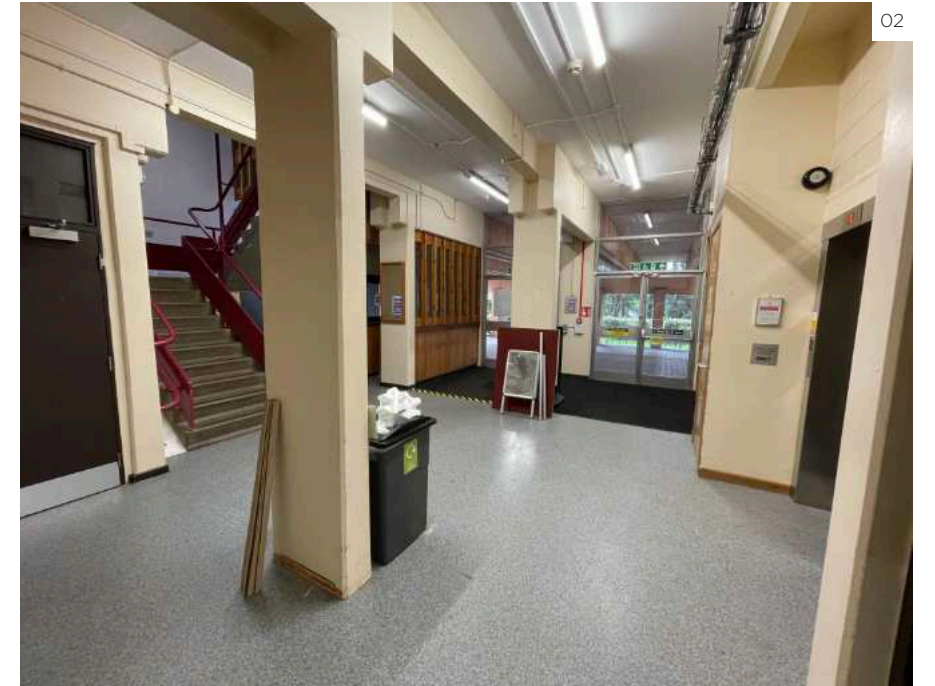
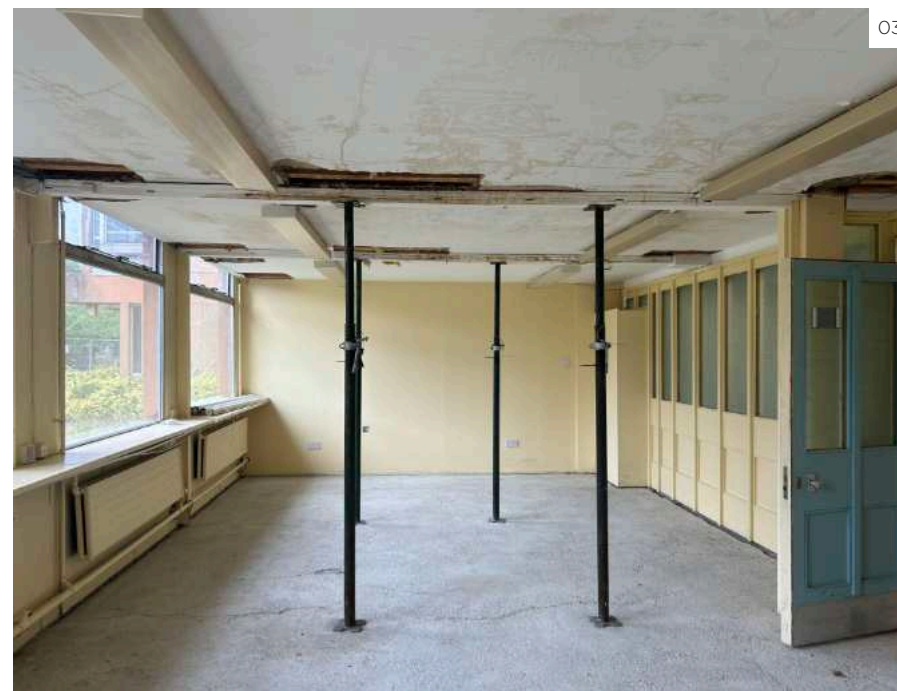
- No clear URS entrance identity.
- Conflicting, mix-matched finishes and fittings.
- No dedicated student study/social area.
- Later addition timber screens and floor plate, not from the original 1970s design and construction.
- Painted concrete beams and columns.

- 01 Photo of existing main entrance foyer.
- 02 Photo of existing main entrance foyer.
- 03 Photo of existing ground floor space connected to the entrance foyer.
- 04 Photo of existing circulation by main entrance foyer.

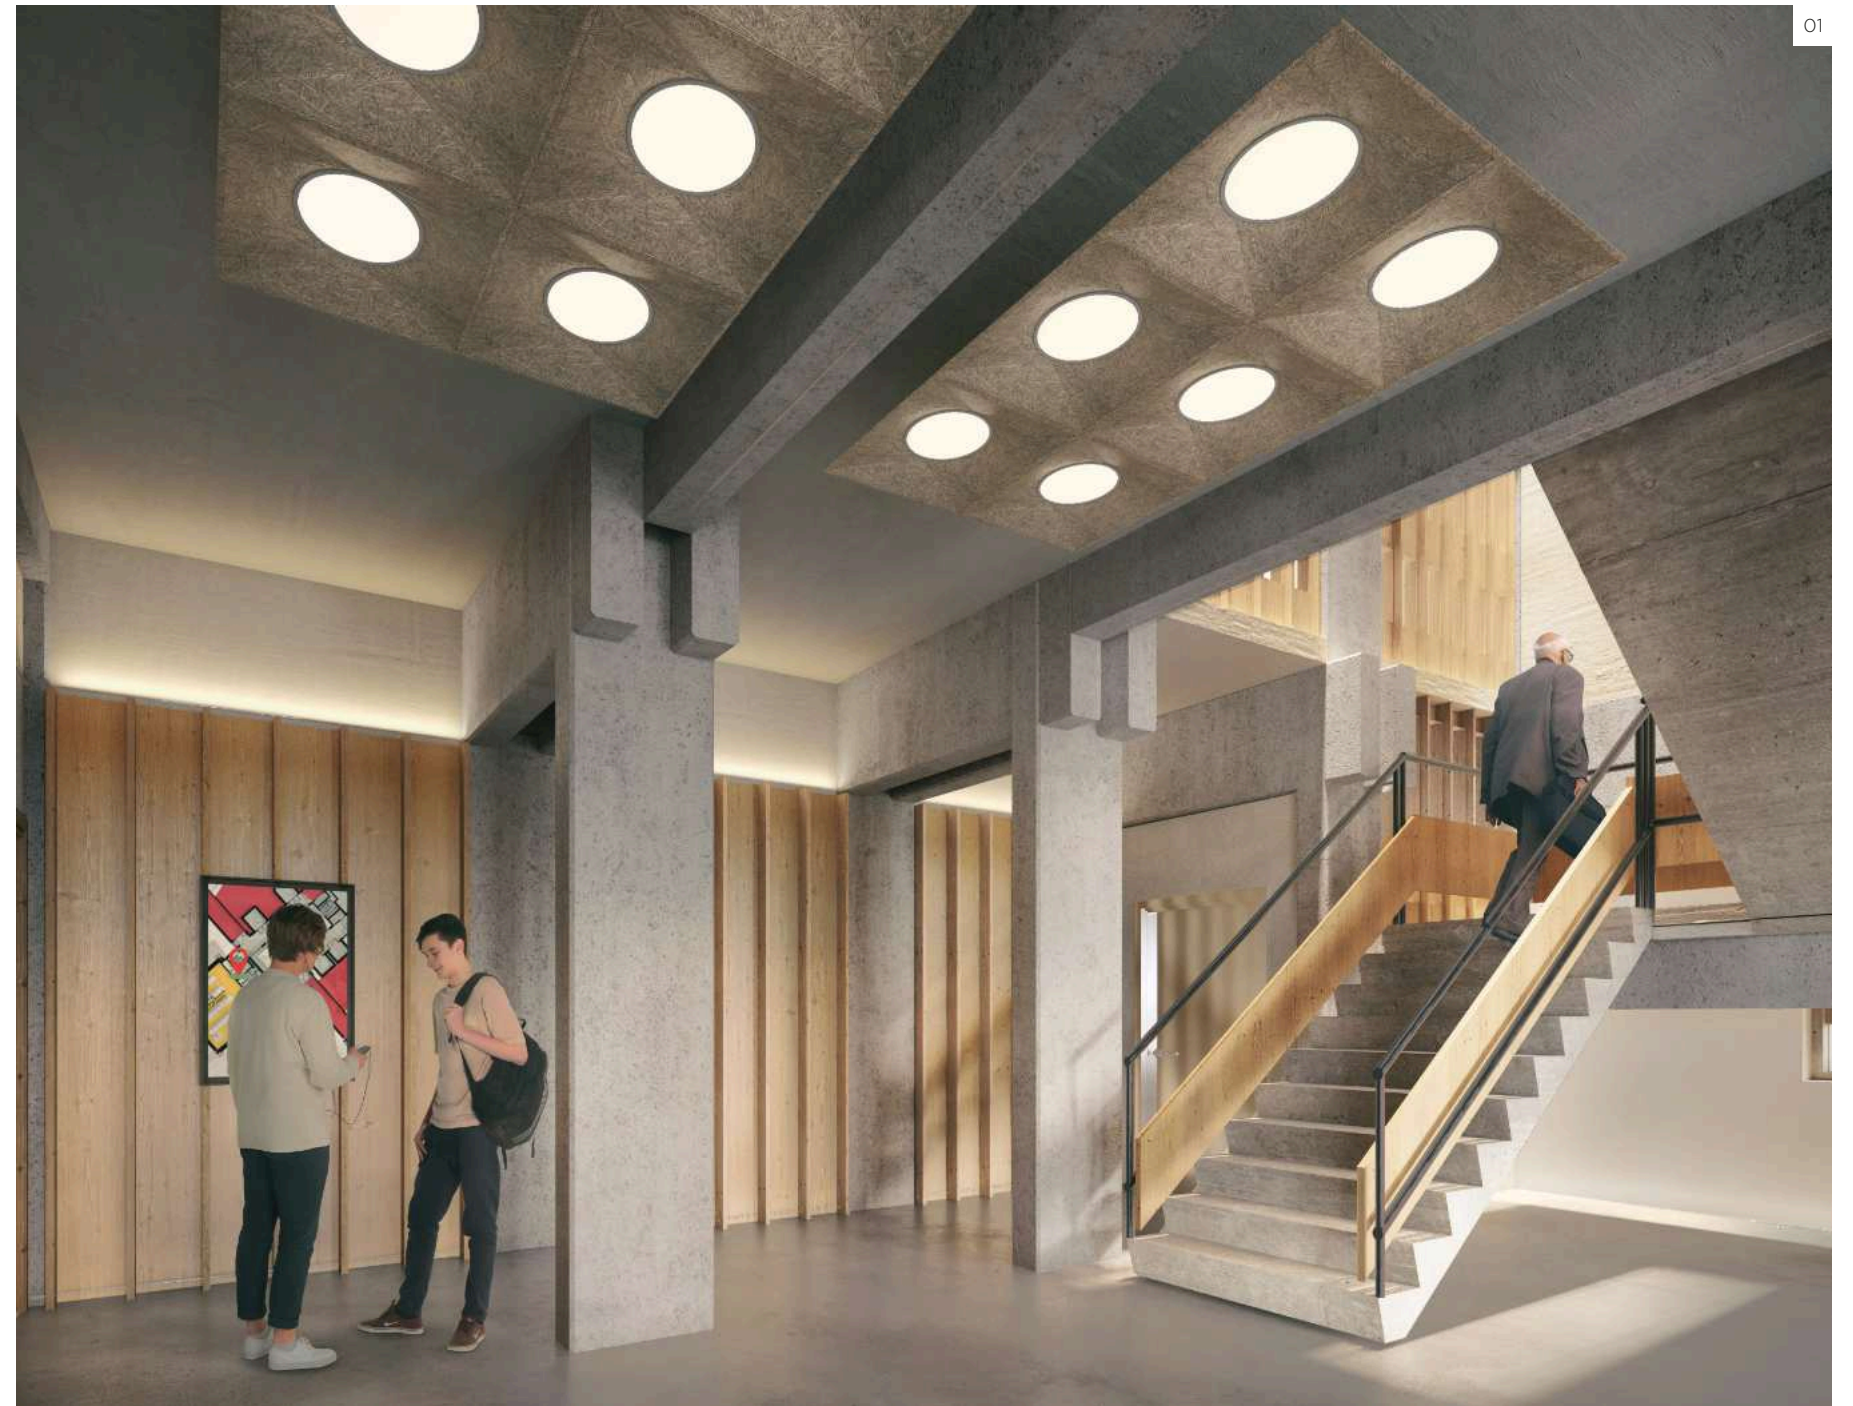
The exposed beams, columns and soffit will be repainted and the stair well opened out at ground floor with the removal of some walls. The flooring will be replaced with a hardwearing fine concrete finish.

01 Indicative visual of the proposed entrance foyer on the ground floor.
