# **URS REFURBISHMENT**

## **UNIVERSITY OF READING**

# **DESIGN & ACCESS STATEMENT**

Our ref: 435-ACG-W033-ZZ-RP-A-1906

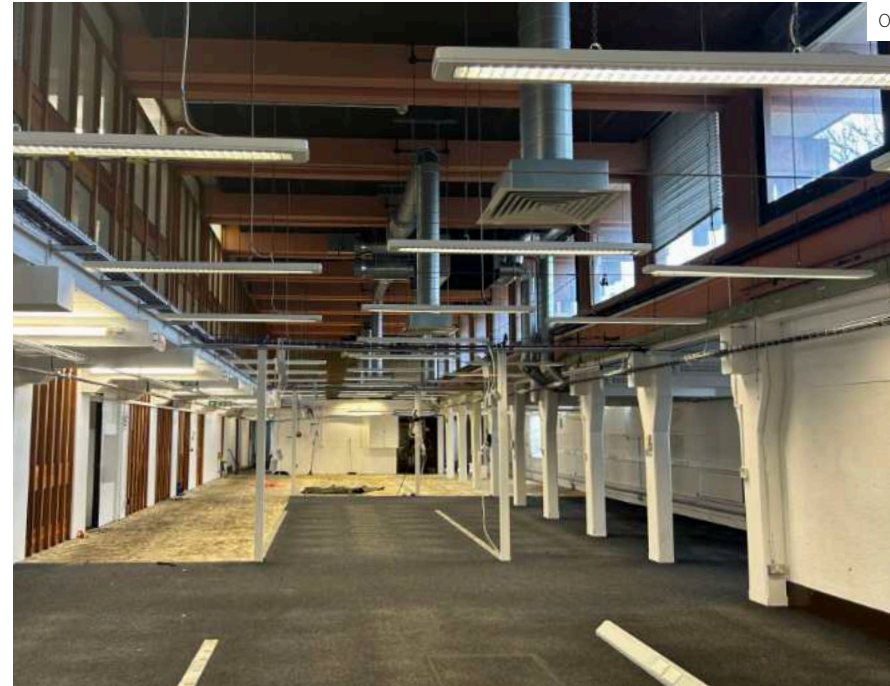
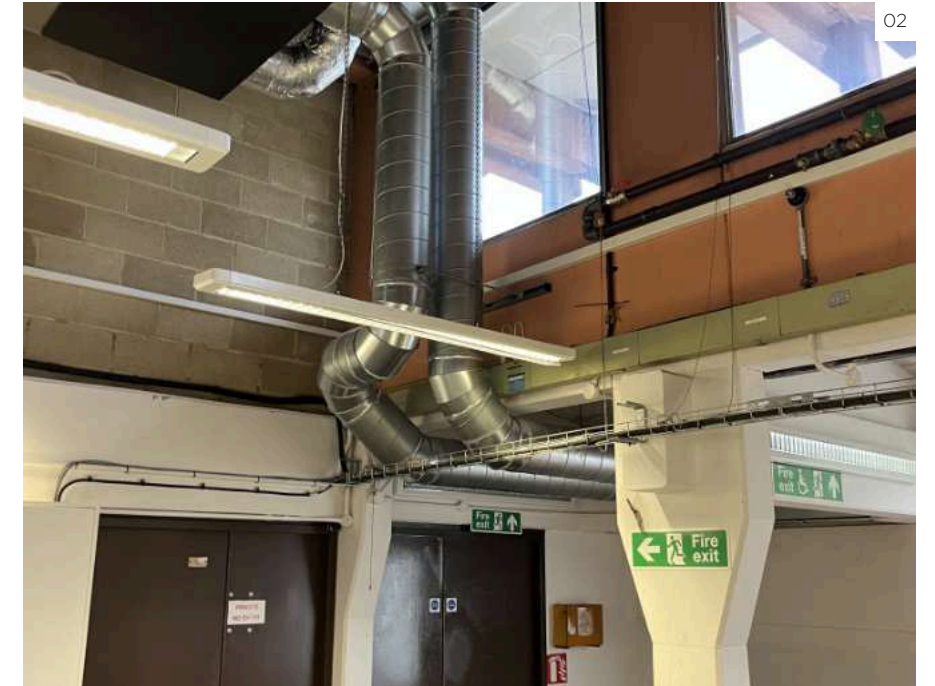
- Exposed plant/M&E pipework.
- Exposed, hanging lighting equipment.
- Timber glazed screens along first floor facade, looking down in to space.
- Both single storey and double height ceiling levels.
- Existing small enclosed space under single-storey area.
- Painted concrete beams and columns.

01 Photo of existing double height 'print room' space.

02 Photo of existing M&E pipes running through the 'print room' space.

The first floor timber and glass screen above the double volume space will be retained and refurbished with new clear glass, replacing the existing Georgian wire glass. Some of the timber screens to ground floor are removed to make an open usable space, however the timber screens to the central stairwell remain.

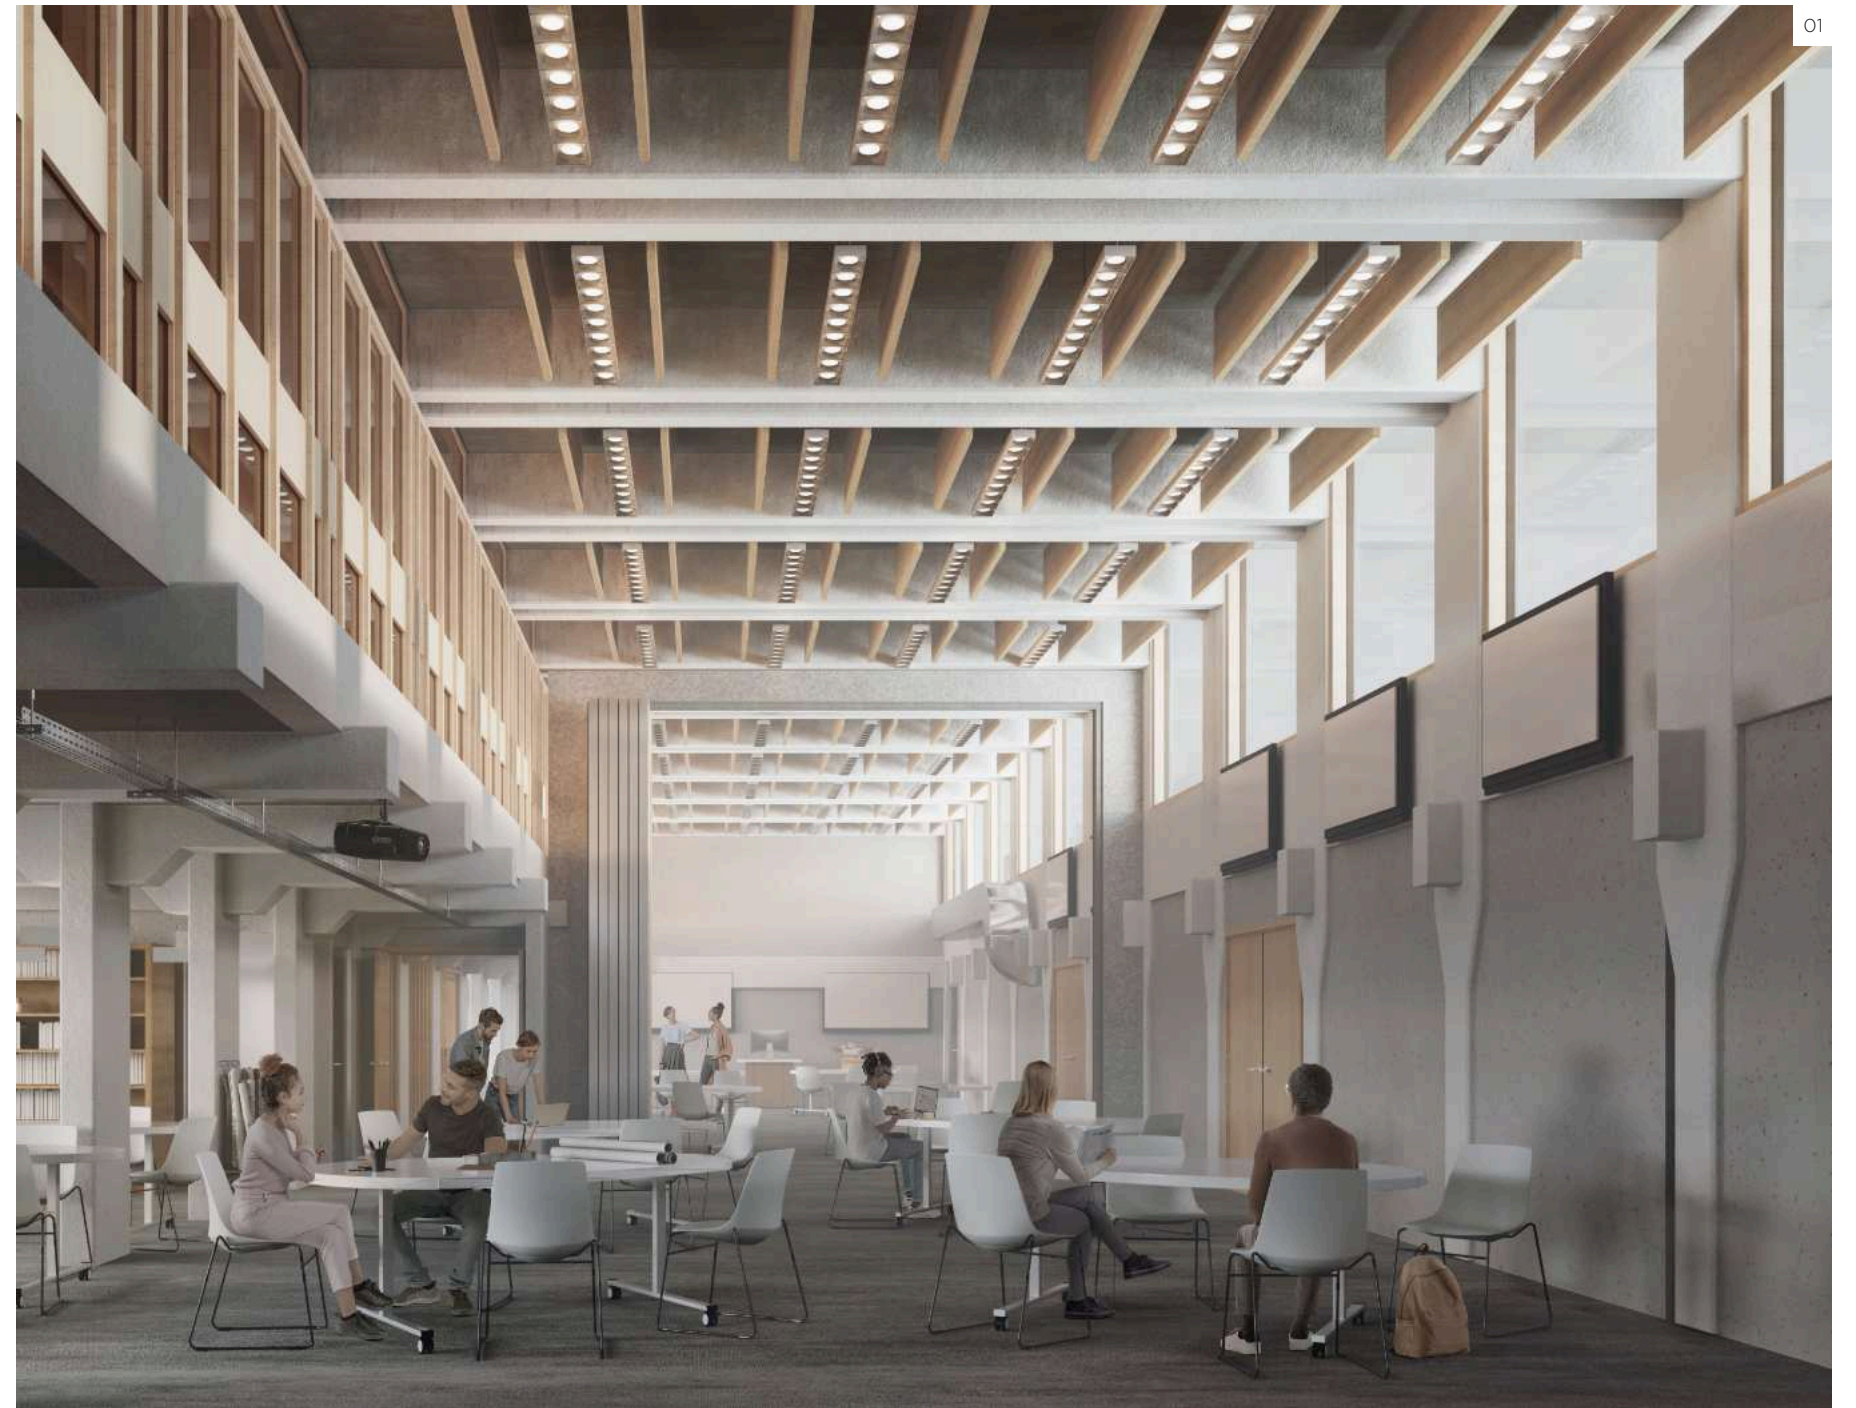
The furniture will seek to promote interactive group learning with the use of 'plectrum' style tables and plenty of visible AV screens.

01 Indicative visual of the proposed general teaching workshop space on the ground floor.

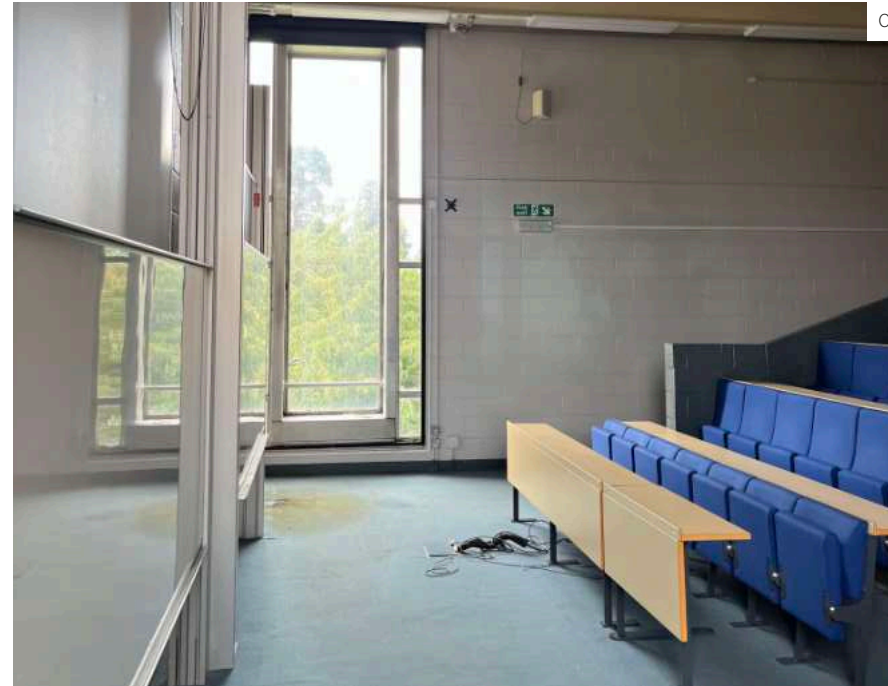
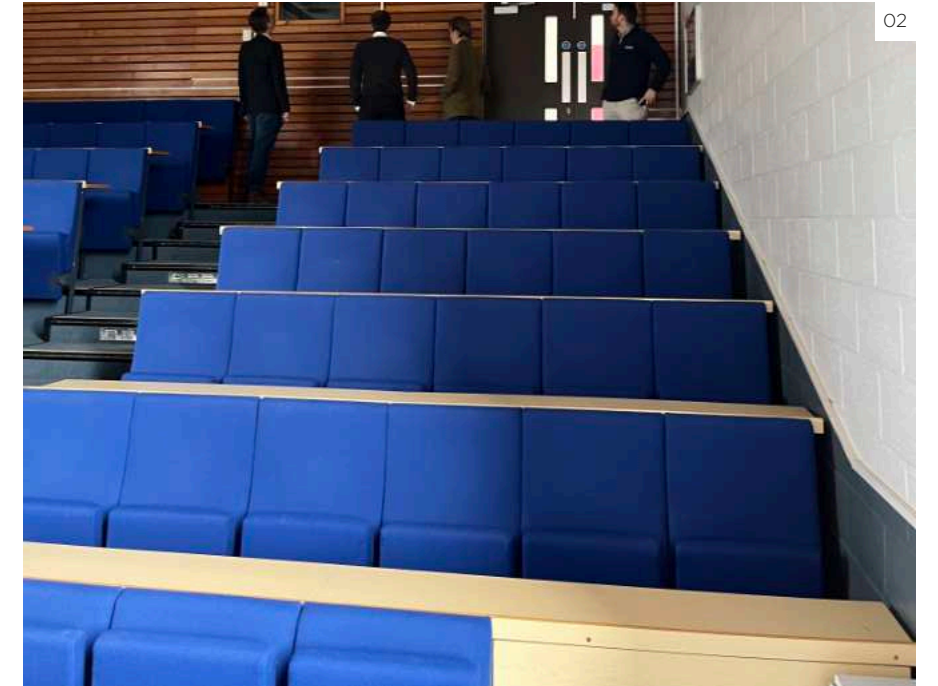
01 Photo of existing 92 seater lecture theatre.

02 Photo of existing 92 seater lecture theatre.

- 2 x Lecture Theatres, with seat capacities of 185 and 92.
- Oriel windows on either side of both spaces.
- Limited disabled provision on second floor level (top of rake seating).
- Painted concrete beams.
- M&E equipment hidden within the centre of the concrete beams and below rake seating, feeding up to fourth floor plant room.
- Timber and woodwool lined wall at rear of lecture theatre and ceiling, for acoustic absorption benefit.

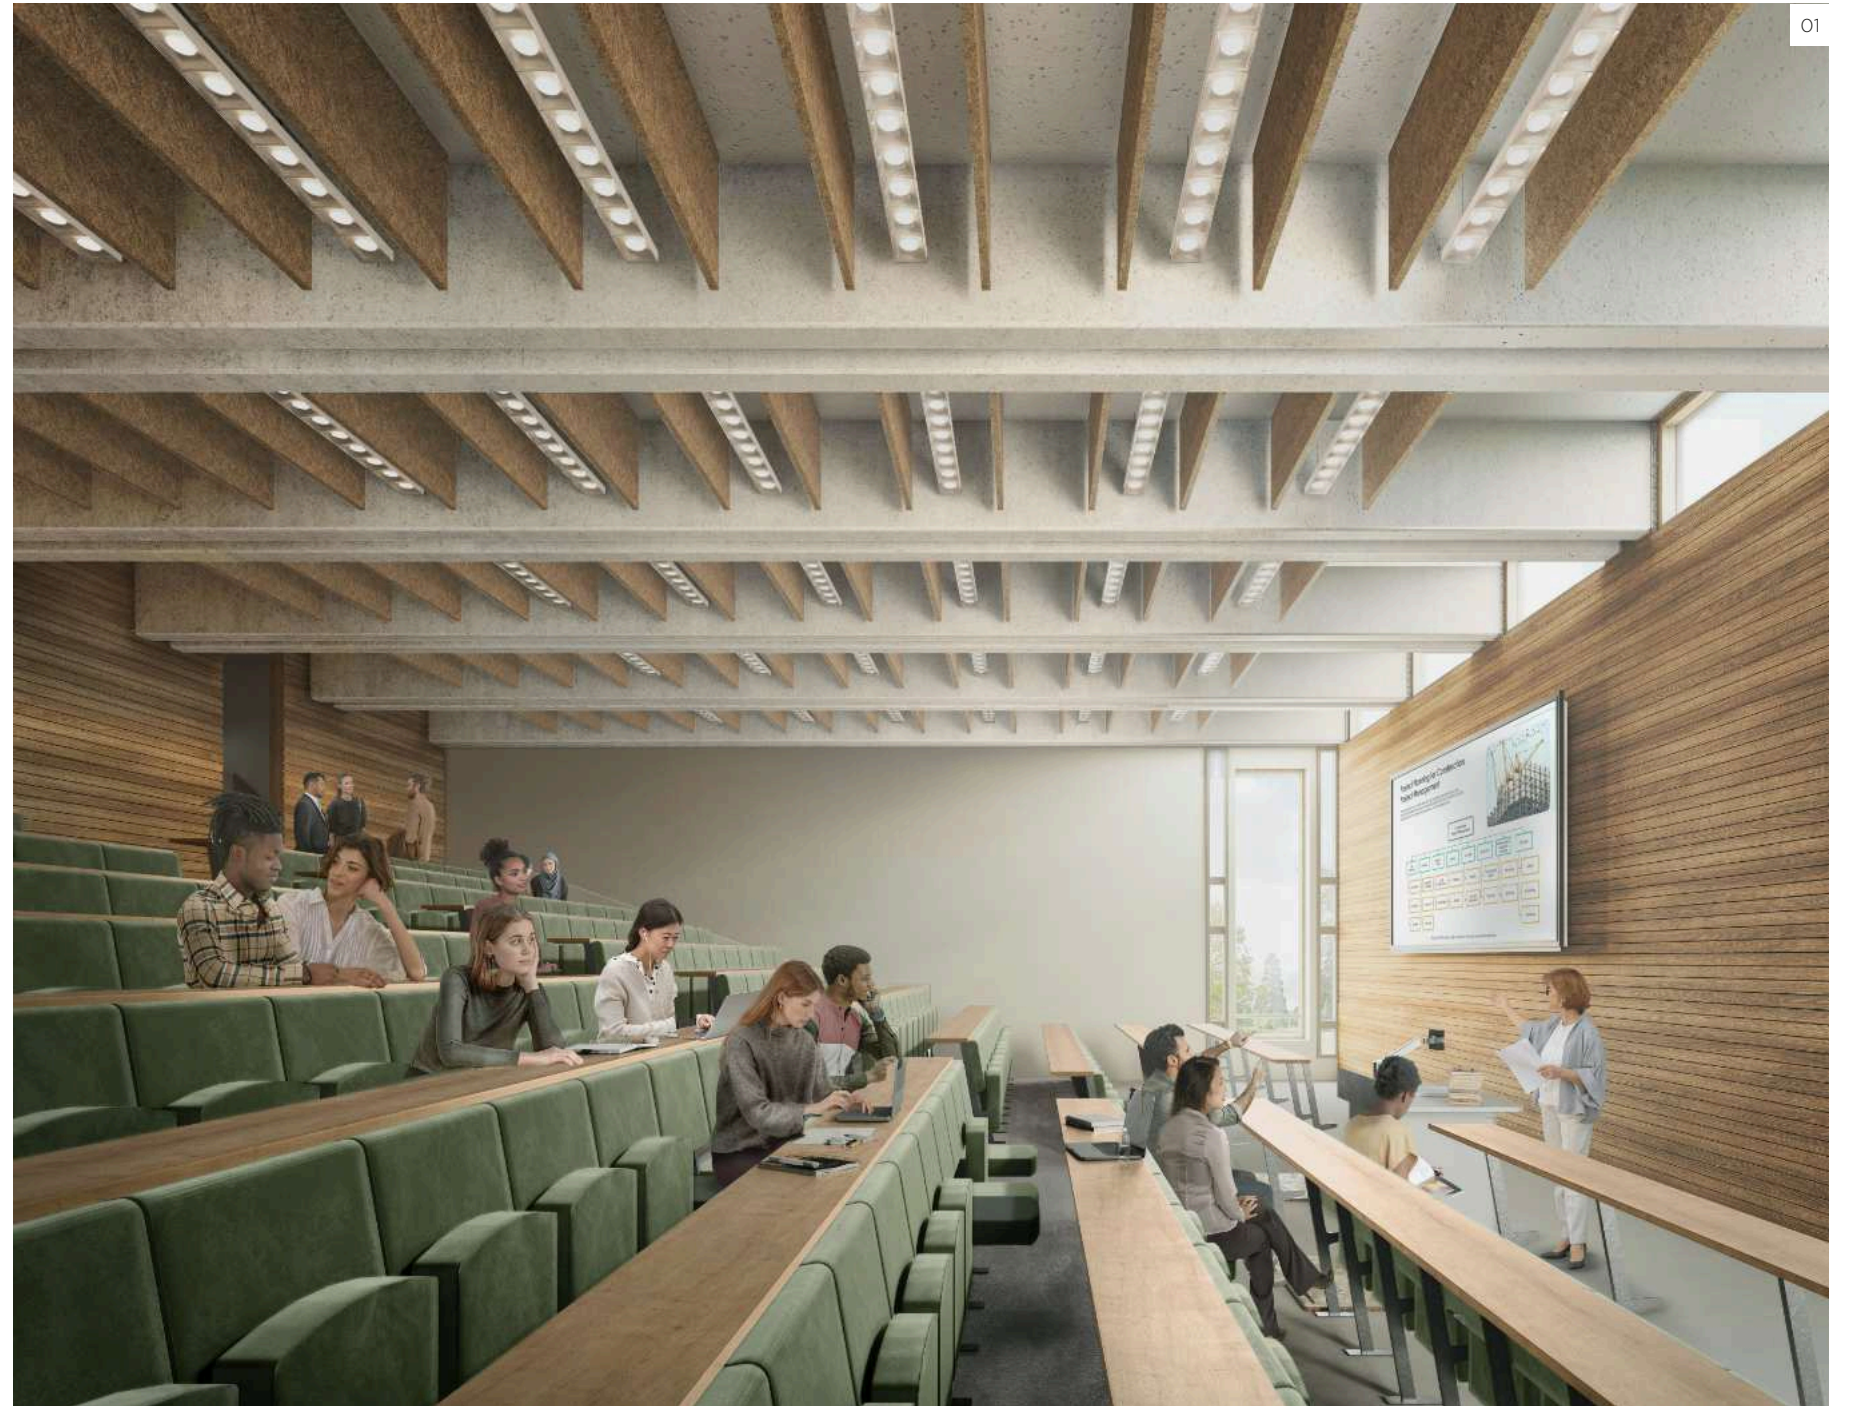
04 Indicative visual of the proposed large lecture theatre.

Woodwool acoustic baffles will be suspended between the exposed beams' allowing the structure to be clearly read. Air is supplied from the level 4 plant rooms to supply grilles below the raked seating, extracted at high level.

Timber acoustic panelling will highlight the front and rear walls. Linear rows of tiered seating facing towards the teaching wall and oriel windows, will be replaced with new durable finishes.

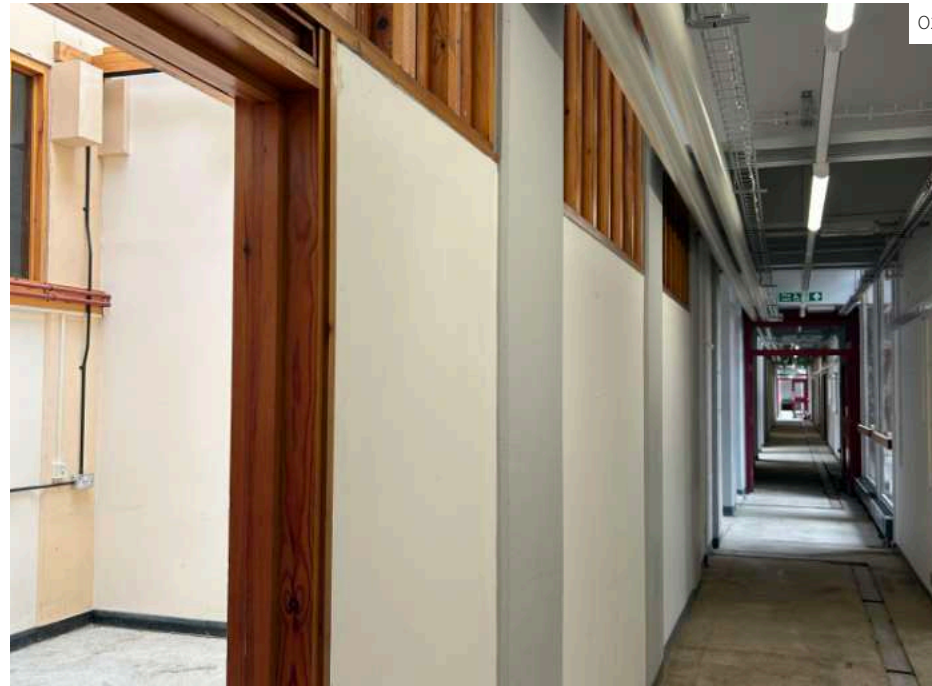
01 Original second floor plan, highlighting the original open circulation space.

- Substandard lightwell enclosures and multiple M&E distribution equipment hung from the ceiling on second floor.
- One example has a ceiling blocking the lightwell off, another includes a partial enclosed space.
- Original drawings indicate it was originally open circulation space with free-standing lockers.
- Studying the timber screens, it can be seen that the clerestory screens at second floor are a different design and coupled with the lower infill being light weight stud partition - it is assumed these enclosures are a later addition.

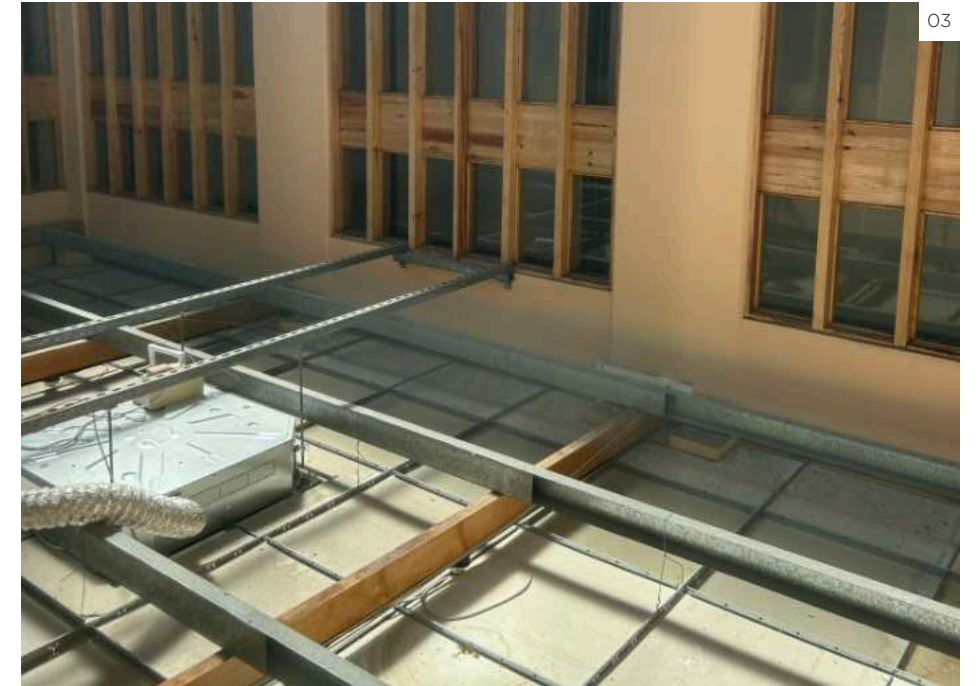
02 Existing lightwell with substandard interventions, adjacent to main circulation route.

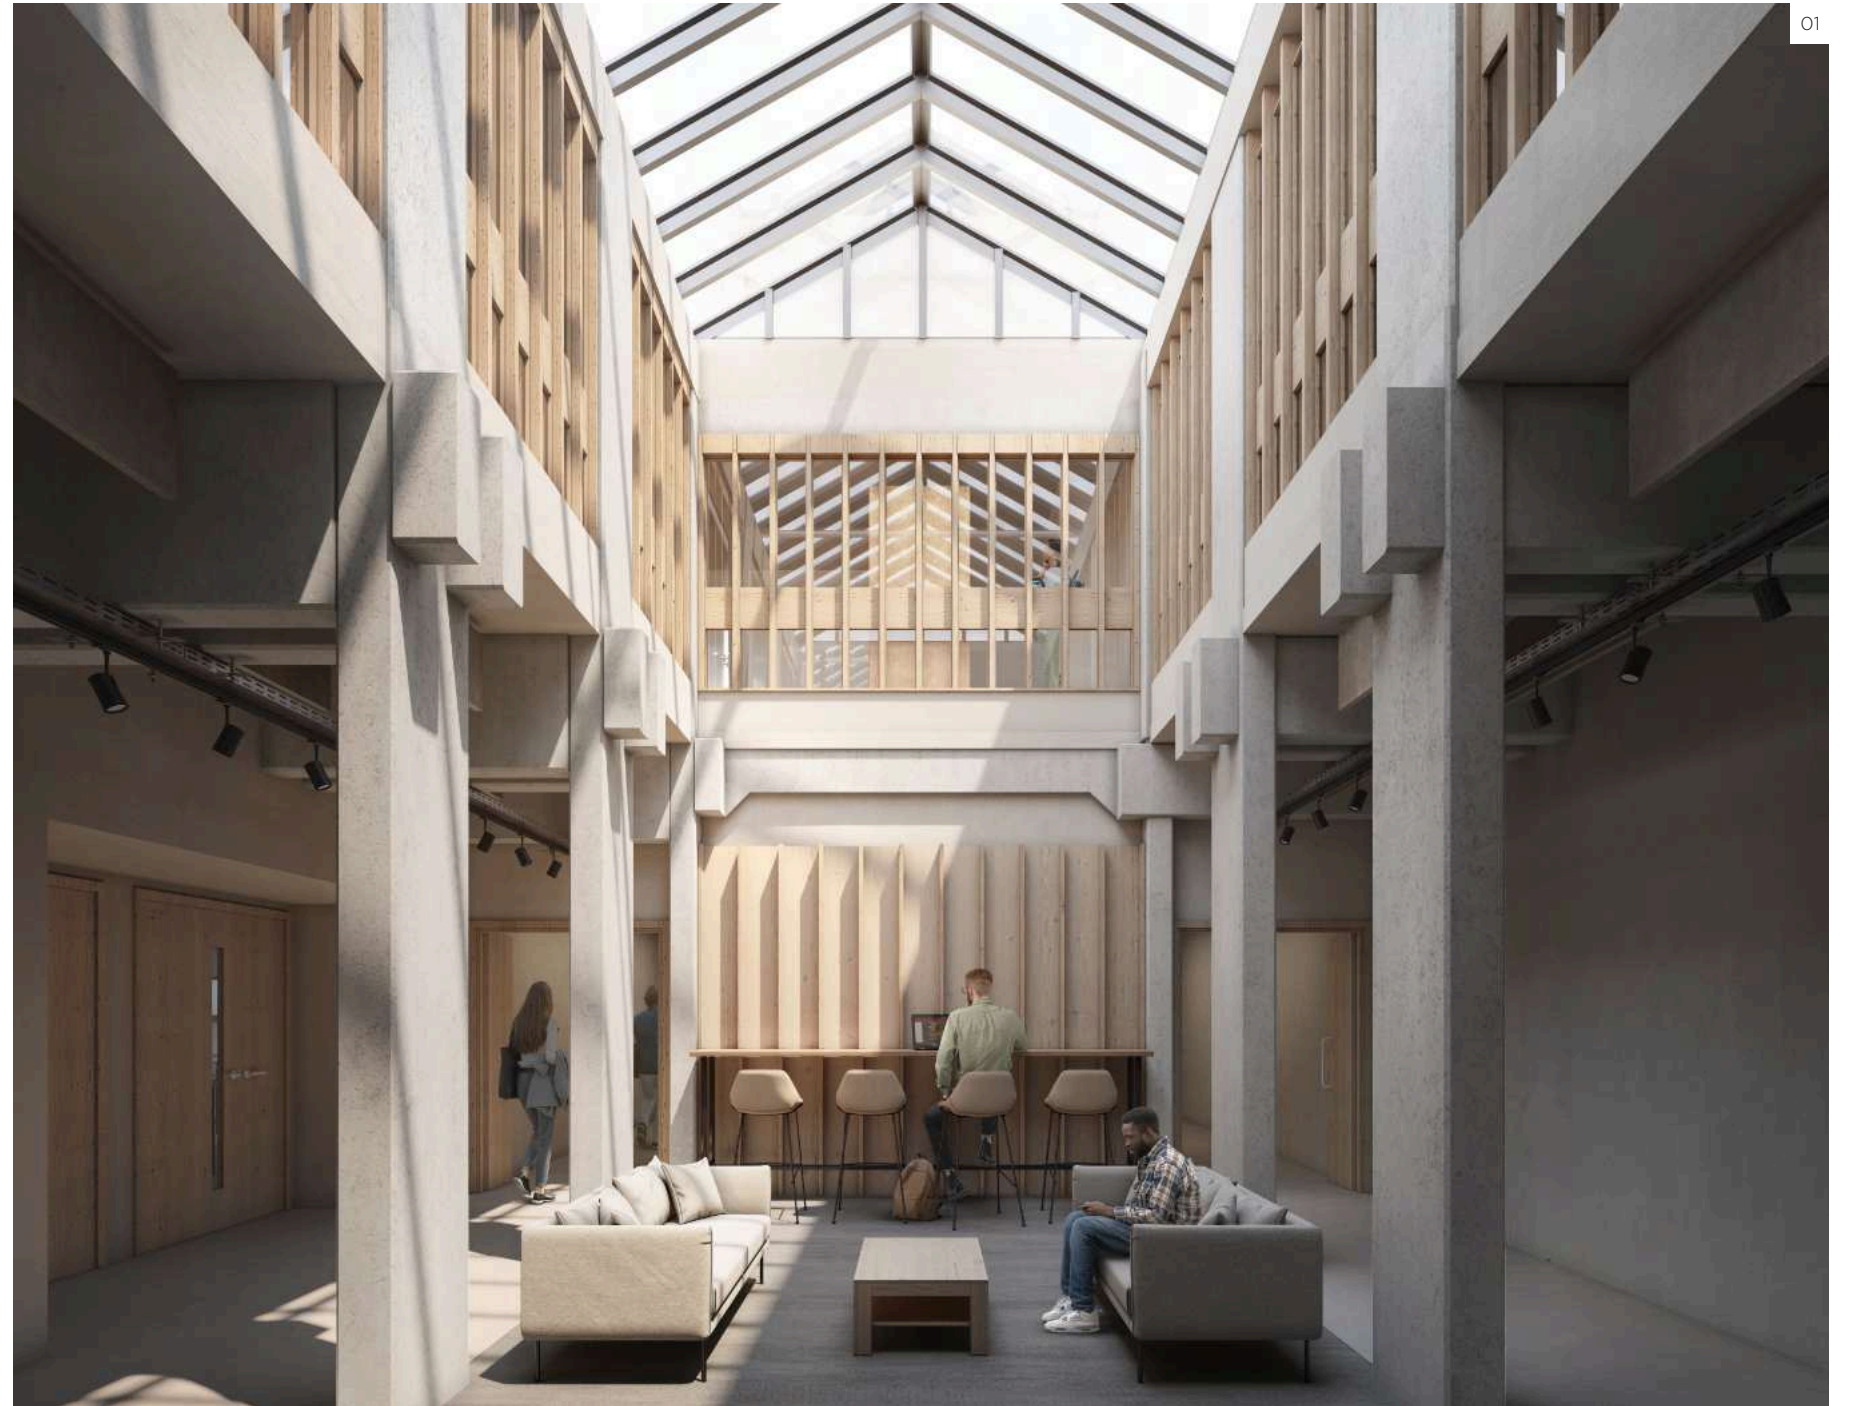
01 Indicative visual of the proposed social study space on the second floor.

The roof lanterns will be replaced with triple glazed units, with a portion opening for ventilation and smoke clearance.

Furniture will be a mixture of sofas, booths, group work tables and chairs as well as individual study spaces.

The twin circulation routes either side will be left clear to express the axial nature of the building and will be differentiated by flooring finish.

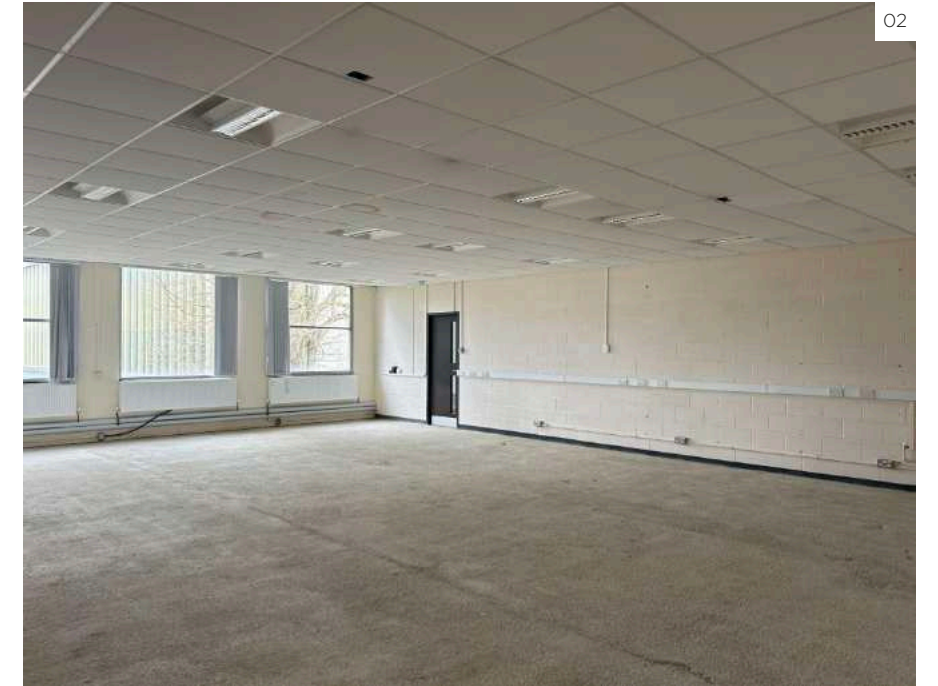
01 Photo of existing second floor classroom space.

02 Photo of existing second floor classroom space.

- Various existing ceiling strategies, i.e. suspended ceiling tiles and acoustic boards.
- Inconsistent and tired wall and floor finishes.
- Painted concrete beams.
- Existing roof lights between beam spans.
- Exposed, painted blockwork walls.

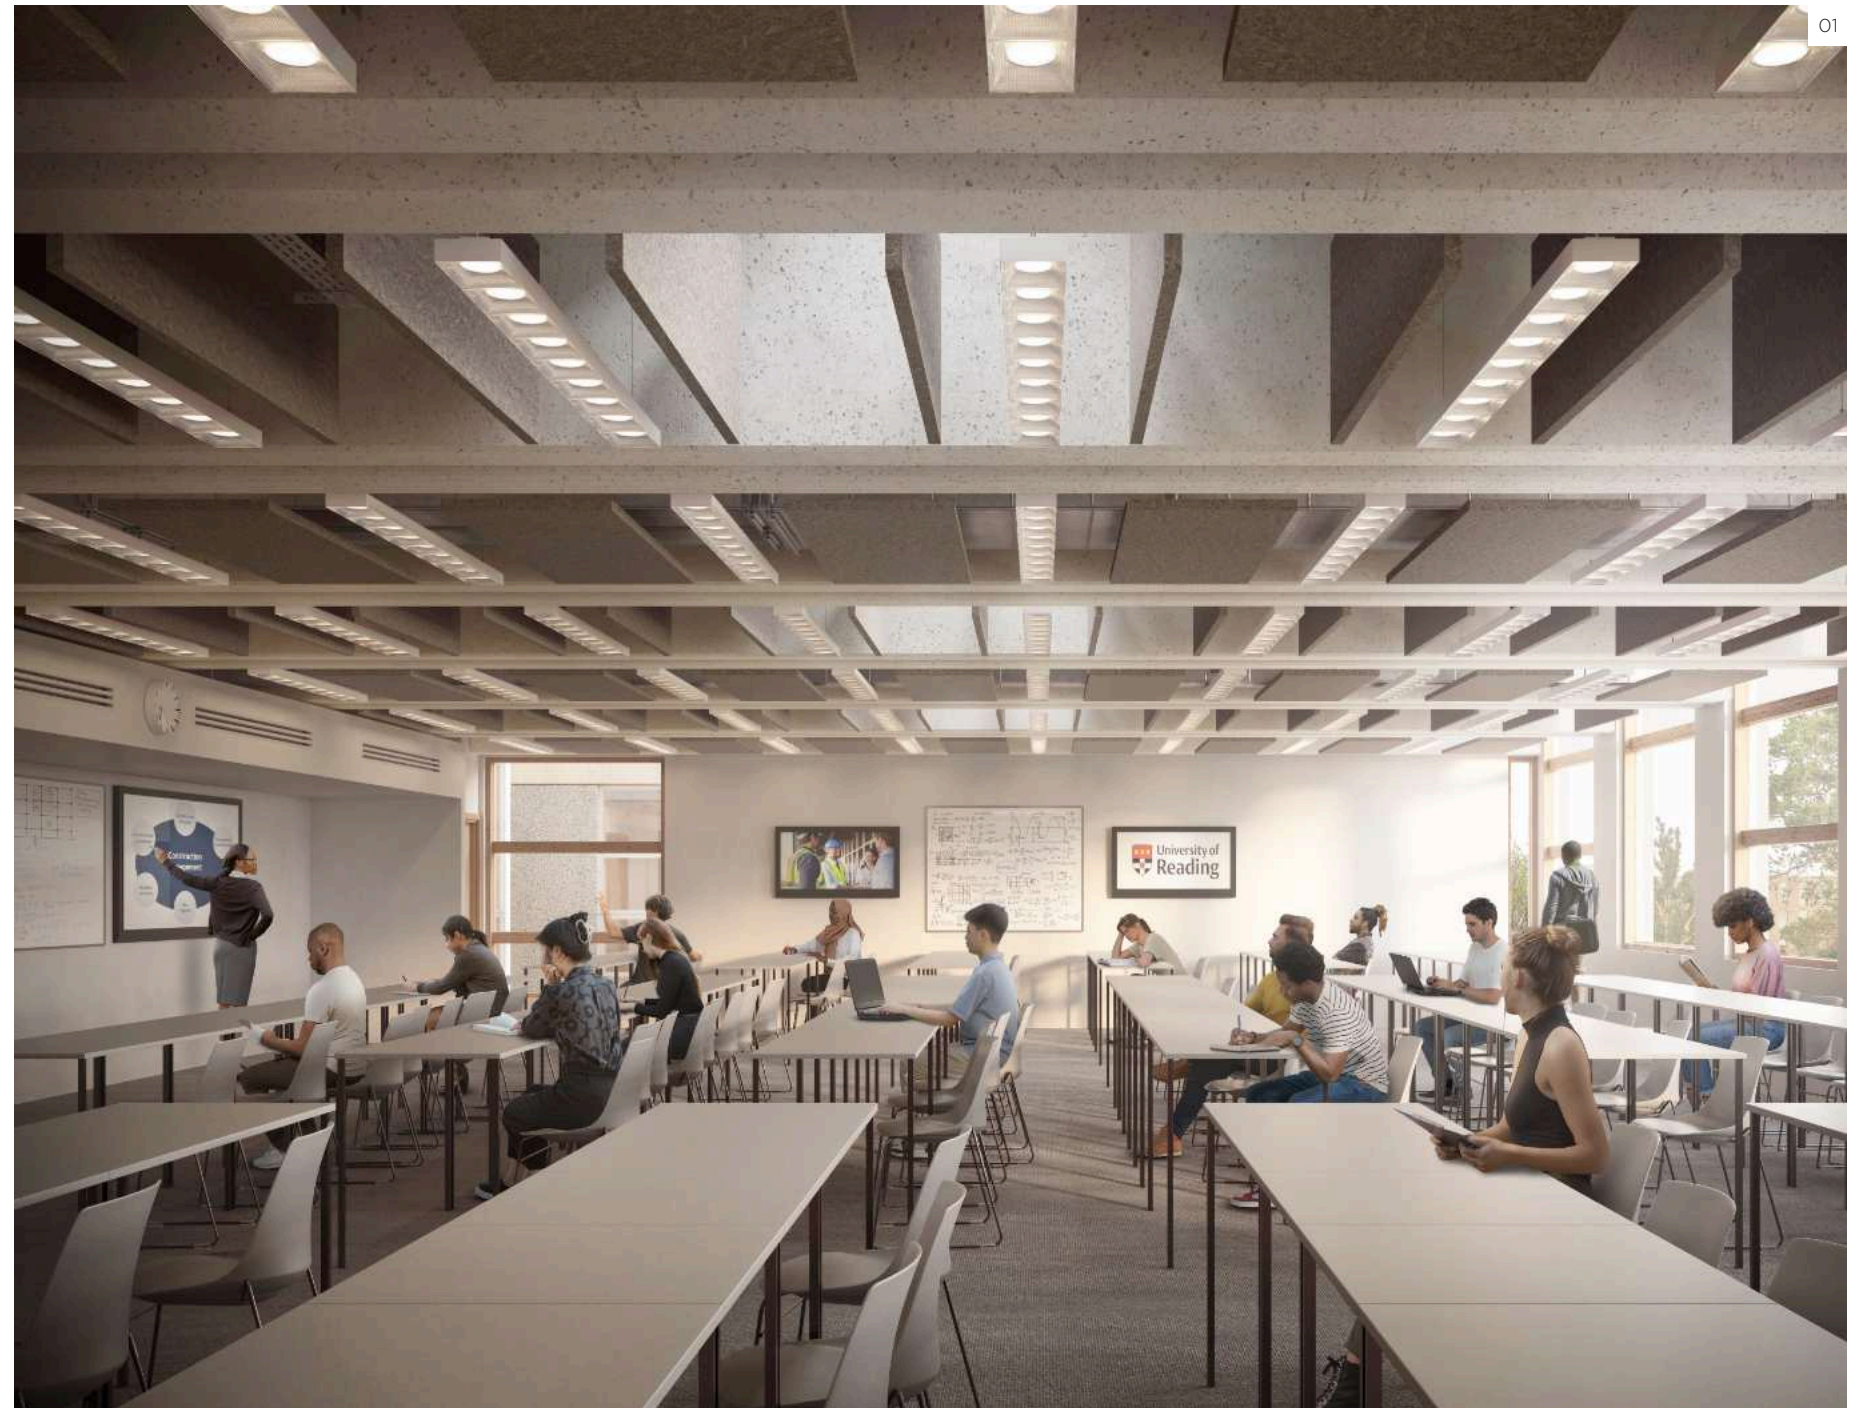
01 Indicative visual of the proposed large classroom spaces on the second floor.

The teaching wall will be located by the classroom entrance door(s) and below a continuous bulkhead to conceal any mechanical plant routes.

AV screens and whiteboards will be located on all 3 x solid walls, to allow for clear visibility and teaching flexibility. Seating will be placed in rows, to maximise teaching capacity.

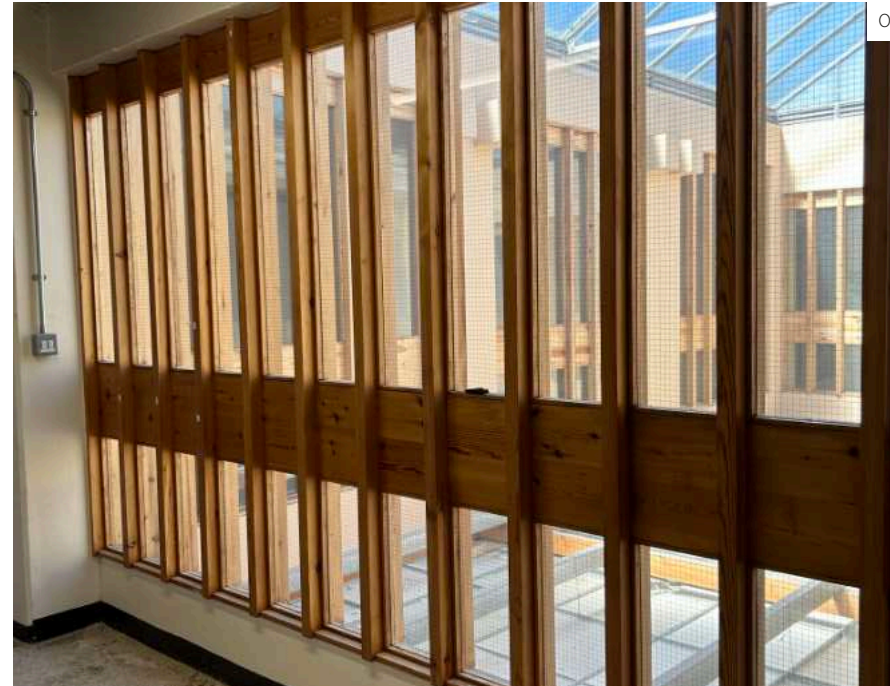
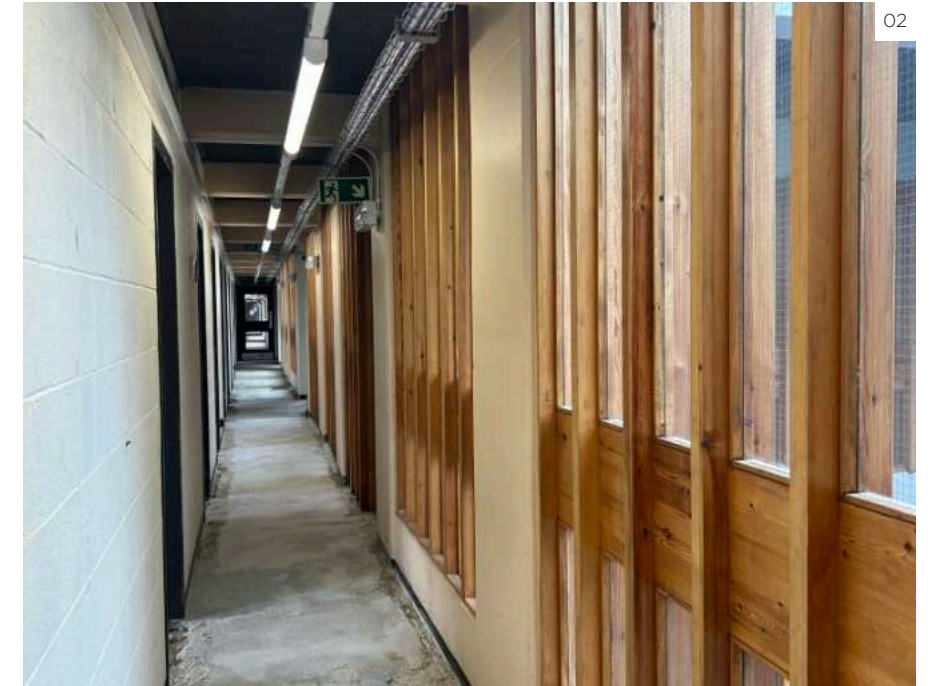
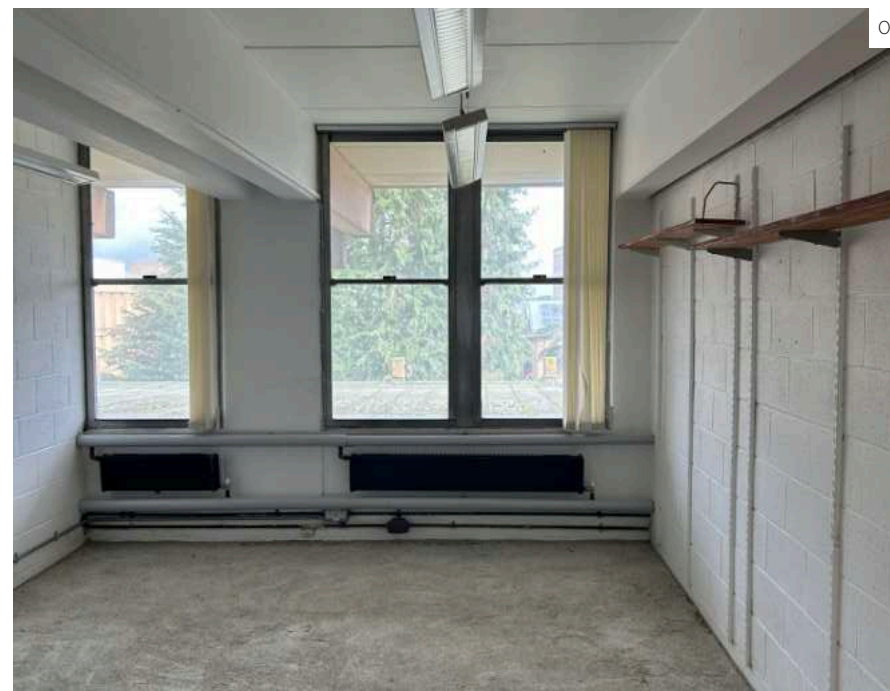
- Narrow corridor widths of approximately 1000-1100mm on this level are not acceptable for good wheelchair accessibility and give a cramped claustrophobic feel to this level.
- Later interventions blocking lightwell view from third floor to second floor (Figure 04).
- Many existing cellular offices/rooms on third floor are not appropriate to modern teaching methods and ways of working.

- 01 Photo of existing lightwell views.
- 02 Photo of existing narrow third floor corridor.
- 03 Photo of existing third floor cellular offices.
- 04 Photo of existing intervention blocking lightwell.

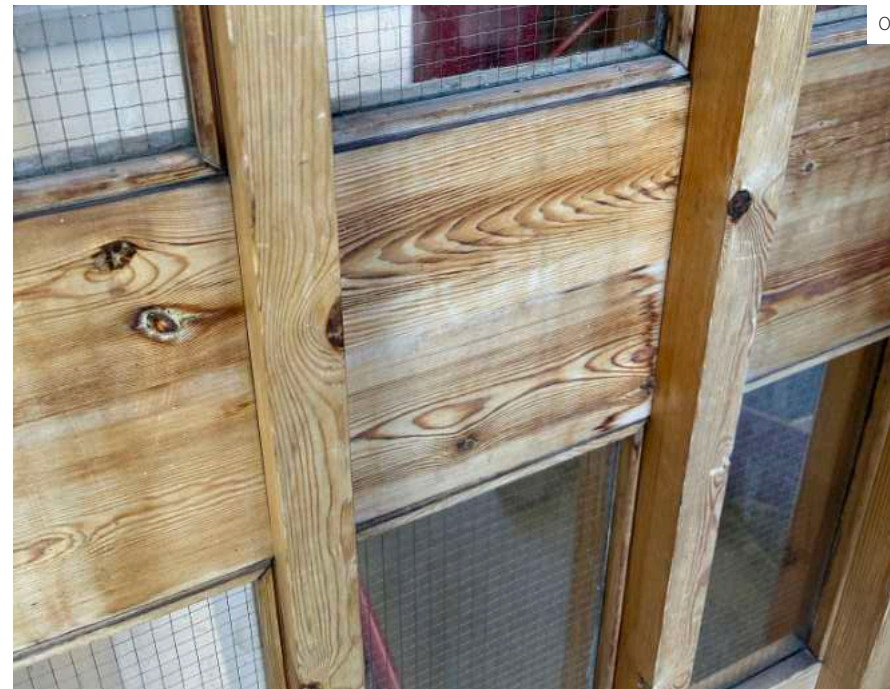
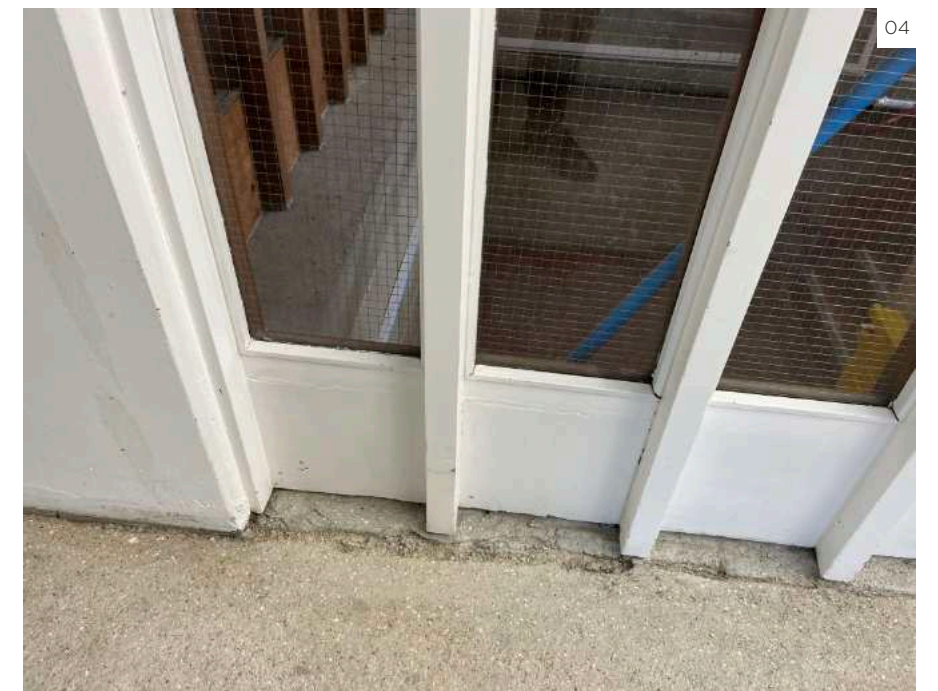
- The timber and glass screens are used throughout the building and are an important design feature and heritage asset.
- The timber screens either have a varnish/coating or in some cases have had areas painted over in white.
- The existing clear coatings appear to have aged and/or been exposed to long periods of sunlight/UV, causing the original coatings to darken in colour.
- The original mullions are at approximately 300mm centres with the recessed base, mid and head panels in wood and the glazing Georgian wired glass.
- Existing screen doors have a clear opening of approximately 800mm, which is narrow by current standards and limits fire evacuation capacity.

- 01 Existing timber glazed screen.
- 02 Existing timber glazed screen.
- 03 Existing timber glazed screen with door.
- 04 Existing painted timber glazed screen.

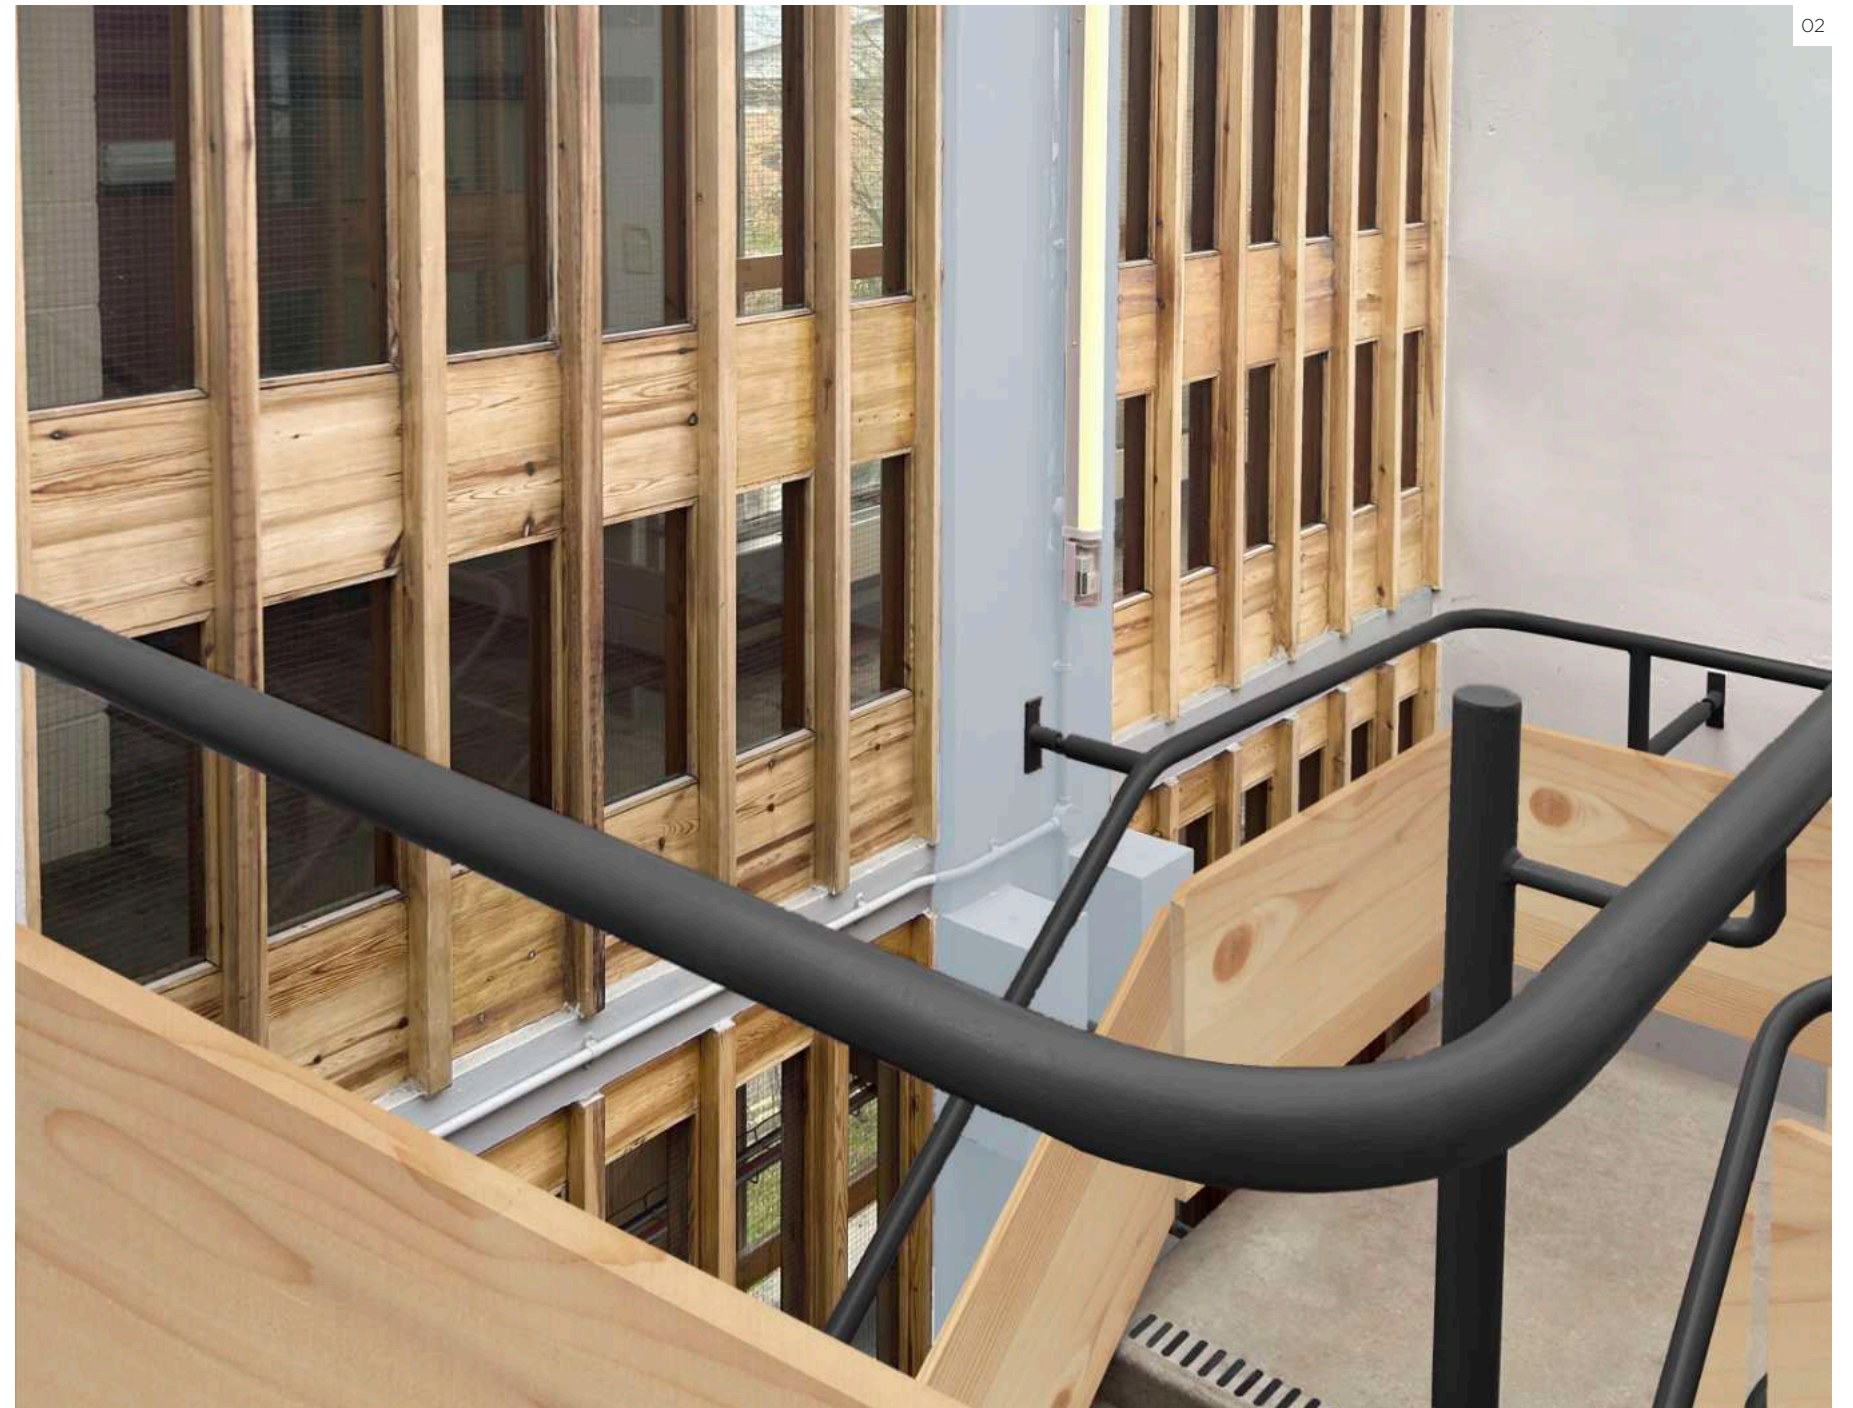
02 Proposed internal stair core 'look & feel'.

Handrails and balustrading will be retained, refurbished and repainted in a dark contrasting colour. The lower timber guarding panel will be replaced with a taller element giving a little more protection while retaining the original look. It will be a natural wood finish to match the timber screens and original detail.

Options for a sensitive solution to the nosing detail is being reviewed to improve grip and riser visibility, while being sensitive to the original aesthetic.
