# **URS REFURBISHMENT**

## **UNIVERSITY OF READING**

# **DESIGN & ACCESS STATEMENT**

Our ref: 435-ACG-W033-ZZ-RP-A-1906

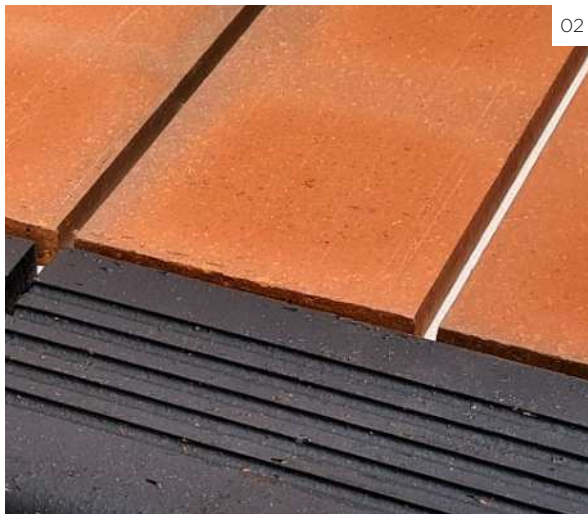
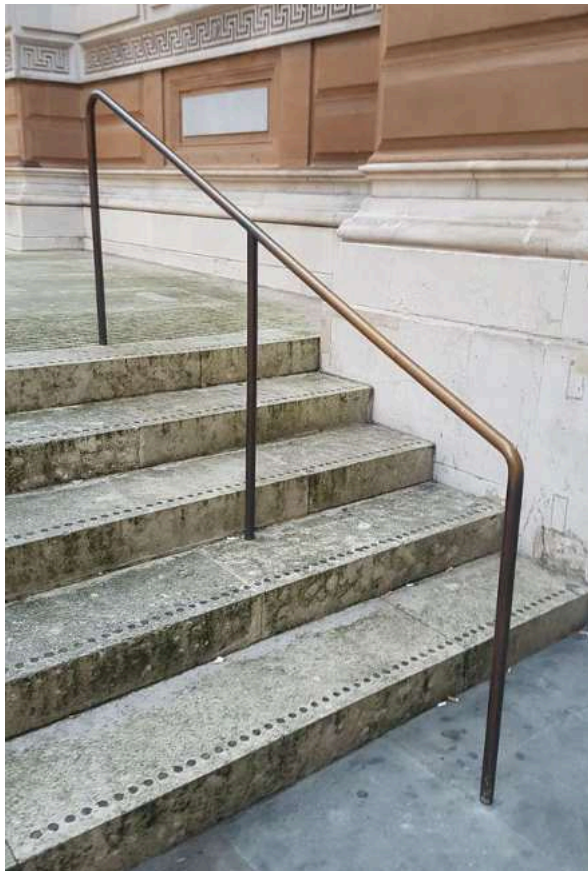
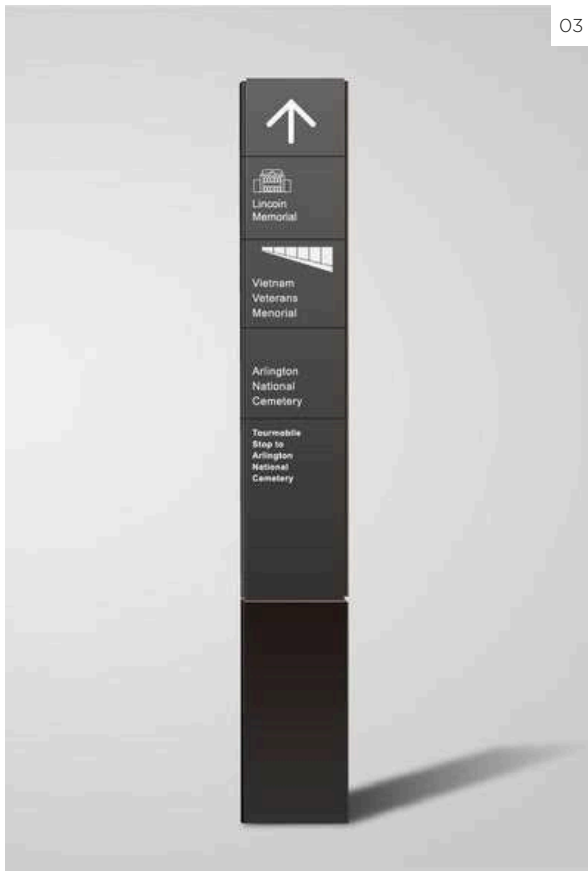
01 Precedent image of an external 'hoop' sign.  
02 Precedent image of black paving nosing.  
03 Precedent image of an external totem sign.

04 Precedent image of handrails with light strips incorporated.  
05 Precedent image of handrails.  
06 Precedent image of feature lighting.

Existing (later addition) handrails will be replaced for new stainless steel balustrades, which look to incorporate lighting into the rail or flooring beneath.

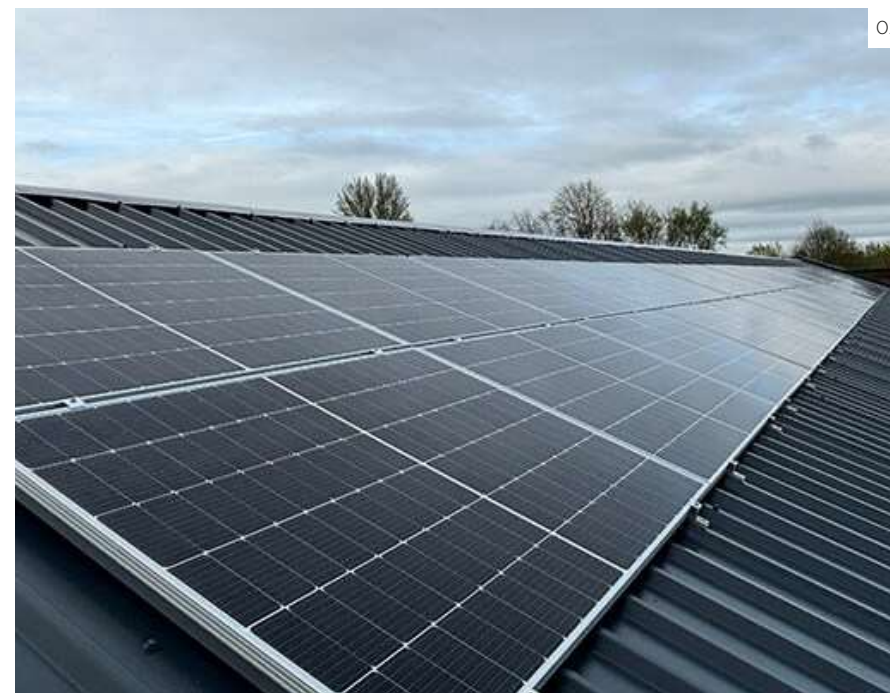
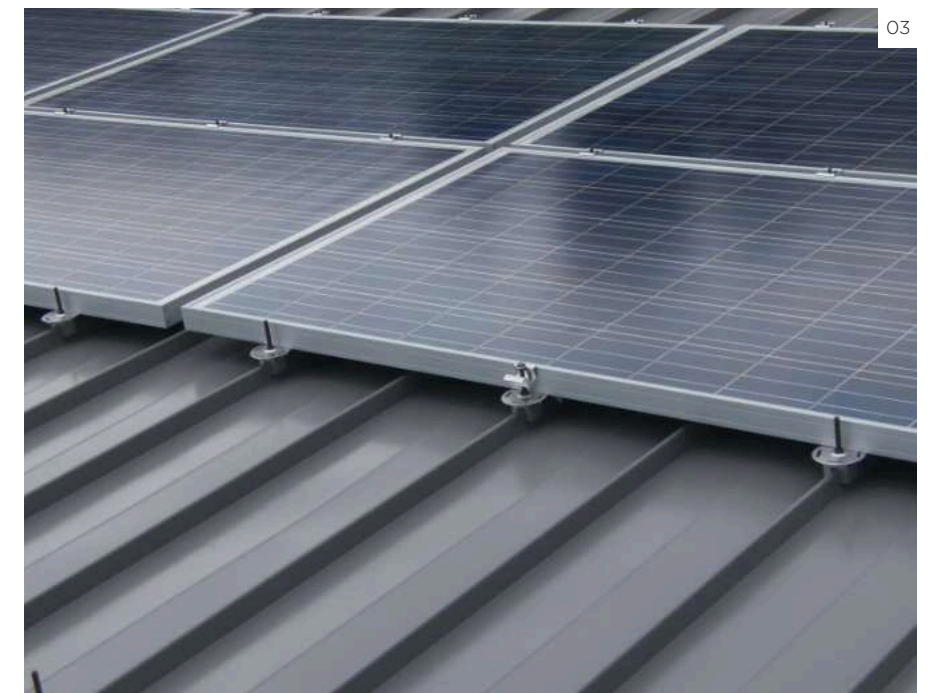
- 01 Indicative visual of the solar pv panels on level 3 roof.
- 02 Precedent image of solar panels attached to a standing seam roof.
- 03 Precedent image of solar panels attached to a standing seam roof.

Notwithstanding Heritage constraints, opportunities exist for large amounts of solar PV, due to the building's north/south orientation and roof form. The proposal illustrates a continuous row of PV panels (approximately 140m<sup>2</sup>), which will be relatively hidden from view on the level 3 roof and accessible for cleaning and maintenance from the accessible flat roof.

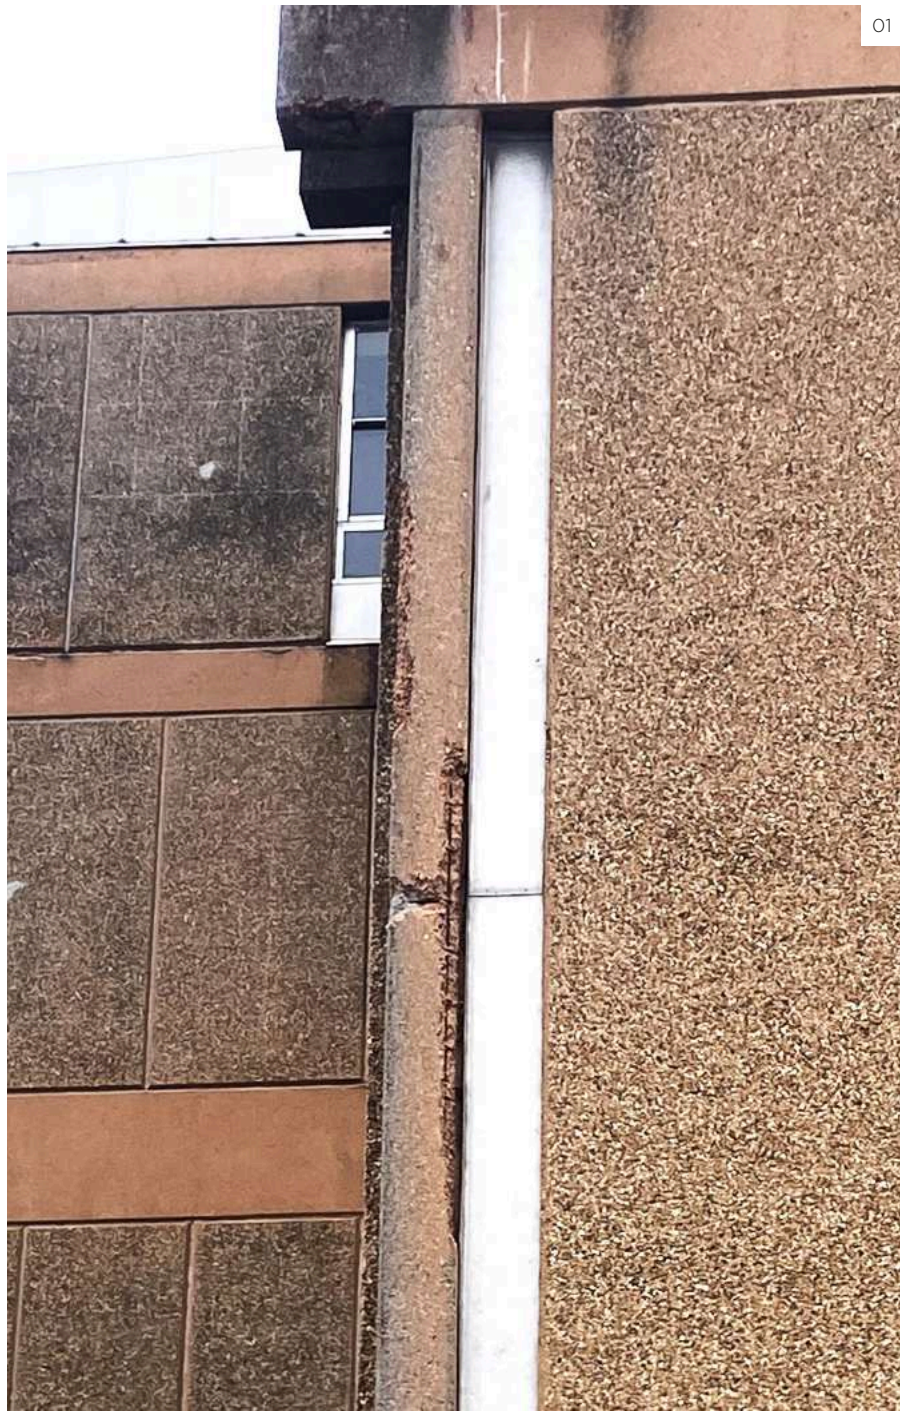
01 Concrete spalling and exposed reinforcement on external RC column.

Purcell and Curtins have categorised priority defects from both a heritage and structural significance as well as from a health & safety perspective e.g. falling debris. Refer to Figure 01, which shows an example of spalled concrete column and possible loose debris.

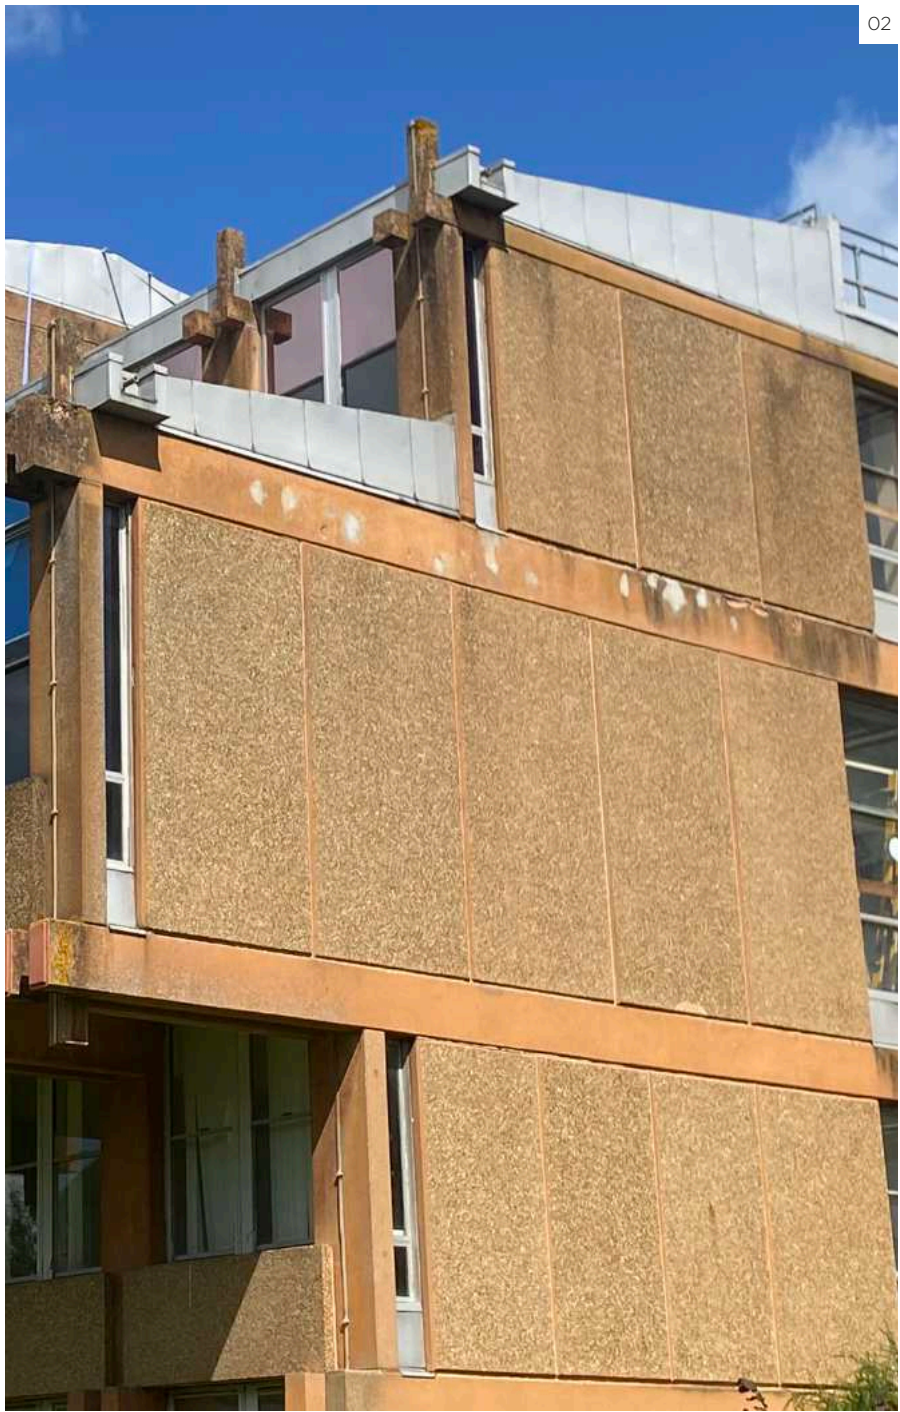
02 Poor quality previous concrete repairs on east elevation façade.

Previous poor quality concrete patch repairs have also negatively affected the building’s external appearance. These conventional concrete repairs have used a grey pigmented product which does not resemble the surrounding ochre-coloured concrete (see Figure 02).

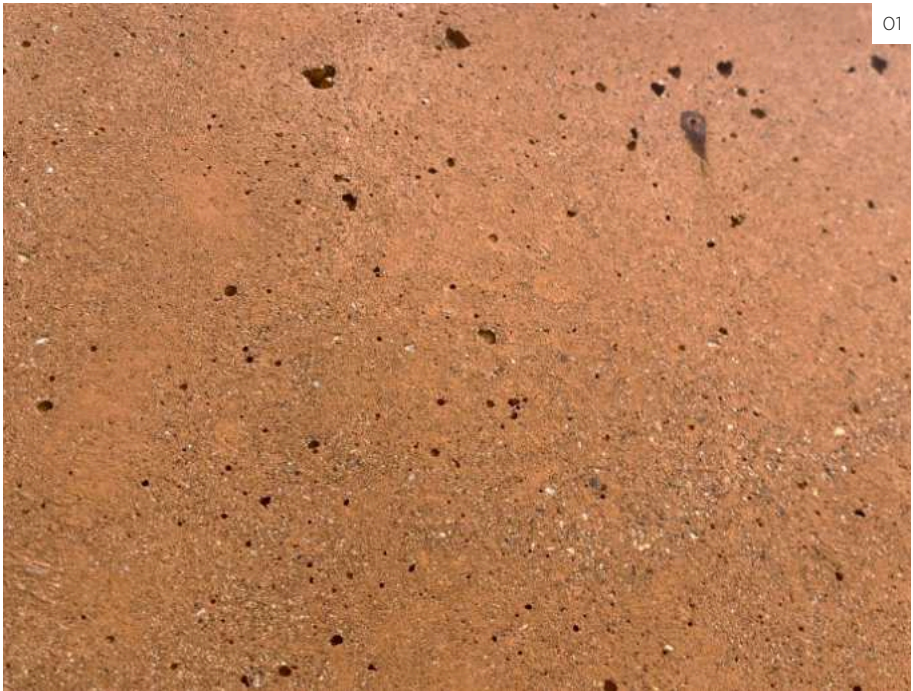
01 Existing pigmented concrete (ochre).

- Arrange for a test clean on a sample of external concrete elements (beams, columns and cladding panels).
- Apply various coating protection options on a test area. Sample areas to include at least 1 beam, 1 column and 1 cladding panel.
- Compare results of hand-applied concrete repair mortar and shuttered poured concrete. Colour matching and pigmentation of repairs to match existing is to be carefully considered. Refer to Figures 01 and 02 for the existing colour scheme.

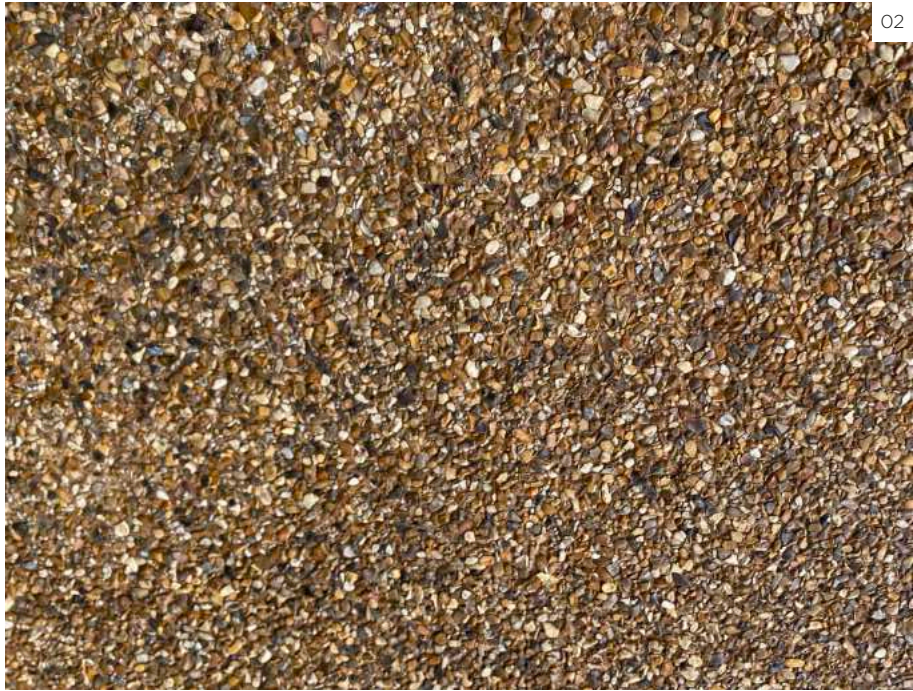
02 Existing concrete cladding panels finished with exposed Thames Valley aggregate.

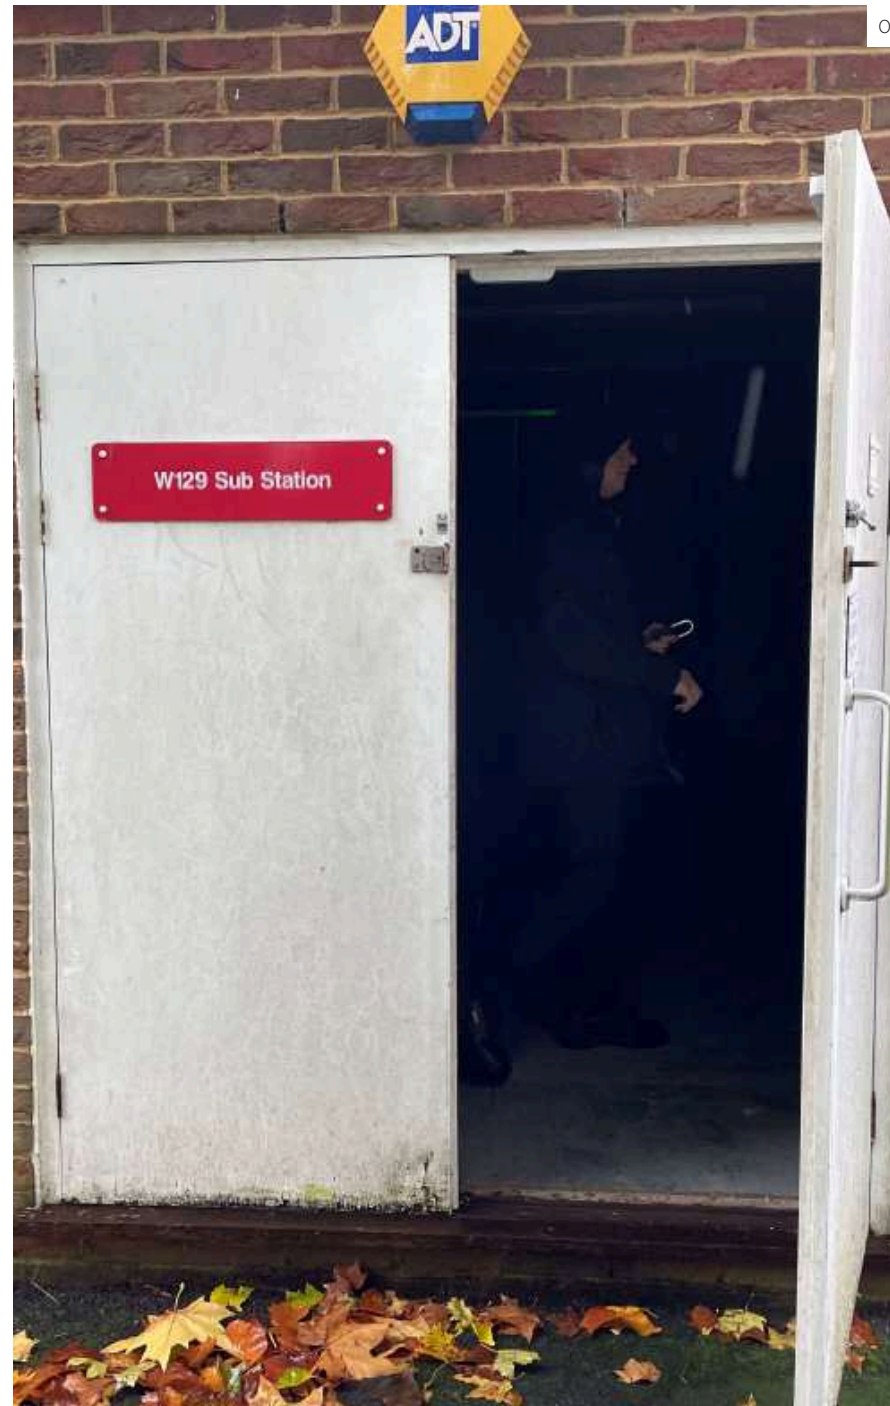
01 Photo of existing W129 Sub Station.

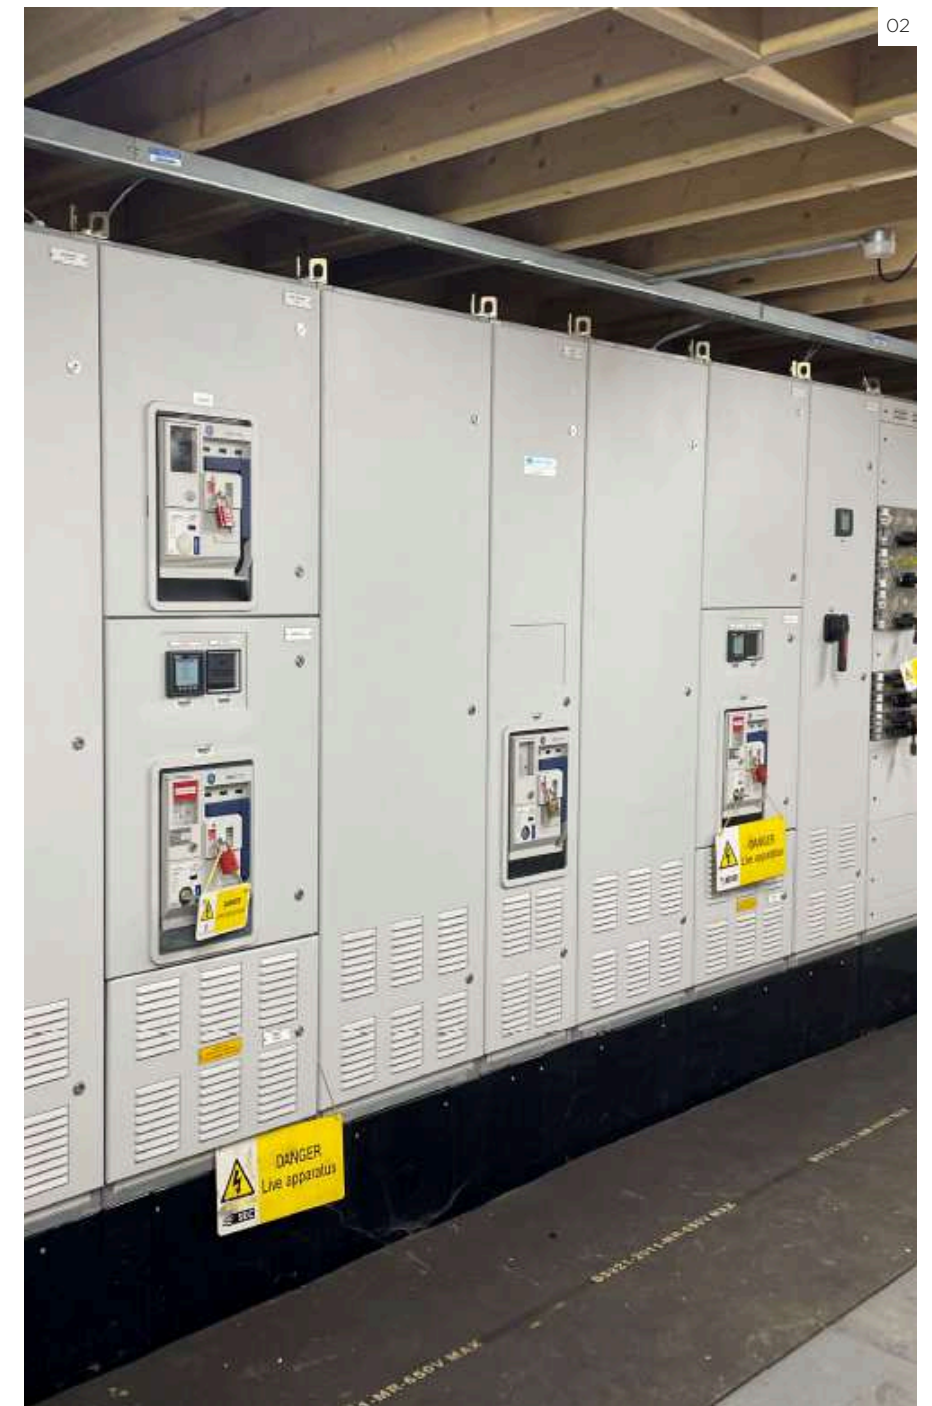
01 Photo of existing switchgear in the the Miller Building.

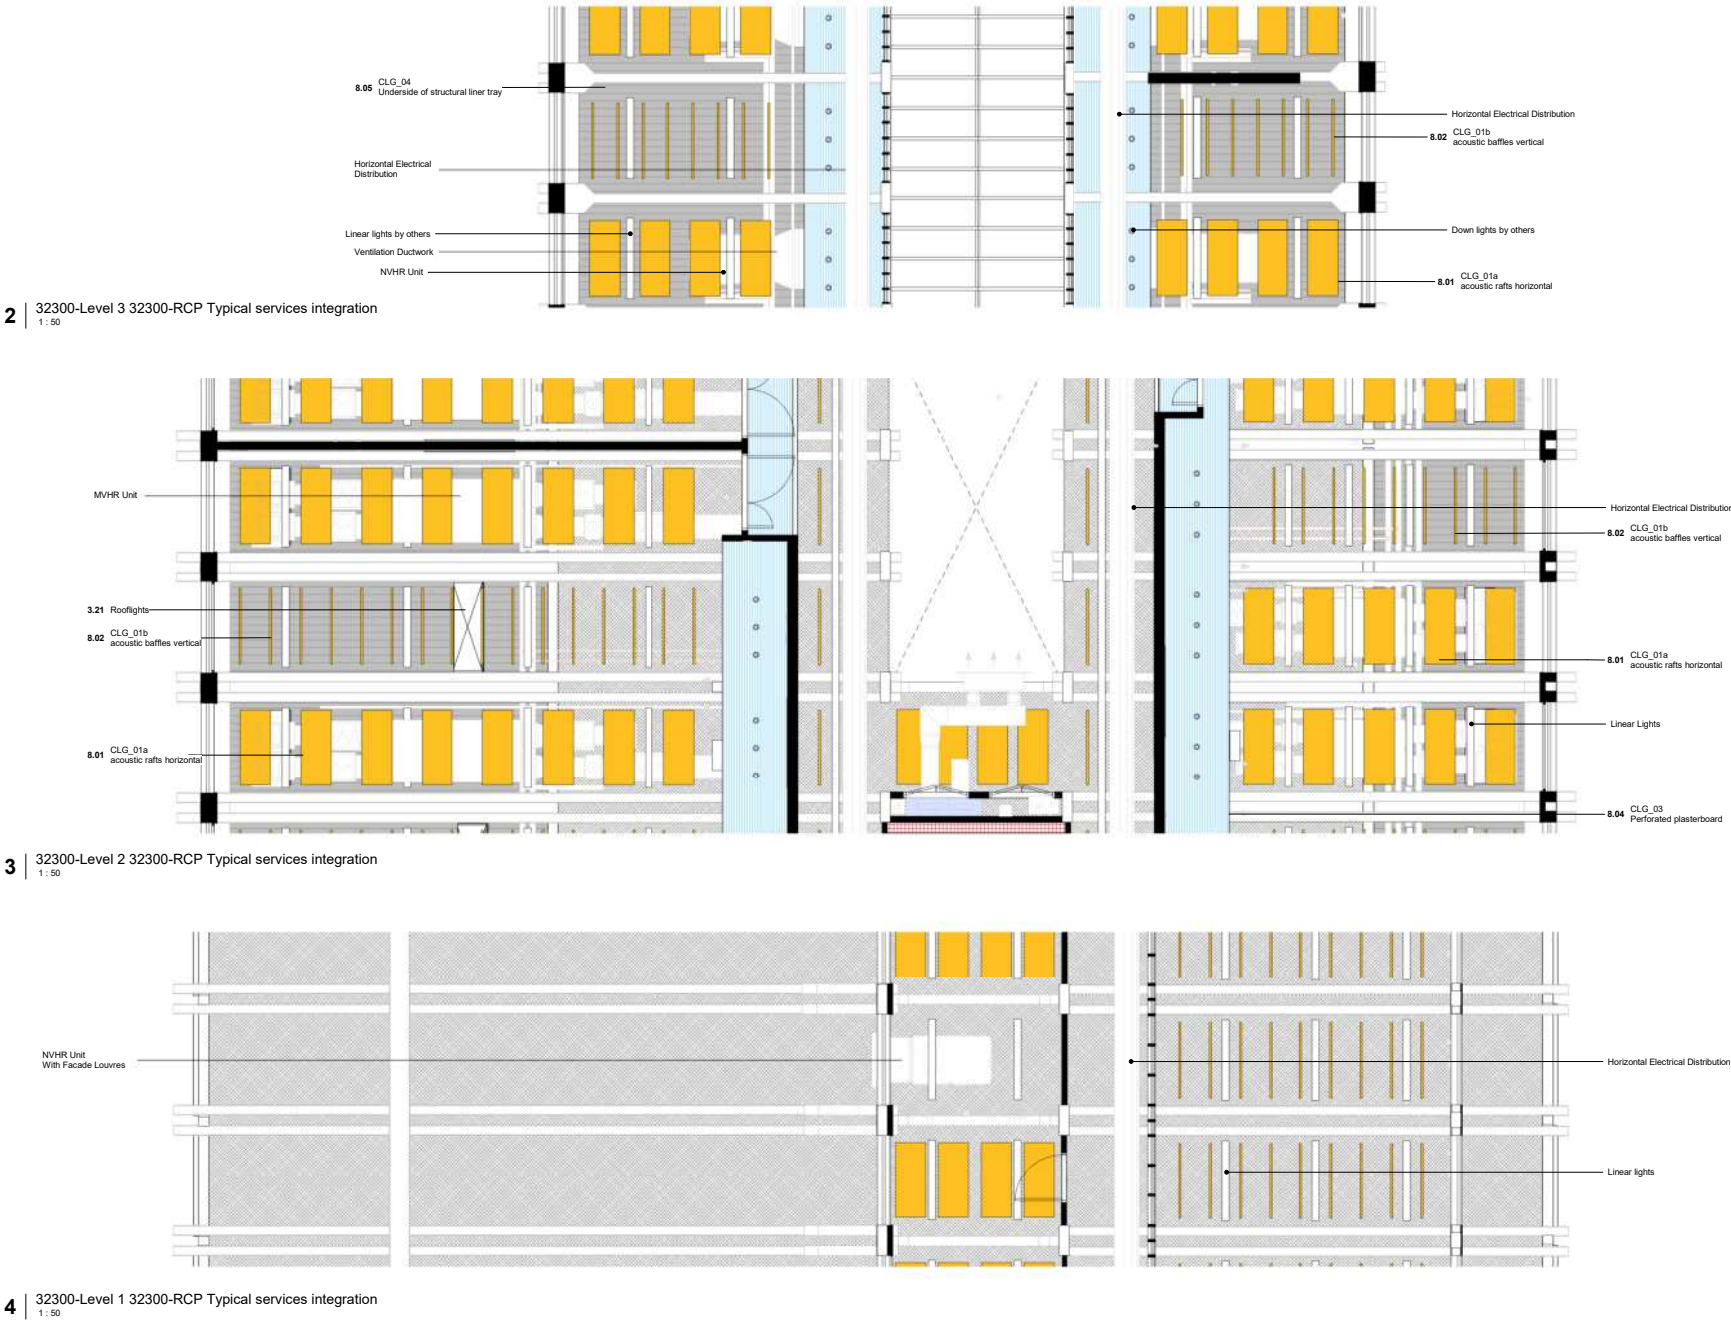
01 Proposed Typical Services Integration RCPs (nts).

Lighting in these spaces is coordinated with the acoustic baffles and is suspended just below the ventilation equipment.

Electrical and data distribution cannot be decentralised, therefore runs along the primary circulation routes suspended below the beams within containment.
