**BS5837:2012 ARBORICULTURAL  
METHOD STATEMENT:  
Land at Johnson Drive, Finchampstead, RG40 3NW**

Dated: 19<sup>th</sup> September 2024

Our reference: GHA/MS/169990:24

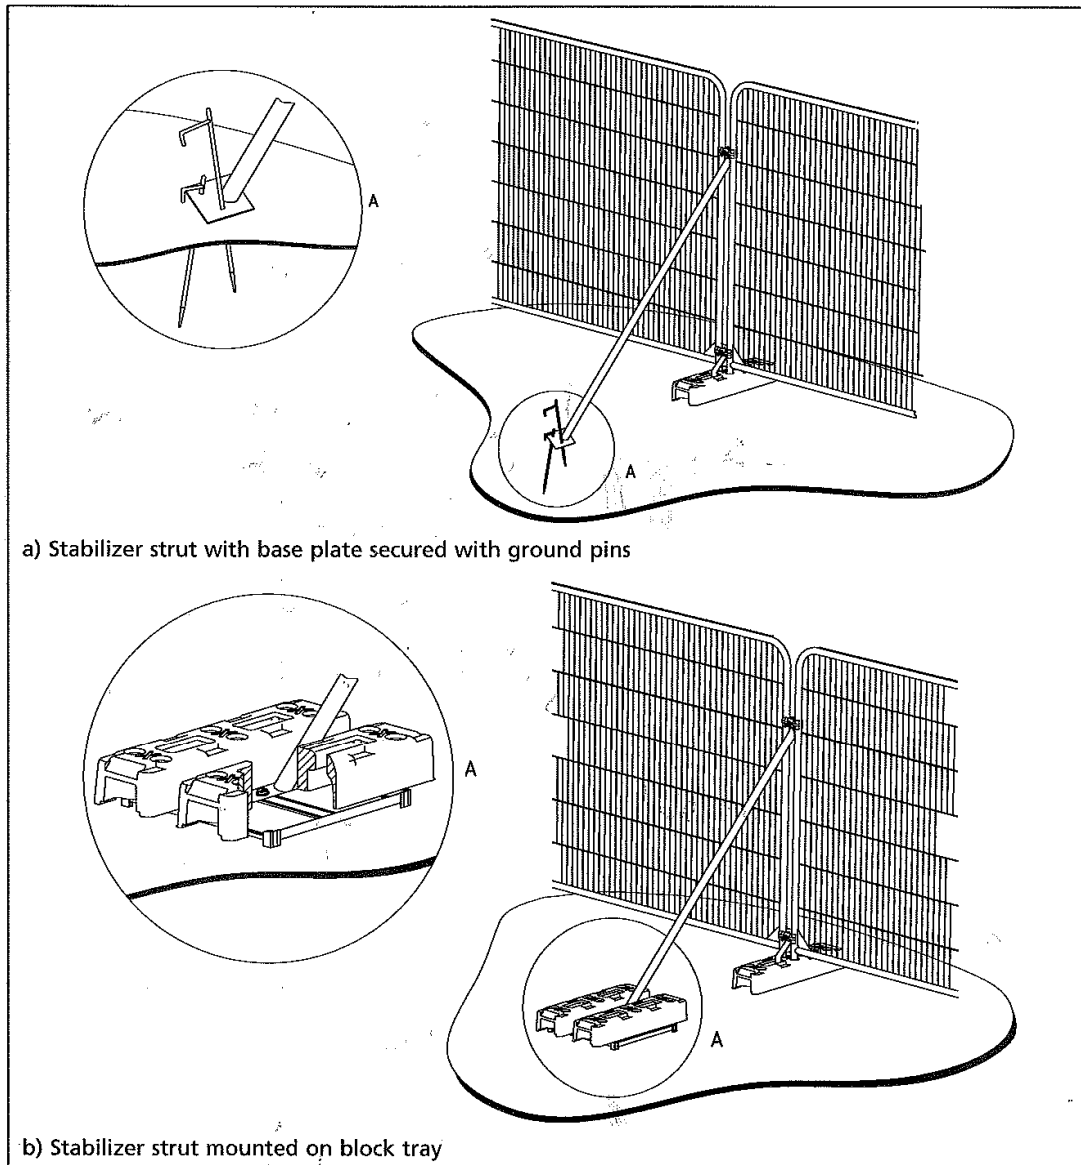
Figure 3 Examples of above-ground stabilizing systems

**Appendix C**  
**TREE FENCING DETAIL**
