### **Southern Elevation**

#### Description – 4. Brick Barn – Internal.

## Description – 5. Brick Stables – External.

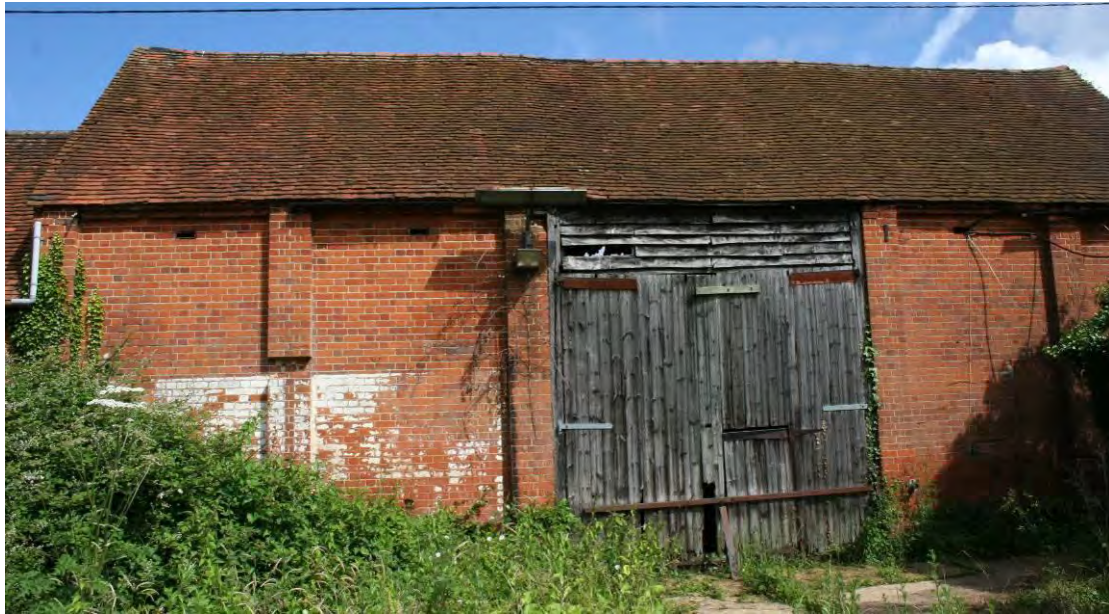
The southern elevation of the Brick Barn.

The south elevation has two tall barn doors under a small section of weather-boarded studwork. The doors are of MC20th tongue and grooved boards with gate and ledgers fixed with French nails and screws and hung on reversible and T-strap hinges. A pedestrian door has been let in to the eastern one.

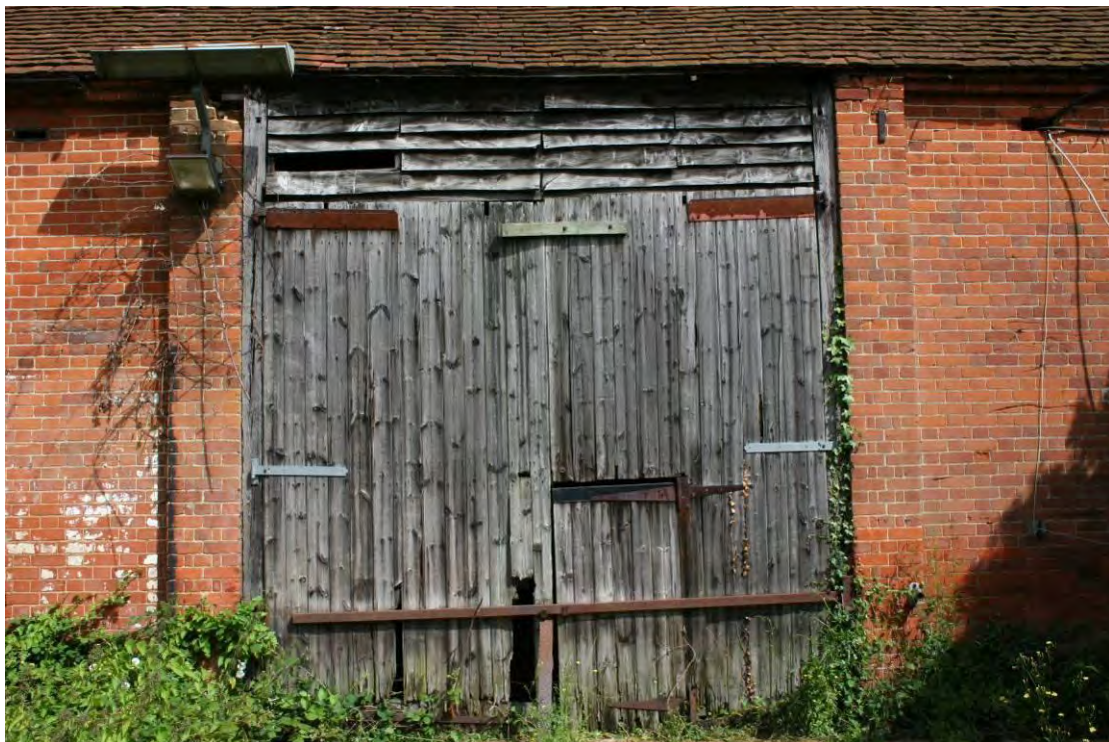
Detail of the C20th barn doors.

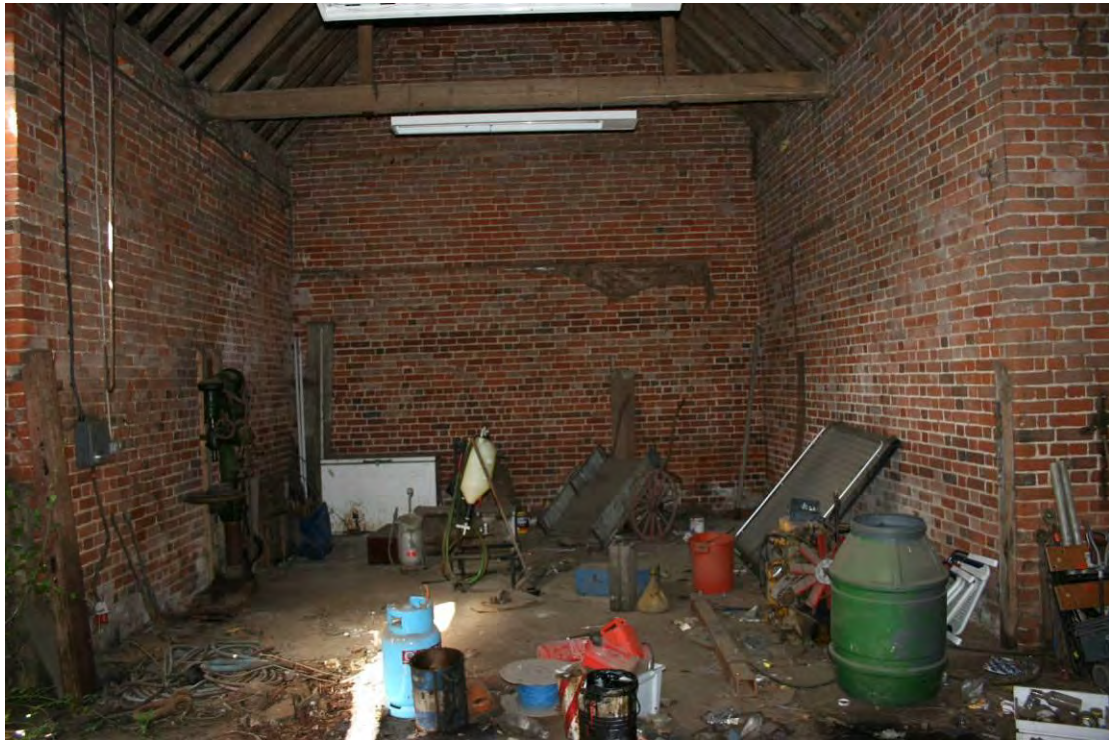
Looking W inside the Brick Barn.

The Brick Barn has five bays defined by the roof trusses. The walls are bare. There is a LC20th service platform at the eastern end built of steel girders. The building contained grain silos.

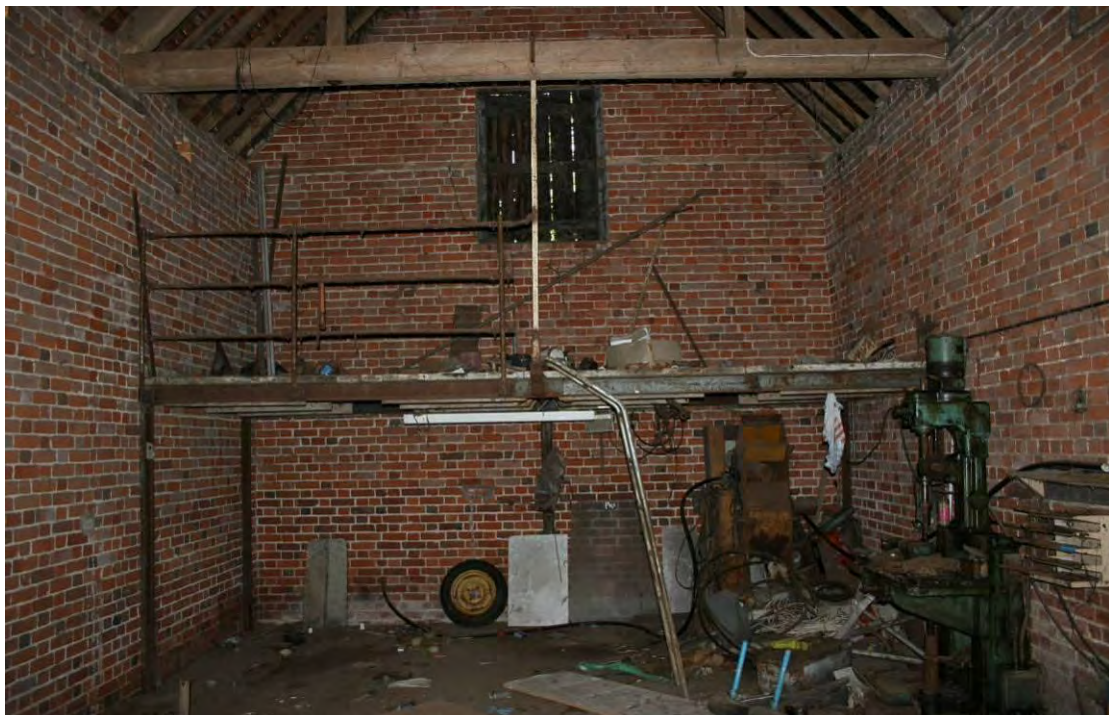
Looking E inside the Brick Barn.

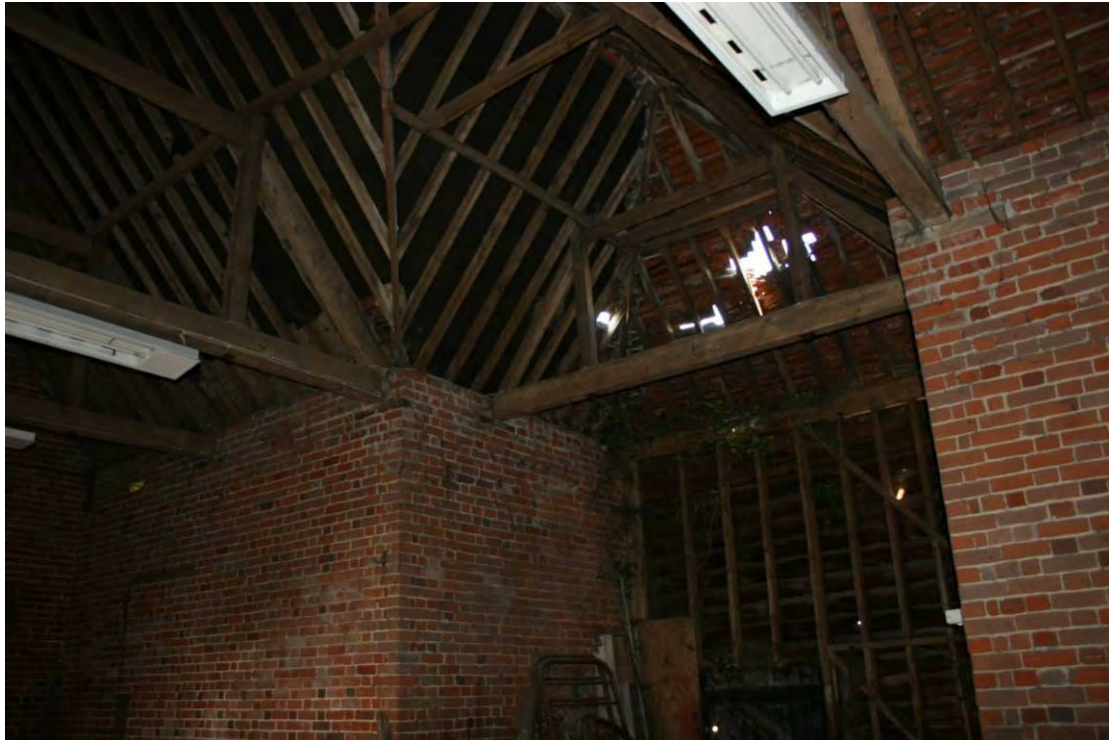
The midstrey porch.

The roof is made of machine sawn softwood and forms a side purlin roof. The truss has queen struts secured with large wrought iron bolts and collets. The principal rafters are shored into the sides of the queen struts which are connected with a collar. The collar supports the side purlins upon which are laid the 2x4in rafters. In this way the truss is independent of the rafters. The extensive use of standardised machine cut softwood timber indicates that the Barn was erected in the second half of the C19th.

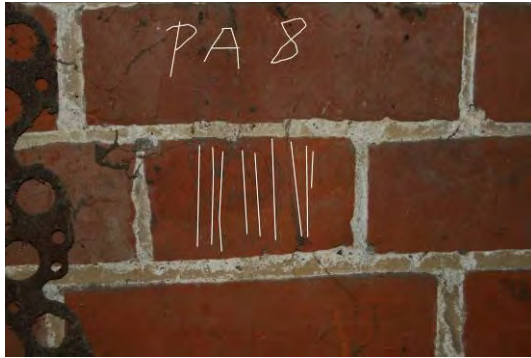
Tally marks in the midstretey.

There are large numbers of tally marks scratched inside and outside on the brickwork. These can represent bags of produce or litters of pigs. There are also modern chalked numbers that represent yields from grain processing.

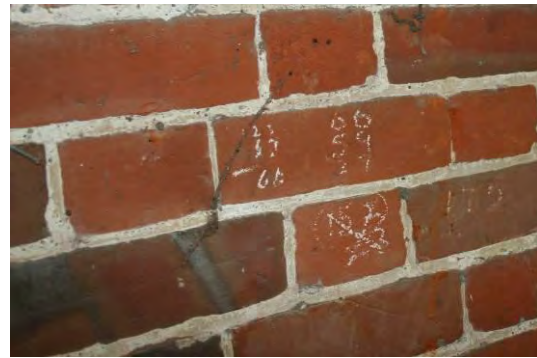
Yields written in chalk.

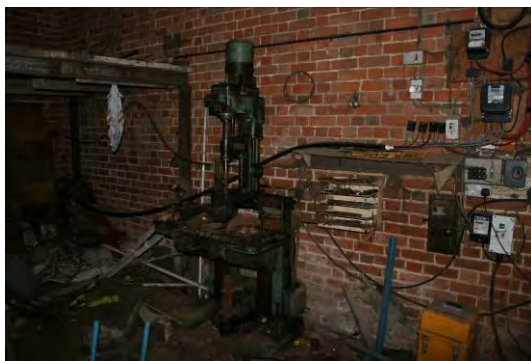
Pillar drill in the Brick Barn.

Any historic fixtures and the MC20th grain dressing machinery and silos have been removed. There are modern power connections and a MC20th pillar drill that appears still in use. There is another belt driven pillar drill that must have been rescued from the Workshop. There is a small hand pulled milk cart in working order that matches another decayed in the Workshop. An EC20th chest contains carpenters tools.

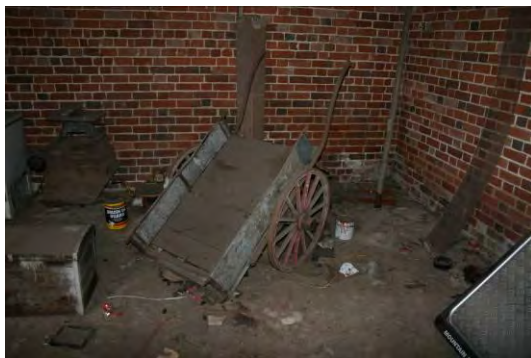
Small milk cart stored in the Brick Barn.

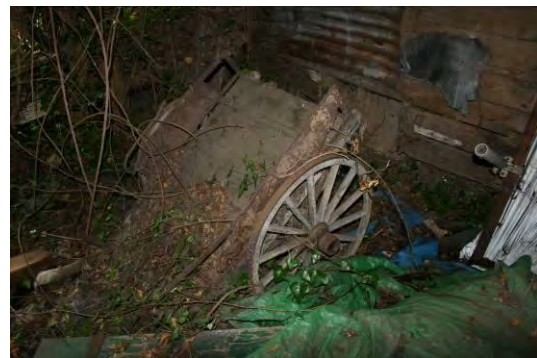
Matching milk cart decaying in the Workshop.

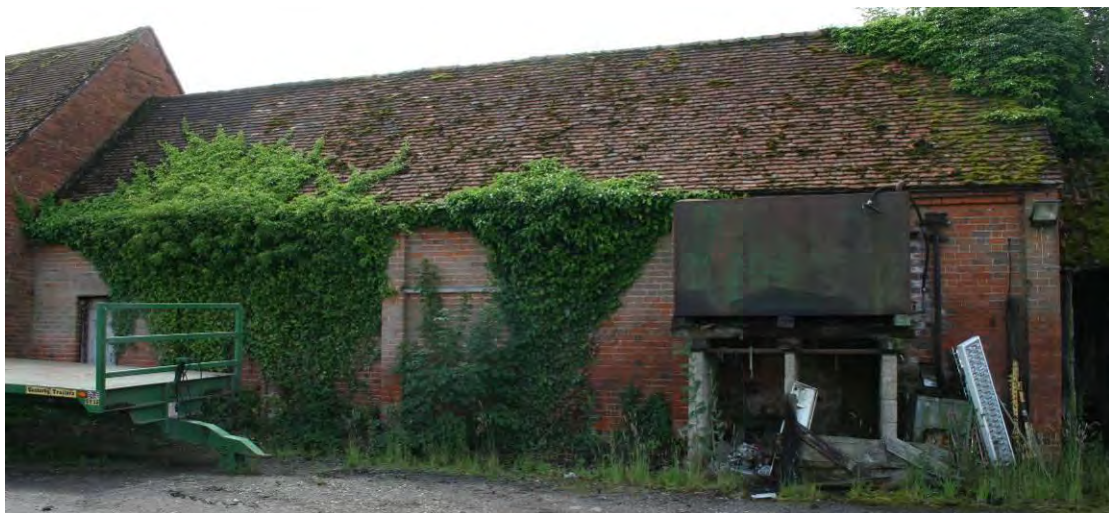
The Brick Stables northern elevation.

The Brick Stables was built at the same time as the Brick Barn using identical 70x110x225mm bricks all correctly keyed in with the same pilaster details. There is a single doorway under a gauged brick arch. The roof is clad with clay peg tiles.

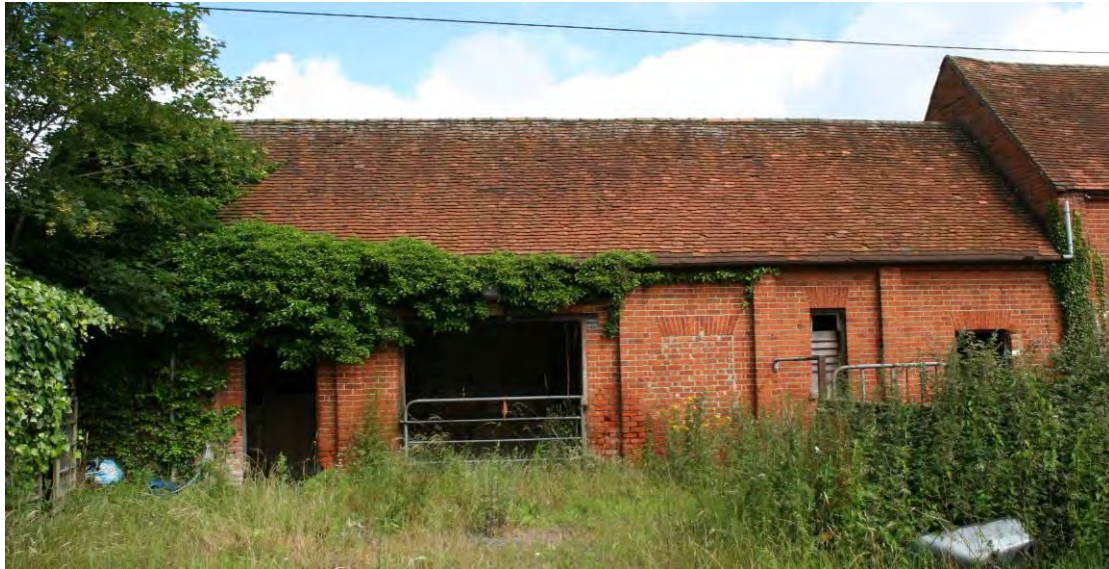
The southern elevation of the Brick Stables.

The southern elevation was originally built with two doorways and four windows under gauged brick arches. The elevation was remodelled in the 1960's, blocking one doorway and opening another up under a steel lintel to accommodate the cattle. A substantial bull pen built of reinforced concrete and steel railings was built around the doorway to the east and is notable for the damage to its jambs.

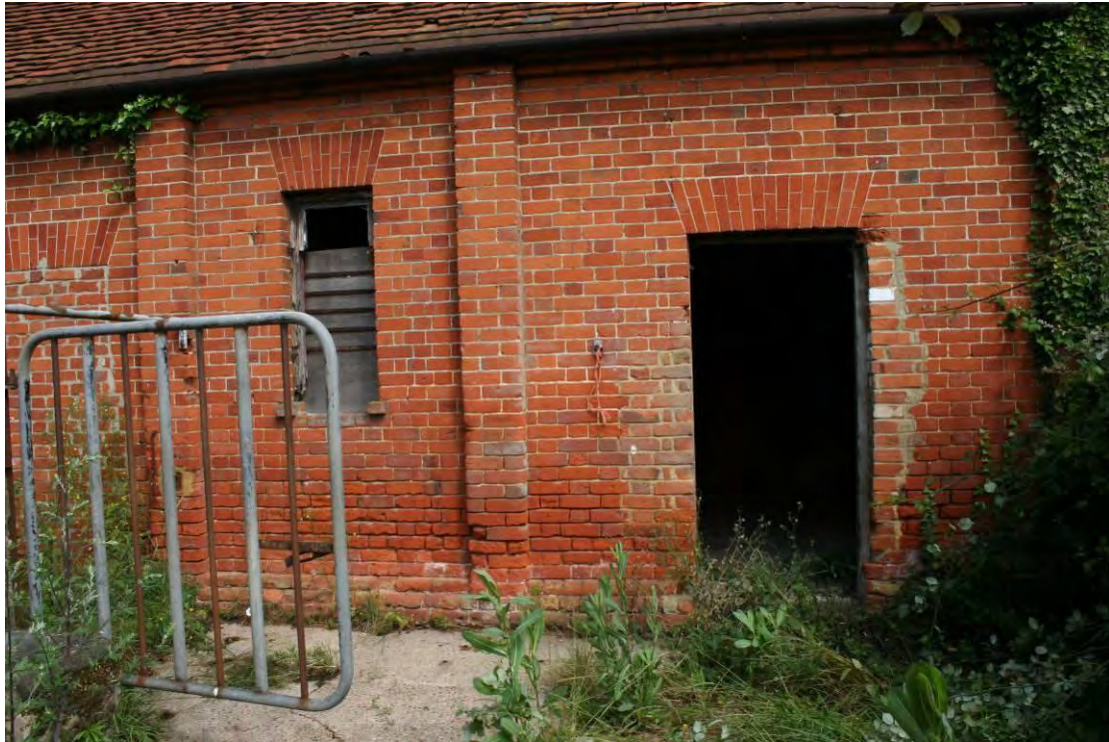
Doorway to the bull pen.

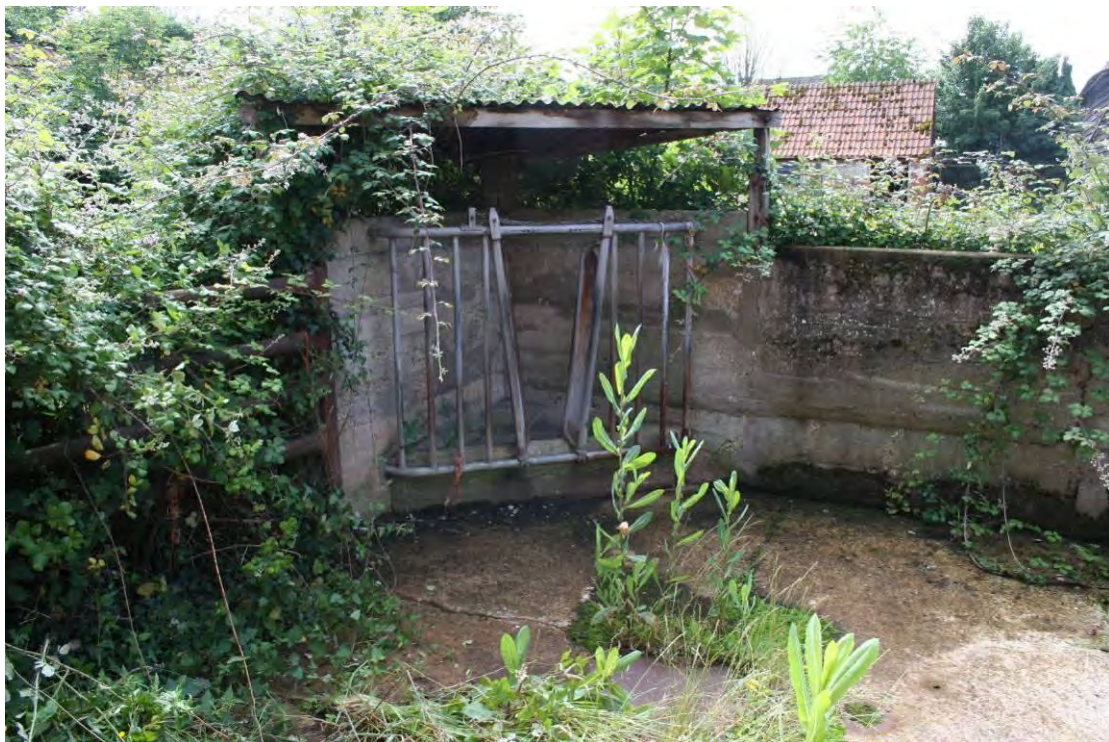
Feeding trough in the bull pen.

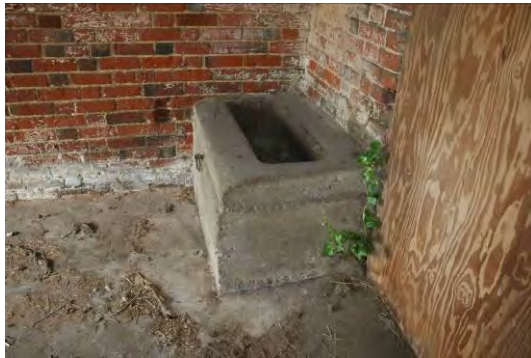
Concrete water trough.

The stall last used to house the bull was most likely originally the tack room as it is the only room with two doors allowing exit to the north. The door has been blocked and covered with Sterling board and another opening broken through on the western side has also been covered. There remains a low level concrete water trough with a tethering ring and an elegant C19th style hay rack riveted to the brickwork indicating that horses were also kept here at one point.

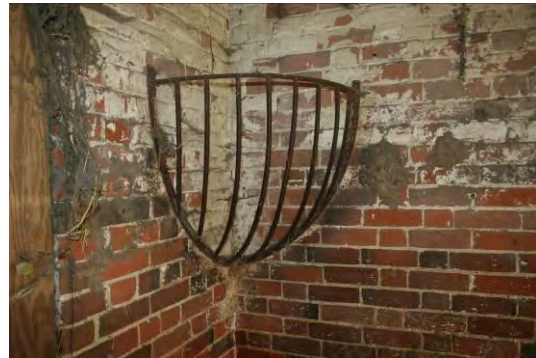
LC19th hay rack.

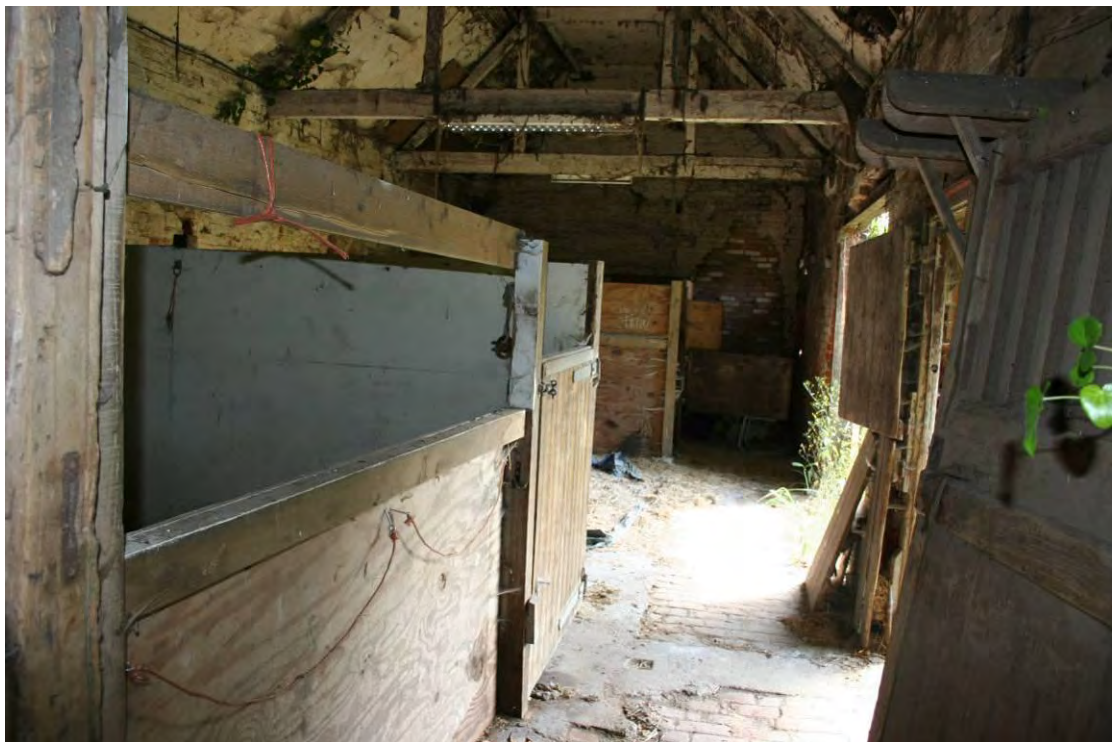
Looking E in the main stable.

The main stable has been divided into two stalls using LC20th machined posts and Sterling board. That to the east of the room has a homemade hay rack of roughly cut timber and metal tubes. The western wall is lined with decaying kick boards nailed to battens fixed to wooden wedges inserted into the brickwork and these are likely to be original.

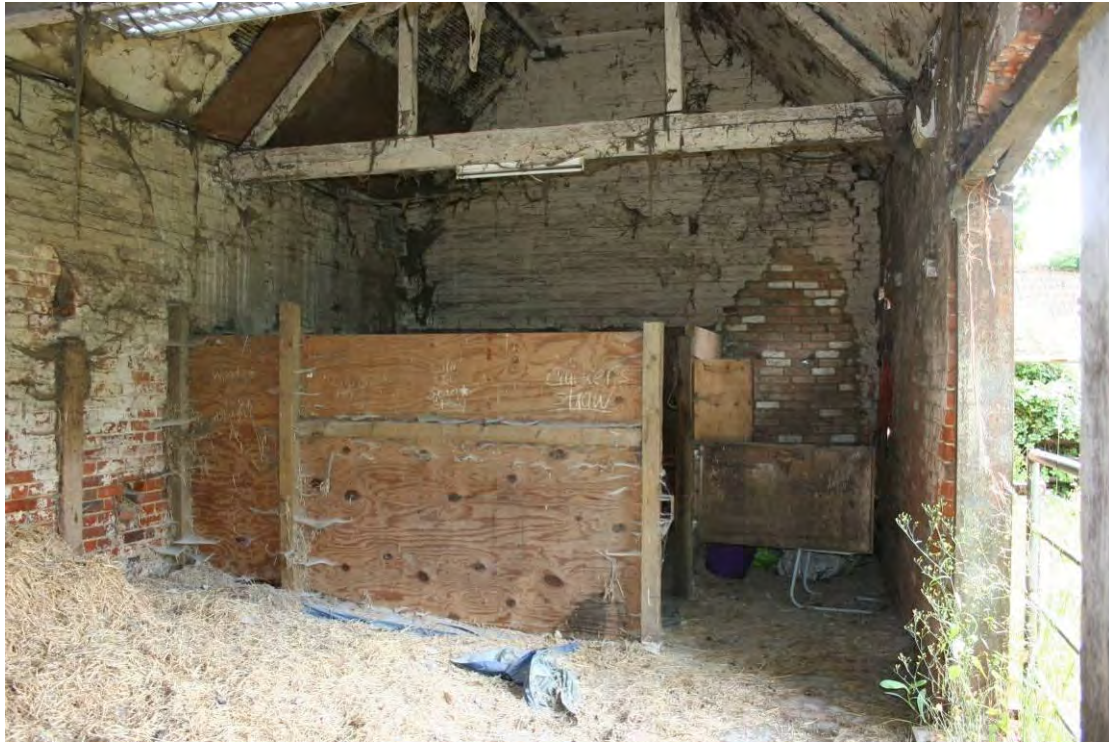
The stalls are made from LC20th materials.

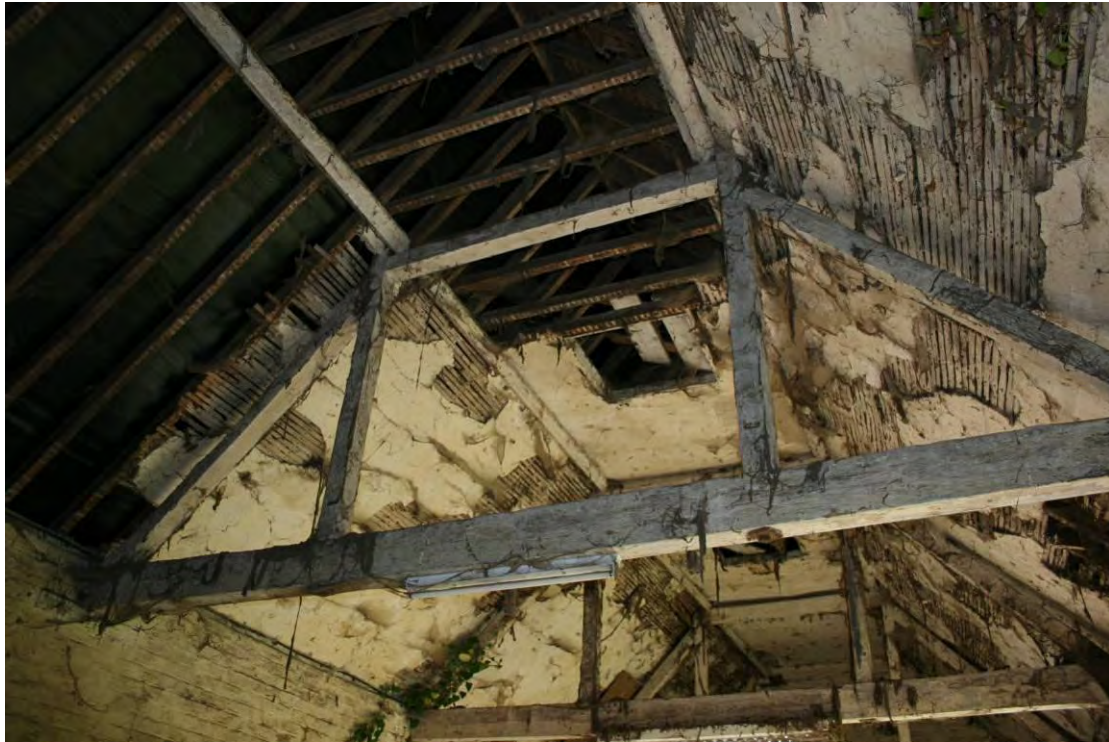
Detail of the roof structure. Looking NE.

The roof is of the same design as that of the Brick Barn. It has the added refinement of a lath and plaster ceiling to improve the insulation for the horses within.

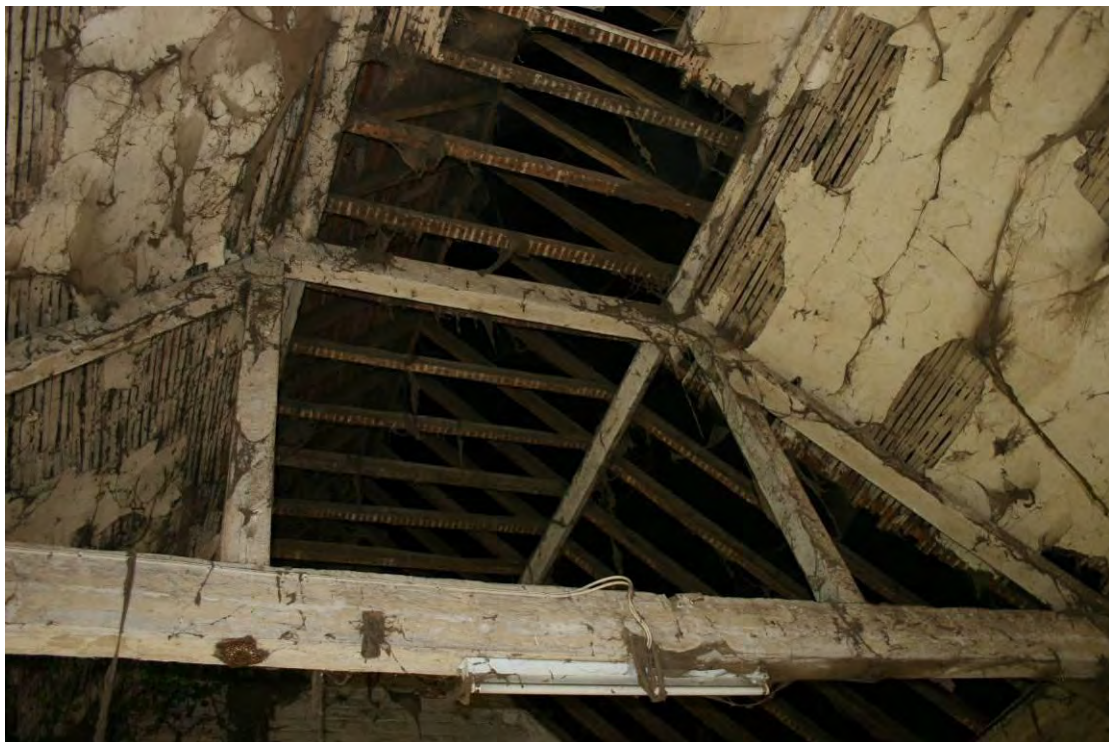
The roof is lath and plastered for insulation. Looking W.

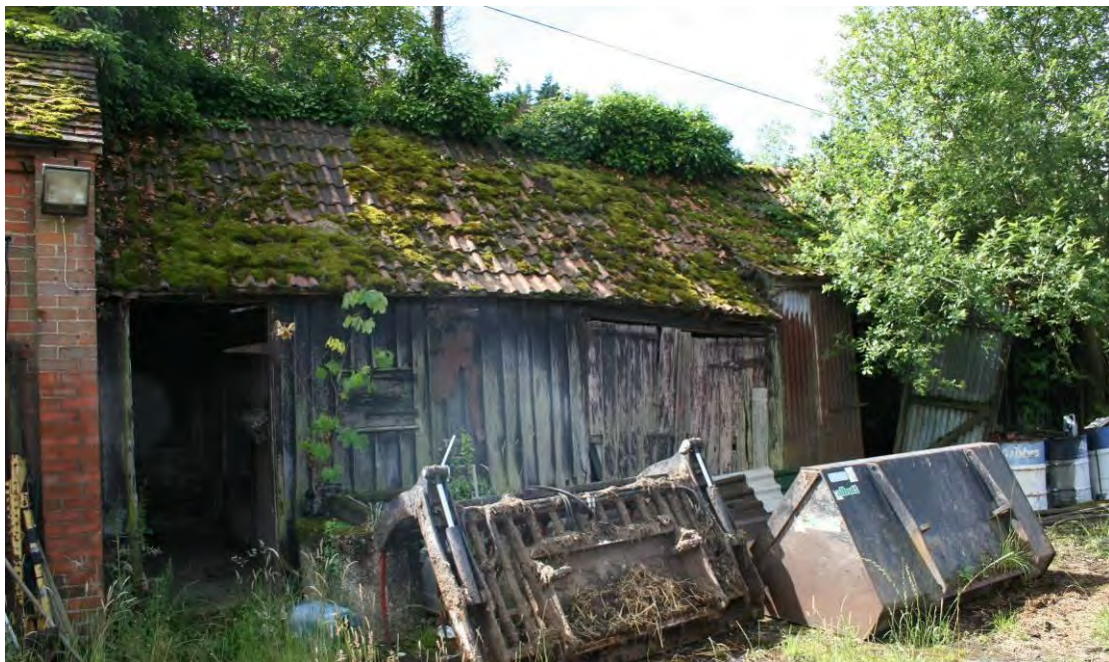
Detail of the exterior of the Tack Room and Garage Workshop.

The piecemeal building is clad in a variety of C20th finishes including vertical weatherboards, corrugated iron sheets, tongue and grooved timber and plywood. The frame is made of machine sawn soft wood with primary bracing and nailed interrupted studwork characteristic of the end of the C19th. The roof is clad with MC20th double roman tiles. The building is divided into an entrance corridor that leads through to the horse stalls and a small Tack Room. There is a large garage workshop with two pairs of mismatched garage doors. At the western end is a car garage that faces the garden and is now blocked off by a fence. The northern elevation is consumed by foliage and inaccessible.

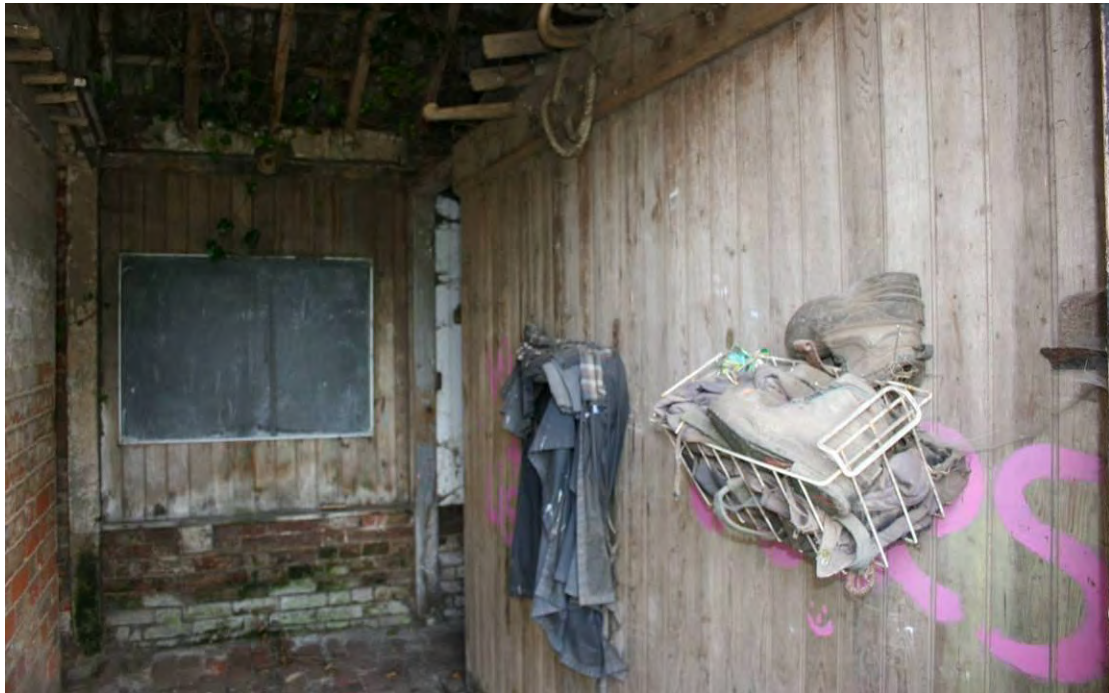
Entrance corridor with tongue and grooved boarded walls. Note the harness pegs.

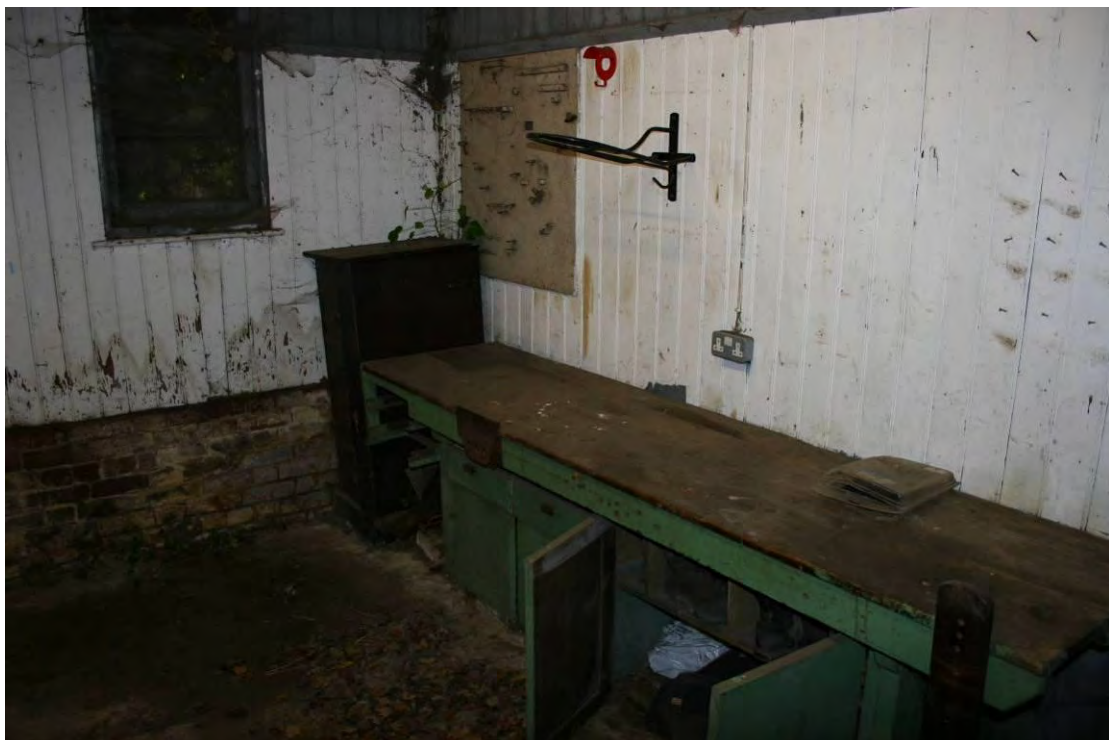
The Tack Room with work bench. Looking SW.

The Tack Room is lined with EC20th tongue and grooved boards and there is an EC20th workbench with woodwork and leatherwork vices and a wall mounted tool board.

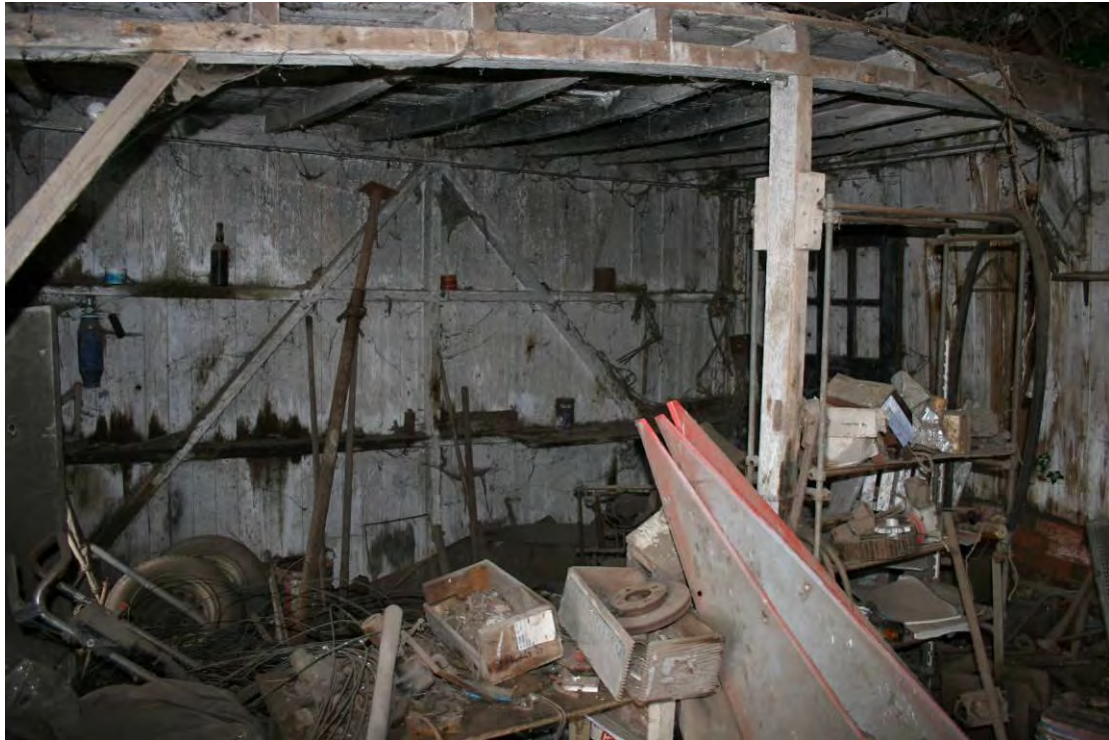
Looking W in the Garage Workshop. The partition is common with the Tack Room.

The Garage Workshop displays the machine cut softwood studwork of the frame and the rafters which are supported on raking struts to the side purlins. The tie-beams are very old but reused. An EC20th timber platform supports a large cylindrical tank.

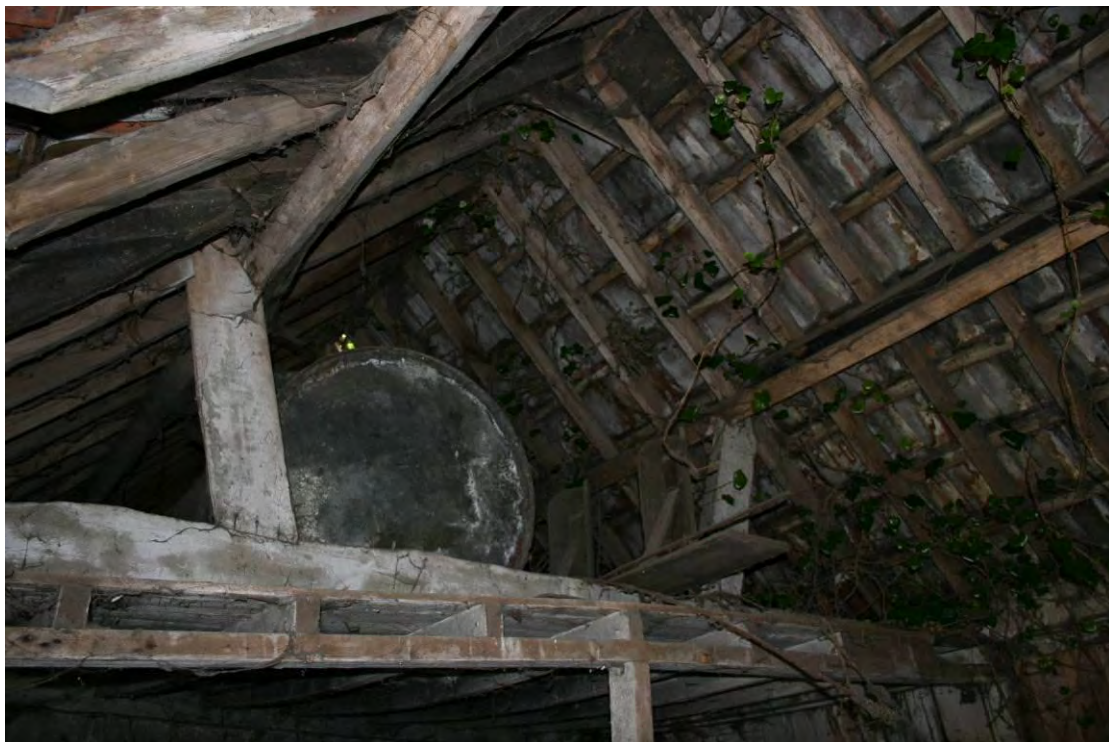
The roof of the Garage Workshop.

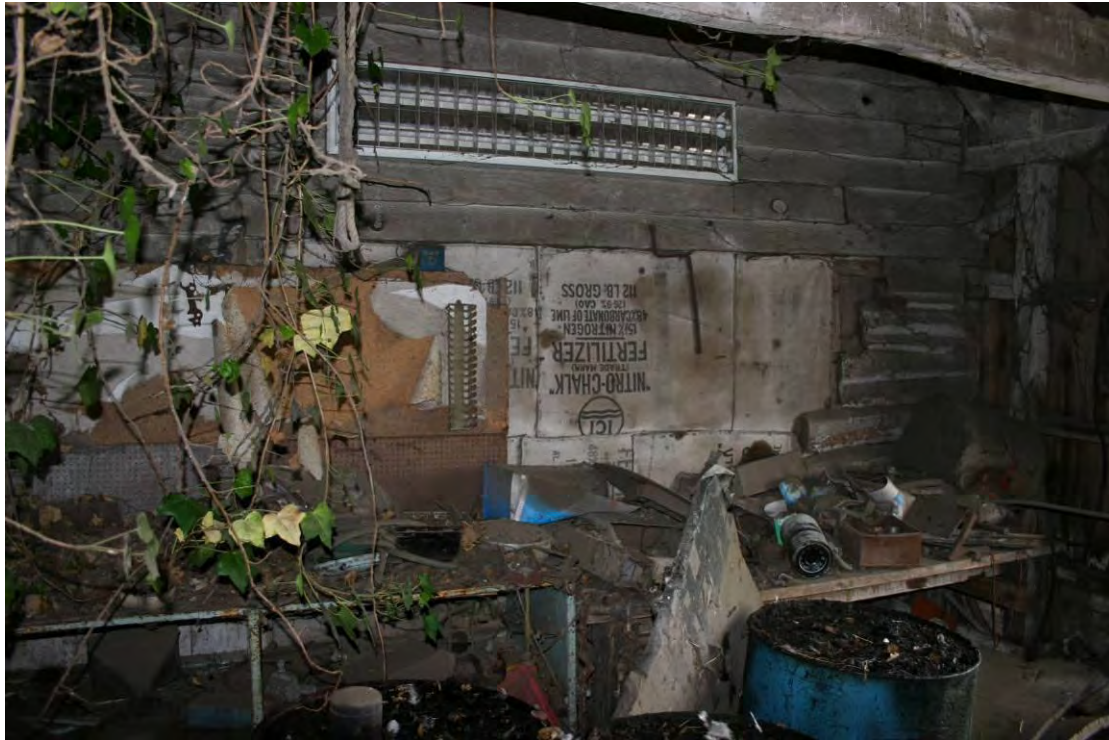
The southern wall has an interesting collage of cladding materials.

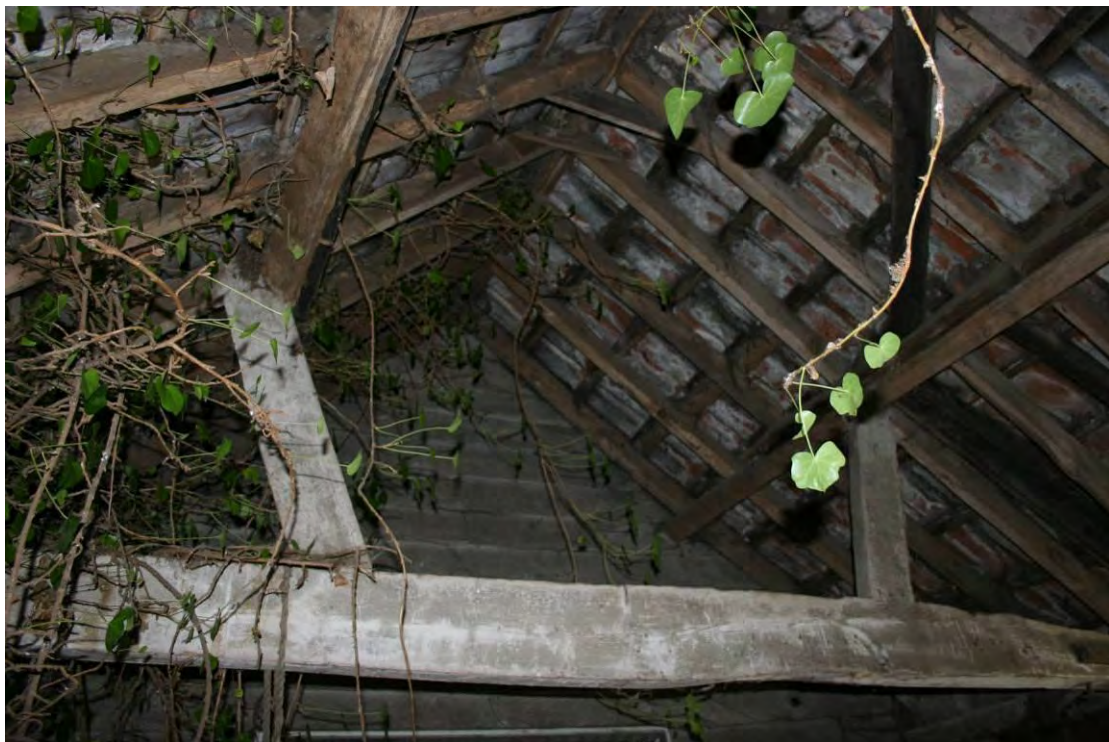
Looking E in the roof of the Garage Workshop.

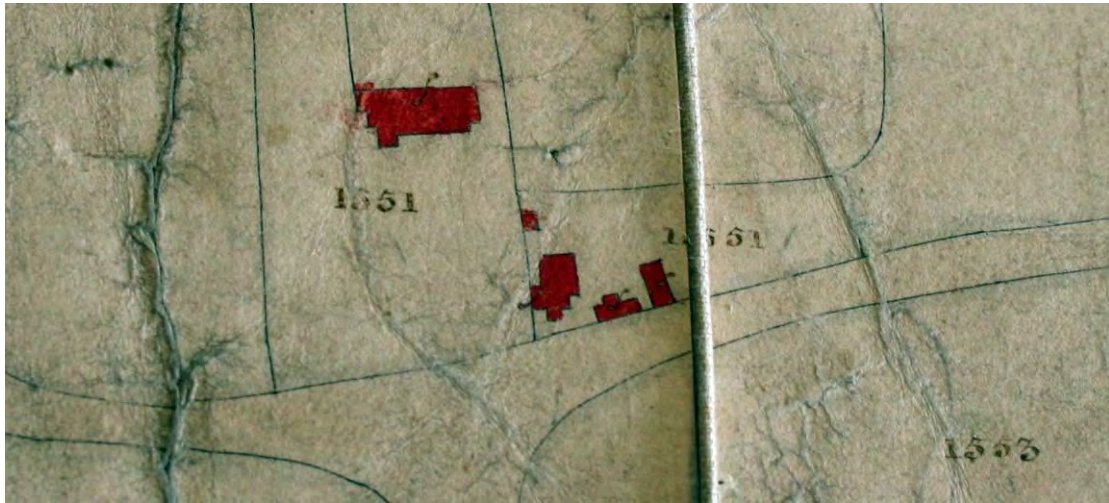
**1838 Tithe Award Map for Wokingham. BRO D/P 154/27B.**

The Tithe Award Map of 1838 shows only the House and the Timber-framed Barn in their current positions. By proportion the Barn is shown shorter than now.

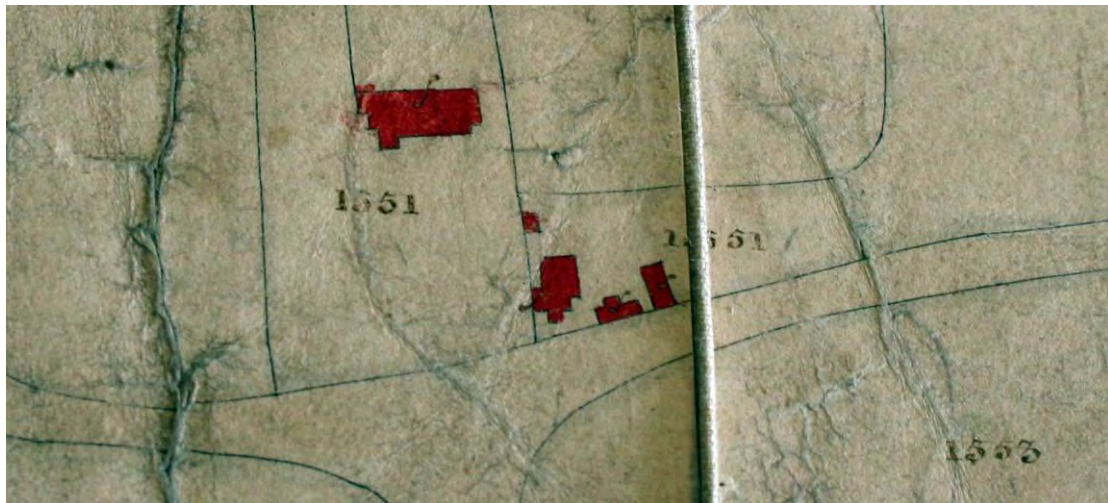
1838 Tithe Award Map for Wokingham. BRO D/P 154/27B.

The Tithe Award of 1838 shows the House, the Timber-framed Barn and a third building (no longer in place) forming the farmstead. To the north is a very large building which disappears by the time of the 1876 Ordnance Survey. The House (which is not part of this study) is Listed as late C16th and extended in the C19th which would account for its asymmetric plan.

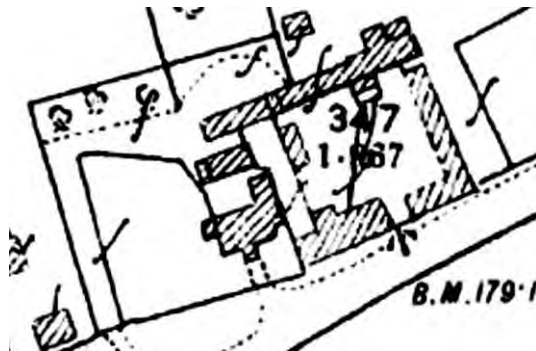
1899 Ordnance Survey Map.

In the farmyard there is a small unit with a pen which is in the position of the present bull pen. The Timber Stables are shown added to the western end of the Brick Stables and again are made of machine sawn softwood concurrent with the period.

The small shelter added to the NE side of the Brick Barn is shown in place but the present one is a C20th replacement.

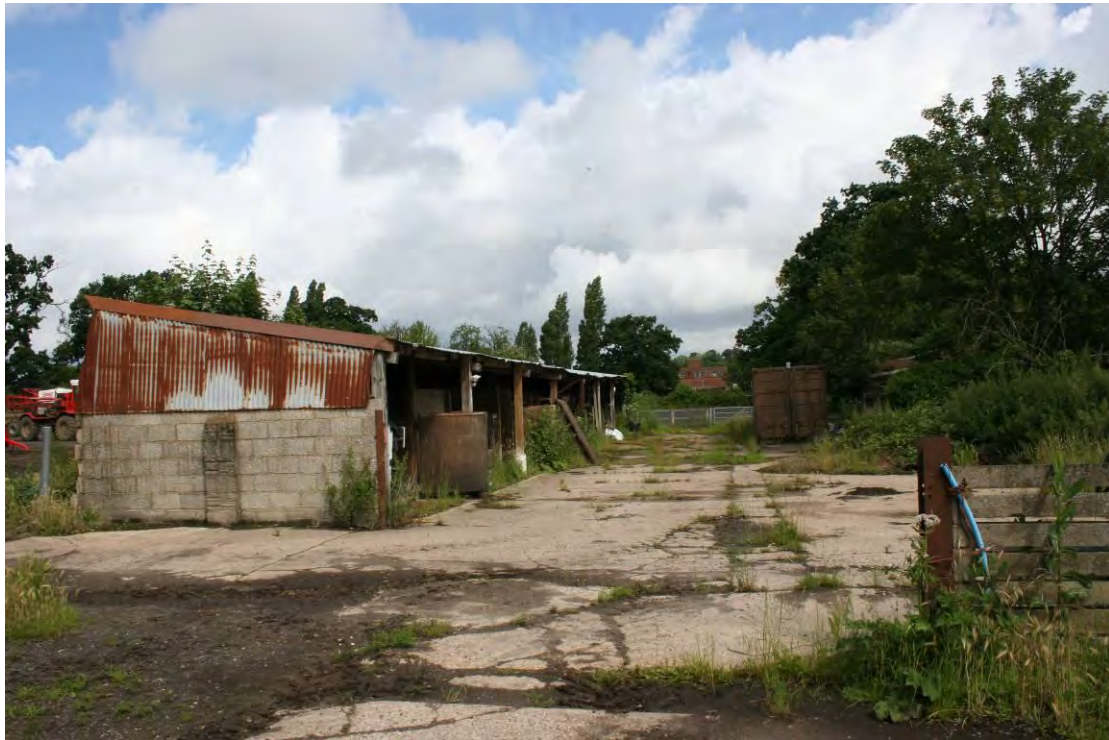
Cow Byre to the NE of the site. One remaining of two built. Looking NE.

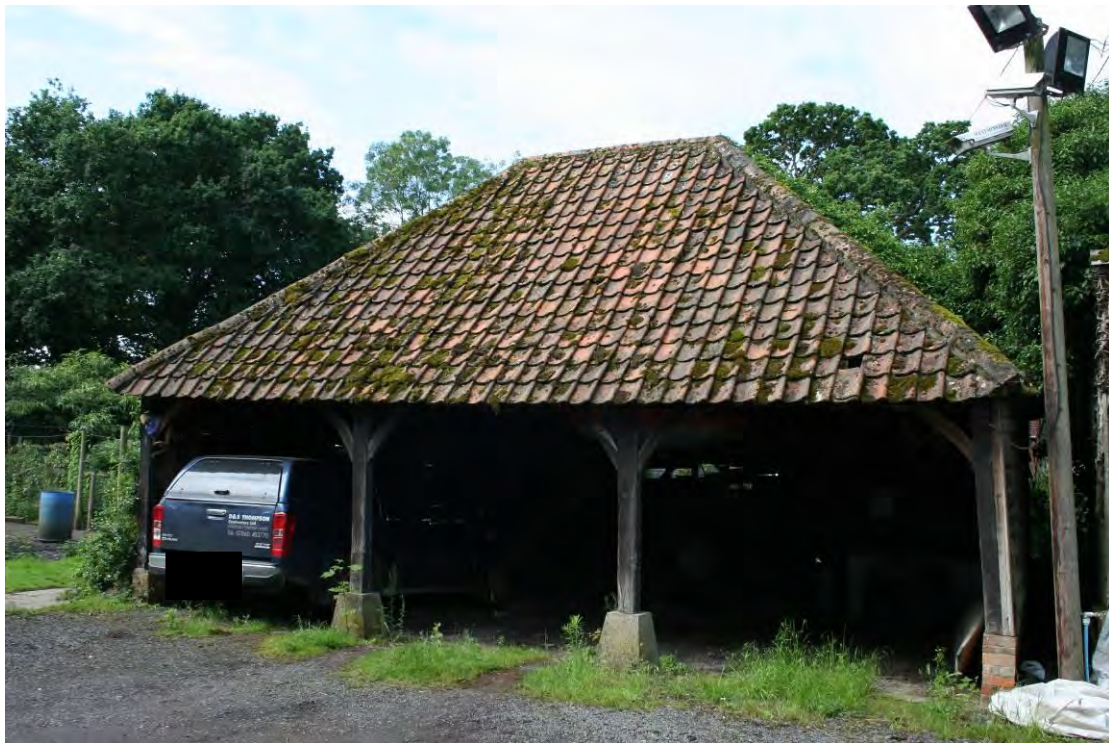
Shelter rebuilt in the 1960's. West of the farmyard. Looking W.

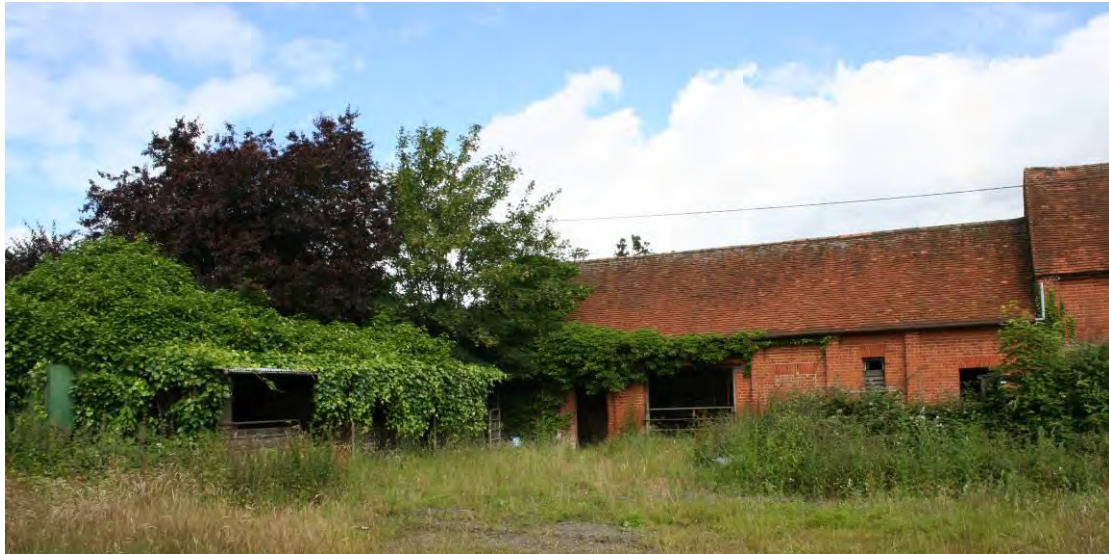
LC20th cow byre to the west of the farmyard. Looking NW.
