**Phase I Desk Study**

**Geotechnical and Geo-Environmental Report**

**Land Adj. Park Lane**

**Report No: 25-07-12**

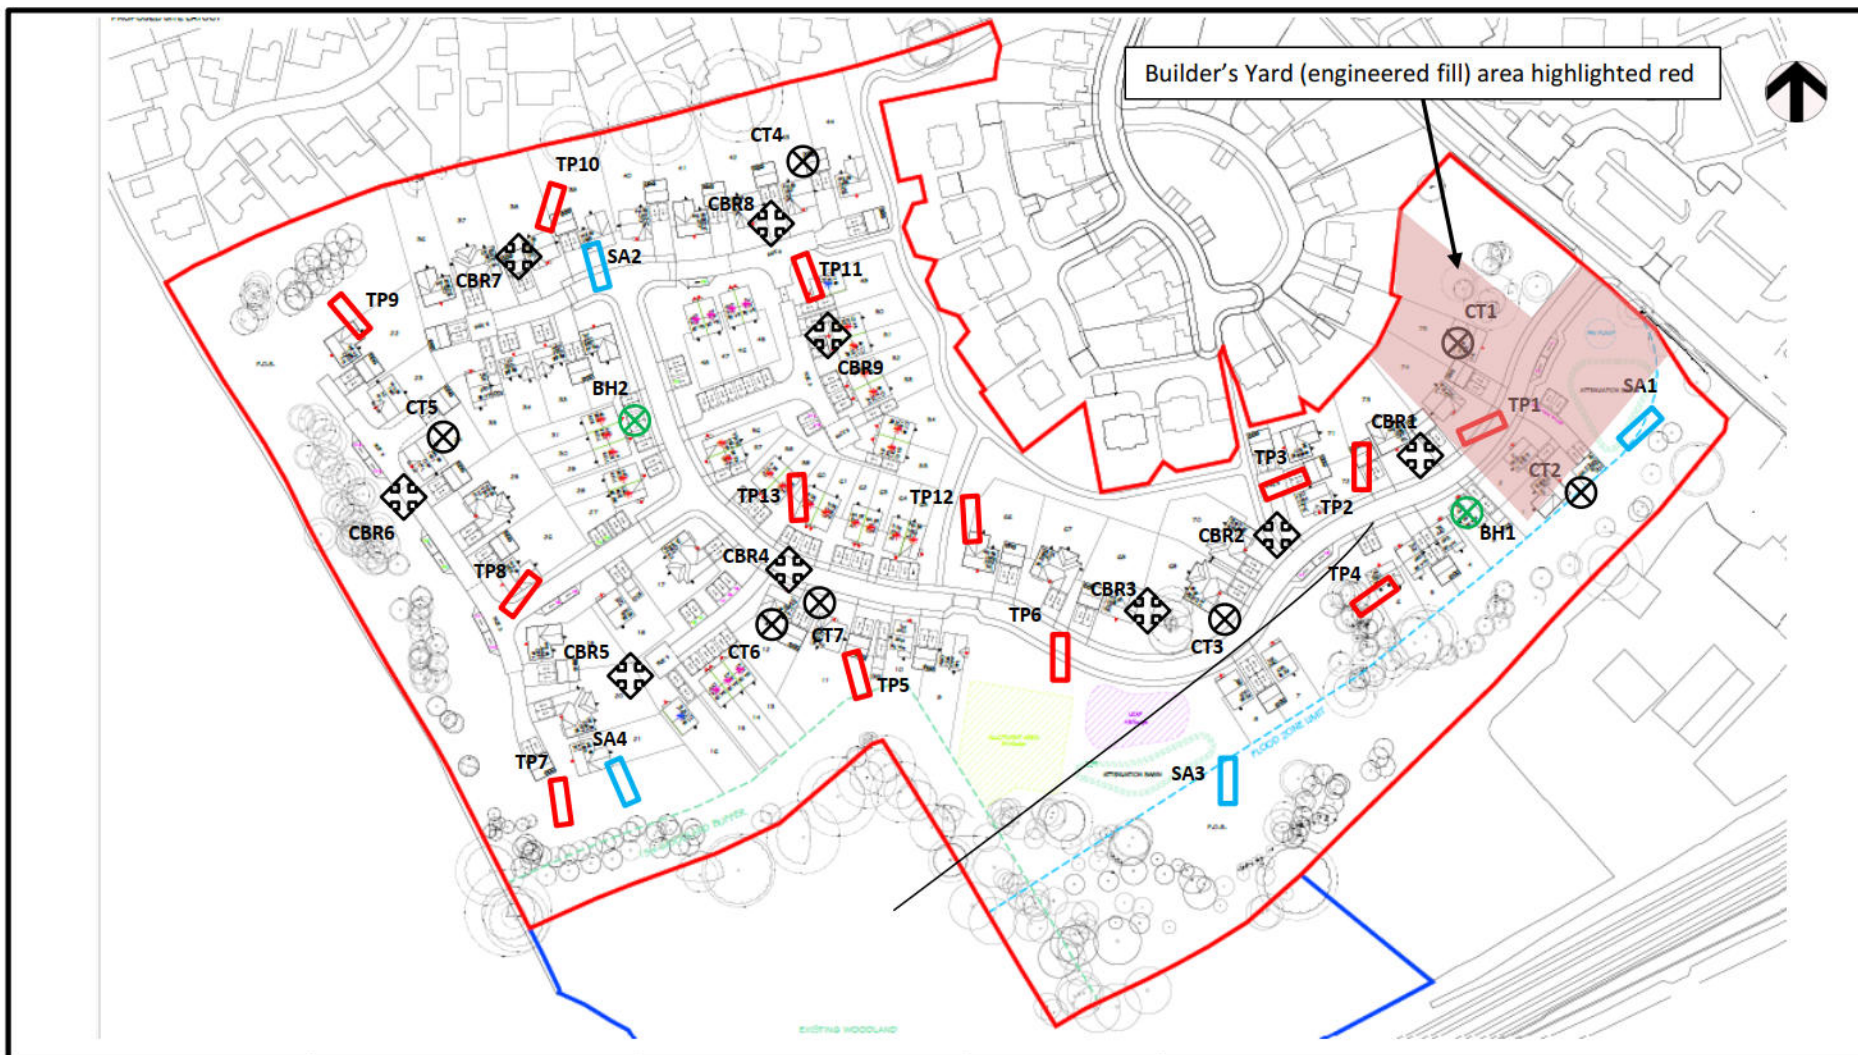
| <b>Key</b><br>Trial Pit<br>Continuous Tube Borehole<br>Soakaway Pit<br>CBR Test<br>Cable Percussive BH | <b>Exploratory Hole Location Plan</b> | <b>SITE:- Park Lane, Charvil</b> | <b>Drawn EM</b> | <br><b>INTEGRITY</b> |

TP9 also recorded evidence of desiccated soils. CT5 to the south also recorded cohesive soils however these displayed no significant evidence of desiccation and the soils within TP10 were found to be entirely granular therefore the zone of desiccation can be zoned to the north-west corner. Further investigation should be undertaken to prove the zone of desiccation.

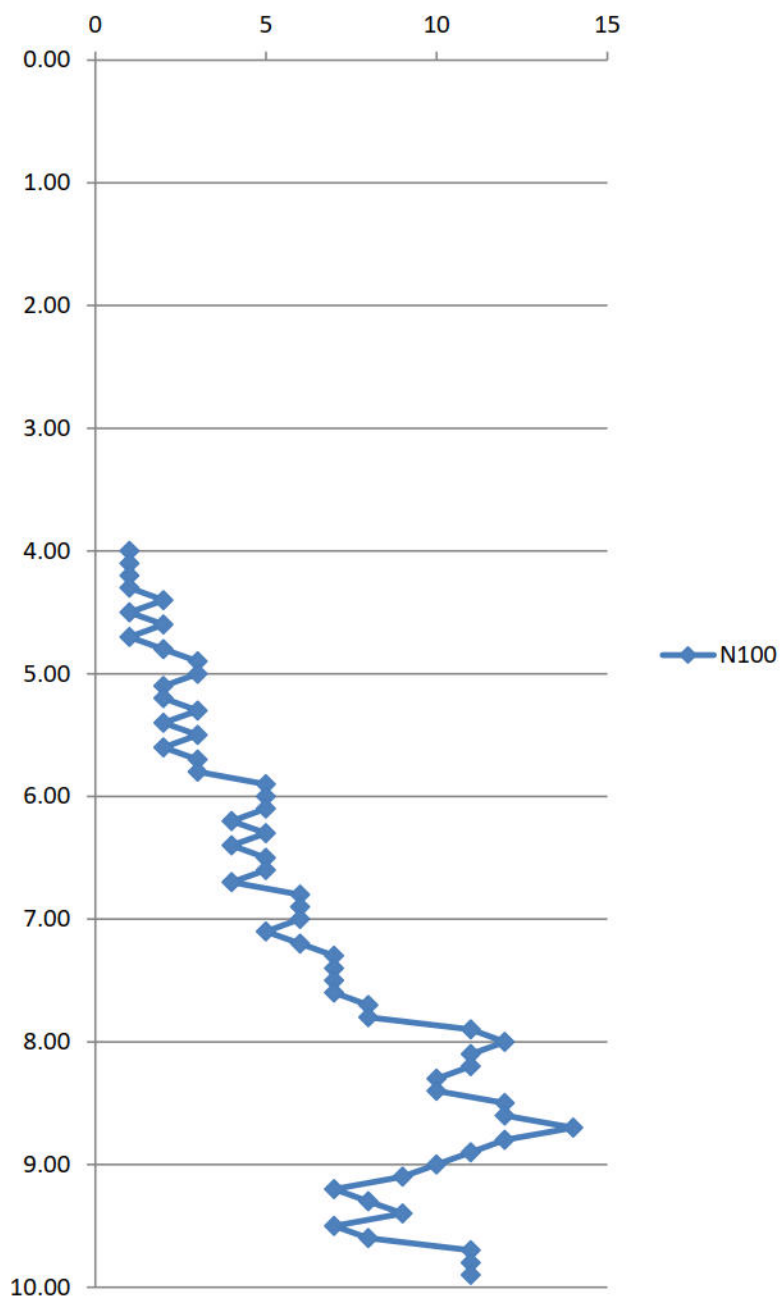
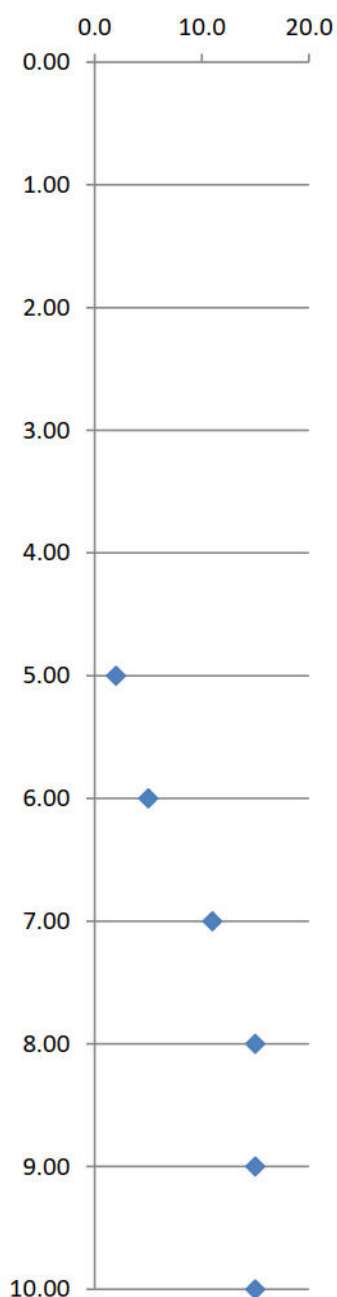
EASTINGS 477661.6  
NORTHINGS 175236.0  
HAMMER WEIGHT 63.5KG  
HAMMER DROP 0.76m

## N100

## Torque

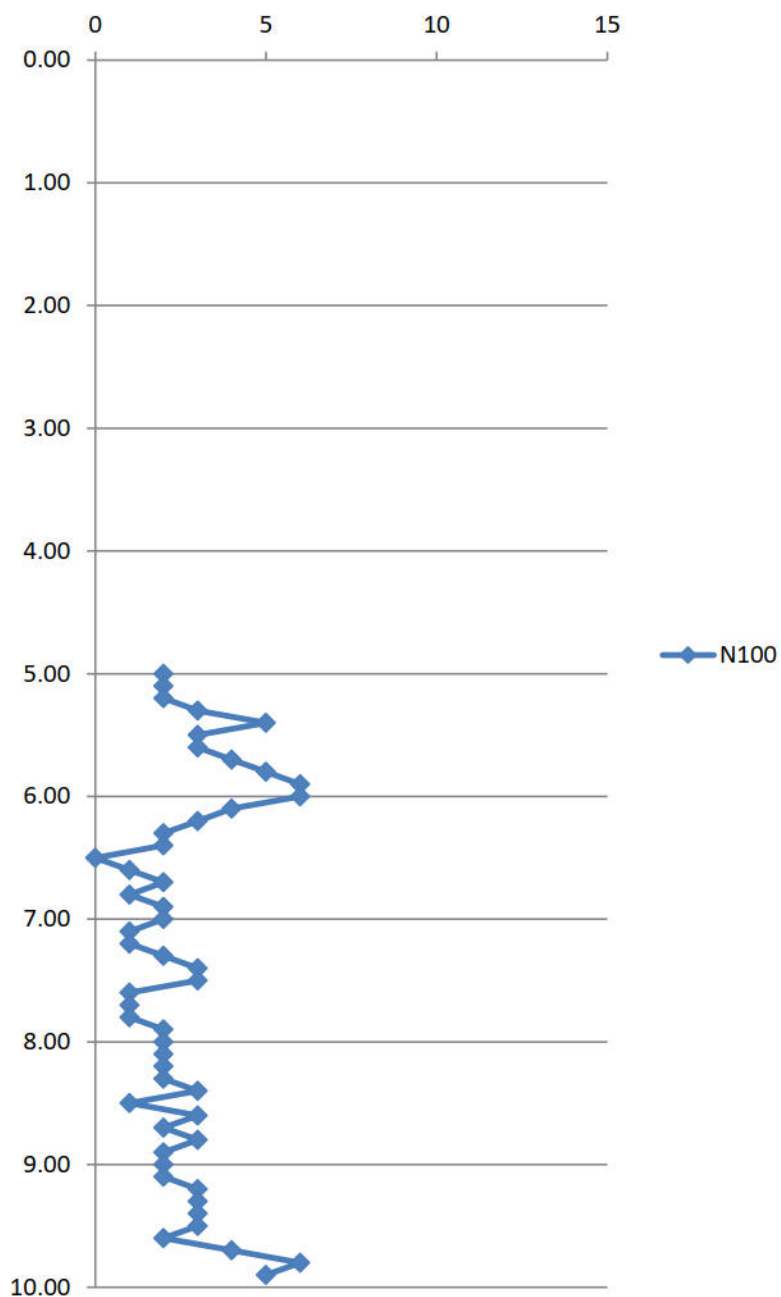
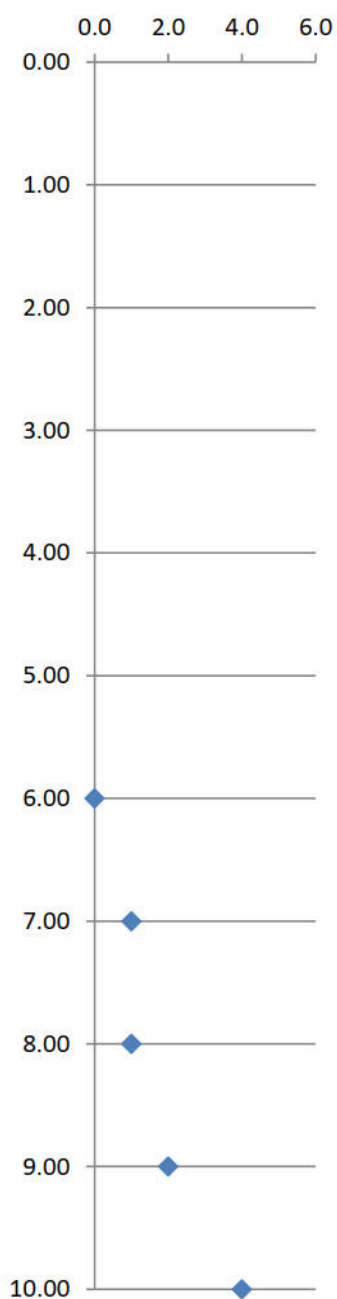
## SUPER HEAVY DYNAMIC PROBE - P2 (CT2)

EASTINGS 477690.7  
NORTHINGS 175194.8  
HAMMER WEIGHT 63.5KG  
HAMMER DROP 0.76m

### N100

### Torque

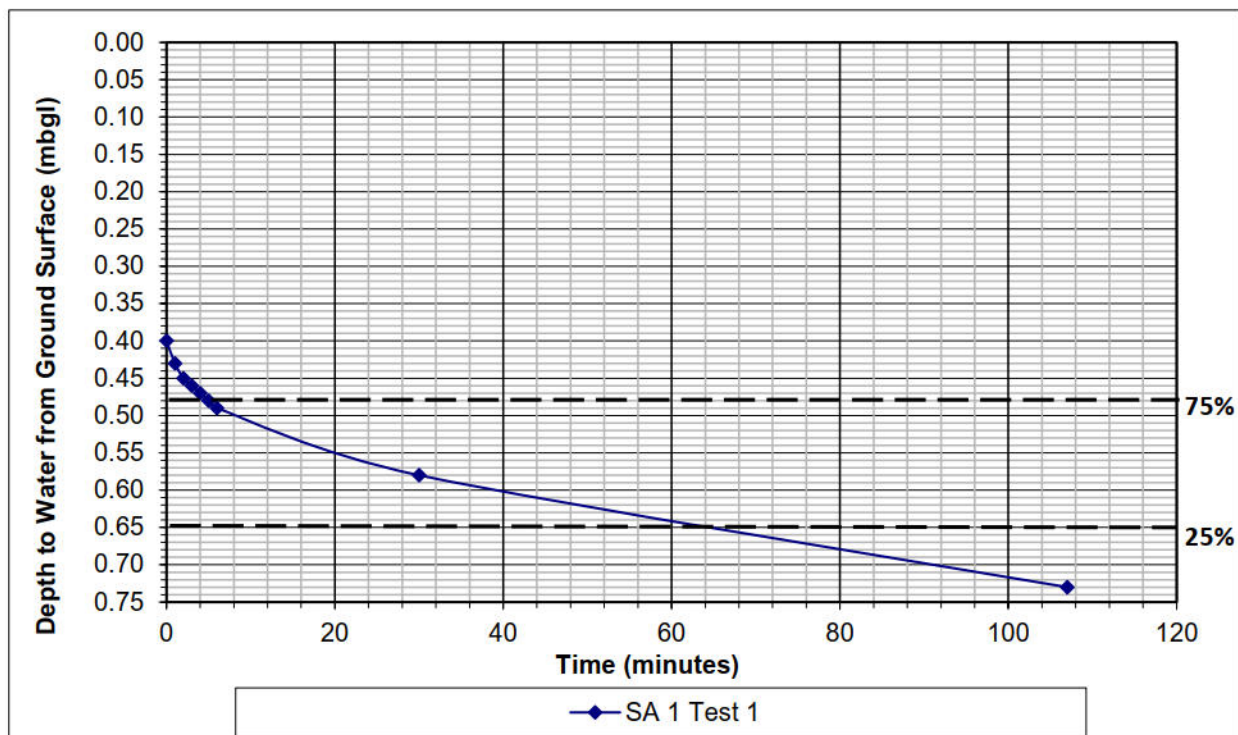
### Trial Pit Infiltration Testing to BRE Digest 365

Soil Infiltration Rate:  $2.44 \times 10^{-5}$  m/s

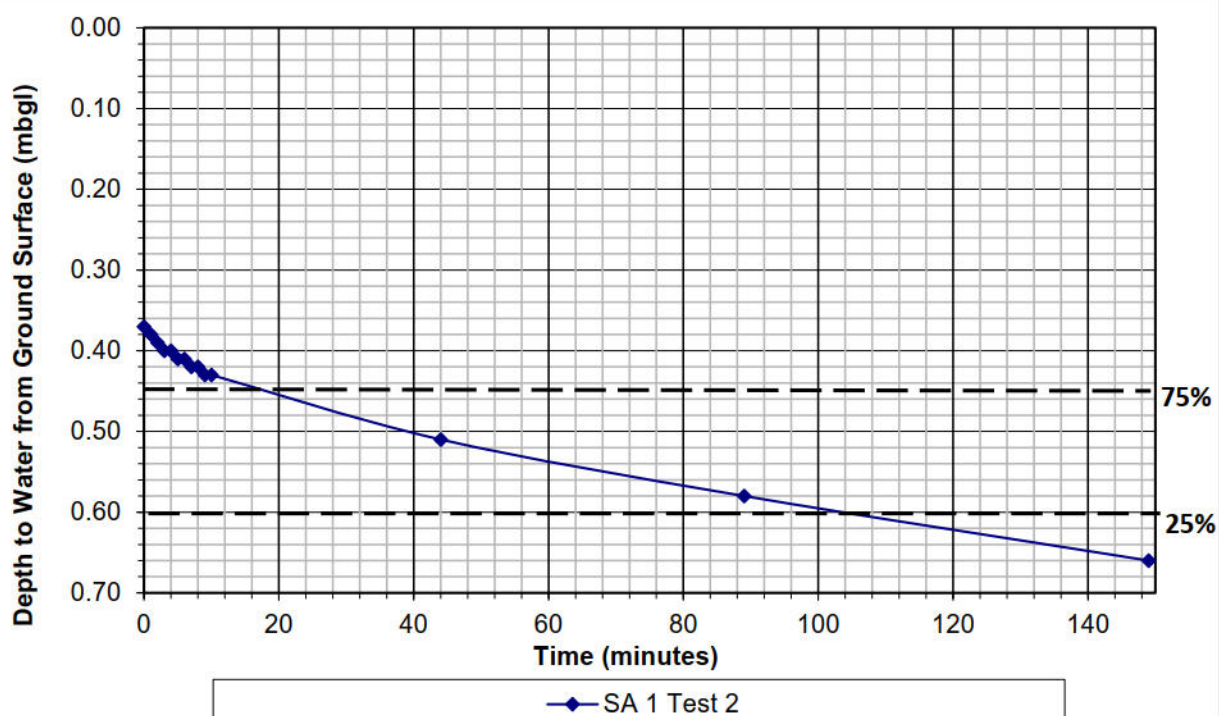
### Trial Pit Infiltration Testing to BRE Digest 365

**Client:** Bellway Thames  
**Site:** Park Lane, Charvil  
**Dimensions:** 0.50m x 1.50m x 0.68m  
(width x length x depth)

Soil Infiltration Rate:  $1.64 \times 10^{-5}$  m/s

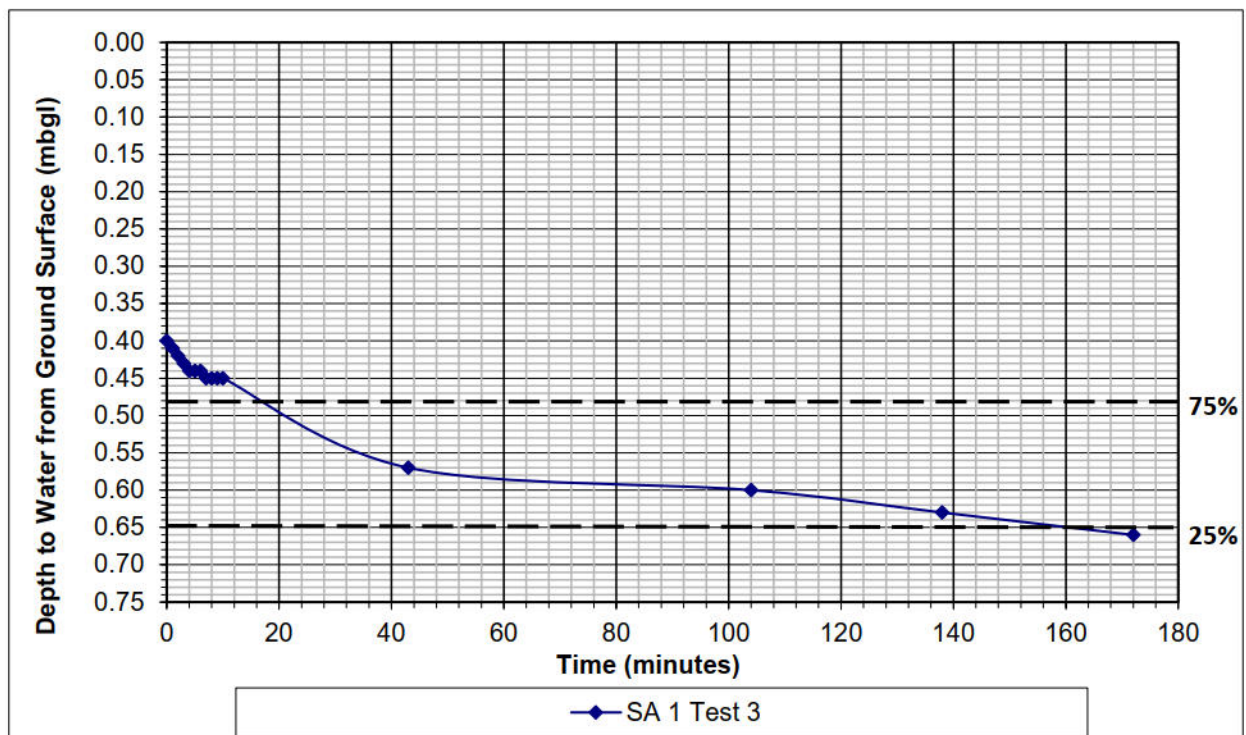
### Trial Pit Infiltration Testing to BRE Digest 365

**Client:** Bellway Thames  
**Site:** Park Lane, Charvil  
**Dimensions:** 0.50m x 1.50m x 0.73m  
 (width x length x depth)

Soil Infiltration Rate:  $9.88 \times 10^{-6}$  m/s

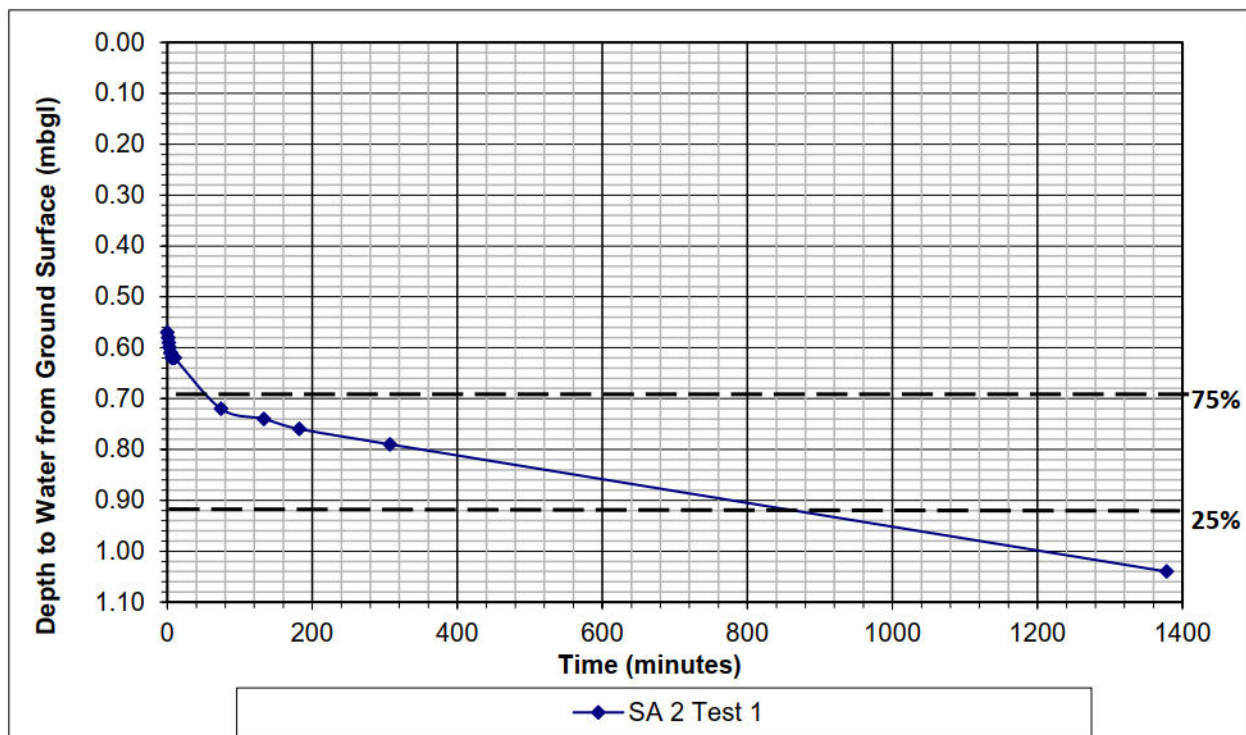
### Trial Pit Infiltration Testing to BRE Digest 365

**Client:** Bellway Thames  
**Site:** Park Lane, Charvil  
**Dimensions:** 0.50m x 1.50m x 1.04m  
(width x length x depth)

Soil Infiltration Rate:  $2.12 \times 10^{-6}$  m/s

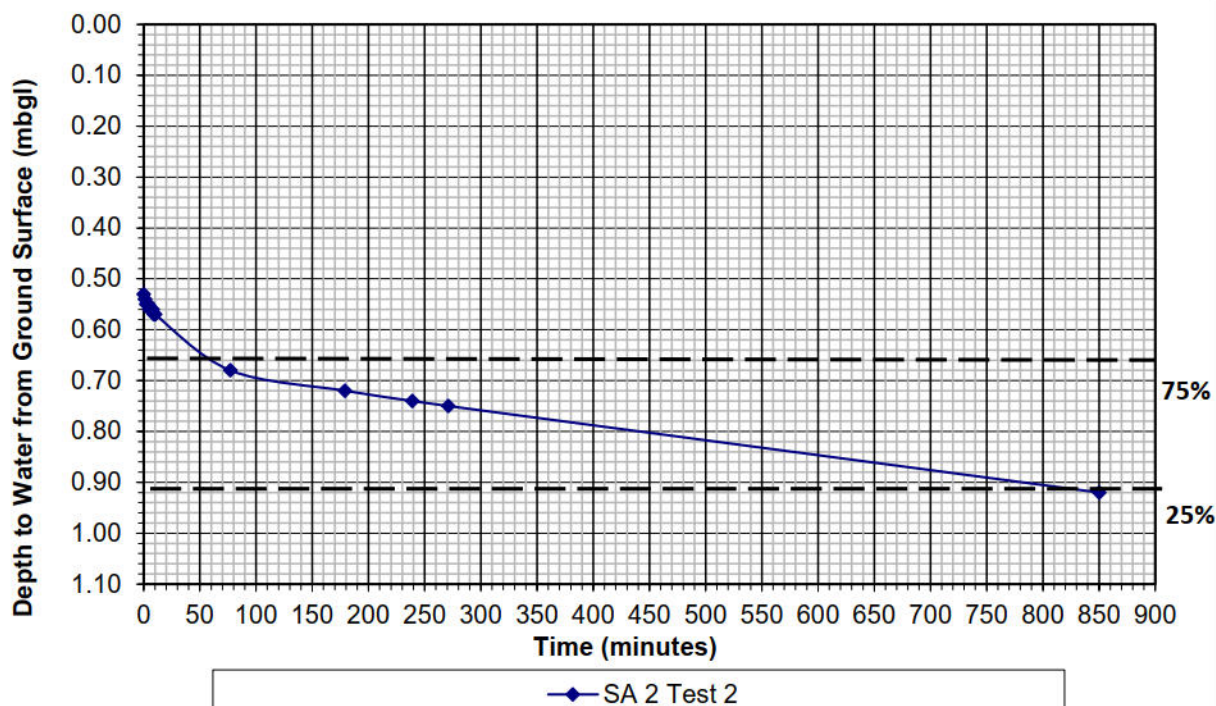
### Trial Pit Infiltration Testing to BRE Digest 365

**Client:** Bellway Thames  
**Site:** Park Lane, Charvil  
**Dimensions:** 0.50m x 1.50m x 1.04m  
(width x length x depth)

Soil Infiltration Rate:  $2.37 \times 10^{-5}$  m/s

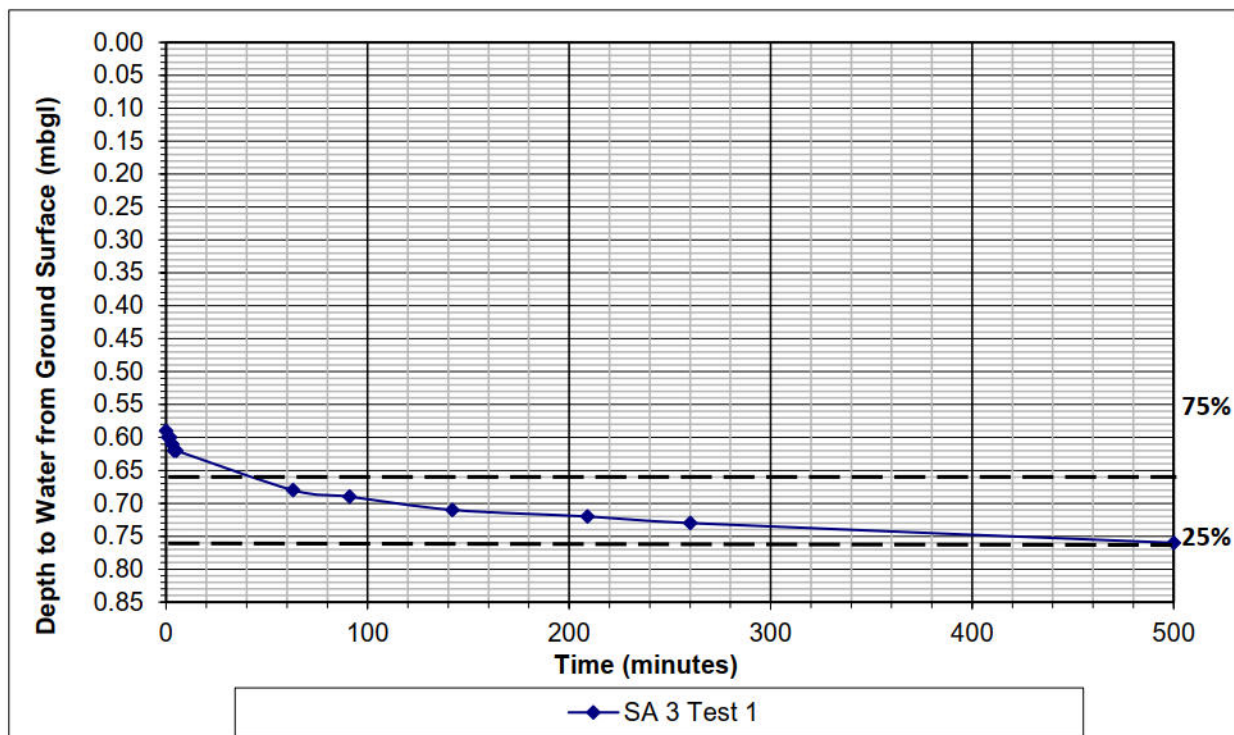
### Trial Pit Infiltration Testing to BRE Digest 365

**Client:** Bellway Thames  
**Site:** Park Lane, Charvil  
**Dimensions:** 0.50m x 1.45m x 0.85m  
 (width x length x depth)

Soil Infiltration Rate:  $2.77 \times 10^{-6}$  m/s

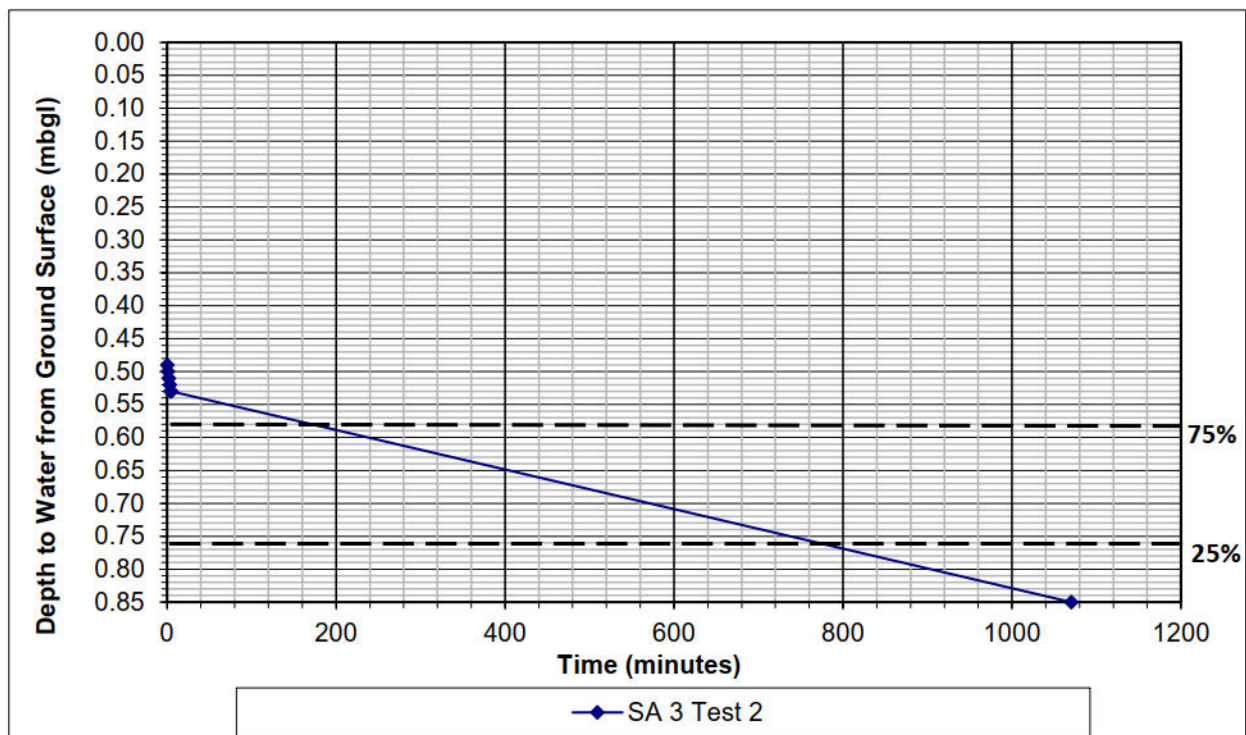
### Trial Pit Infiltration Testing to BRE Digest 365

**Client:** Bellway Thames  
**Site:** Park Lane, Charvil  
**Dimensions:** 0.50m x 1.45m x 0.85m  
 (width x length x depth)

Soil Infiltration Rate:  $2.58 \times 10^{-6}$  m/s

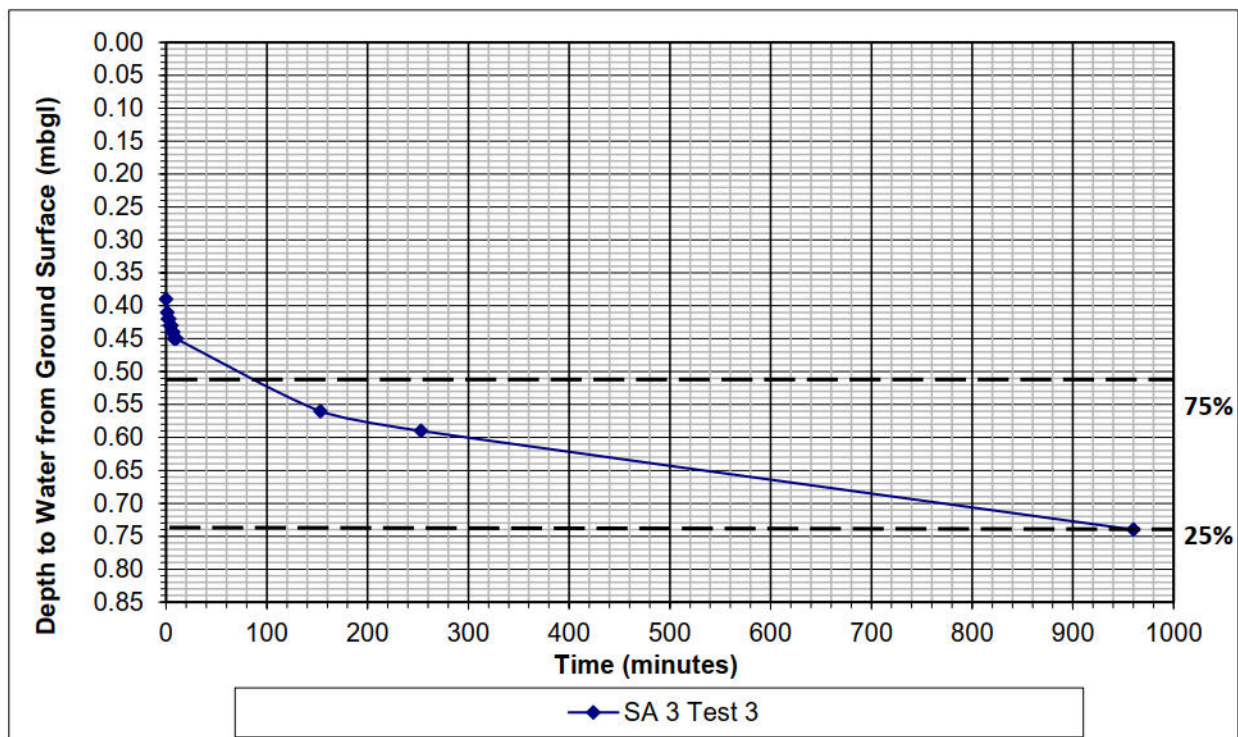
## **Trial Pit Infiltration Testing to BRE Digest 365**

**Client:** Bellway Thames  
**Site:** Park Lane, Charvil  
**Dimensions:** 0.50m x 1.45m x 0.85m  
(width x length x depth)

**Soil Infiltration Rate:  $1.97 \times 10^{-6}$  m/s**

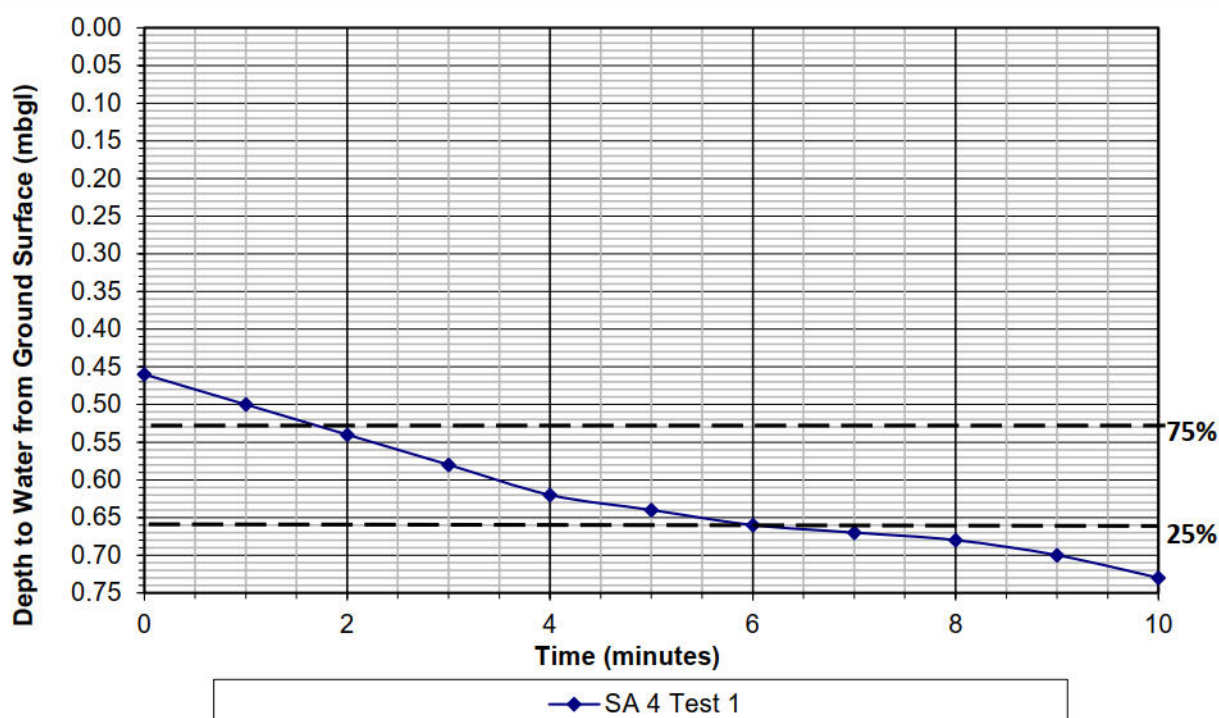
### Trial Pit Infiltration Testing to BRE Digest 365

**Client:** Bellway Thames  
**Site:** Park Lane, Charvil  
**Dimensions:** 0.50m x 1.30m x 0.73m  
(width x length x depth)

Soil Infiltration Rate:  $3.03 \times 10^{-4}$  m/s

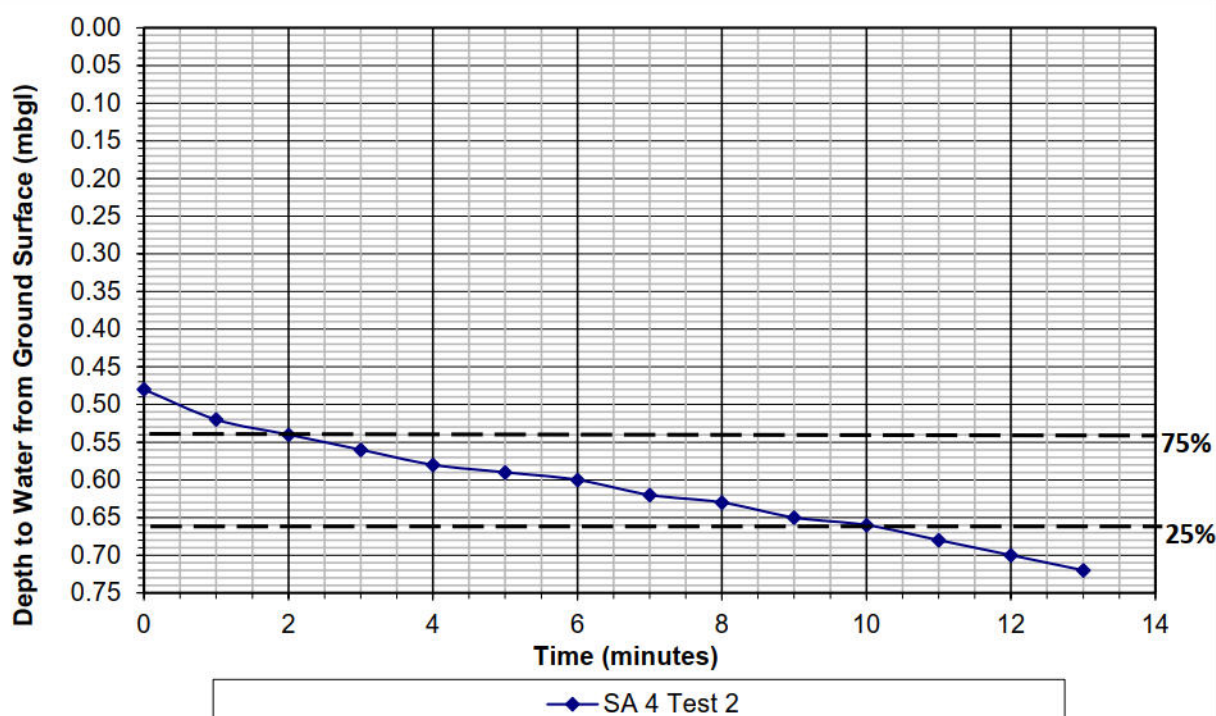
### Trial Pit Infiltration Testing to BRE Digest 365

**Client:** Bellway Thames  
**Site:** Park Lane, Charvil  
**Dimensions:** 0.50m x 1.30m x 0.72m  
(width x length x depth)

Soil Infiltration Rate:  $1.50 \times 10^{-4}$  m/s

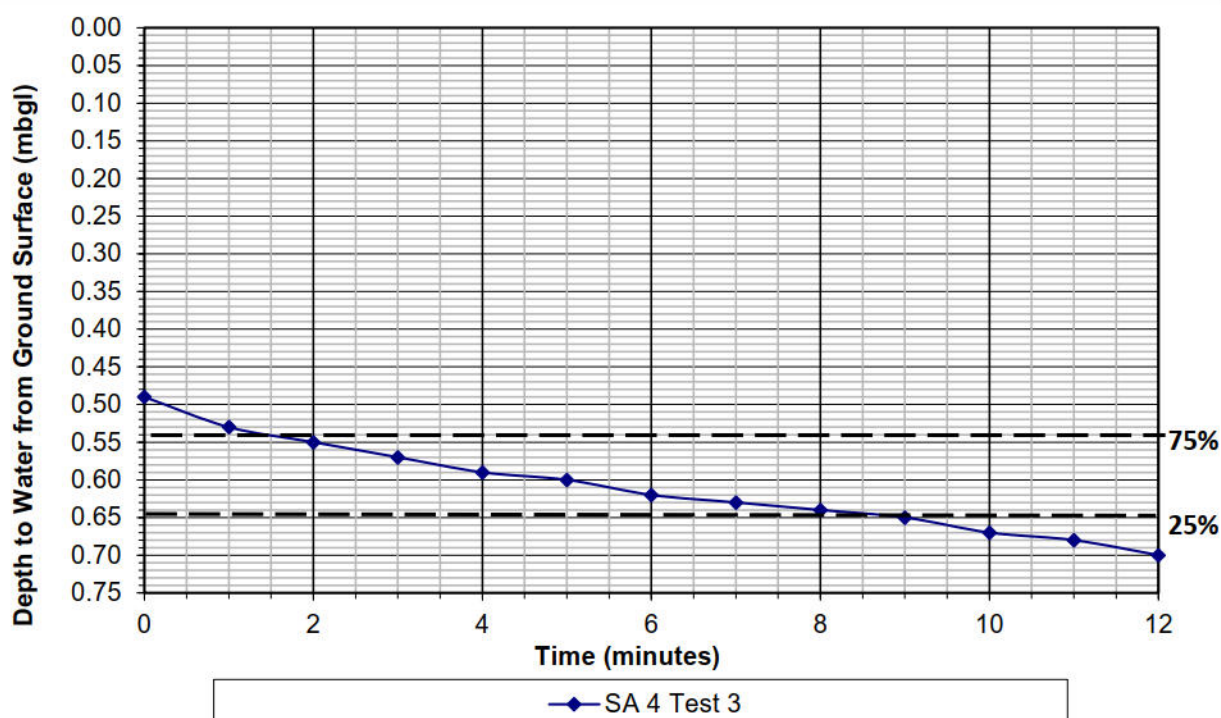
### Trial Pit Infiltration Testing to BRE Digest 365

**Client:** Bellway Thames  
**Site:** Park Lane, Charvil  
**Dimensions:** 0.50m x 1.30m x 0.70m  
 (width x length x depth)

Soil Infiltration Rate:  $1.48 \times 10^{-4}$  m/s

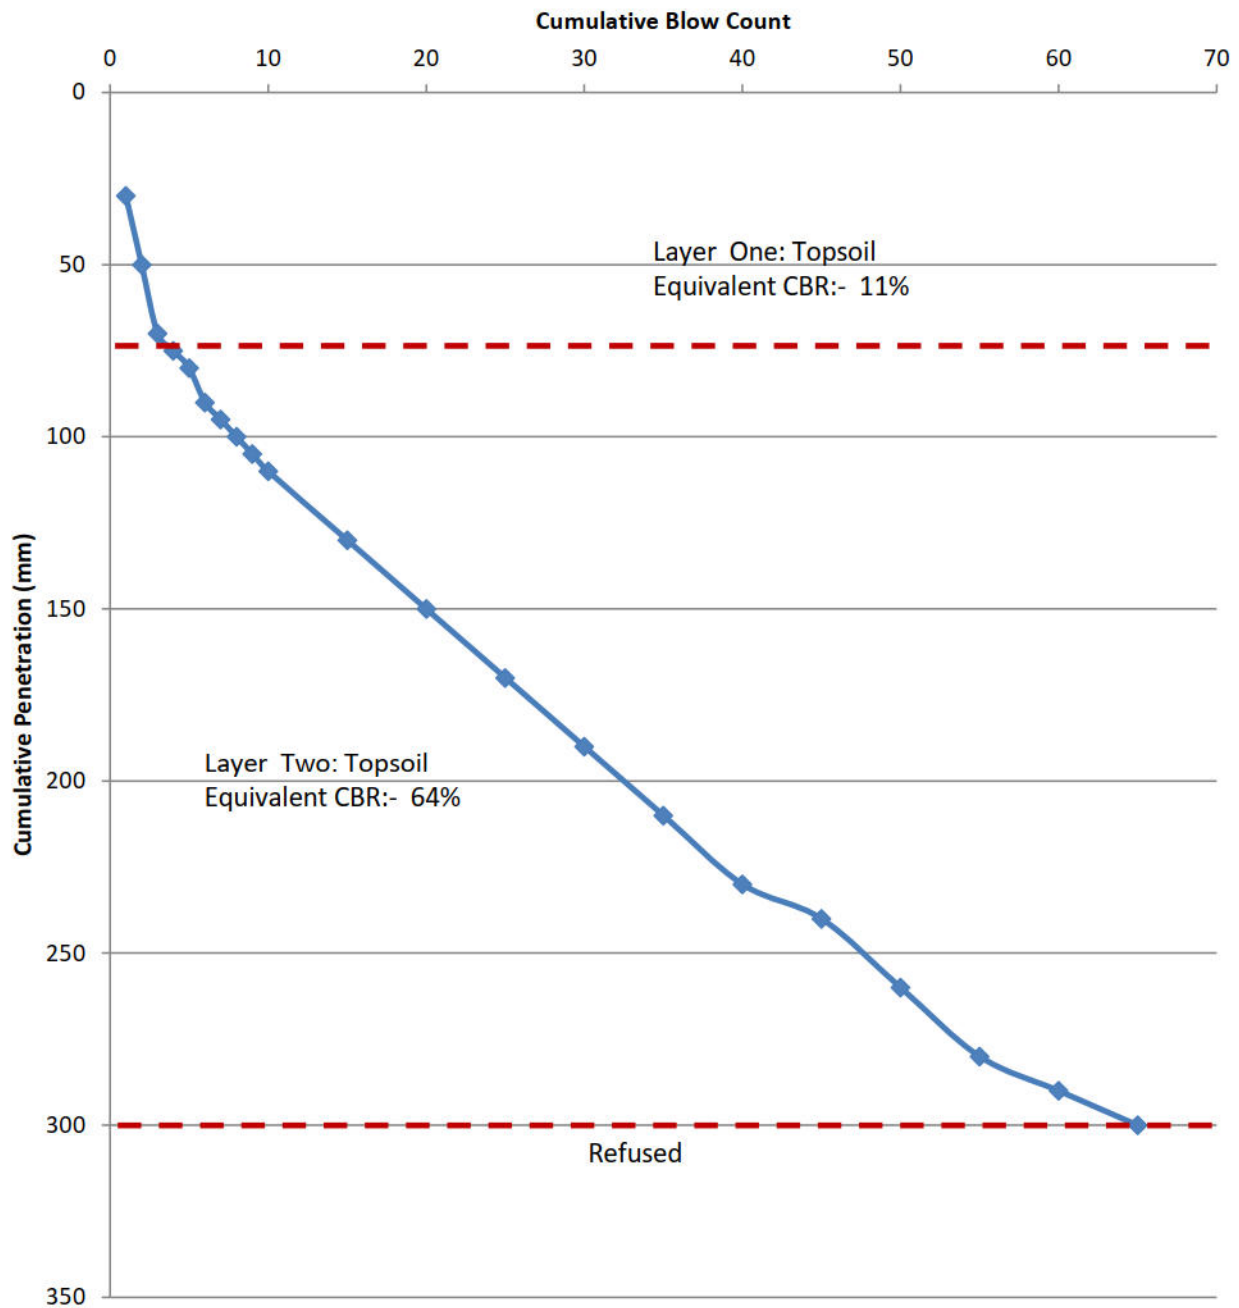
## TRL DYNAMIC CONE PENETROMETER RECORD

### Cumulative Blows Vs Penetration (mm)

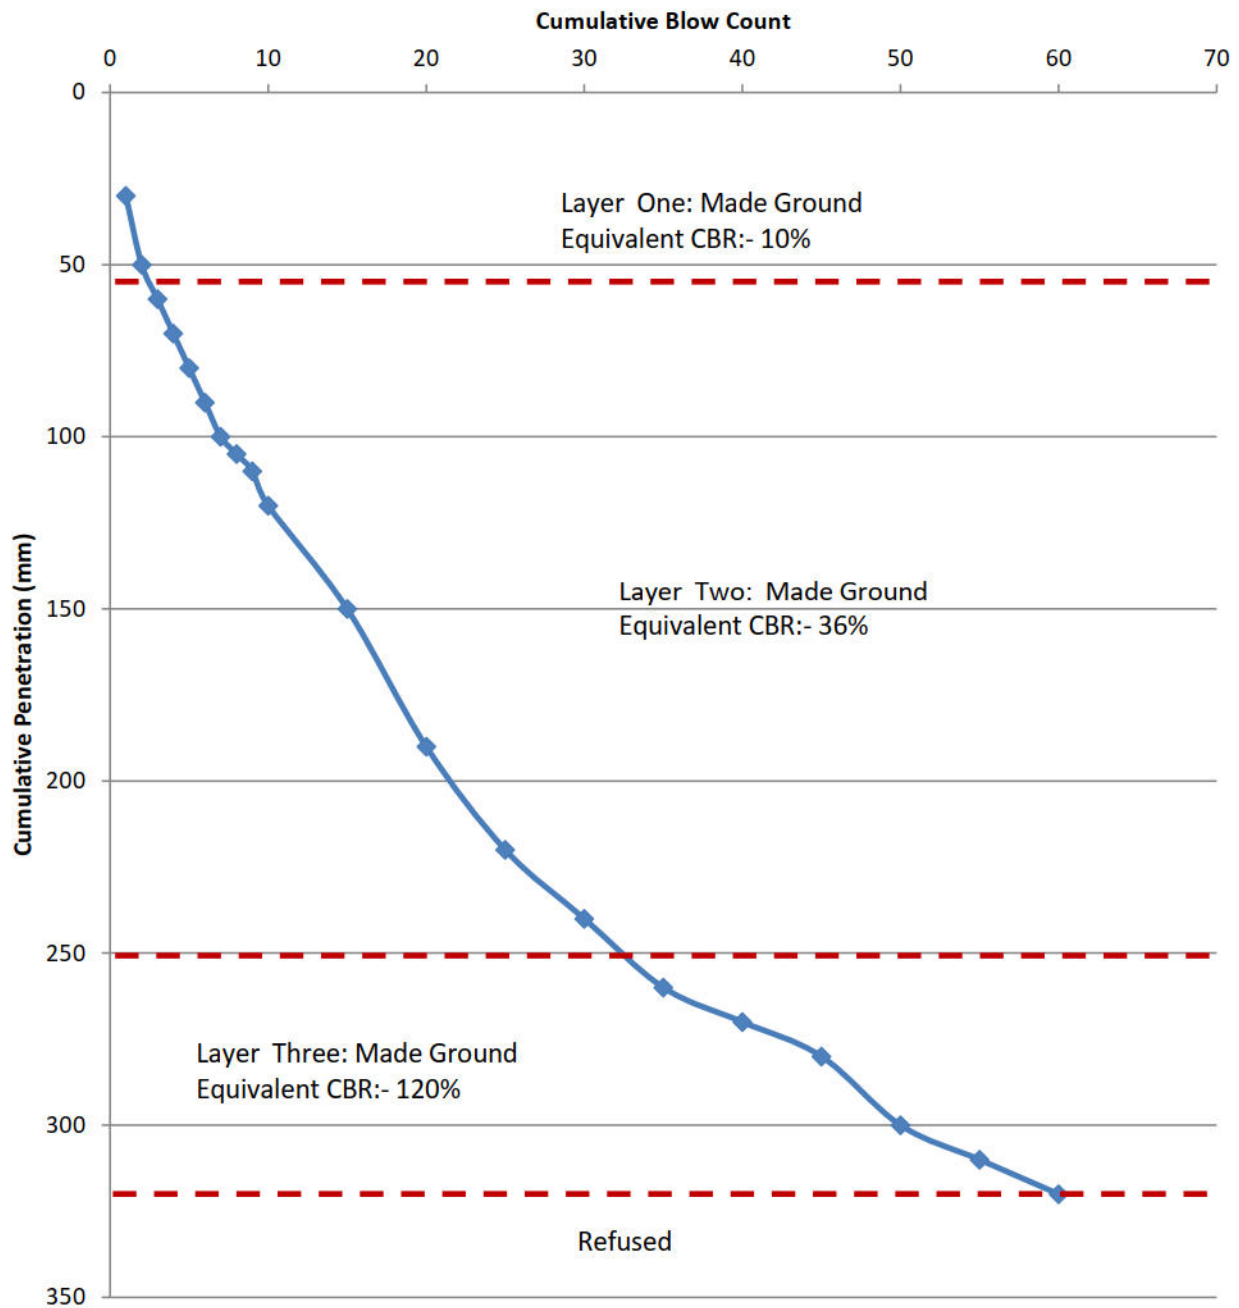
## TRL DYNAMIC CONE PENETROMETER RECORD

### Cumulative Blows Vs Penetration (mm)

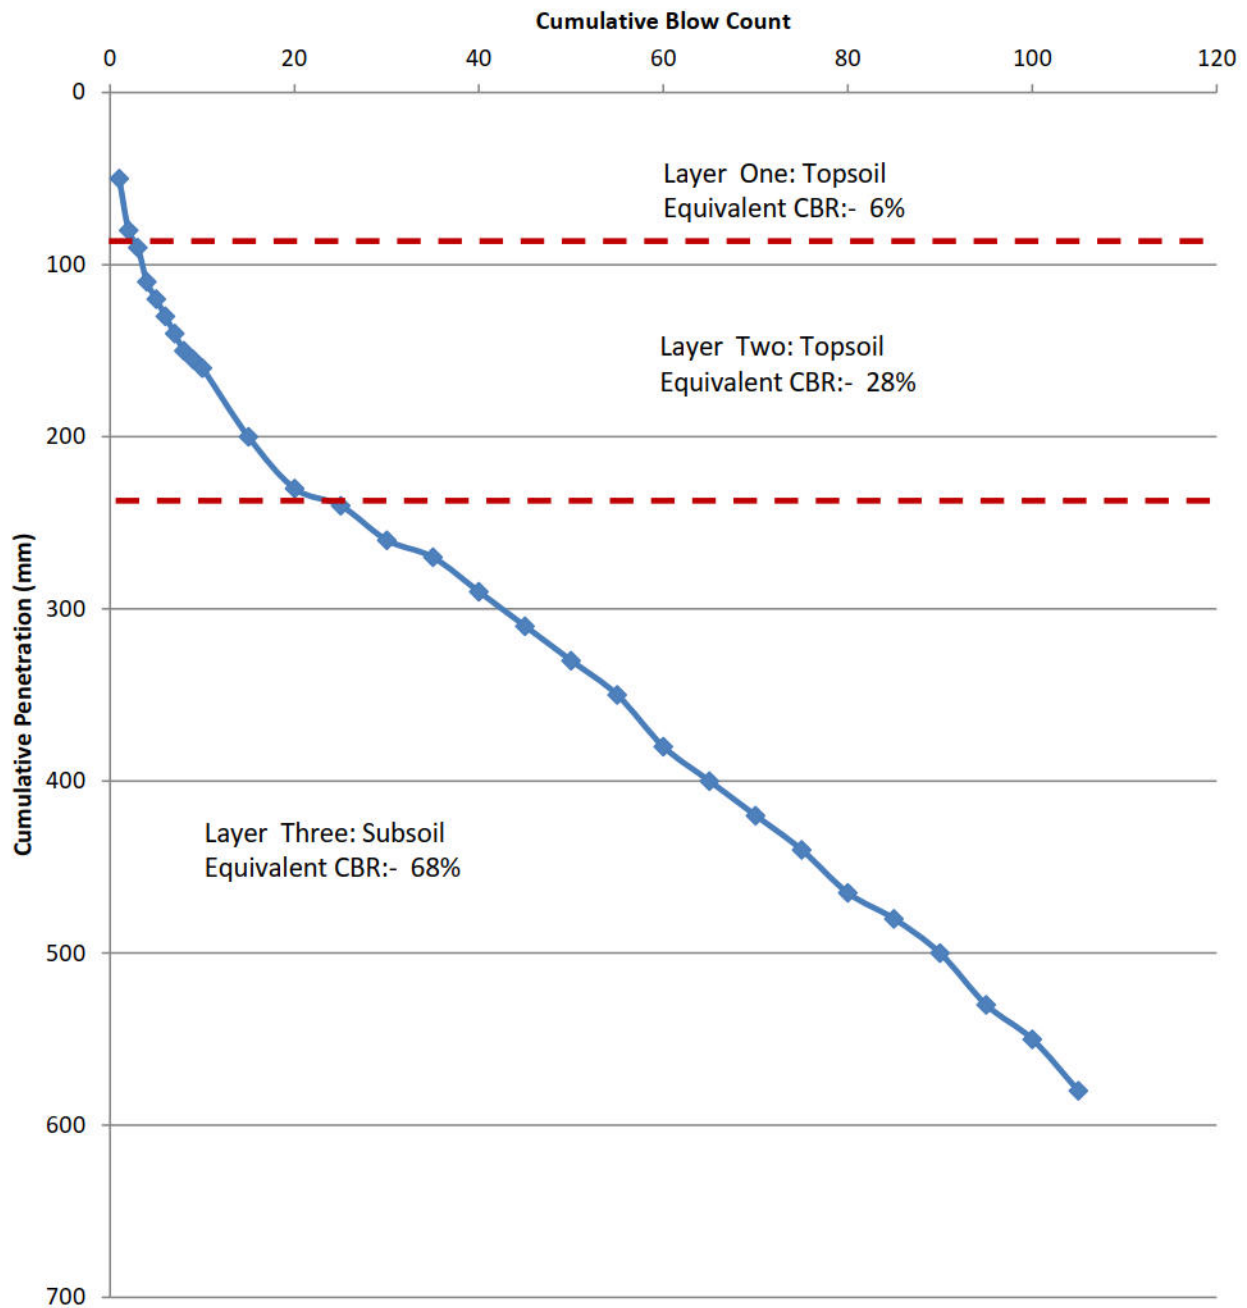
## TRL DYNAMIC CONE PENETROMETER RECORD

### Cumulative Blows Vs Penetration (mm)

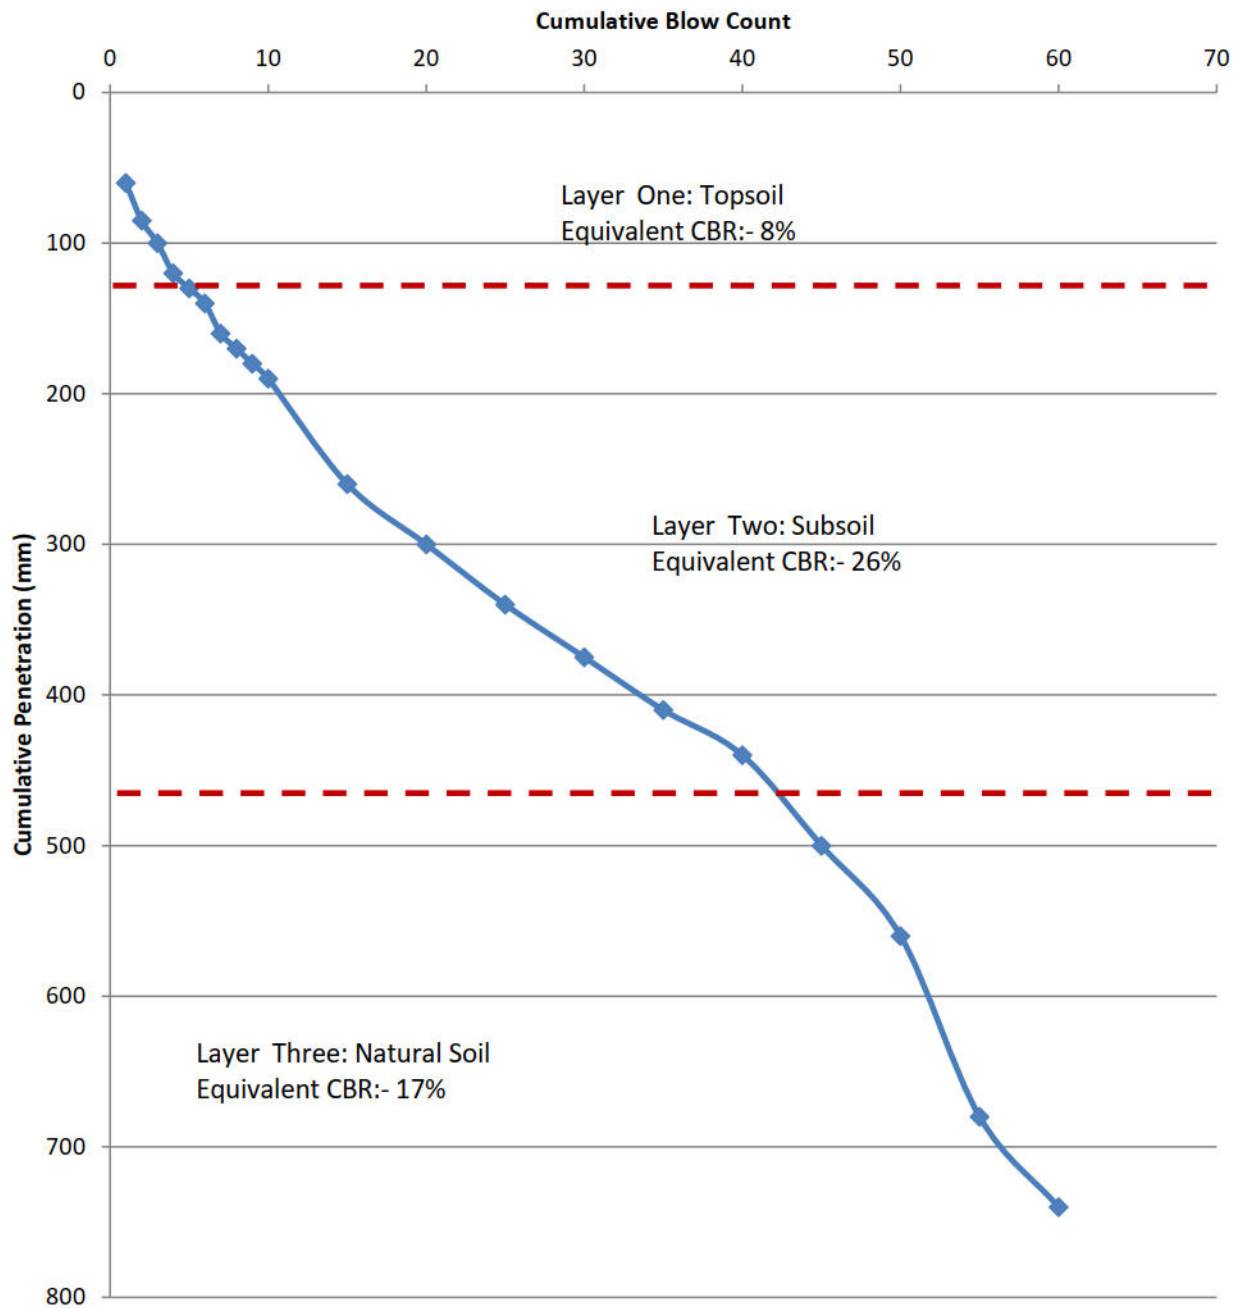
## TRL DYNAMIC CONE PENETROMETER RECORD

### Cumulative Blows Vs Penetration (mm)
