**Phase I Desk Study**

**Geotechnical and Geo-Environmental Report**

**Land Adj. Park Lane**

**Report No: 25-07-12**

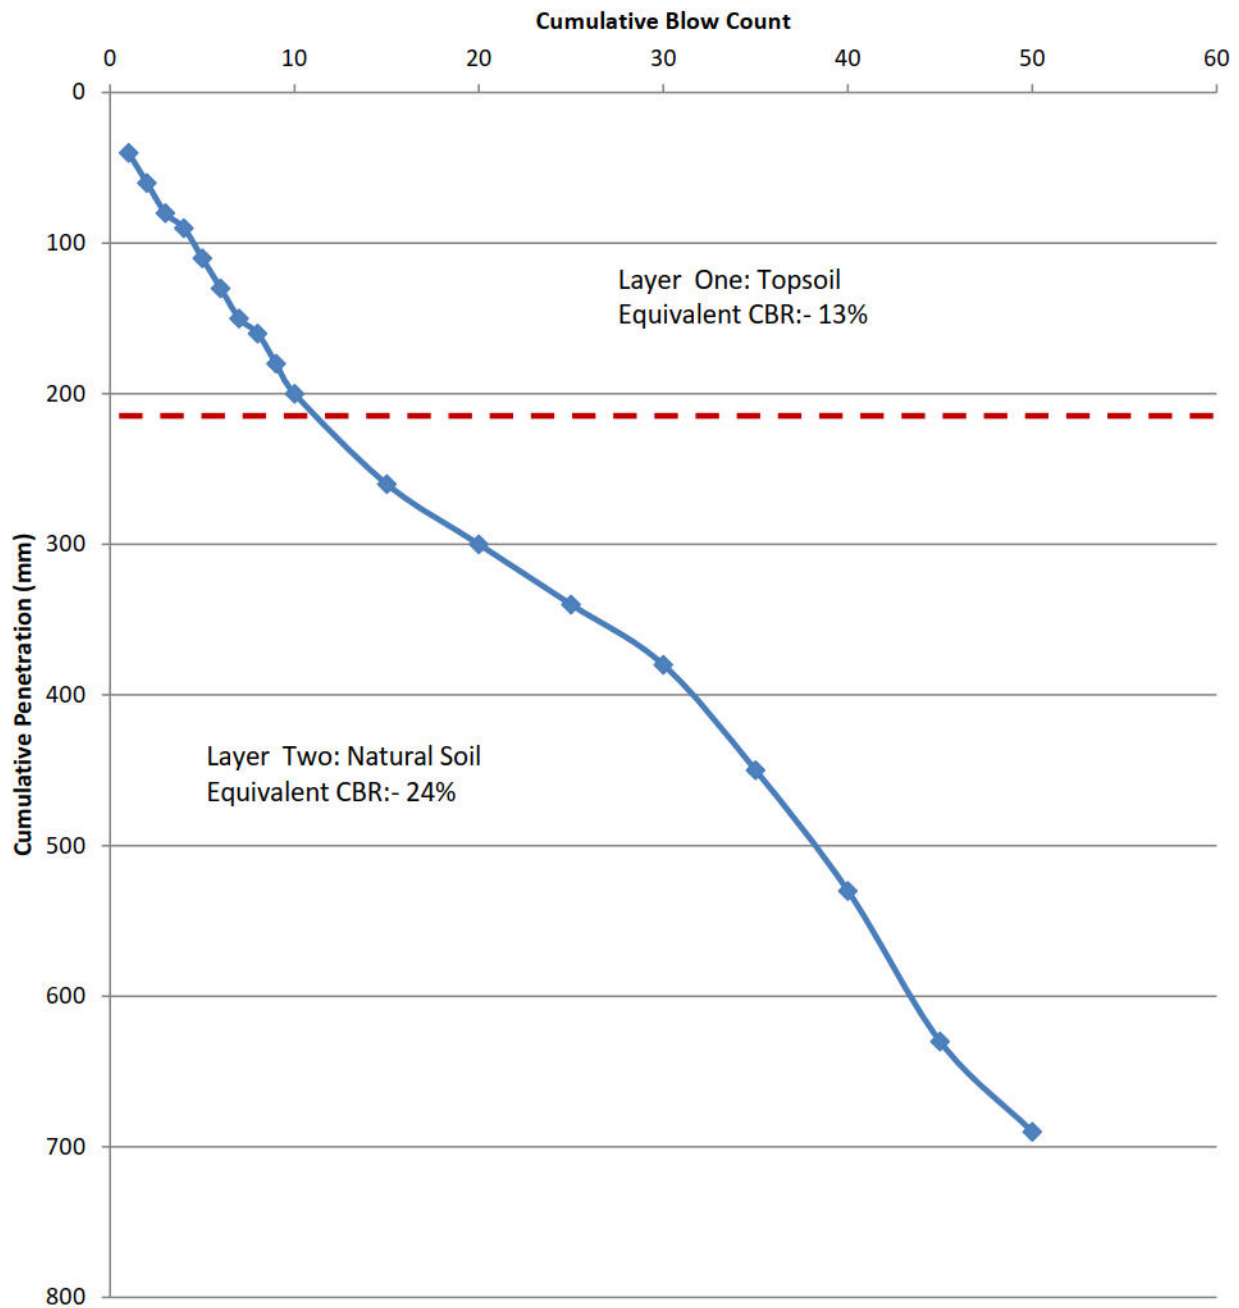
## TRL DYNAMIC CONE PENETROMETER RECORD

### Cumulative Blows Vs Penetration (mm)

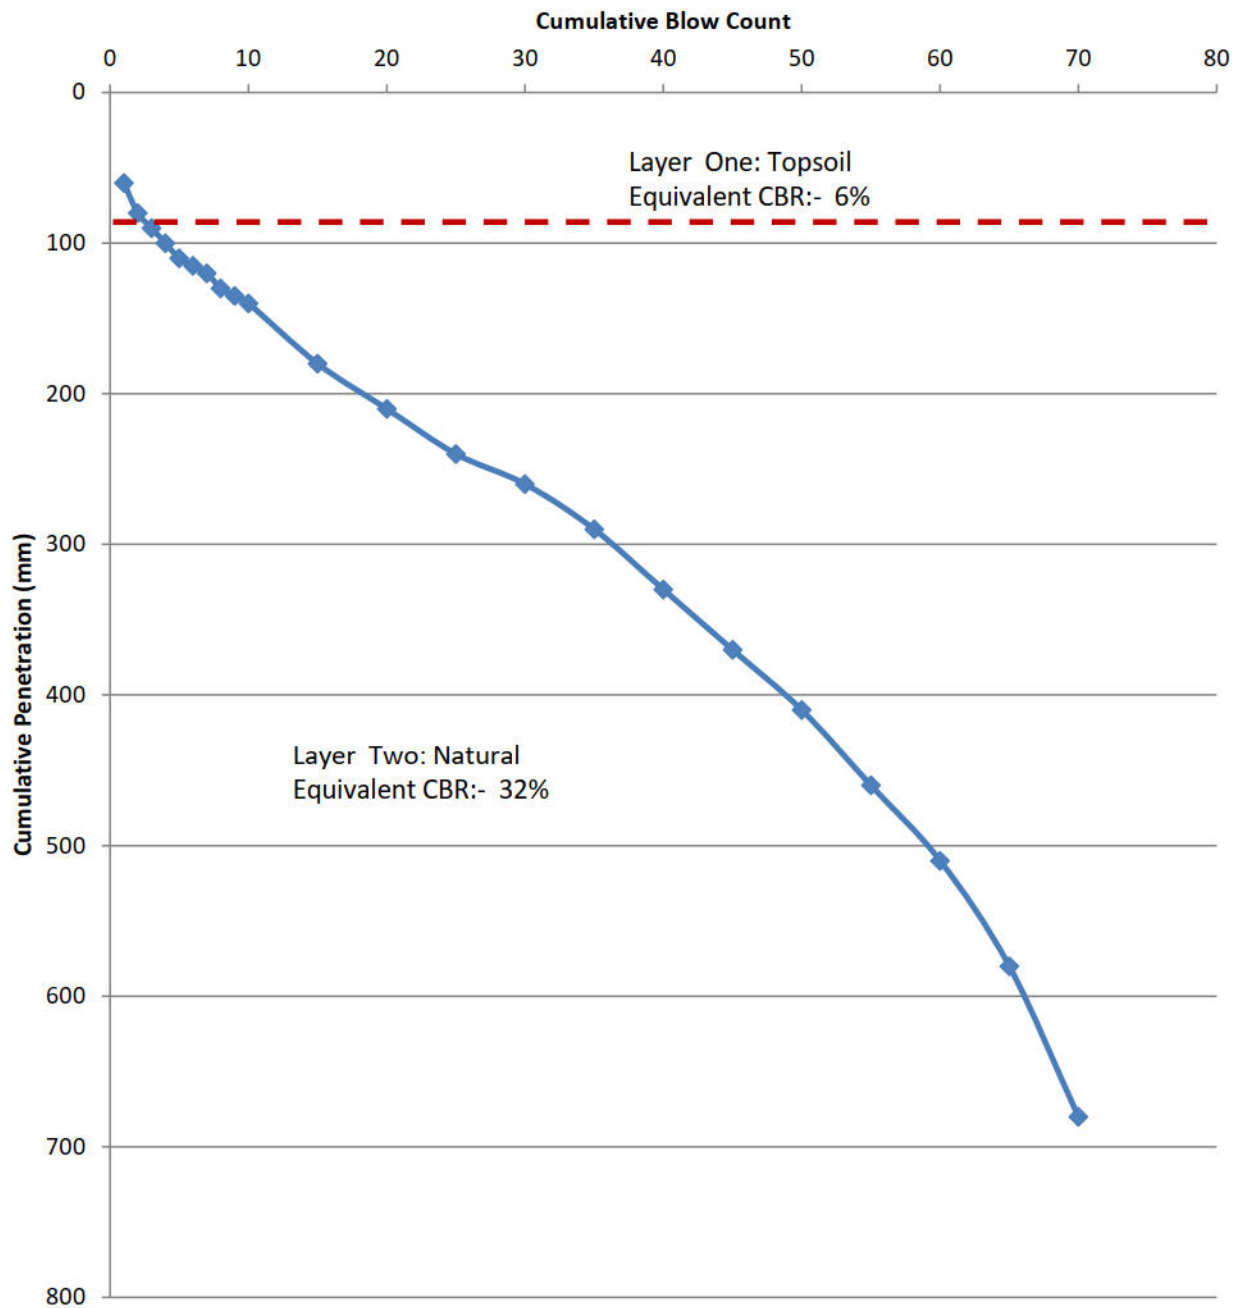
## TRL DYNAMIC CONE PENETROMETER RECORD

### Cumulative Blows Vs Penetration (mm)

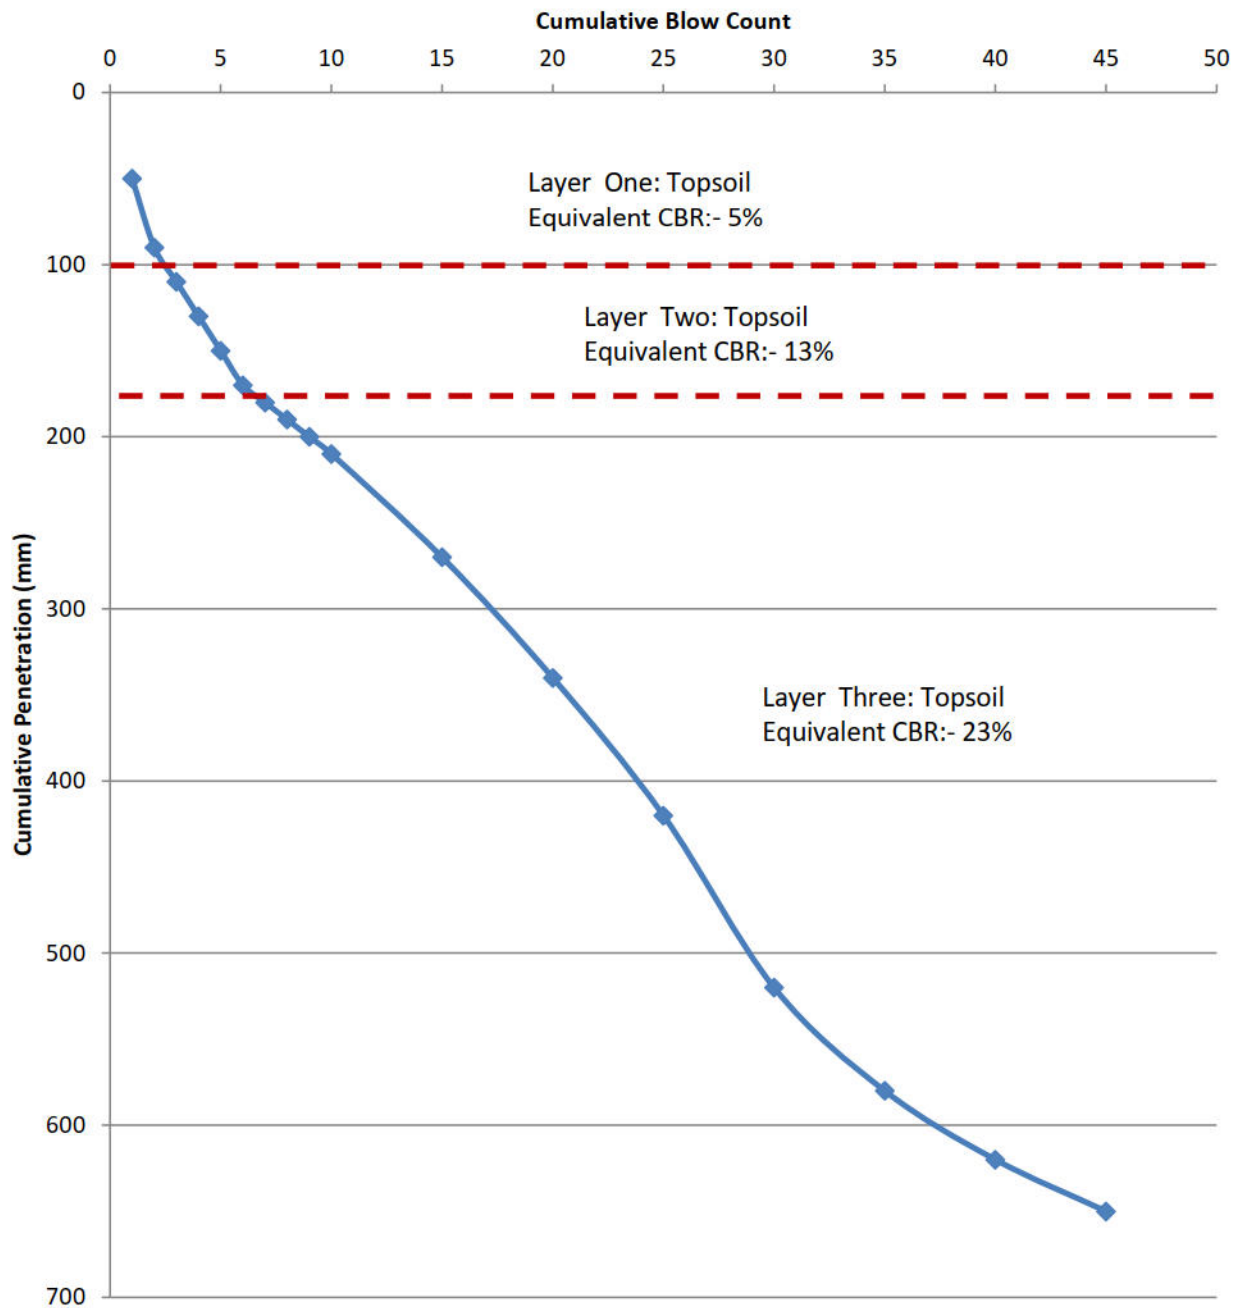
## TRL DYNAMIC CONE PENETROMETER RECORD

### Cumulative Blows Vs Penetration (mm)

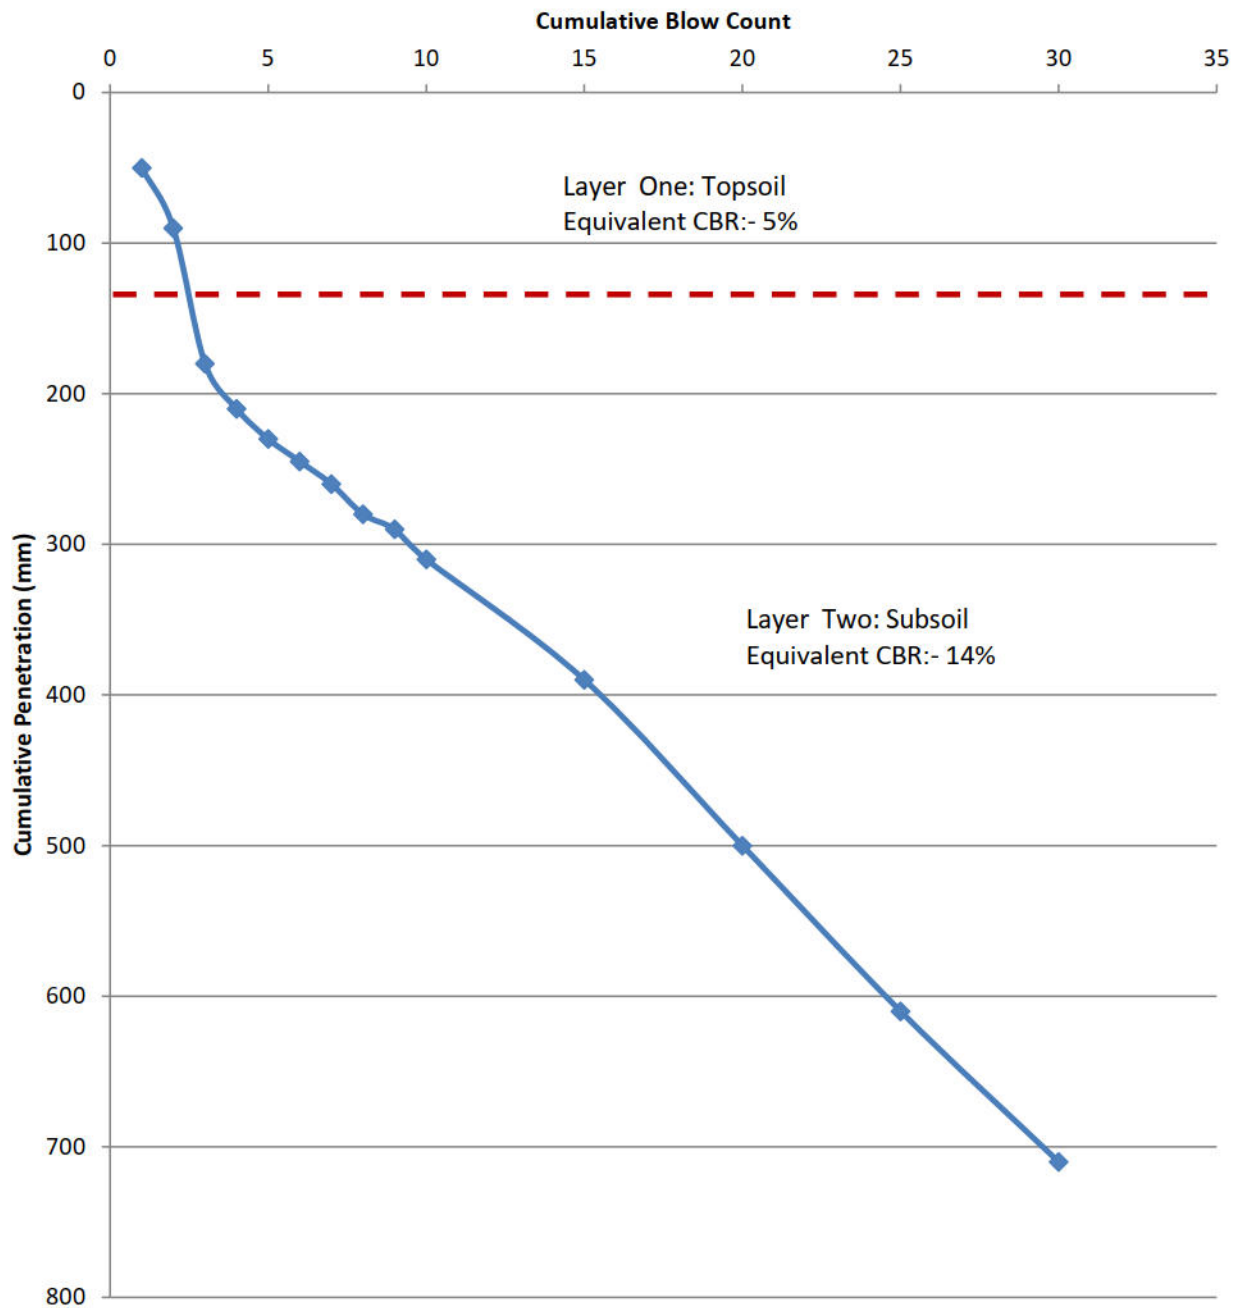
**TRL DYNAMIC CONE PENETROMETER RECORD**

**Cumulative Blows Vs Penetration (mm)**

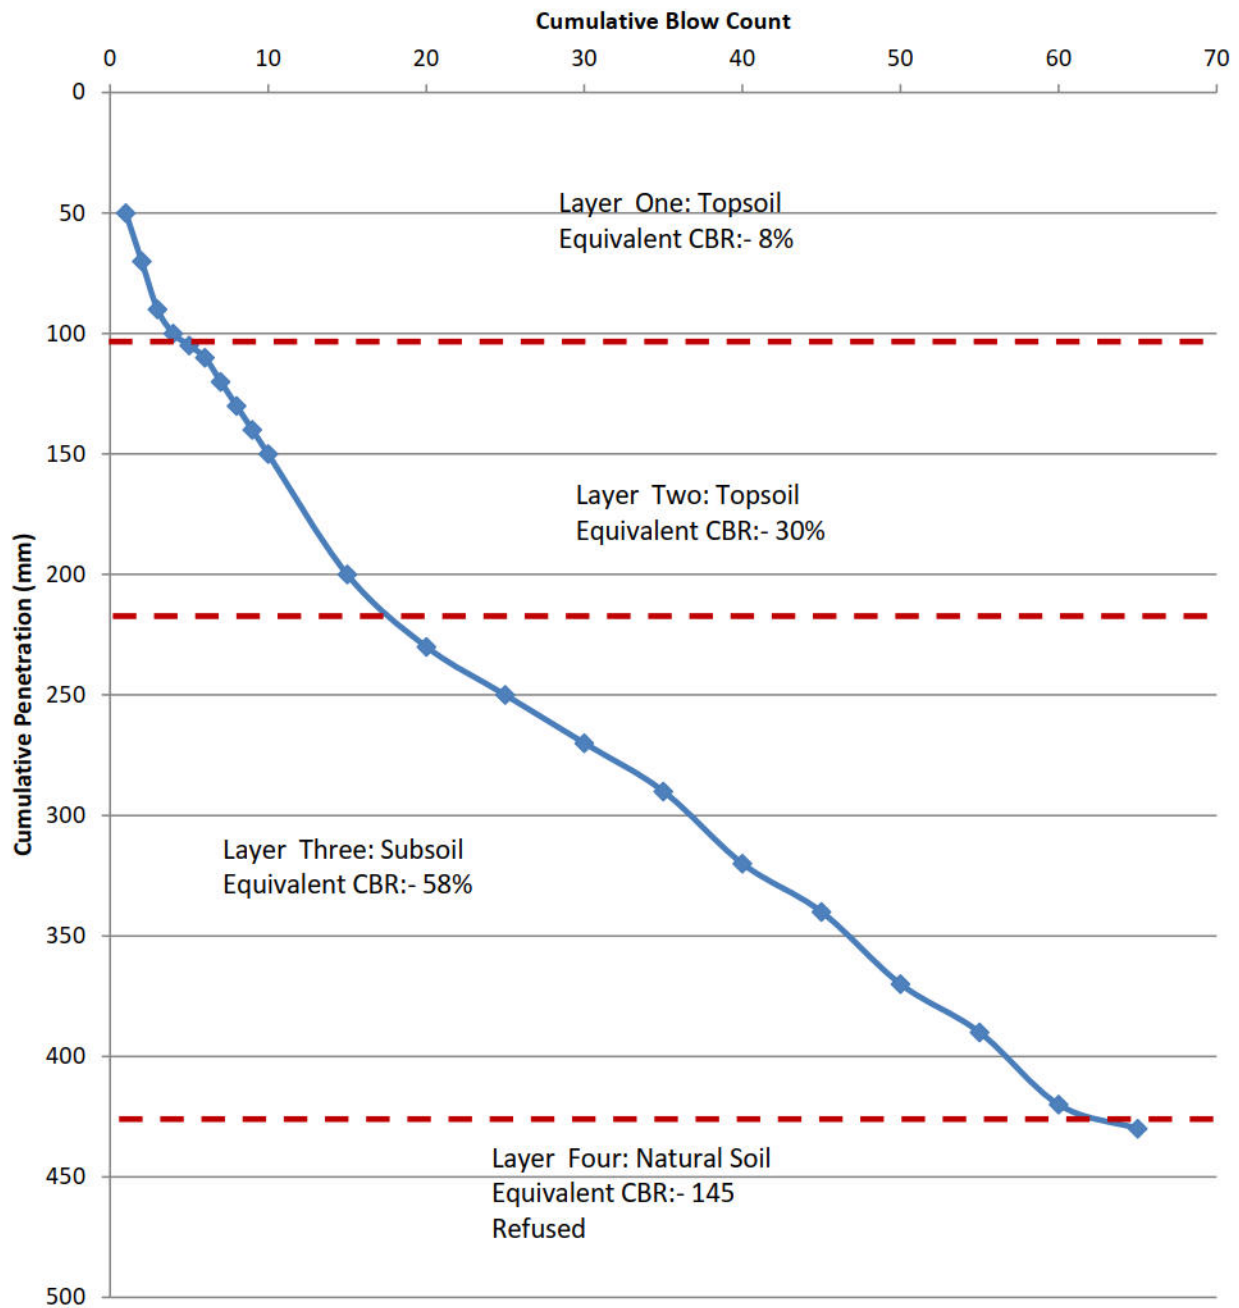
## TRL DYNAMIC CONE PENETROMETER RECORD

### Cumulative Blows Vs Penetration (mm)
