Design Risk Assessment:

ROSE STREET ELEVATION

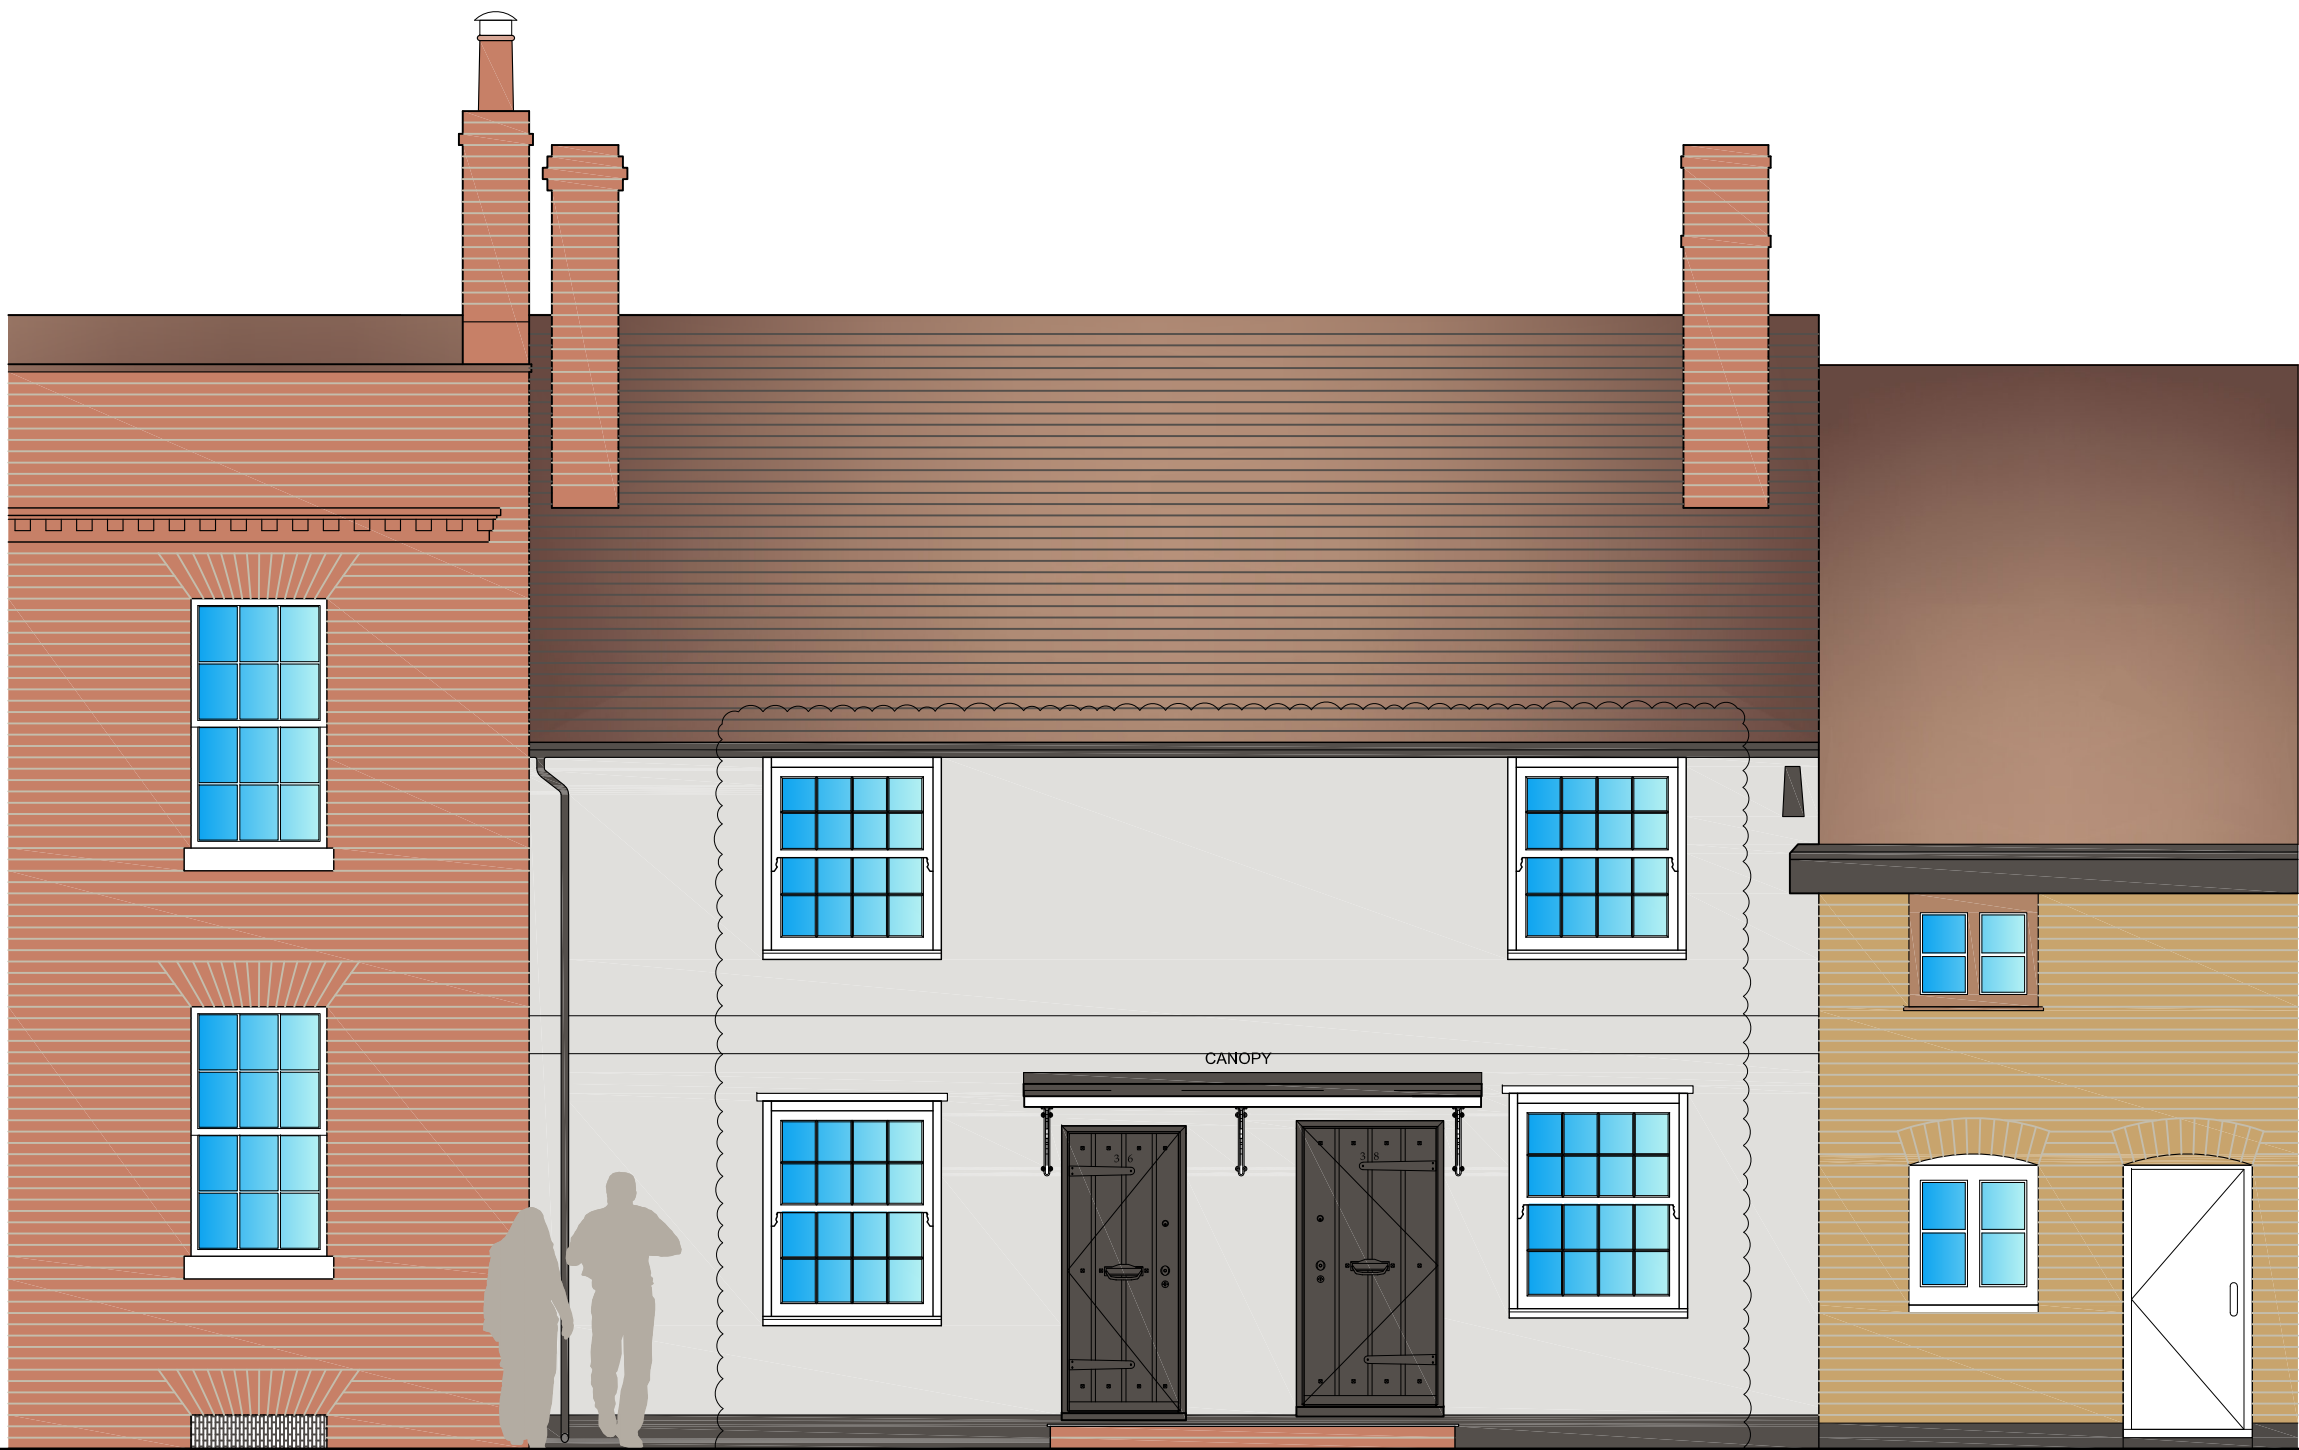
No. 36 Rose Street

No. 38 Rose Street

- 01 Elevation updated to show new entrance doors to replace existing to match No.38 style and new sash windows. Scope of works noted updated to shows new works including replacement of entrance canopy.  
SRH 10.11.2024

No new structural openings are planned in the facade and the front street facade is to be retained as existing but with new timber sash windows and cosmetic decorative works only planned. No new structural openings are planned to the rear elevation with windows proposed to be upgraded in existing openings with new aluminium casement windows, and include works to repair the facade resulting from the removal of the conservatory planned. This would involve masonry infill and render repairs only. The existing patio sliding door to No.36 will be refurbished or replaced to match the existing.

Facade render finish - allow for localised repairs, patched in to match existing where damage is evident.  
Front doors to No.36 and No.38 to be replaced in heritage style - see Drawing P003.10-501-Proposed\_Replacement\_Timber\_Front\_Door.  
Front elevation windows to be replaced with Timber sash windows in existing structural openings. See Drawing P003.10-500-Proposed\_Replacement\_Heritage\_Style\_Sash\_Window  
Rear elevation windows to be replaced with Aluminium casement windows in existing structural openings.  
Locally prepare all remaining external exposed timber frames and cills as required ready to receive paint finish in suitable exterior grade gloss paint.  
Existing street canopy to be replaced with new - See Drawing P003.10-502-Proposed\_Replacement\_Entrance\_Canopy
