Design Risk Assessment:

No. 38 Rose Street

No. 36 Rose Street

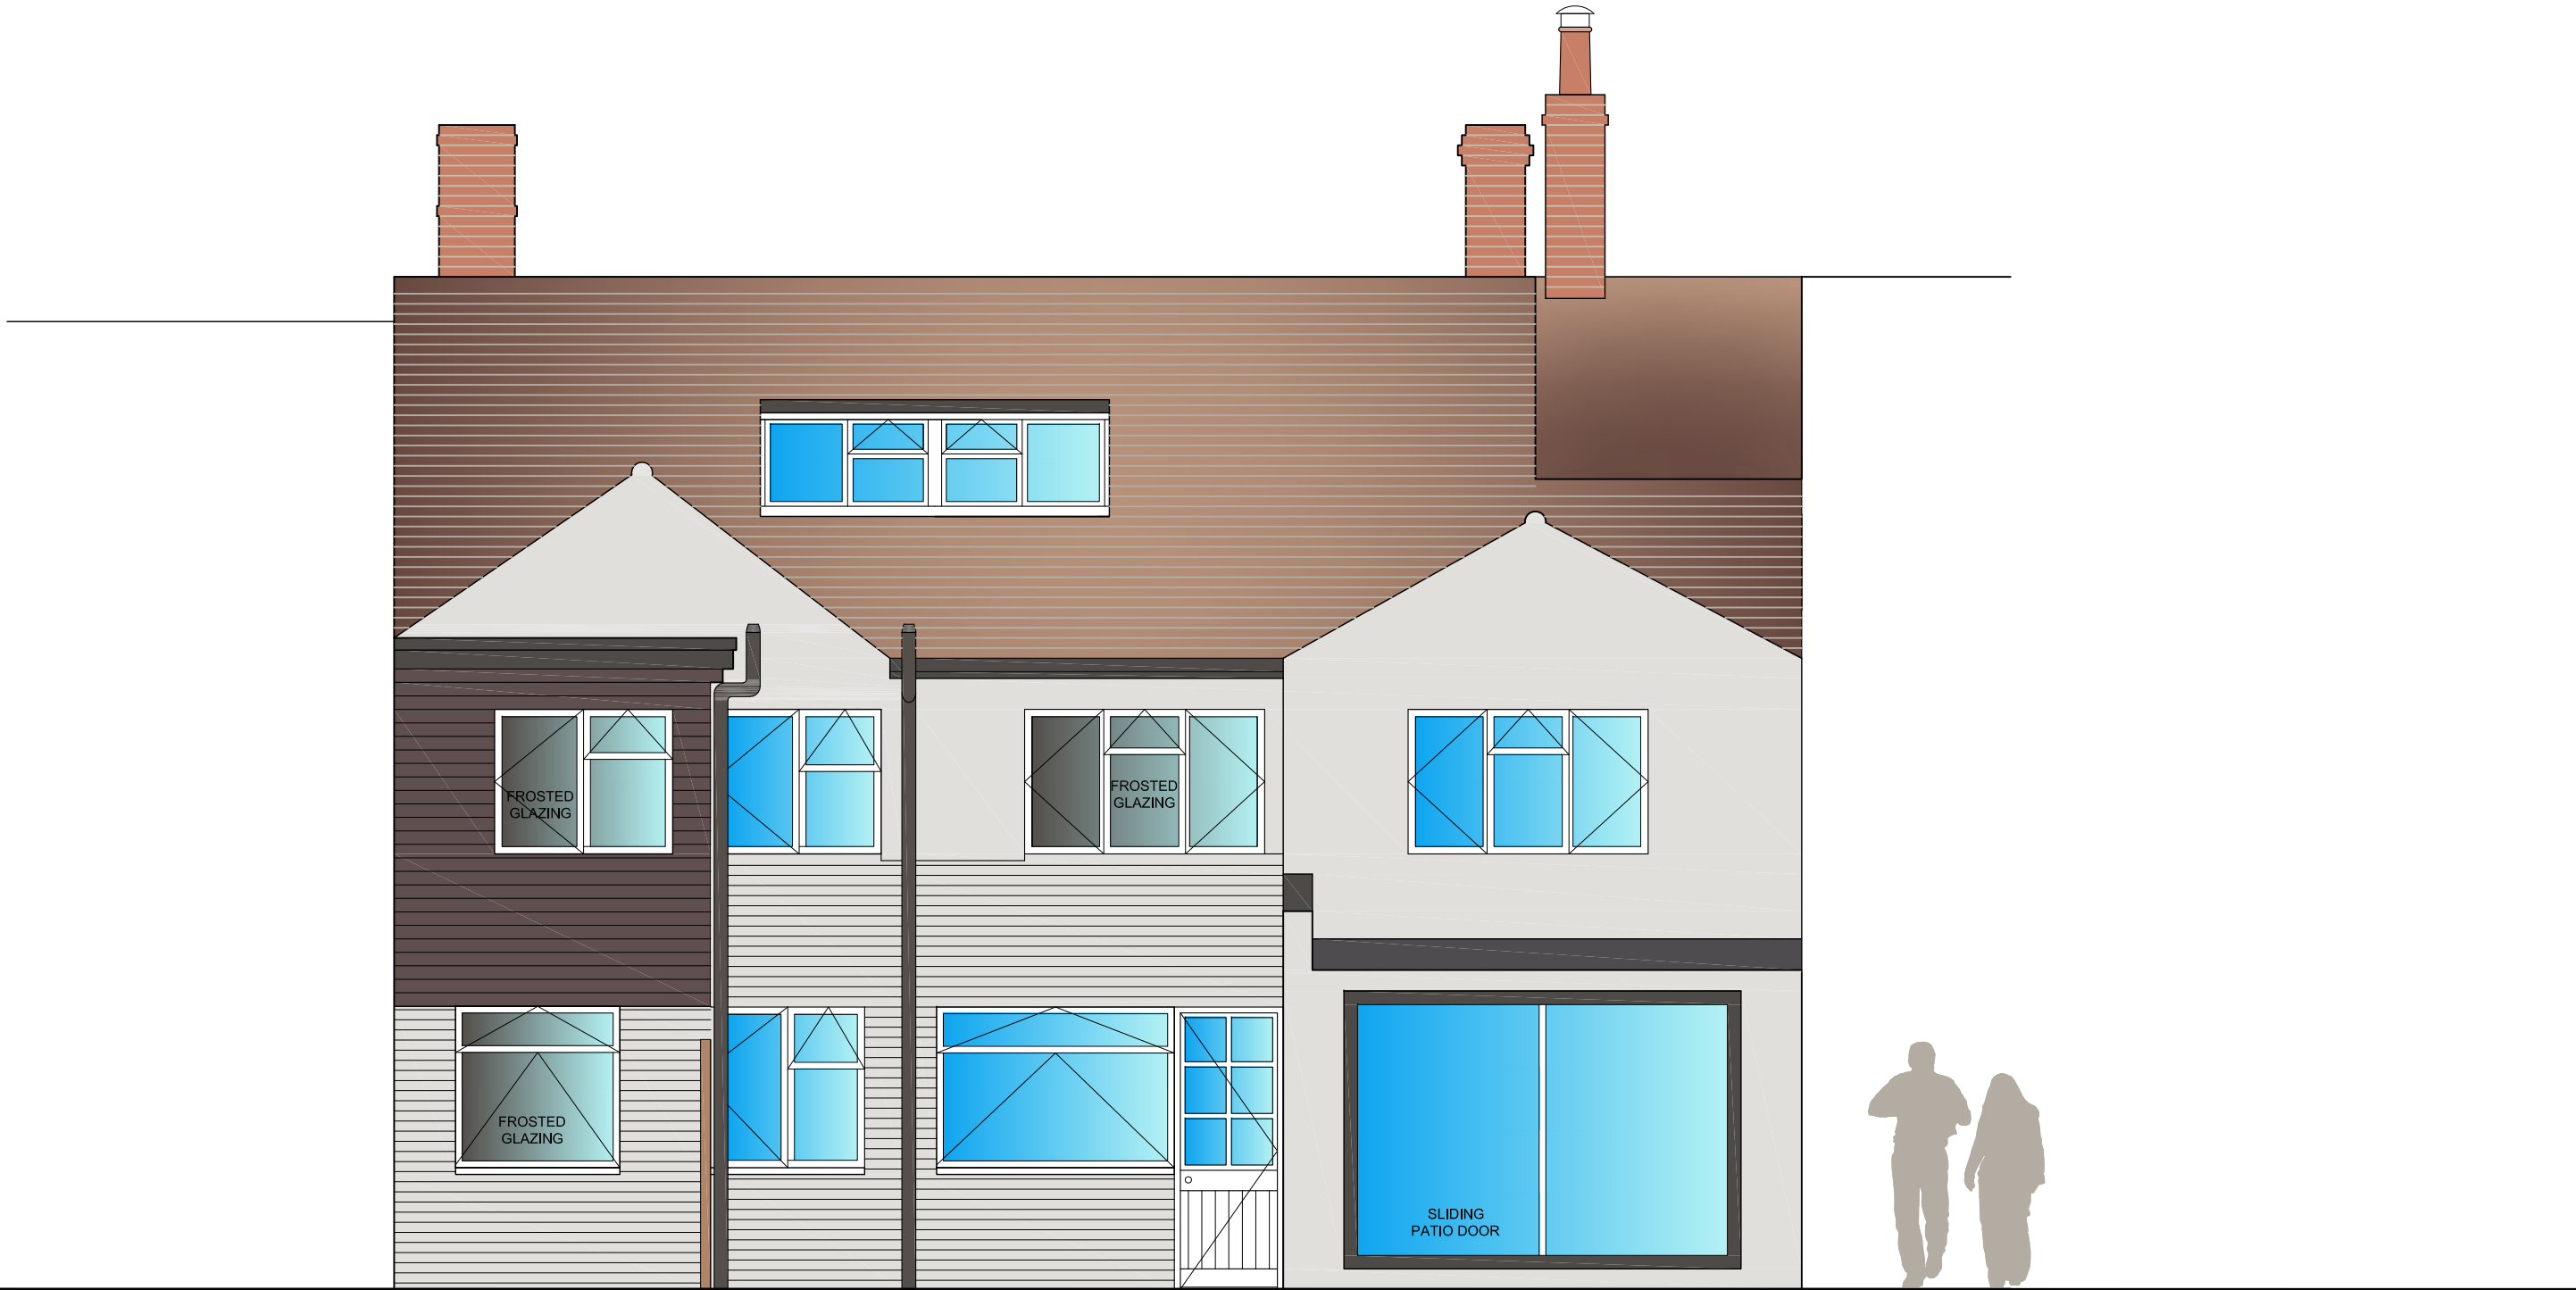
GARDEN VIEW ELEVATION

The rear elevation of both properties is primarily rendered masonry facade which is to be retained, while the extension of No.38 at first floor has a timber shiplap cladding. Localised repairs with some possible replacement is proposed in keeping with the existing finishes.

adjacent garden

The existing conservatory is a fully glazed jolsted roof frame lean-to construction with an intermediate steel beam support. The removal of the conservatory should be undertaken by a competent contractor using panel removal to avoid unnecessary glass debris. The steel support beam is bearing on the masonry walls and can be easily removed and the walls repaired by a competent contractor.

No new structural openings are planned in the facade and the front street facade is to be retained as existing but with new timber sash windows and cosmetic decorative works only planned. No new structural openings are planned to the rear elevation with windows proposed to be upgraded in existing openings with new aluminium casement windows, and include works to repair the facade resulting from the removal of the conservatory planned. This would involve masonry infill and render repairs only. The existing patio sliding door to No.36 will be refurbished or replaced to match the existing.
