Design Risk Assessment:

NORTH EAST GARDEN VIEW SIDE ELEVATION

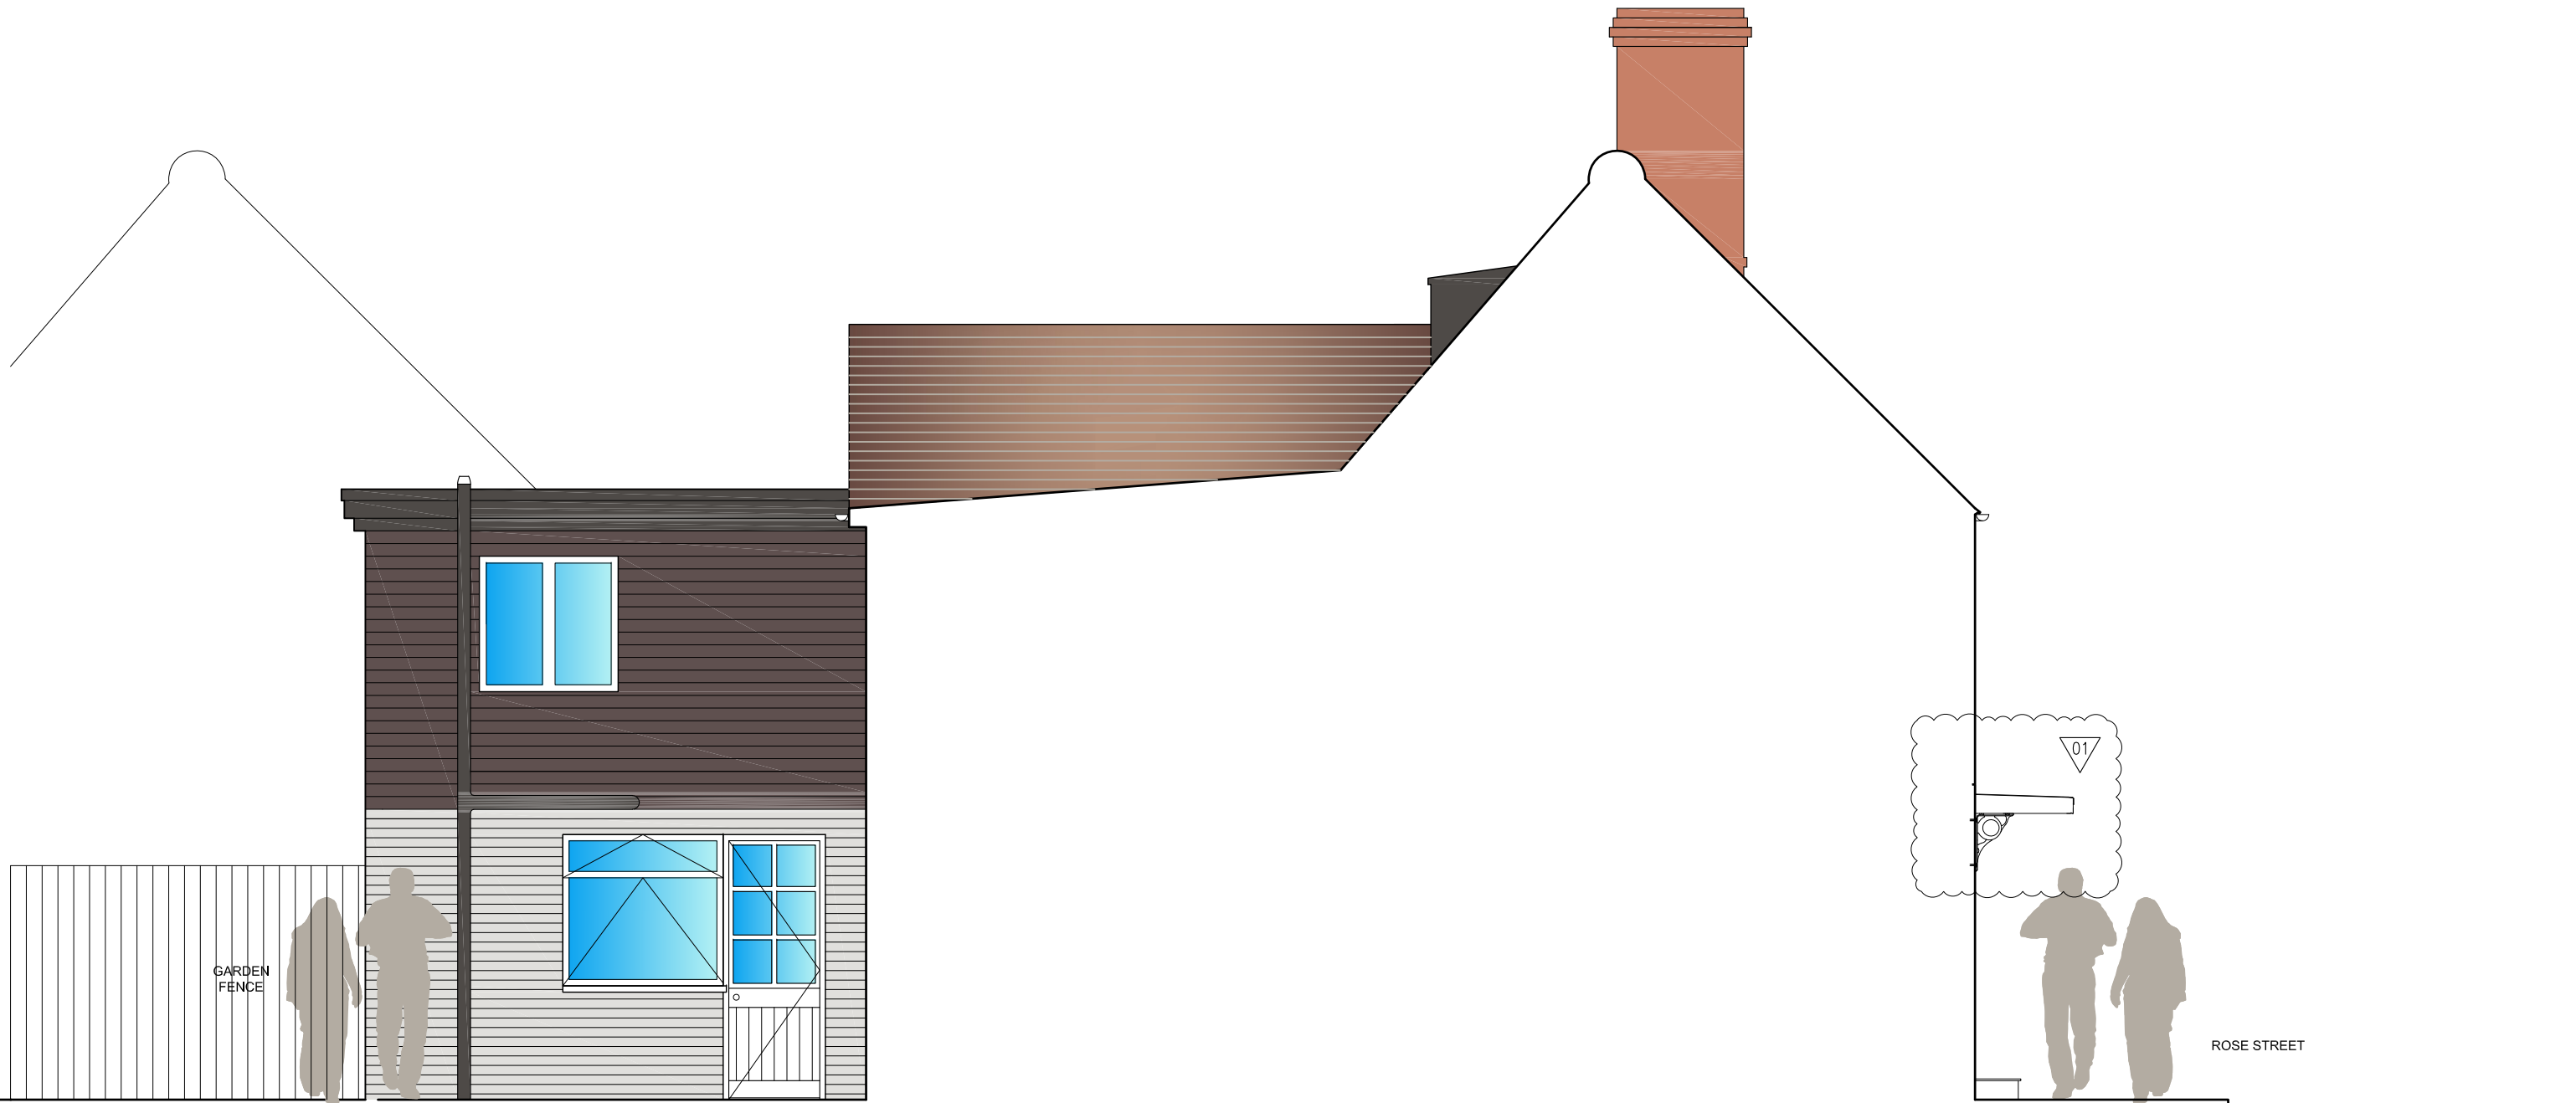
No. 38 Rose Street

adjacent garden

01 Elevation updated to show scope of works noted updated to shows new works including replacement of entrance canopy.
