## Optera Structural Solutions

### SOW OPT-9940 Agreement to install a root barrier for Crawford.

**OUR REFERENCE:** OPT-9940

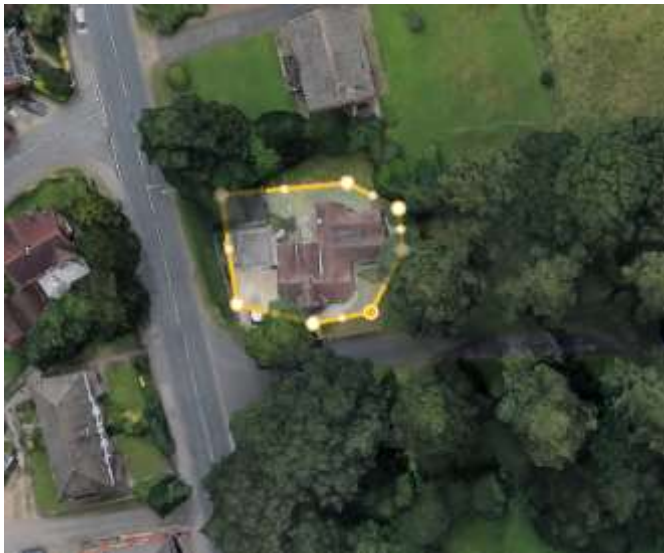
Aerial plan indicating proposed 79m length and alignment of barrier.

| Specifications of Barrier | | | | | |
| Barrier Type | length | Max Root Depth from SI | Minimum depth to be achieved with barrier | Distance between tree / Vegetation and barrier | shortest distance between barrier and foundation |
| Copper | 79m | 2.5m | 3.5m | 5m | 1.5m |

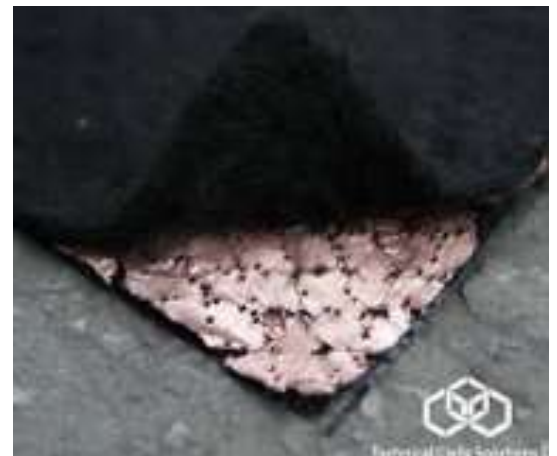
The bio-root barrier is strong and flexible, with very high tear resistance, as well as being water-permeable, thus allowing the natural movement of water through the ground without impediment. The Copper contained within the core of the membrane also acts as a chemical repellent to the roots without constituting a hazard to plants or animals. The Copper foil securely bonded within the porous geotextile membrane, releases Copper ions into the adjacent soil by forming Copper Carbonate (verdigris); these signal adverse conditions to any roots growing towards the barrier, preventing a proliferation of roots close to the barrier. The levels of Copper generated do not constitute a burden on the eco-system or impact groundwater quality.

Outdated, impervious barriers divert rather stop roots and may prevent the movement of groundwater causing unintended consequences. The use of Optera's permeable barrier stops roots both by forming a physical impenetrable obstacle and by acting as a chemical inhibitor to the reestablishment of roots.

The multi layered membrane is welded together, retaining its flexible qualities, allowing it to be cut and effectively resealed to fit round buried services. The barrier material itself has a 60 year service life expectancy.
