**159/2025: Land East of Trowe's Lane, Swallowfield, Reading, Berkshire, RG7 1RW**

**Environment Agency Historic Flood Mapping and Recorded Flood Outline Mapping**

# WOKINGHAM BOROUGH COUNCIL FLOOD INVESTIGATION REPORTS

### Proposed Drainage Strategy Drawings

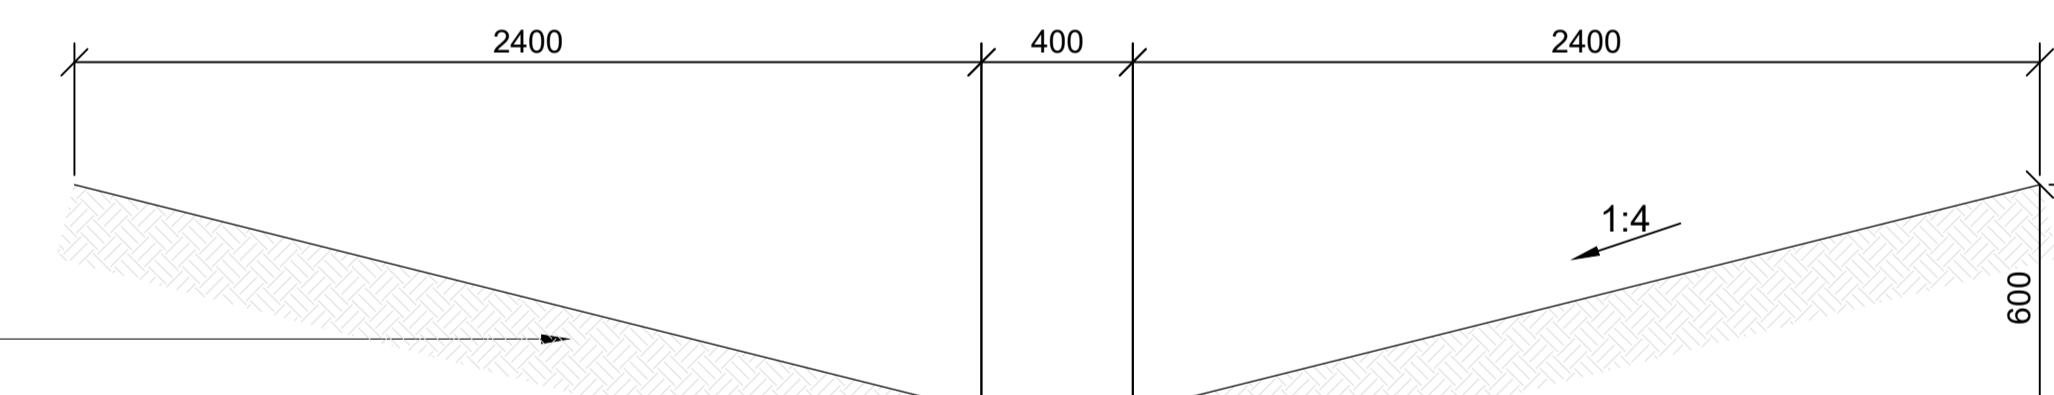
TYPICAL CATCHPIT DETAIL

Largest Pipe Diameter	*Internal Diameter of Chamber
<375	1200
375 to 700	1500

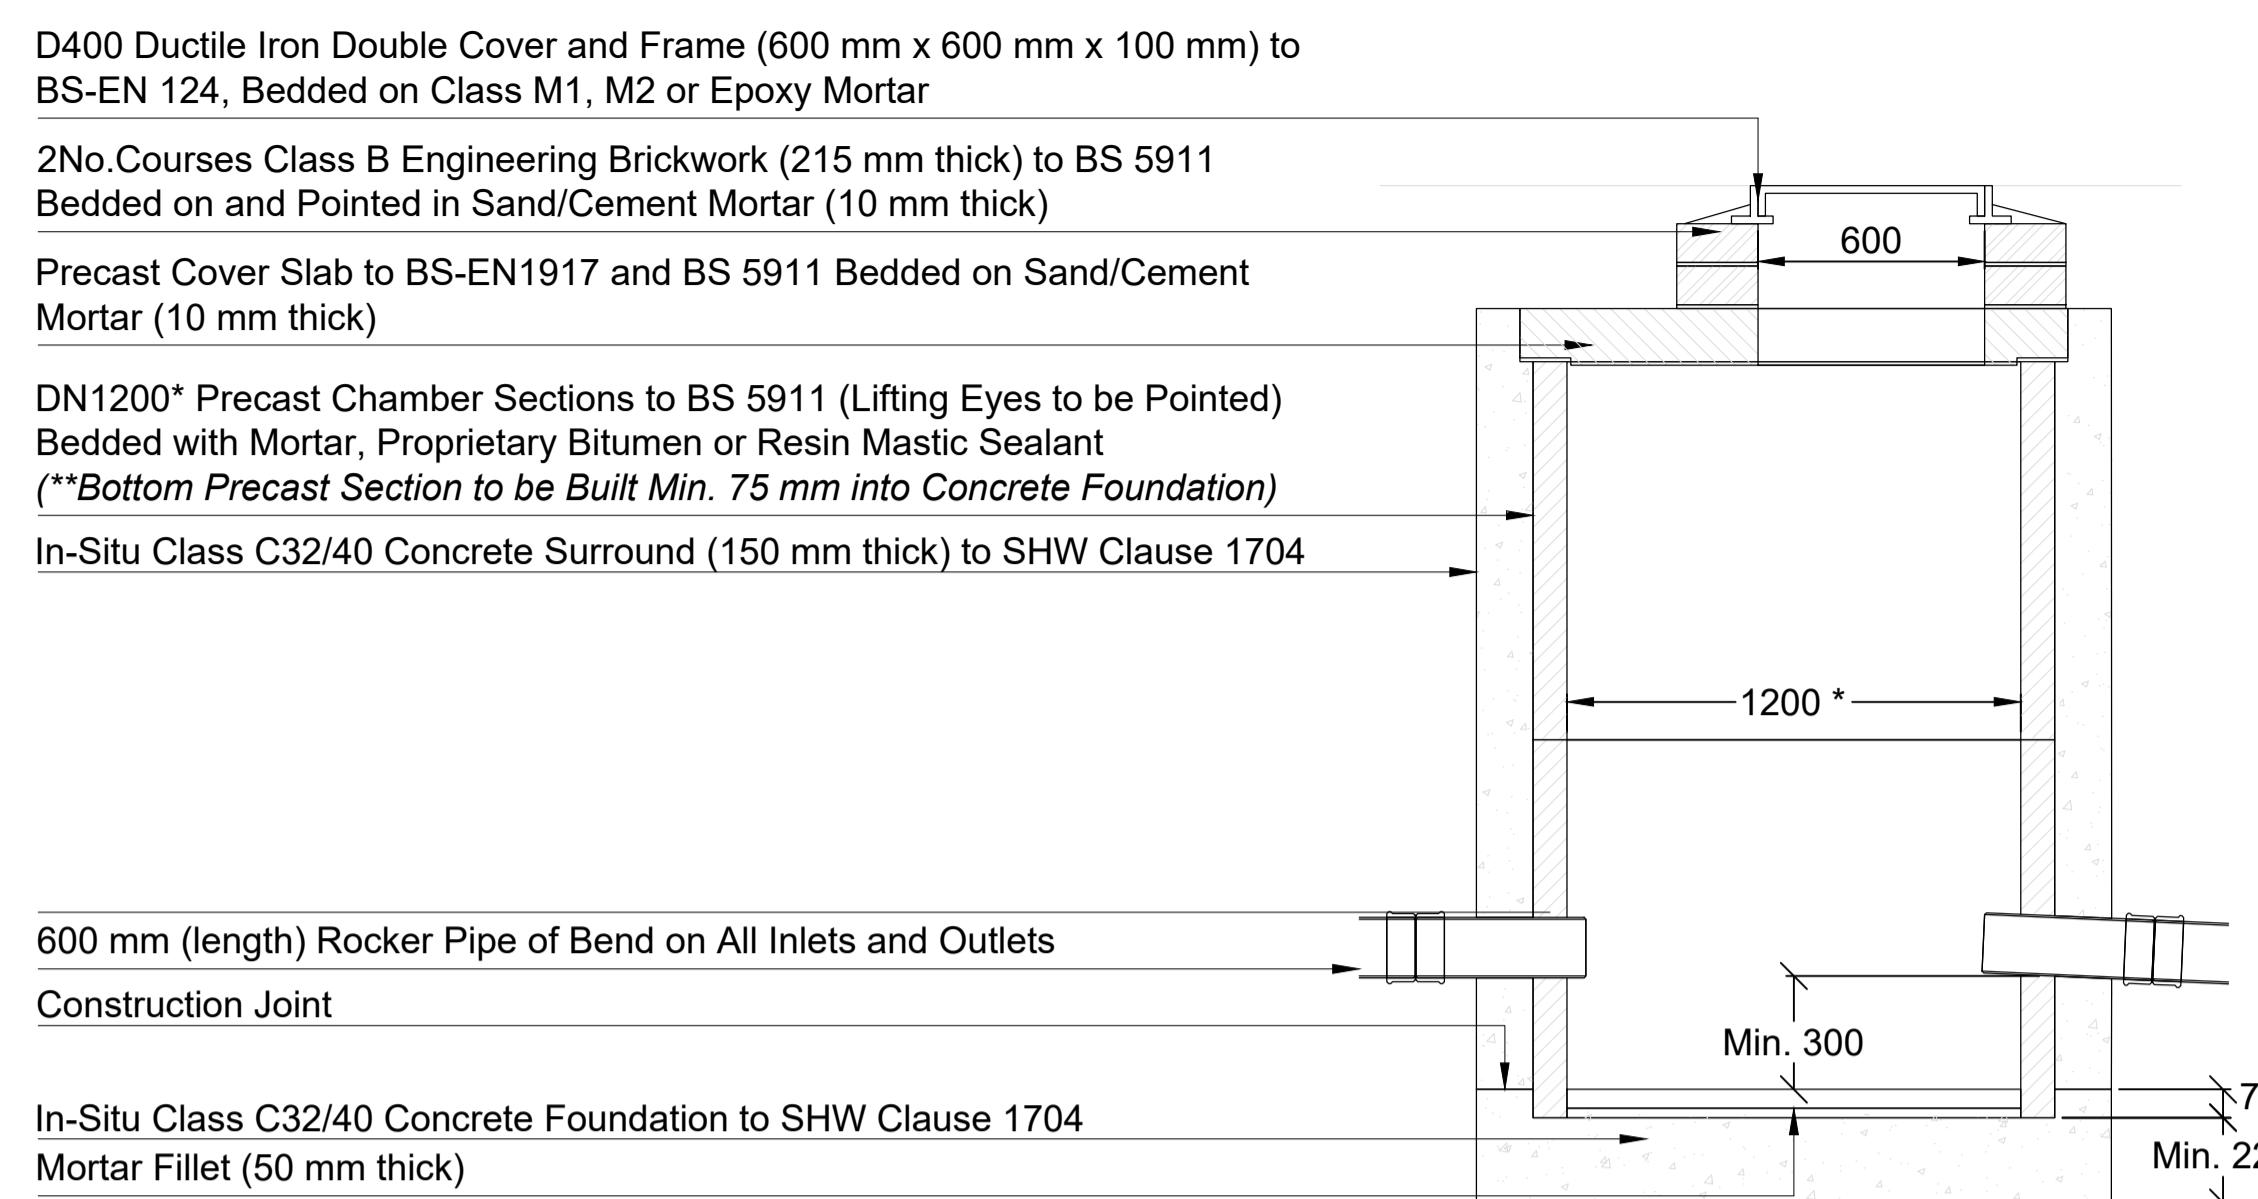
TYPICAL ORIFICE PLATE FLOW CONTROL CATCHPIT DETAIL

Inlet Pipe (Invert Level and Diameter as Detailed on Plan)  
Entry & Exit Points Thoroughly Packed and Sealed with Mortar Around Joints

Largest Pipe Diameter	*Internal Diameter of Chamber
<375	1200
375 to 700	1500

D400 Ductile Iron Double Cover and Frame (600 mm x 600 mm x 100 mm) to BS-EN 124, Bedded on Class M1, M2 or Epoxy Mortar

2No.Courses Class B Engineering Brickwork (215 mm thick) to BS 5911 Bedded on and Pointed in Sand/Cement Mortar (10 mm thick)

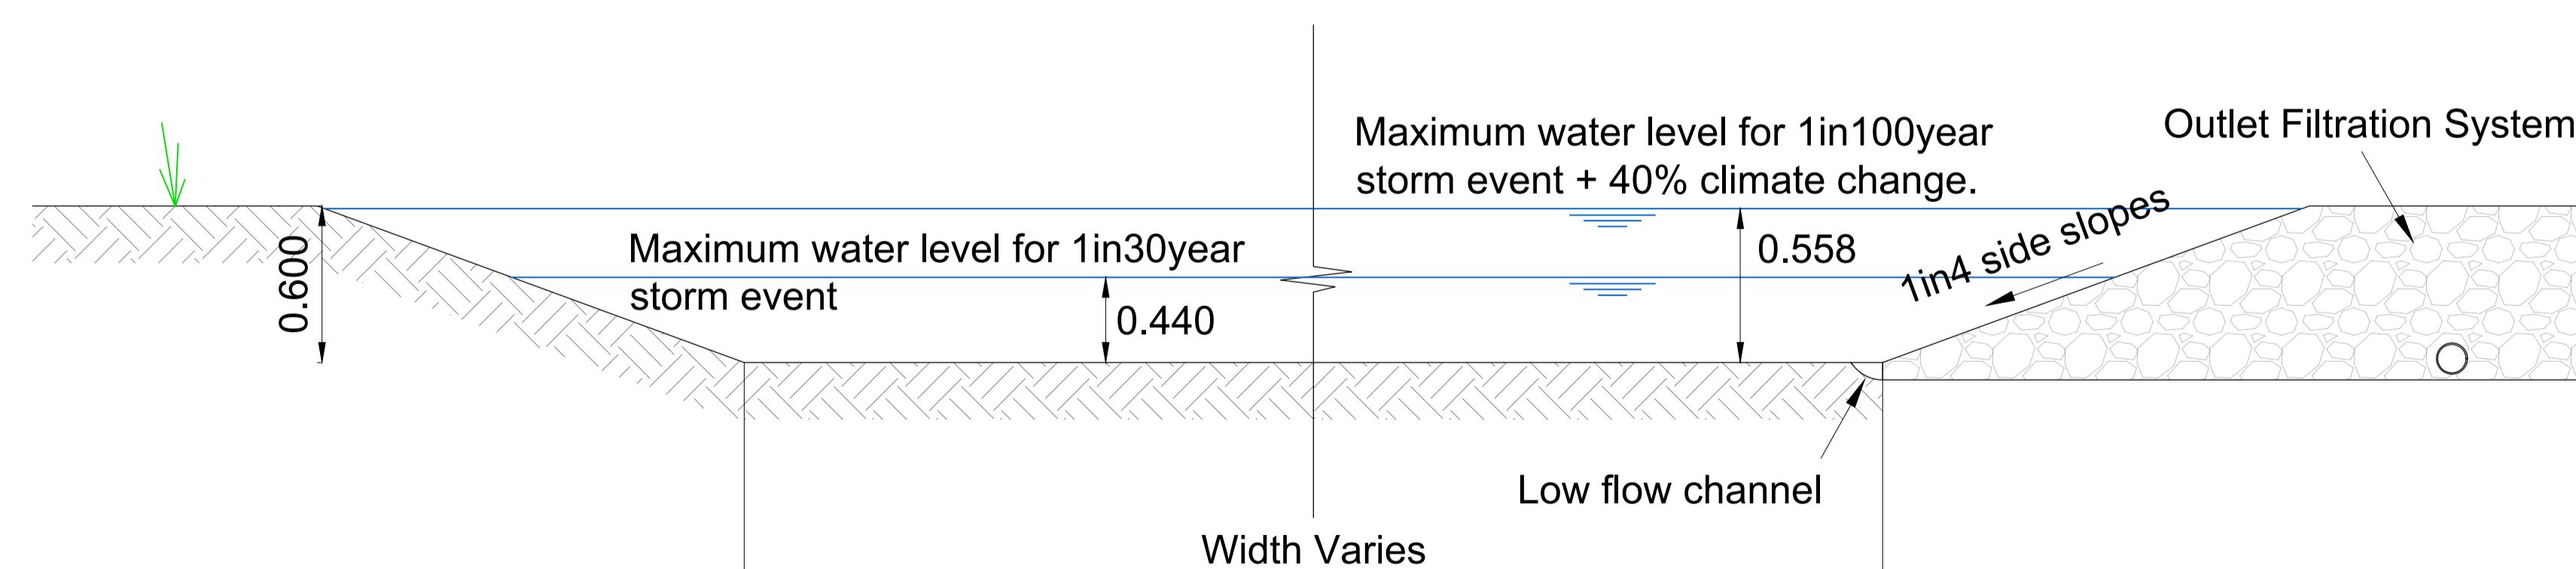
Typical section: Attenuation Basin With Outlet Filtration System

TYPICAL SWALE PROFILE

300 - 400 Landscaping and Topsoil Specially Selected for Use in Wet Flow Conditions. Turfed or Seeded with Swale Vegetation in Coir Matting until Vegetation Established.
