## Optera Structural Solutions

### SOW OPT-9484 Agreement to install a root barrier for Crawford and Co.

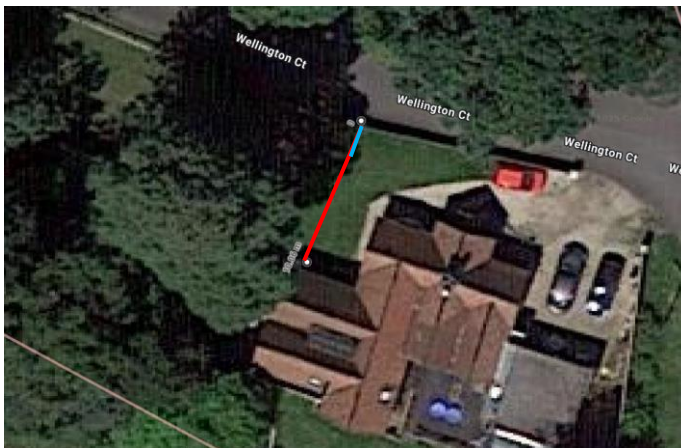
Aerial plan indicating proposed 2m length and alignment of barrier. Blue line indicates 2m extension

| Specifications of Barrier | | | | | |
|---|---|---|---|---|---|
| Copper | 2m | 3.0m | 3.0m | 9 | 8 |
