# The Old Cottage

Pearson Road, Sonning, RG4 6UH

## Heritage Statement & Design and Access Statement for Proposed Cork & Lime Plaster Panels to the Ground Floor of the West Gable

Document No: 1362-HR-A-HS-XX-03  
Rev 02

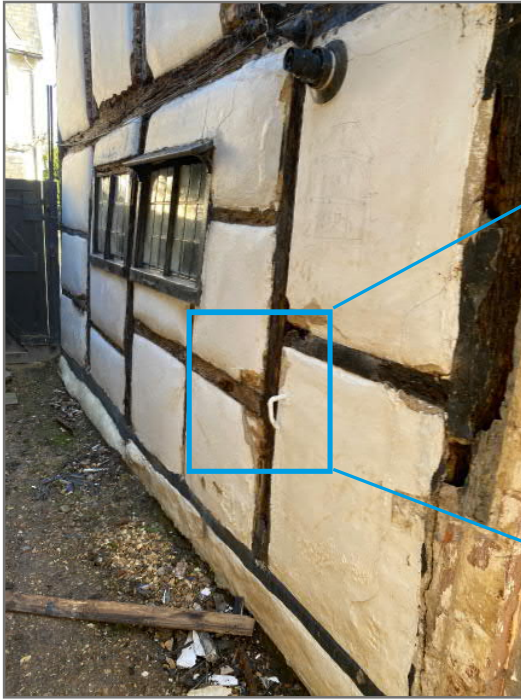
Image 05a: View of West gable

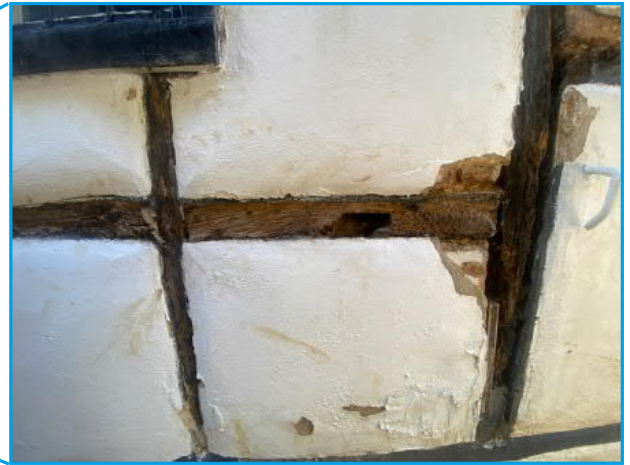
Image 05b: Detail of revealed brick

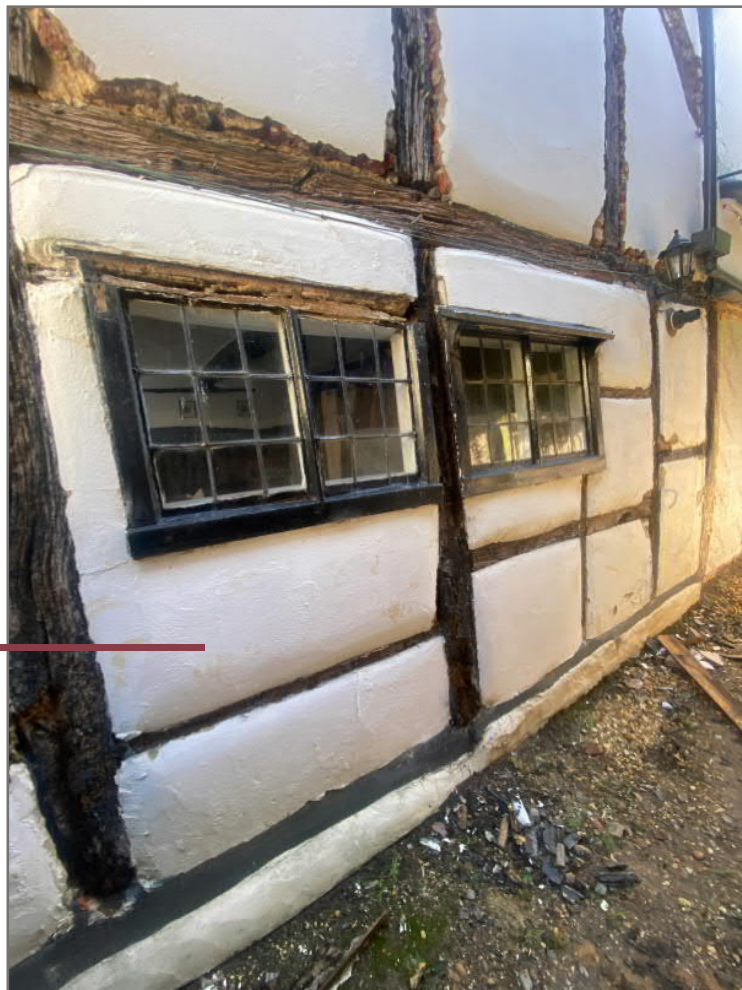
Brick and cement  
plaster protruding  
past the timber frame

Image 06: View of south elevation of west gable return -  
timber frame repairs due to be carried out as approved under  
application 260979

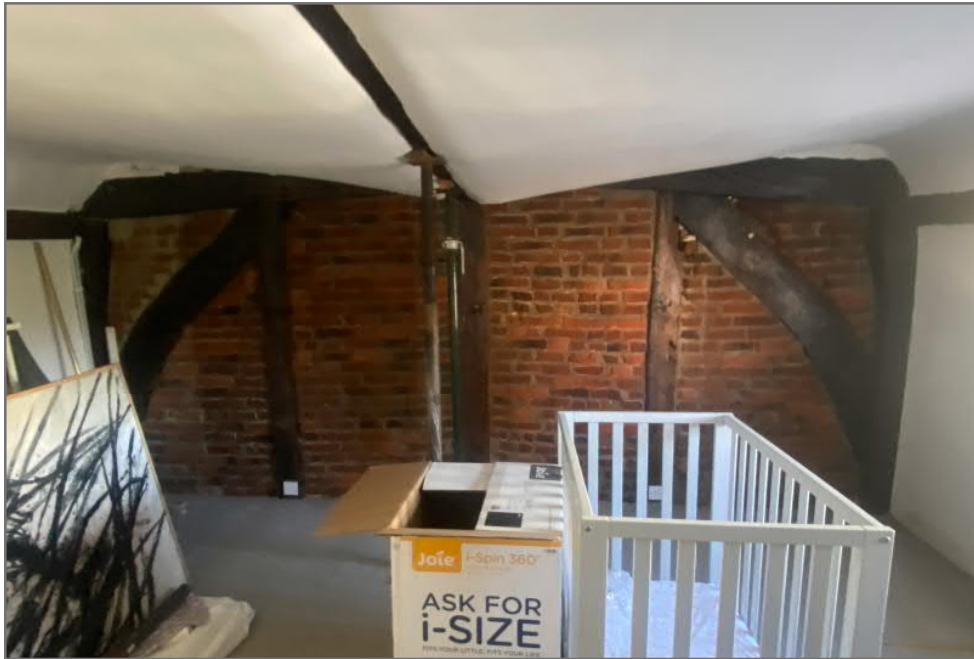
Image 09: View of brickwork to First Floor West gable

Additionally, the first floor brickwork infill panels have been repointed in cement internally making the bricks susceptible to retaining moisture within the bricks, rather than being wicked away from the joints - refer to Image 09.

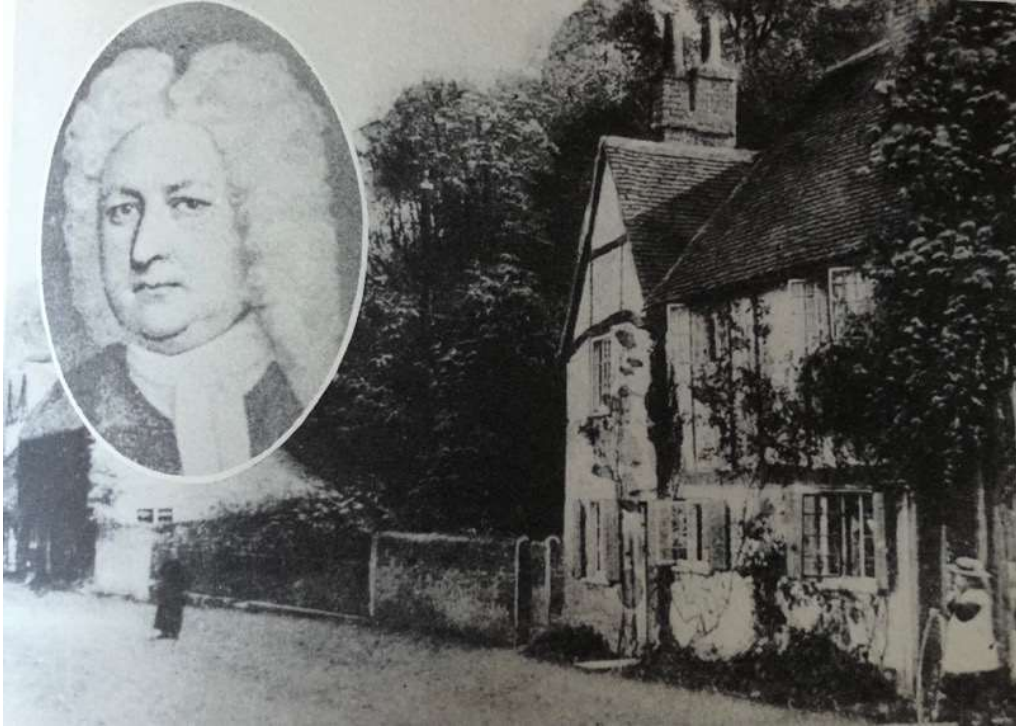
The Old Cottage, late 19<sup>th</sup> century, Source: *The Book of Sonning* by Angela Perkins, 1977

The above photo shows the majority of the front elevation. From this we can clearly see past alterations to the front boundary giving way to the driveway and garage addition to the east. All of the window frames appear to be a light colour (externally) or a broken white as brilliant white was not commonly used until post 1920 following the advent of titanium oxide. The ground floor windows also appear to have shutters now lost and the east wing is shown without the applied facing timbers to the first floor.

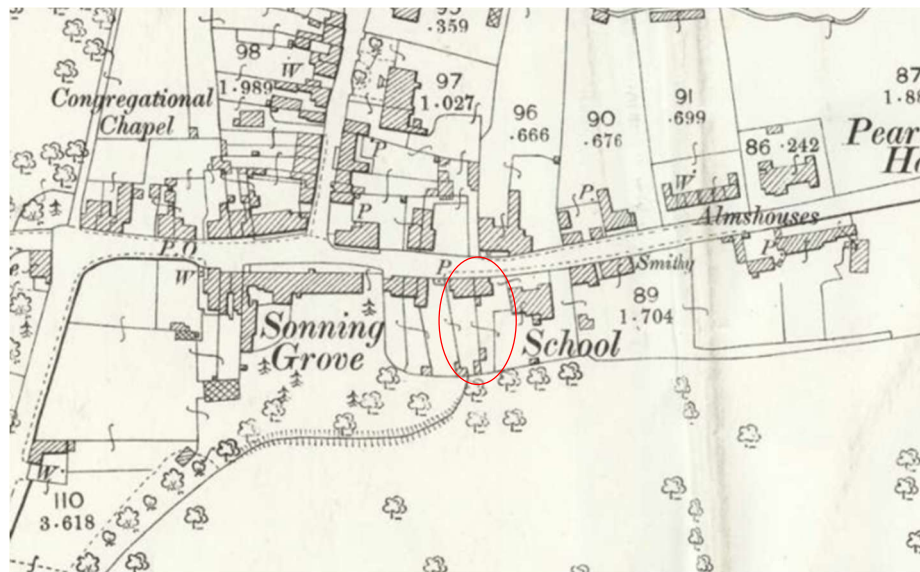
Source: National Library of Scotland, Extract from historic OS Map (1875) – The Old Cottage highlighted in red

The extract above from the 1875 OS map shows The Old Cottage which appears to be split into two distinct units/sites at that time and without the current rear additions to the south elevation. There is very little change in the 1911 and 1932 edition OS maps except the loss of some smaller attached and detached out buildings. The 1932 mapping shown below appears to show the two units as one with the centre boundary treatment removed and still no additions to the rear. Interestingly the 1932 historic map on page 11 of the Sonning Conservation Area Appraisal (unsourced) shows the kitchen and utility room additions to the rear which may indicate their addition at this point?

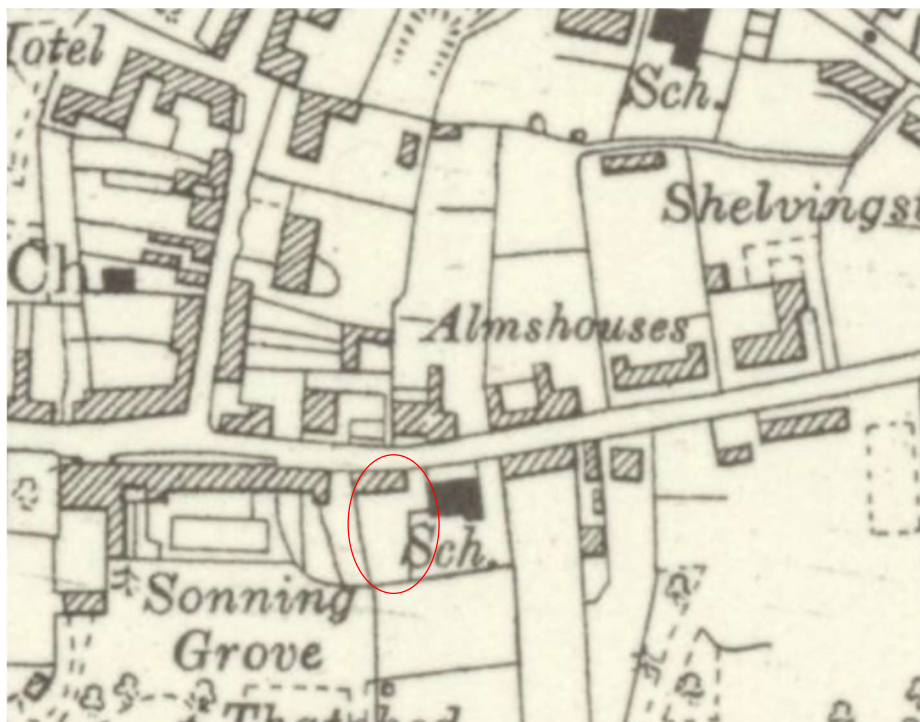
Source: National Library of Scotland, Extract from historic OS Map (1932) – The Old Cottage highlighted in red
