PROJECT: Loddon Garden Village

MAP 11.19.3g Baseline Linear Habitats (North-West)

MAP 11.19.3i Baseline Watercourses

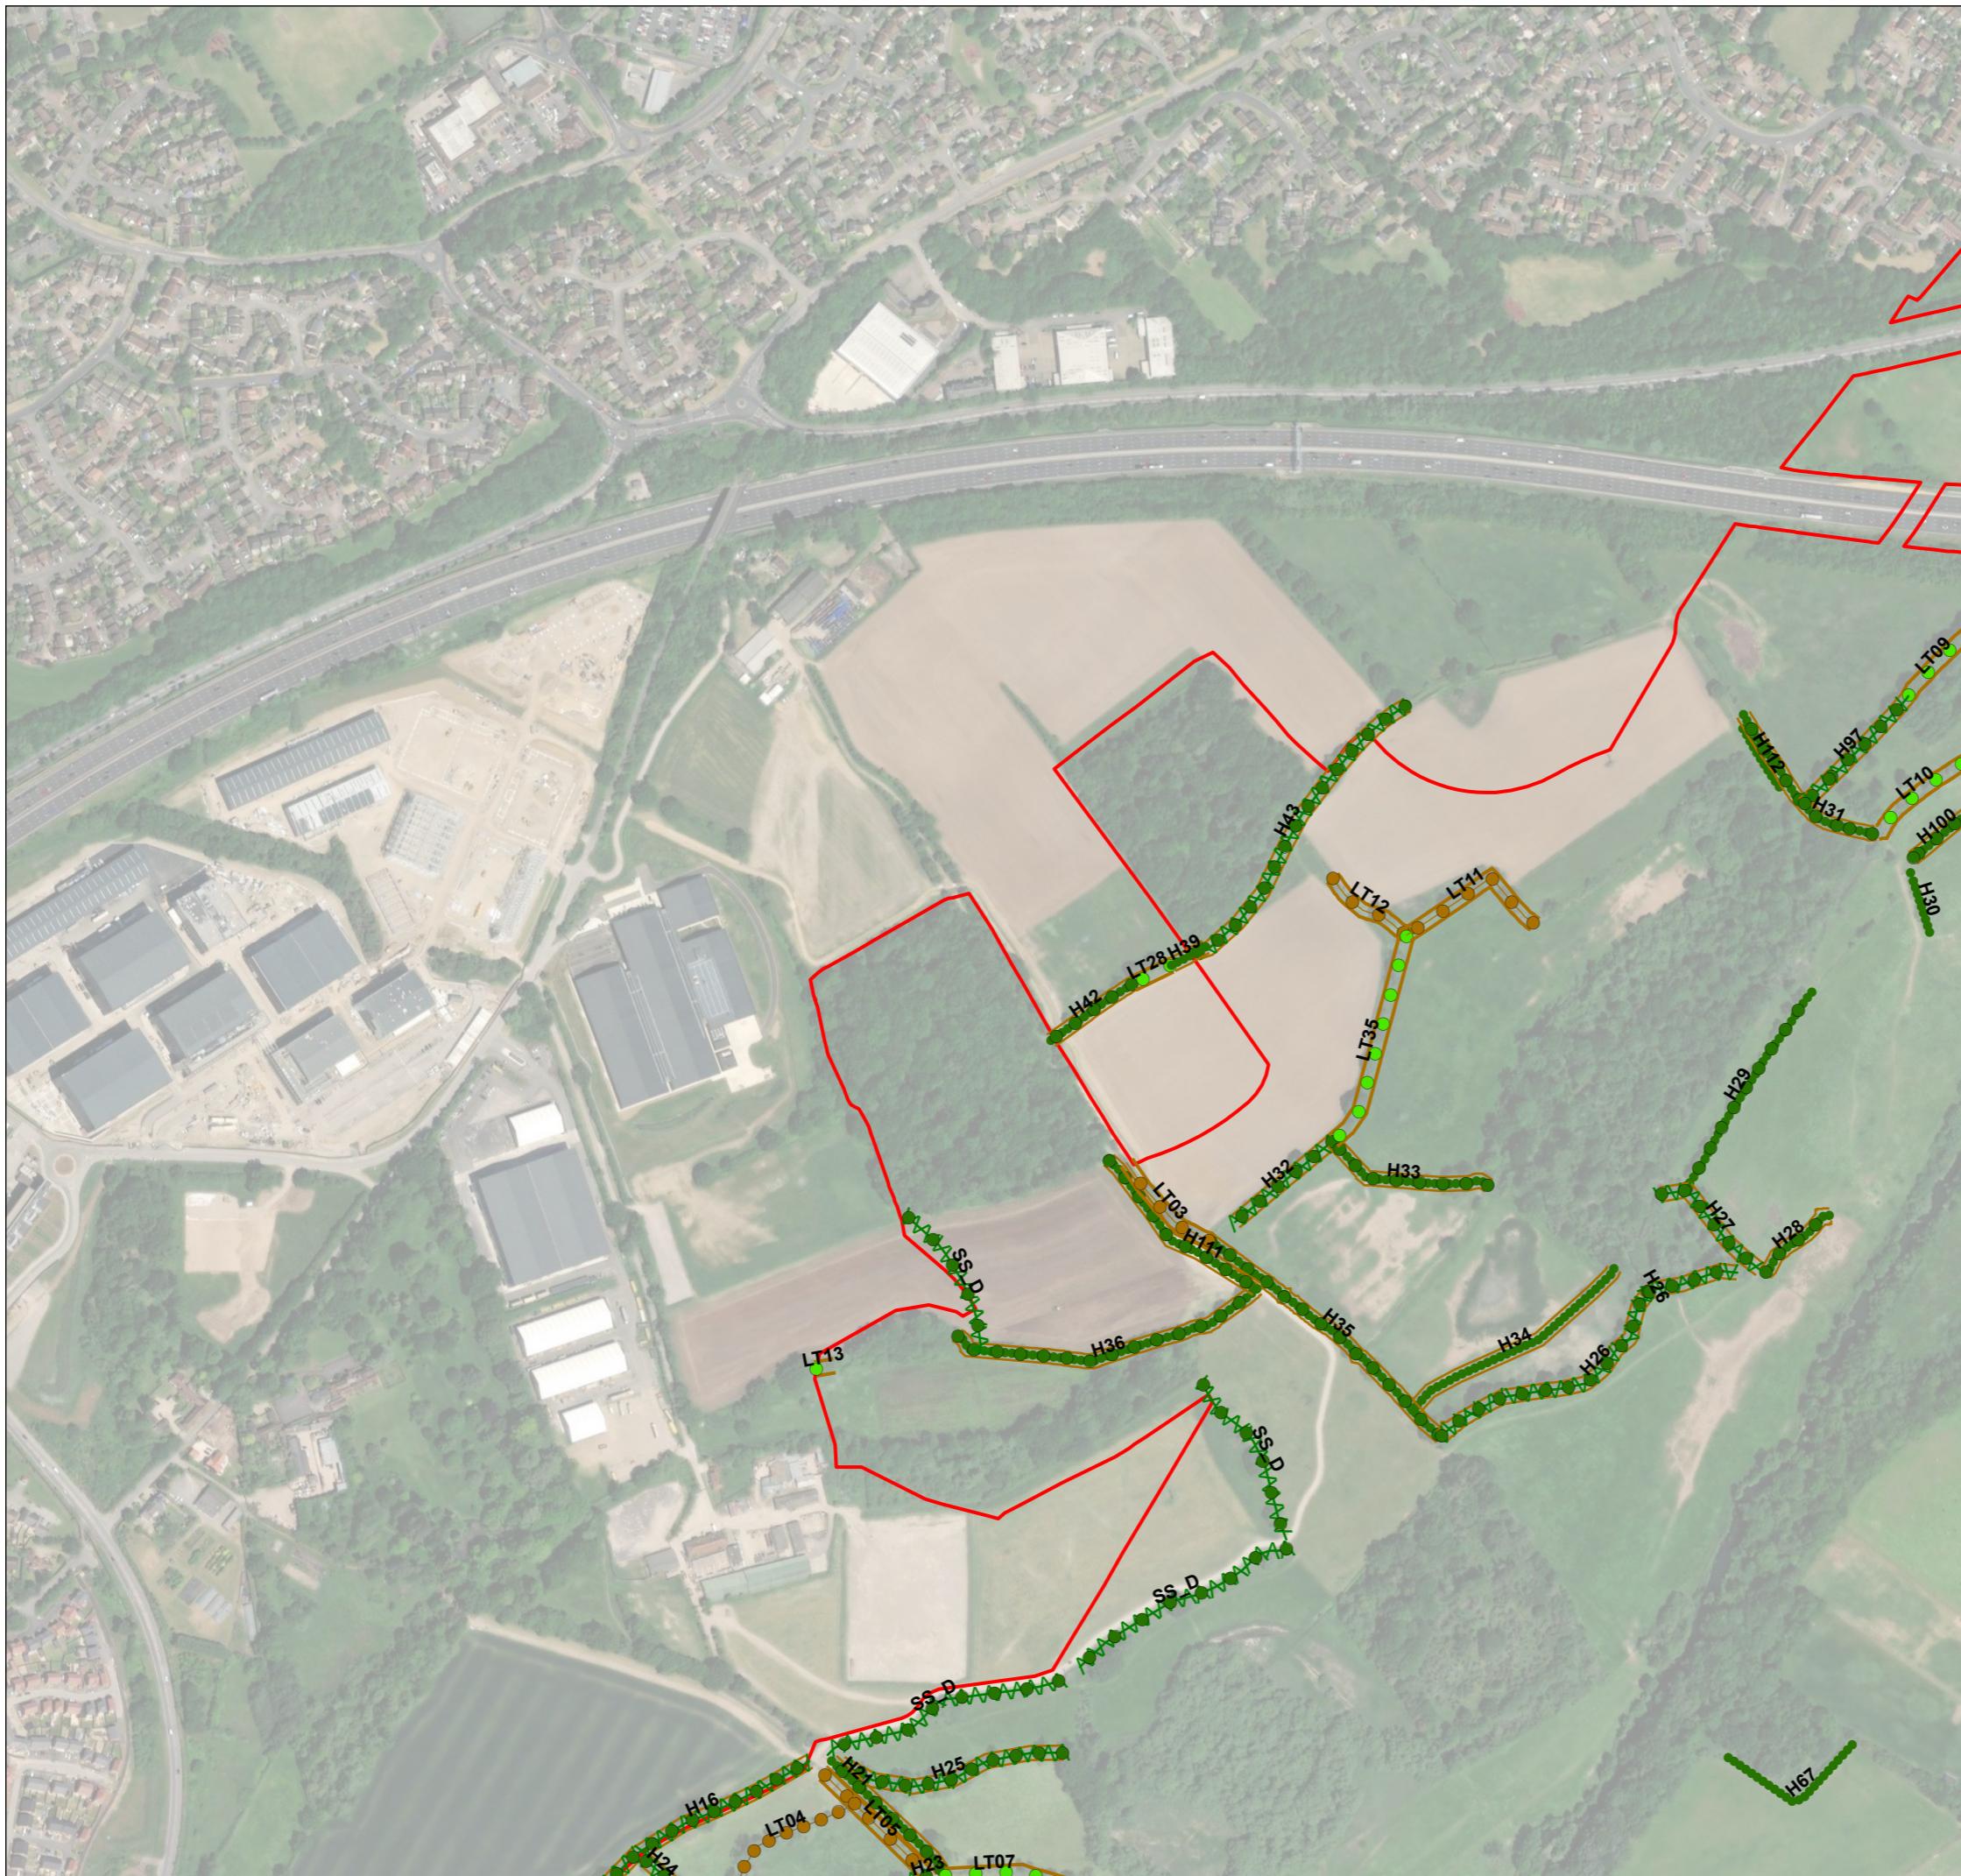
- Site boundary
- Species-rich native hedgerow with trees - associated with bank or ditch
- Species-rich native hedgerow with trees
- Native hedgerow with trees - associated with bank or ditch
- Native hedgerow - associated with bank or ditch
- Native hedgerow with trees
- Ecologically valuable line of trees - associated with bank or ditch
- Native hedgerow
- Line of trees
- Line of trees - associated with bank or ditch

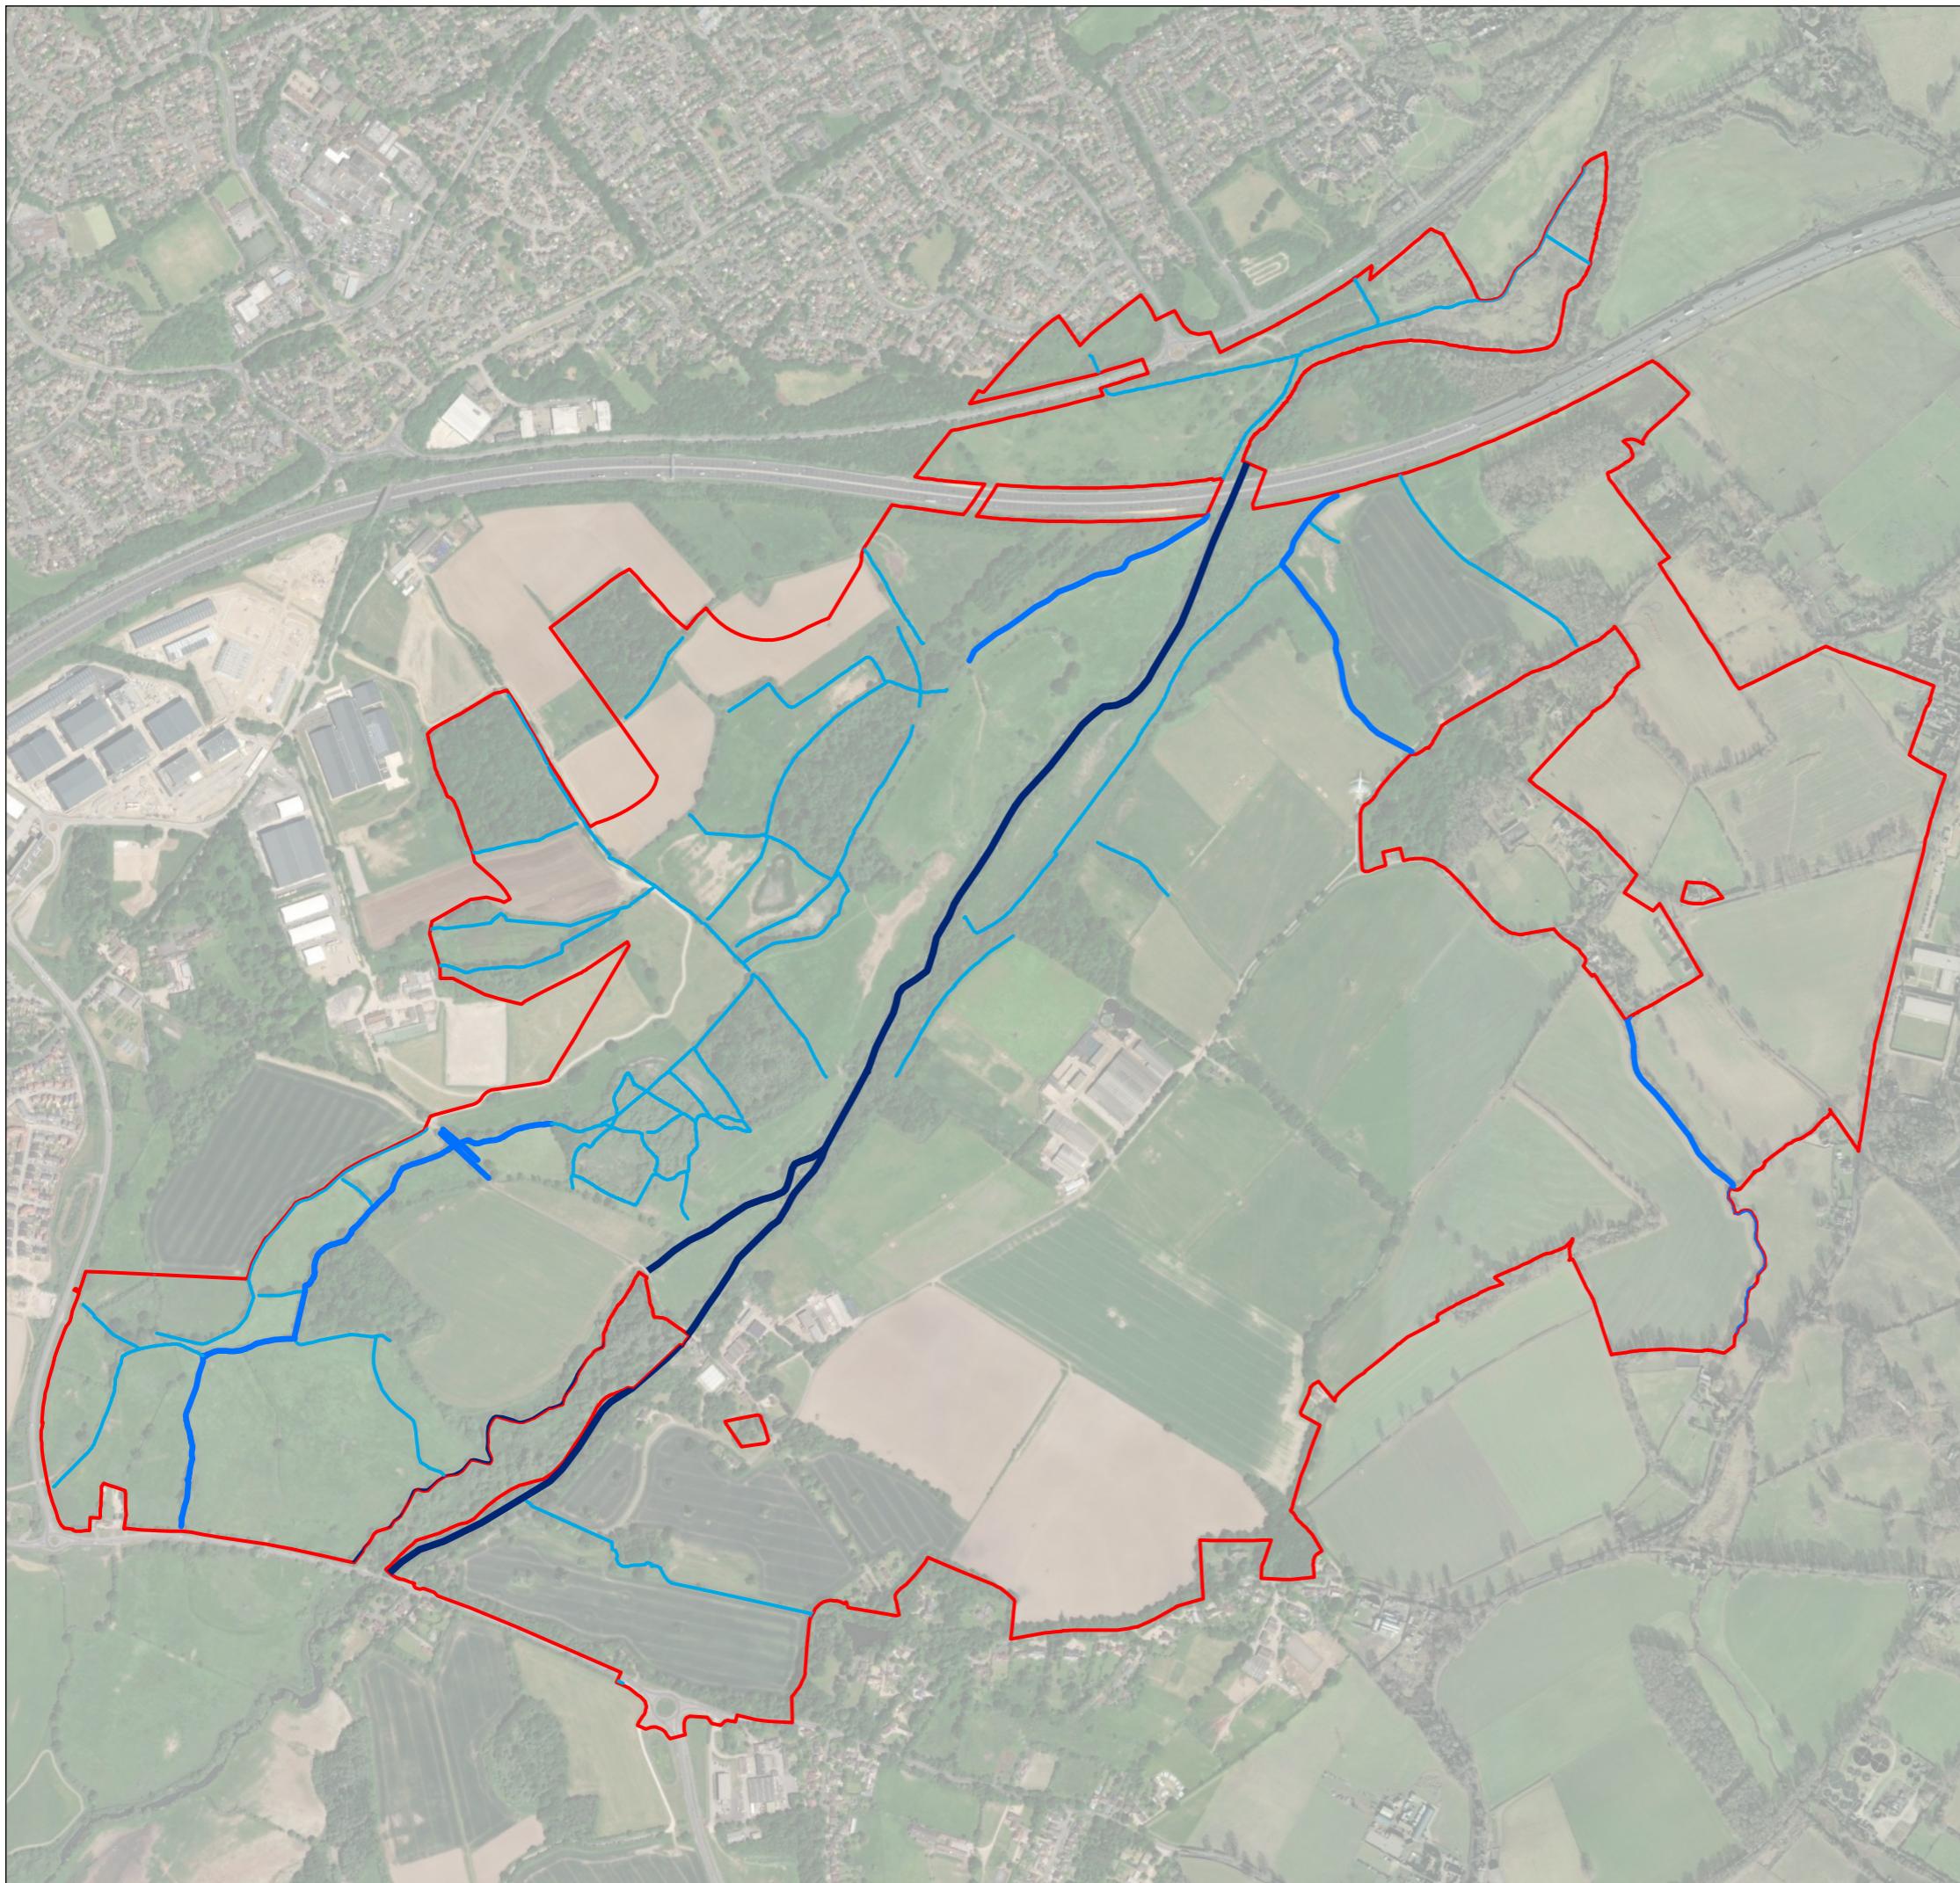
- Site boundary
- Rivers (Priority habitat)
- Other rivers and streams
- Ditches

Four watercourses requiring River Condition Assessment (RCA) have been identified for inclusion within the watercourse category of the Statutory Biodiversity Metric. These are:

Whilst designated as a main river, watercourse D70 (also known as the ‘Arborfield Cut’) (see **Map 11.19-A1**) has been assessed as a ditch based on field conditions. The channel is dry for much of the year and appears to provide seasonal drainage for the surrounding arable fields. Unlike the watercourses listed above, the ditch is not shown on historic maps dating from 1873 indicating it is a more recent addition into the local landscape. It is therefore considered to meet the criteria to be classified as a ditch as a ‘artificially created linear water-conveyancing feature’ of less than 5m in width.

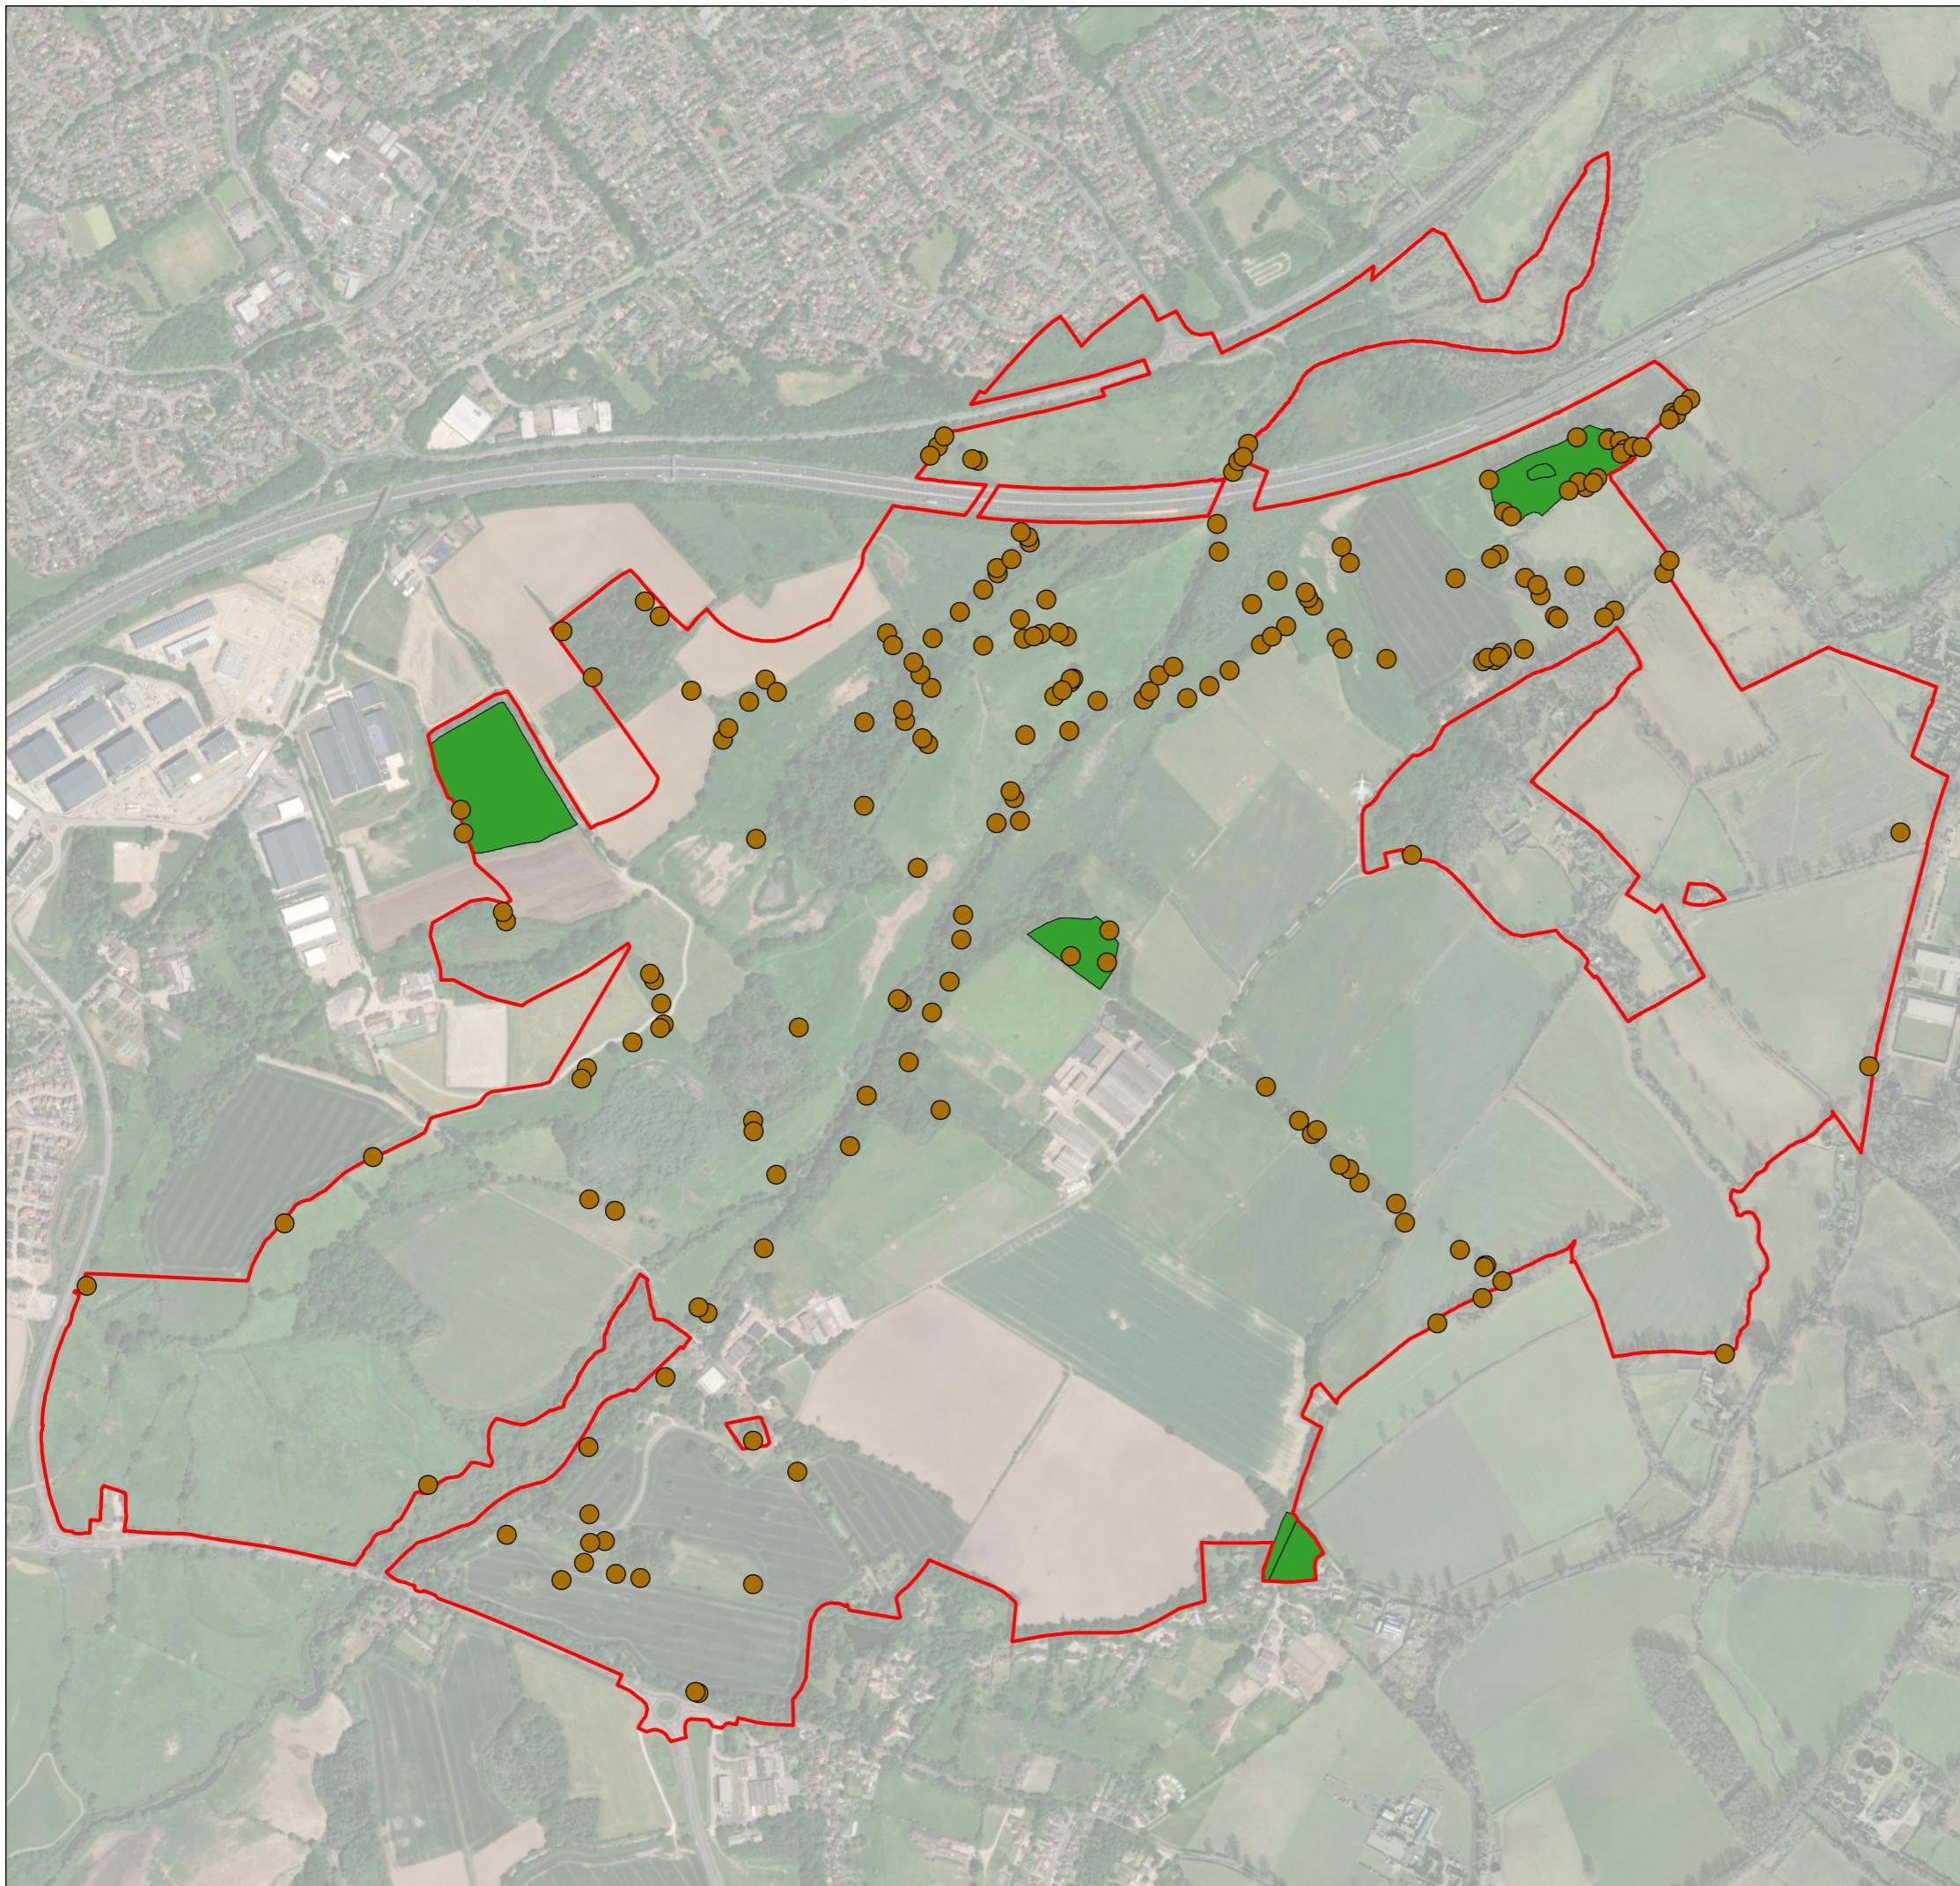
MAP 11.19.5 Baseline Irreplaceable Habitats

Site boundary

Veteran trees

Provisional Ancient Woodland
