**Geotechnical and Geo-Environmental Report**

**Land Adj. Park Lane**

**Charvil**

**Report No: 25-07-12**

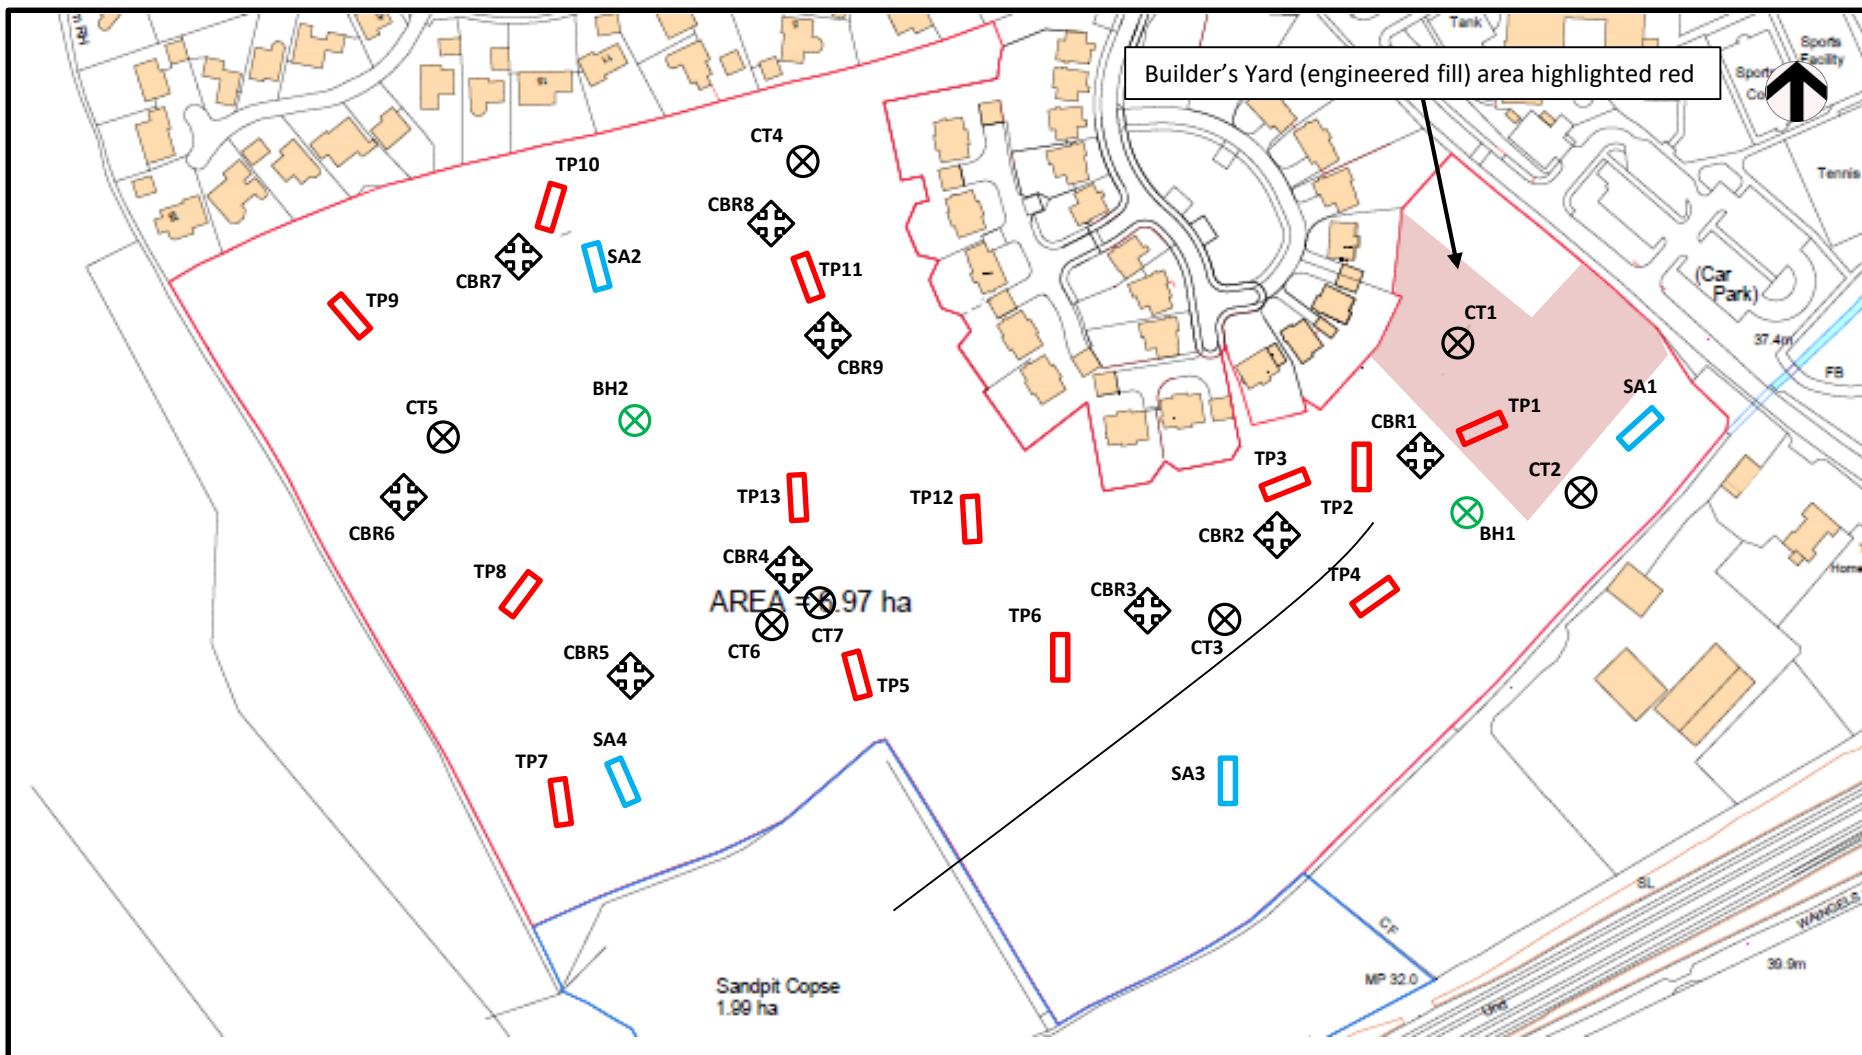
# Key

- Trial Pit
- Continuous Tube Borehole
- Soakaway Pit
- CBR Test
- Cable Percussive BH

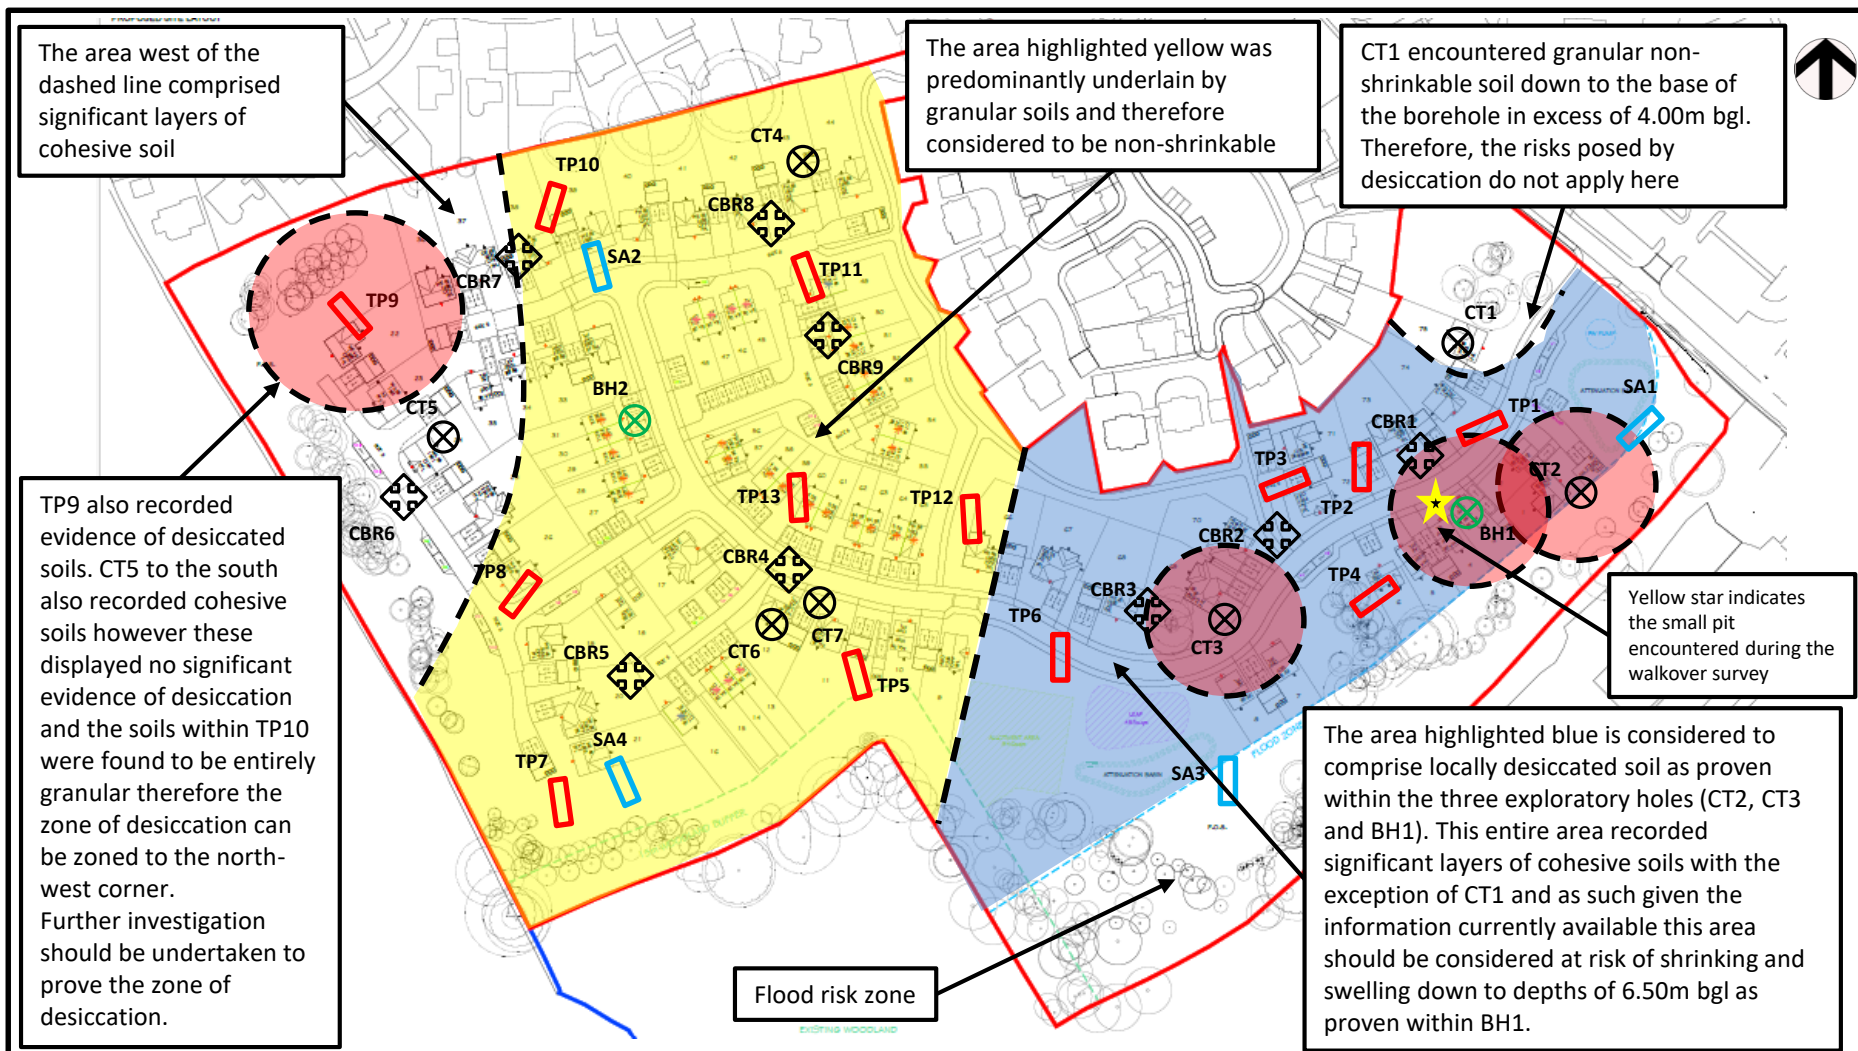
| <b>Key</b><br>Trial Pit<br>Continuous Tube Borehole<br>Soakaway Pit<br>CBR Test<br>Cable Percussive BH | Geological Plan | SITE:- Park Lane, Charvil | Drawn LA |

The western half of the site highlighted yellow on the geological plan in Appendix A is predominantly underlain by granular soils considered to be non-shrinkable, and as such, conventional shallow foundations are considered viable. However, foundations should be reinforced to combat potential differential settlement caused by foundations crossing both granular and cohesive soil

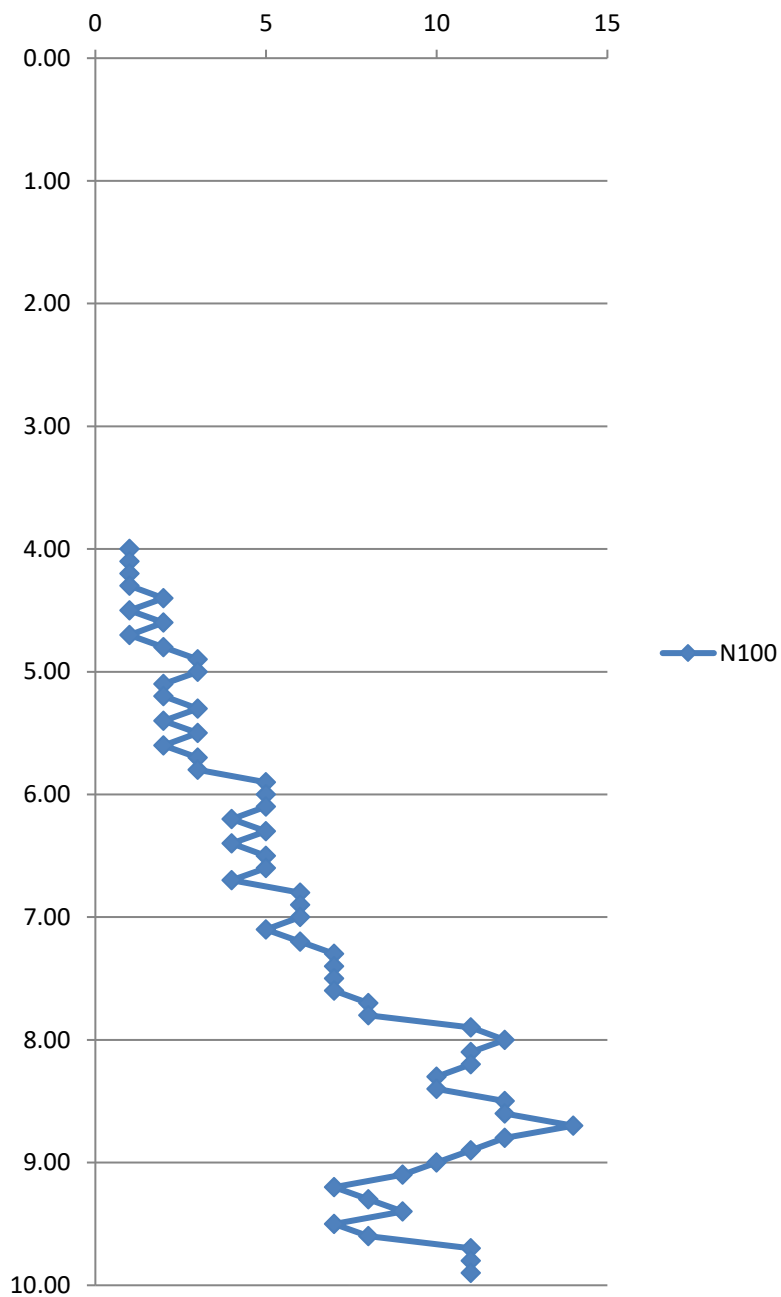
### N100

EASTINGS 477661.6  
NORTHINGS 175236.0  
HAMMER WEIGHT 63.5KG  
HAMMER DROP 0.76m

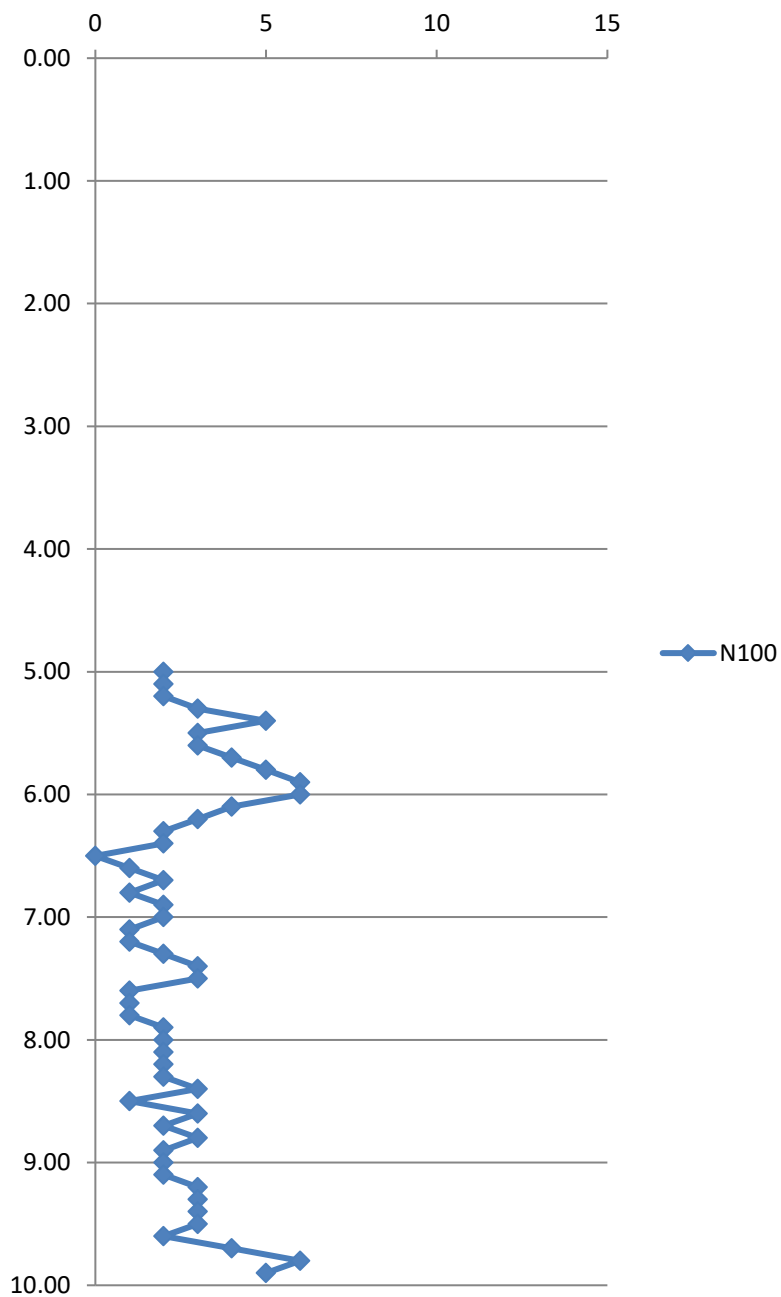
### N100

## SUPER HEAVY DYNAMIC PROBE - P2 (CT2)

EASTINGS 477690.7  
NORTHINGS 175194.8  
HAMMER WEIGHT 63.5KG  
HAMMER DROP 0.76m

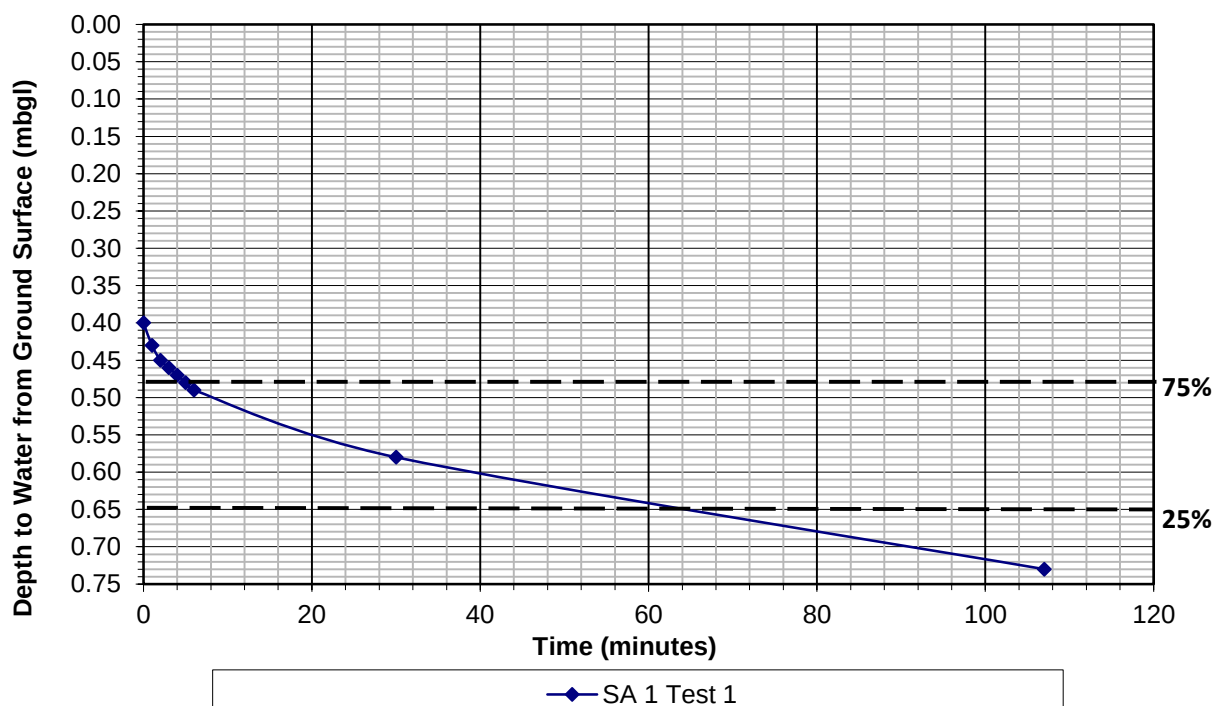
## Trial Pit Infiltration Testing to BRE Digest 365

**Soil Infiltration Rate:  $2.44 \times 10^{-5}$  m/s**

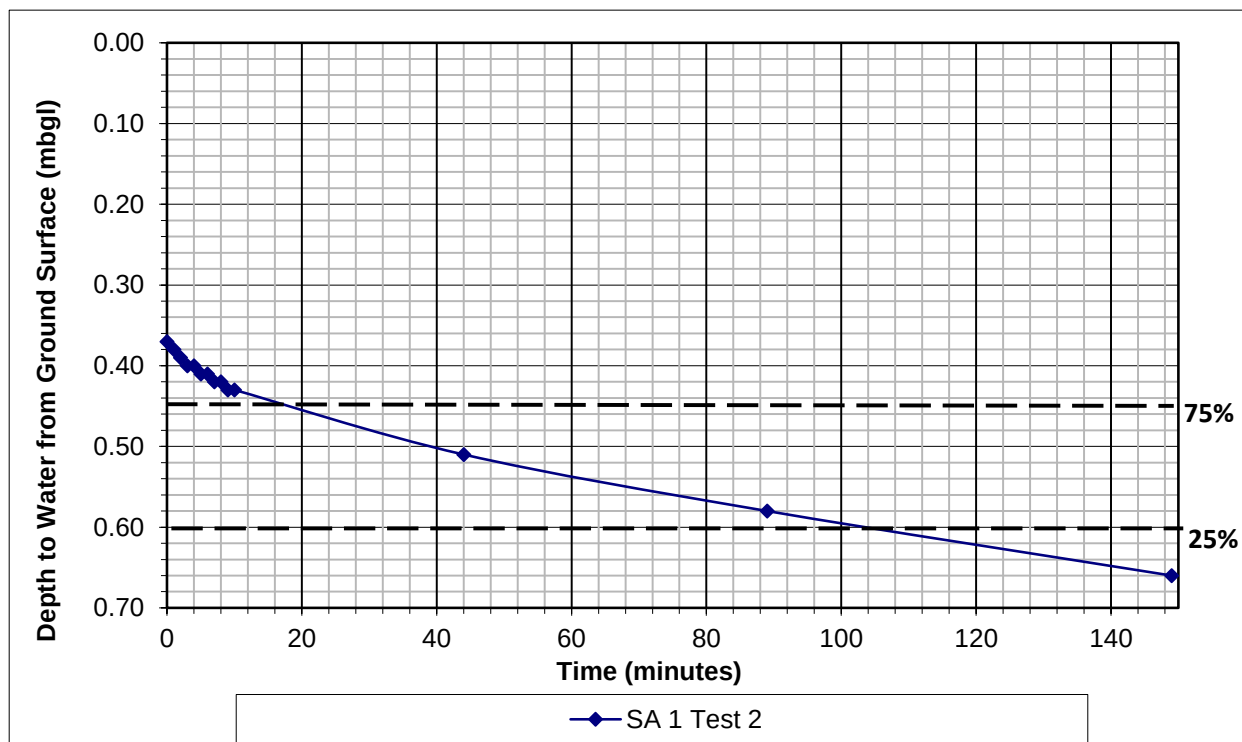
### Trial Pit Infiltration Testing to BRE Digest 365

**Client:** Bellway Thames  
**Site:** Park Lane, Charvil  
**Dimensions:** 0.50m x 1.50m x 0.68m  
(width x length x depth)

Soil Infiltration Rate:  $1.64 \times 10^{-5}$  m/s

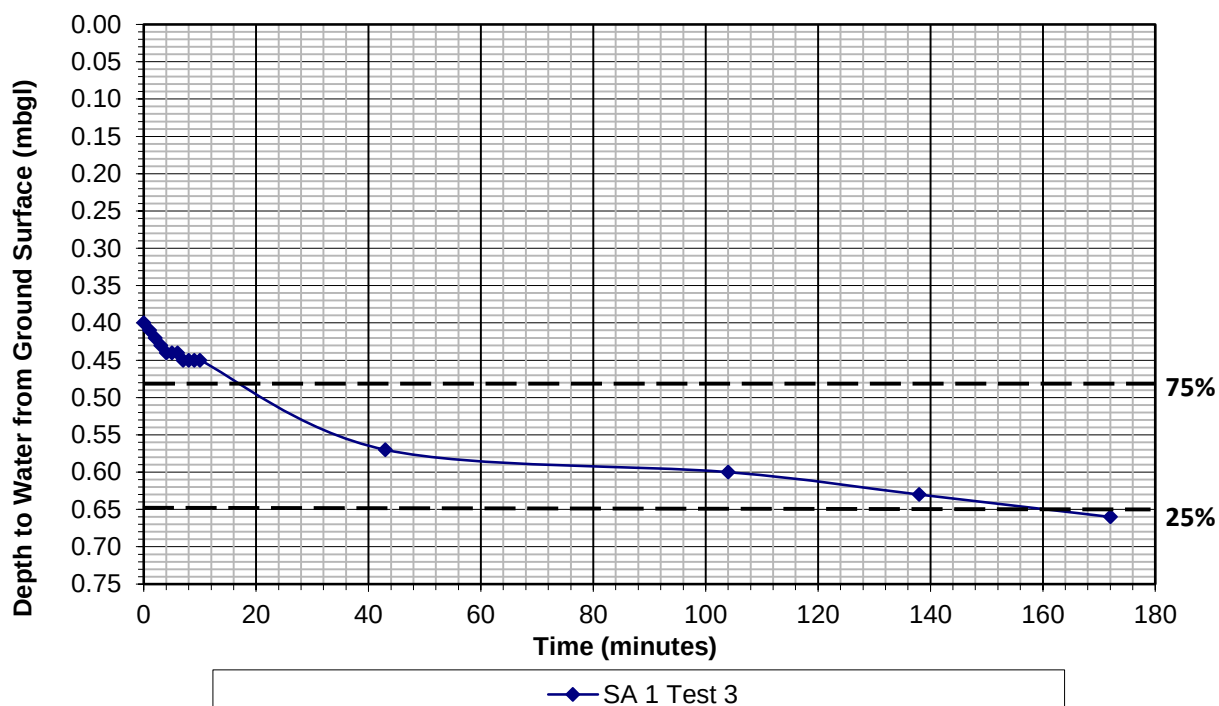
## Trial Pit Infiltration Testing to BRE Digest 365

**Client:** Bellway Thames  
**Site:** Park Lane, Charvil  
**Dimensions:** 0.50m x 1.50m x 0.73m  
(width x length x depth)

**Soil Infiltration Rate:  $9.88 \times 10^{-6}$  m/s**

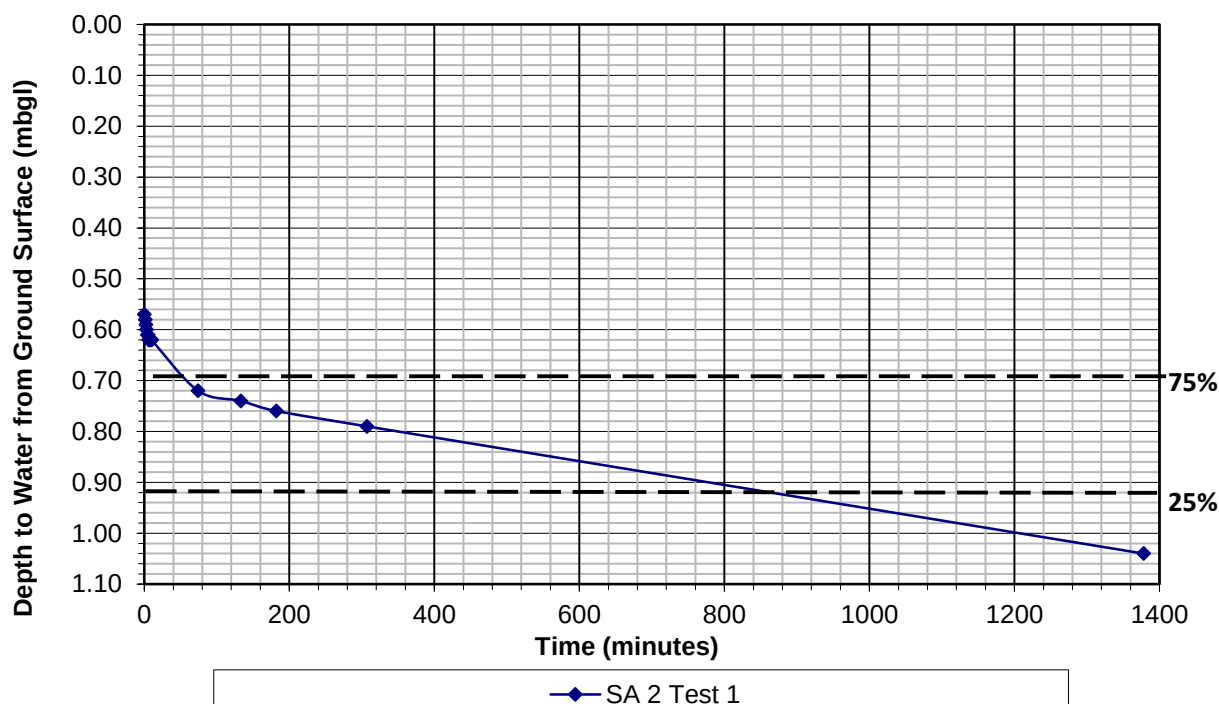
## Trial Pit Infiltration Testing to BRE Digest 365

**Client:** Bellway Thames  
**Site:** Park Lane, Charvil  
**Dimensions:** 0.50m x 1.50m x 1.04m  
(width x length x depth)

**Soil Infiltration Rate:  $2.12 \times 10^{-6}$  m/s**

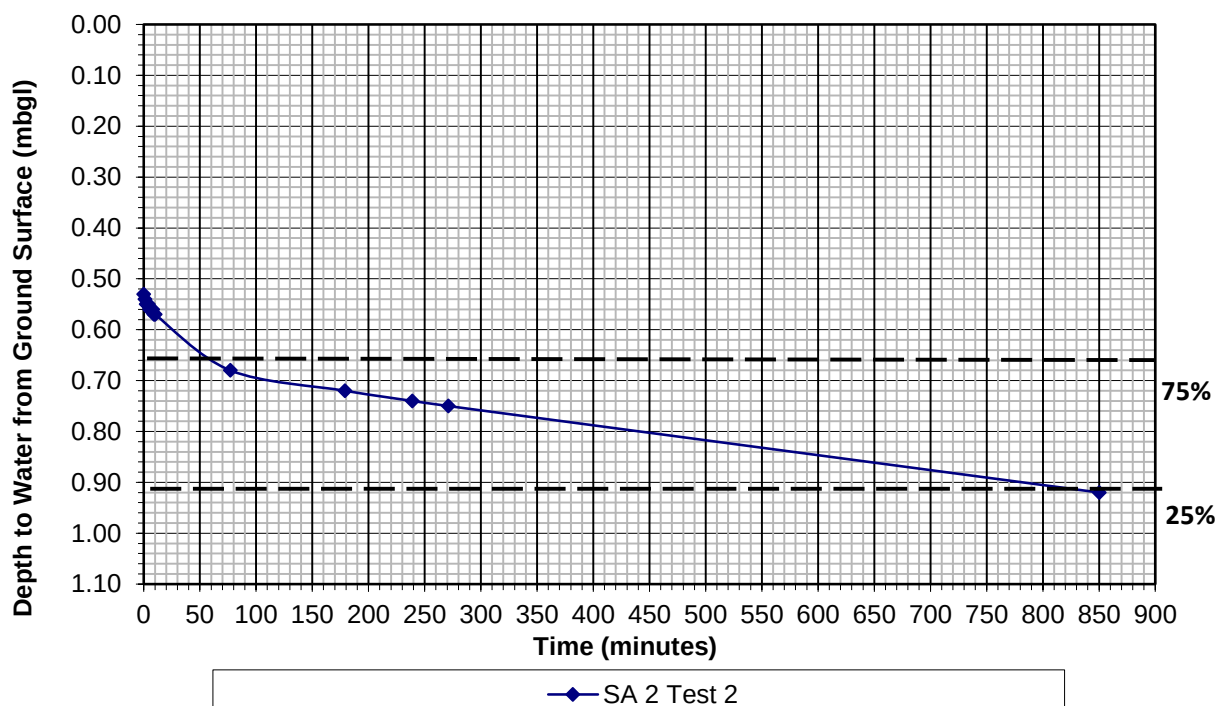
## Trial Pit Infiltration Testing to BRE Digest 365

**Client:** Bellway Thames  
**Site:** Park Lane, Charvil  
**Dimensions:** 0.50m x 1.50m x 1.04m  
(width x length x depth)

**Soil Infiltration Rate:  $2.37 \times 10^{-5}$  m/s**

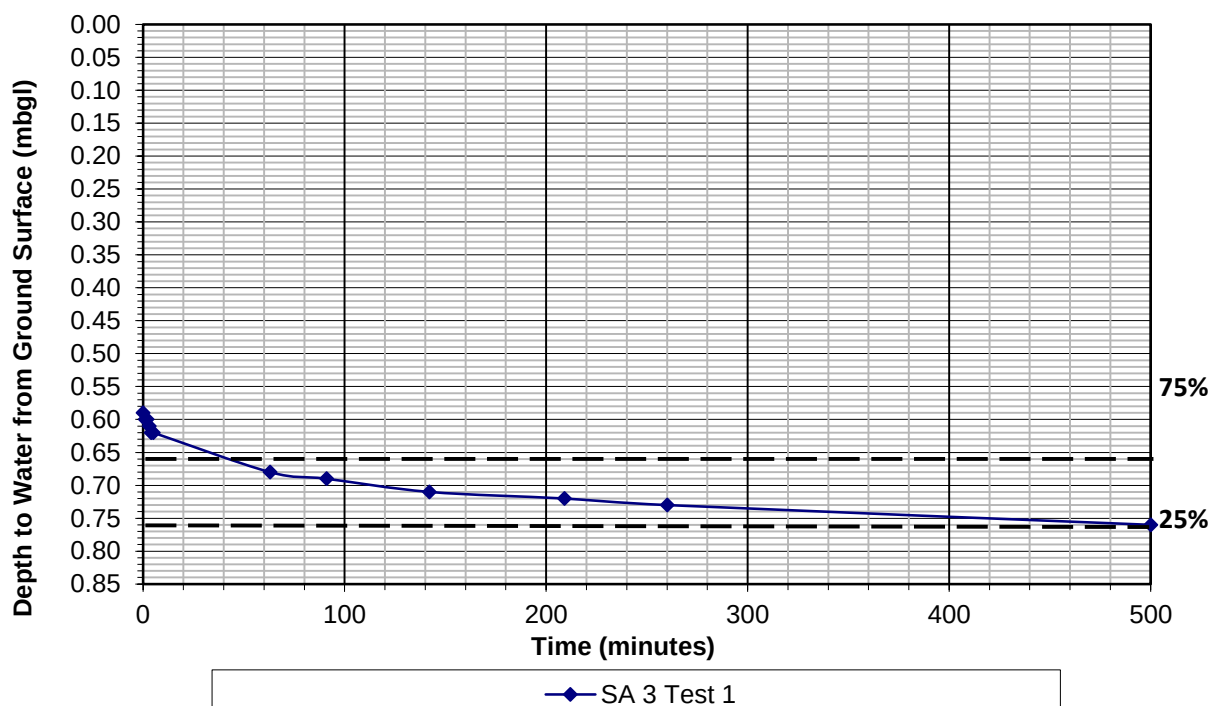
## Trial Pit Infiltration Testing to BRE Digest 365

**Client:** Bellway Thames  
**Site:** Park Lane, Charvil  
**Dimensions:** 0.50m x 1.45m x 0.85m  
(width x length x depth)

Soil Infiltration Rate:  $2.77 \times 10^{-6}$  m/s

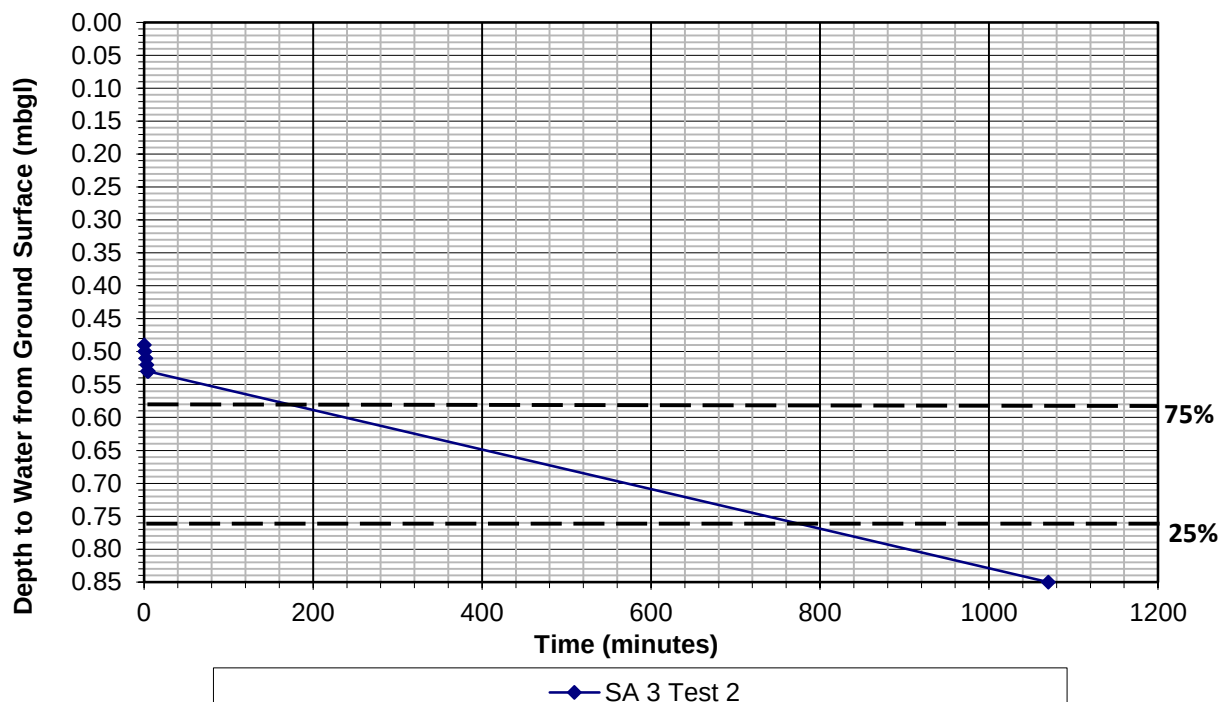
## Trial Pit Infiltration Testing to BRE Digest 365

**Client:** Bellway Thames  
**Site:** Park Lane, Charvil  
**Dimensions:** 0.50m x 1.45m x 0.85m  
(width x length x depth)

Soil Infiltration Rate:  $2.58 \times 10^{-6}$  m/s

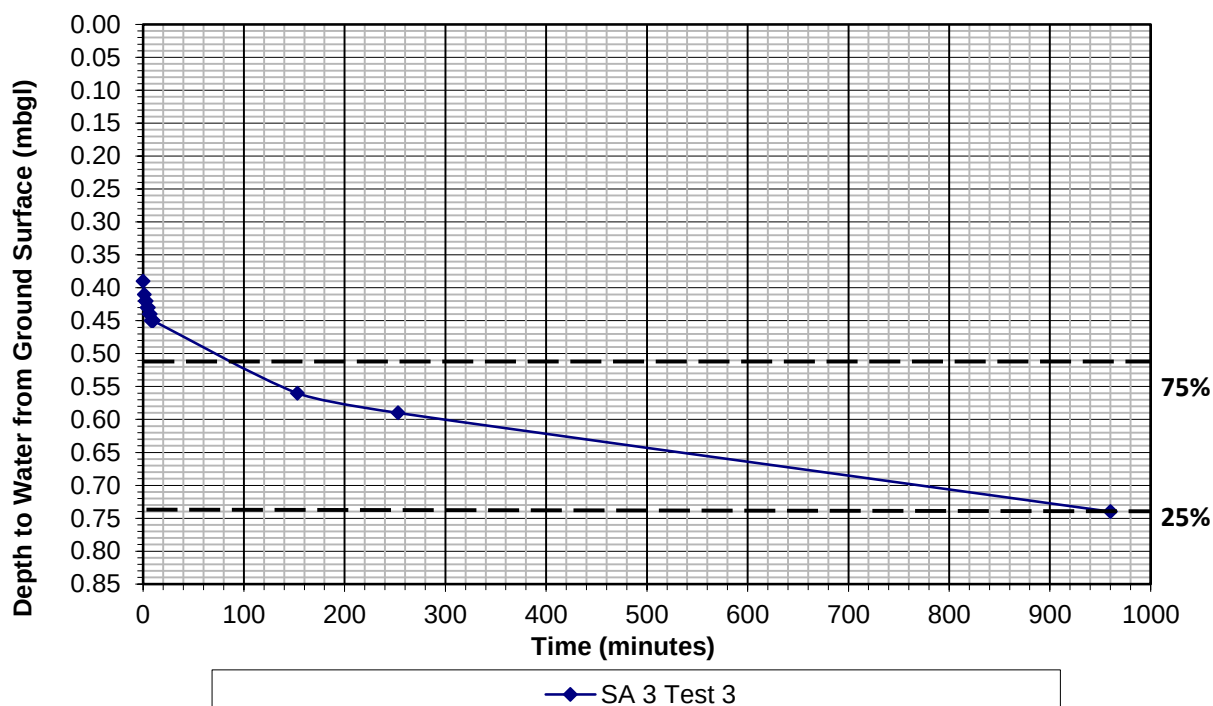
## Trial Pit Infiltration Testing to BRE Digest 365

**Client:** Bellway Thames  
**Site:** Park Lane, Charvil  
**Dimensions:** 0.50m x 1.45m x 0.85m  
(width x length x depth)

**Soil Infiltration Rate:  $1.97 \times 10^{-6}$  m/s**

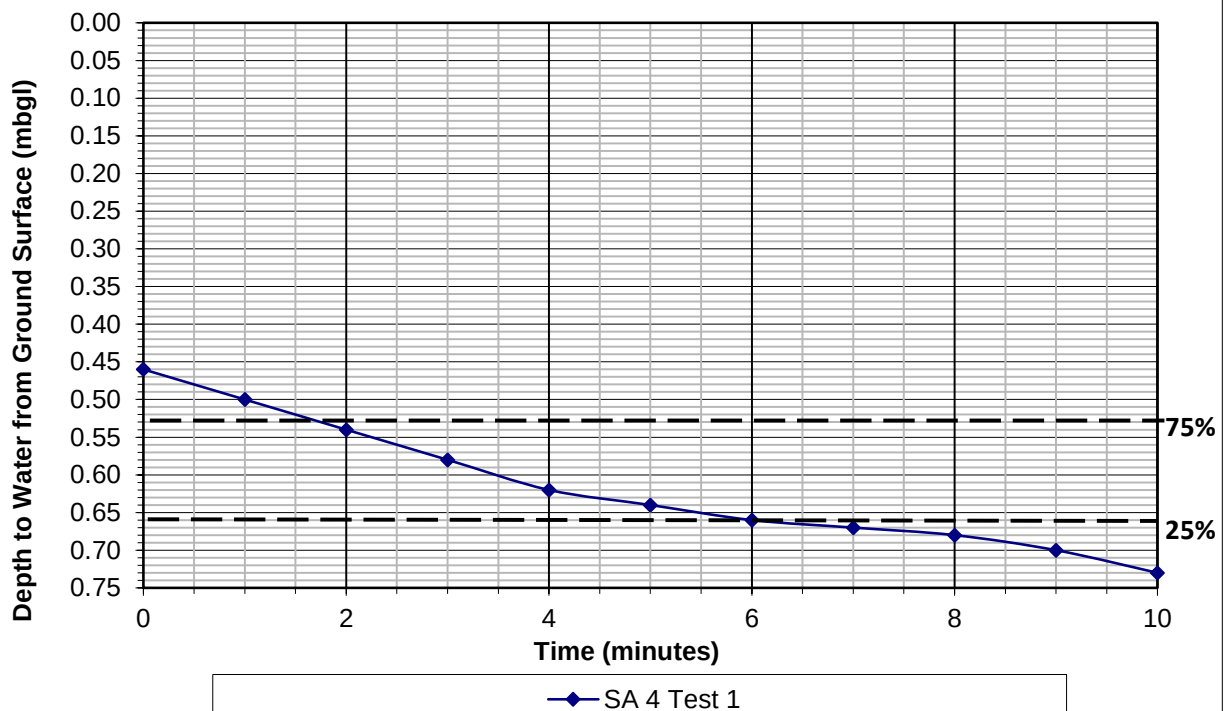
### Trial Pit Infiltration Testing to BRE Digest 365

**Client:** Bellway Thames  
**Site:** Park Lane, Charvil  
**Dimensions:** 0.50m x 1.30m x 0.73m  
 (width x length x depth)

Soil Infiltration Rate:  $3.03 \times 10^{-4}$  m/s

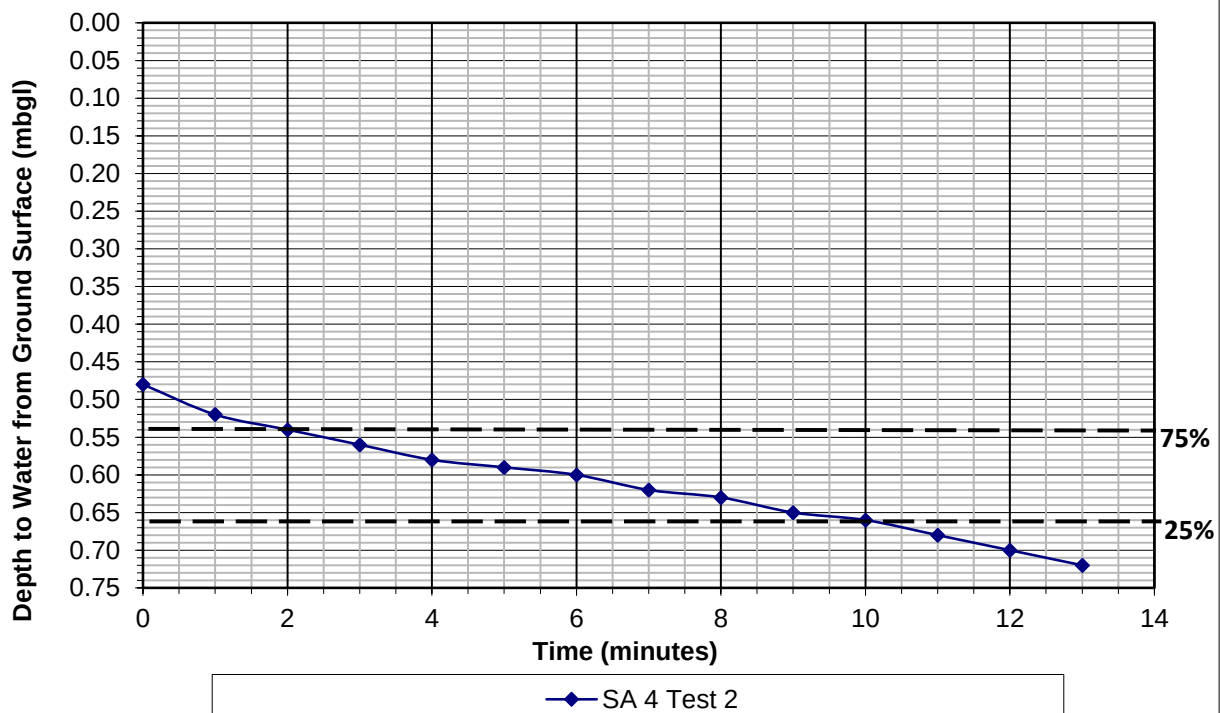
### Trial Pit Infiltration Testing to BRE Digest 365

**Client:** Bellway Thames  
**Site:** Park Lane, Charvil  
**Dimensions:** 0.50m x 1.30m x 0.72m  
(width x length x depth)

Soil Infiltration Rate:  $1.50 \times 10^{-4}$  m/s

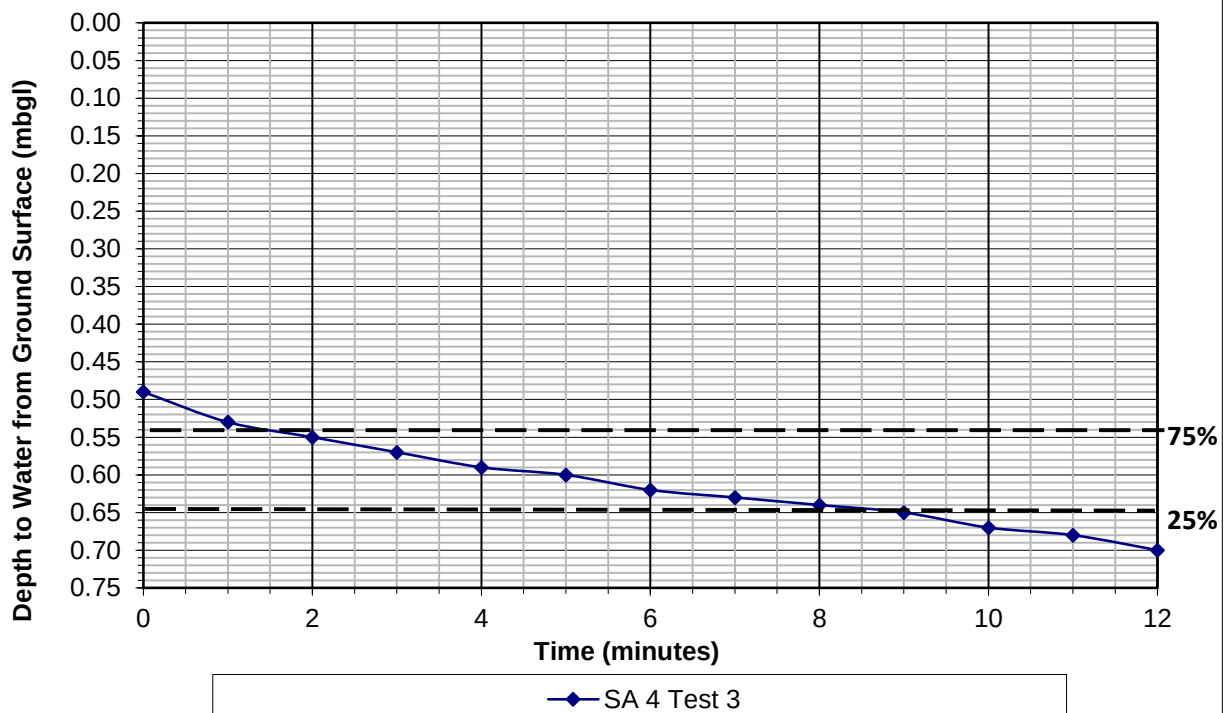
### Trial Pit Infiltration Testing to BRE Digest 365

**Client:** Bellway Thames  
**Site:** Park Lane, Charvil  
**Dimensions:** 0.50m x 1.30m x 0.70m  
 (width x length x depth)

Soil Infiltration Rate:  $1.48 \times 10^{-4}$  m/s

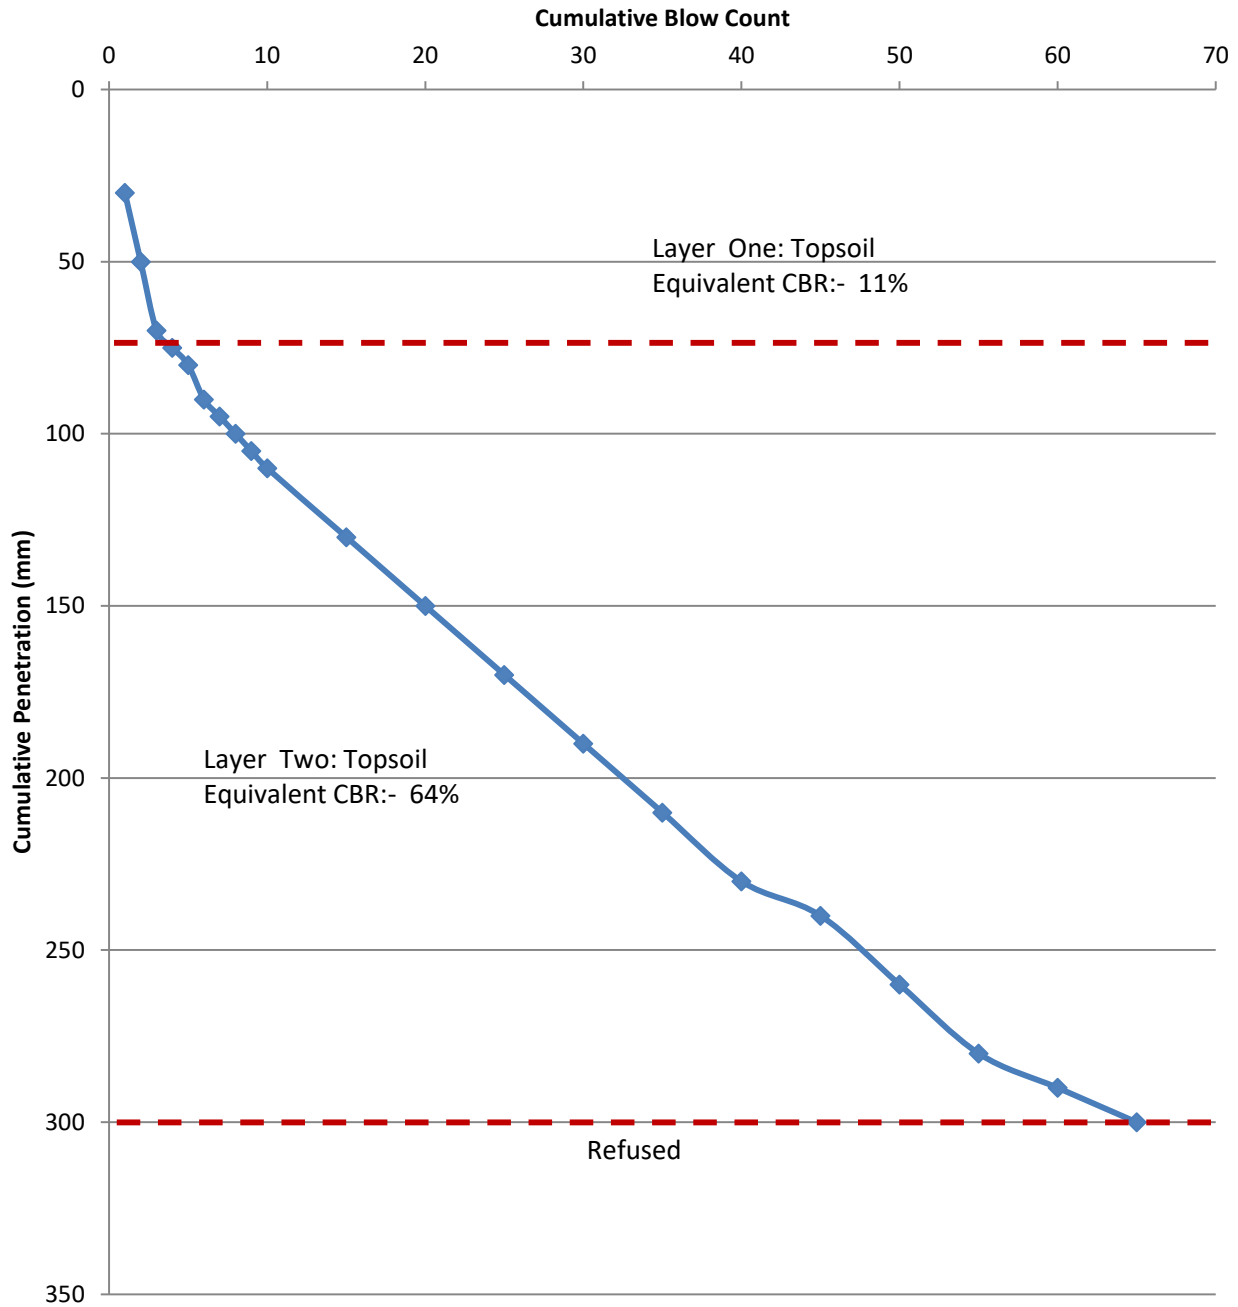
**TRL DYNAMIC CONE PENETROMETER RECORD**

Depth below ground level at start of test:- 0.0m

**Cumulative Blows Vs Penetration (mm)**

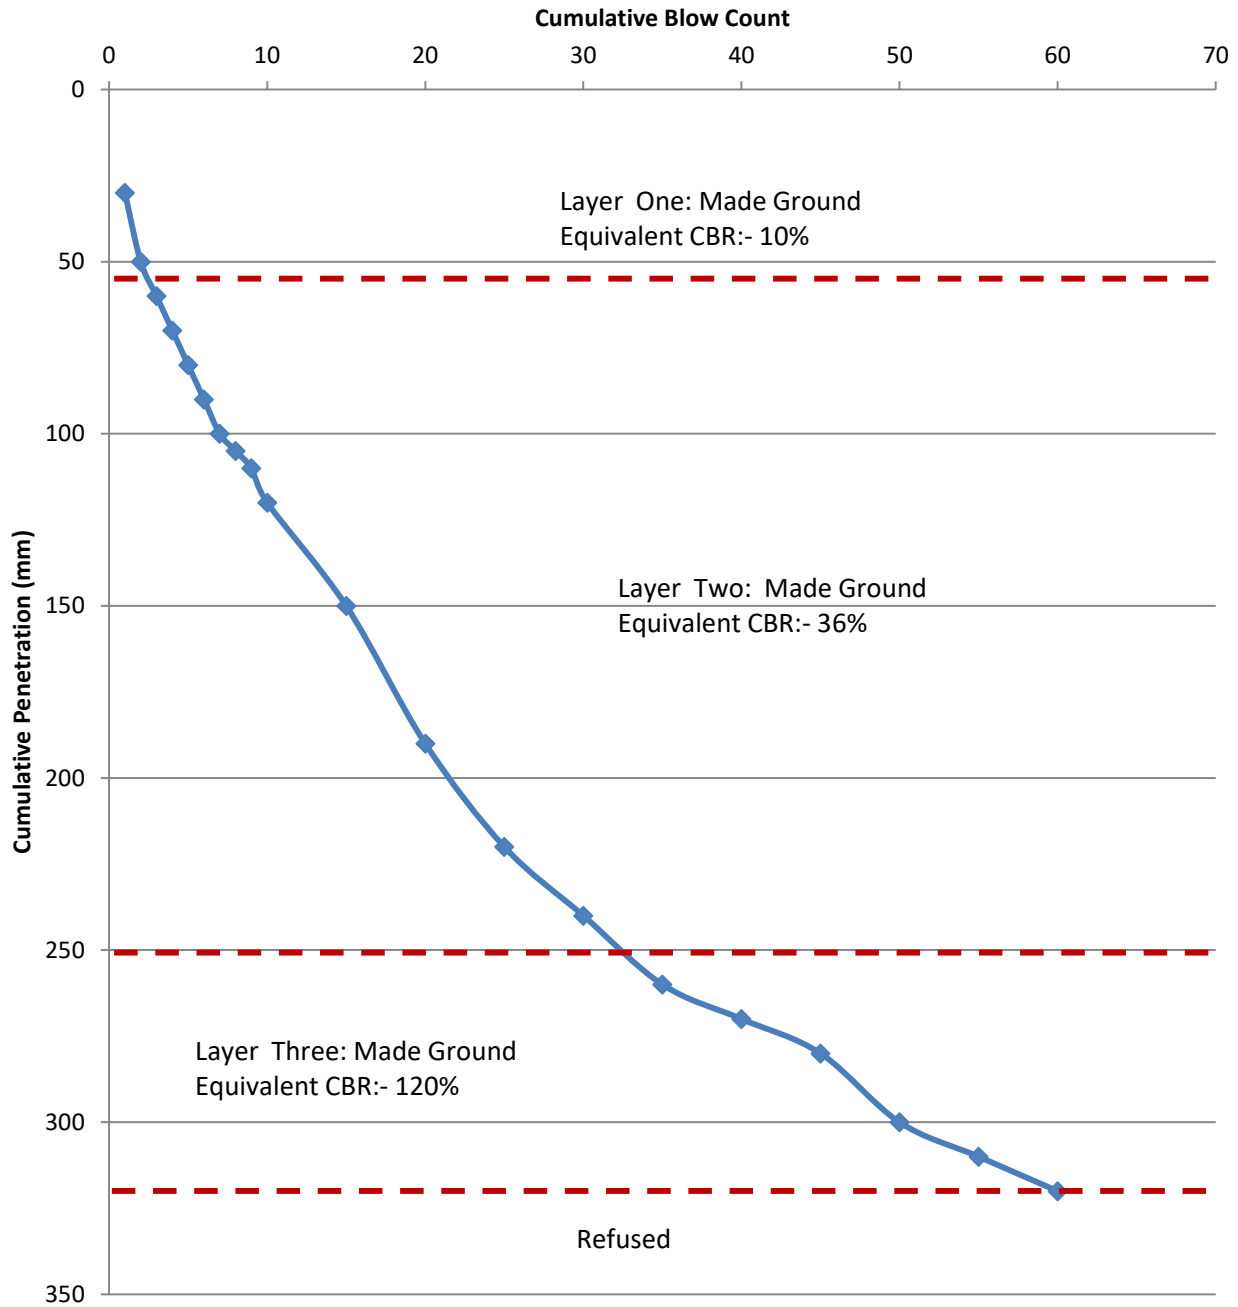
## TRL DYNAMIC CONE PENETROMETER RECORD

Depth below ground level at start of test:- 0.0m

### Cumulative Blows Vs Penetration (mm)

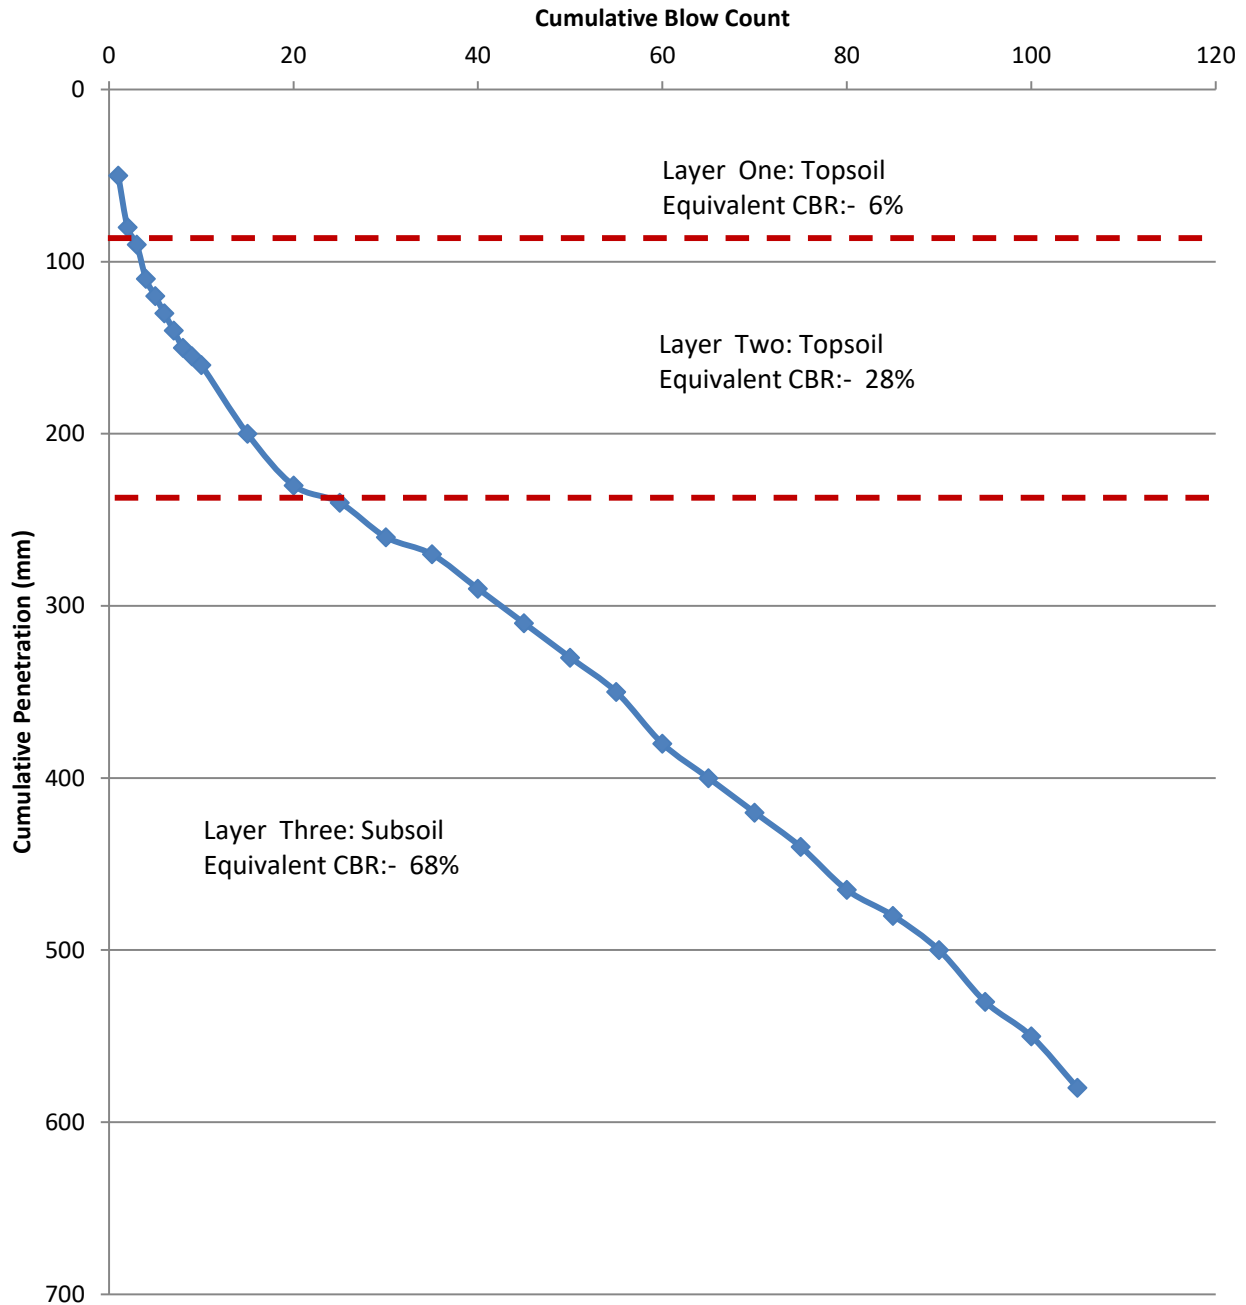
## TRL DYNAMIC CONE PENETROMETER RECORD

Depth below ground level at start of test:- 0.0m

### Cumulative Blows Vs Penetration (mm)

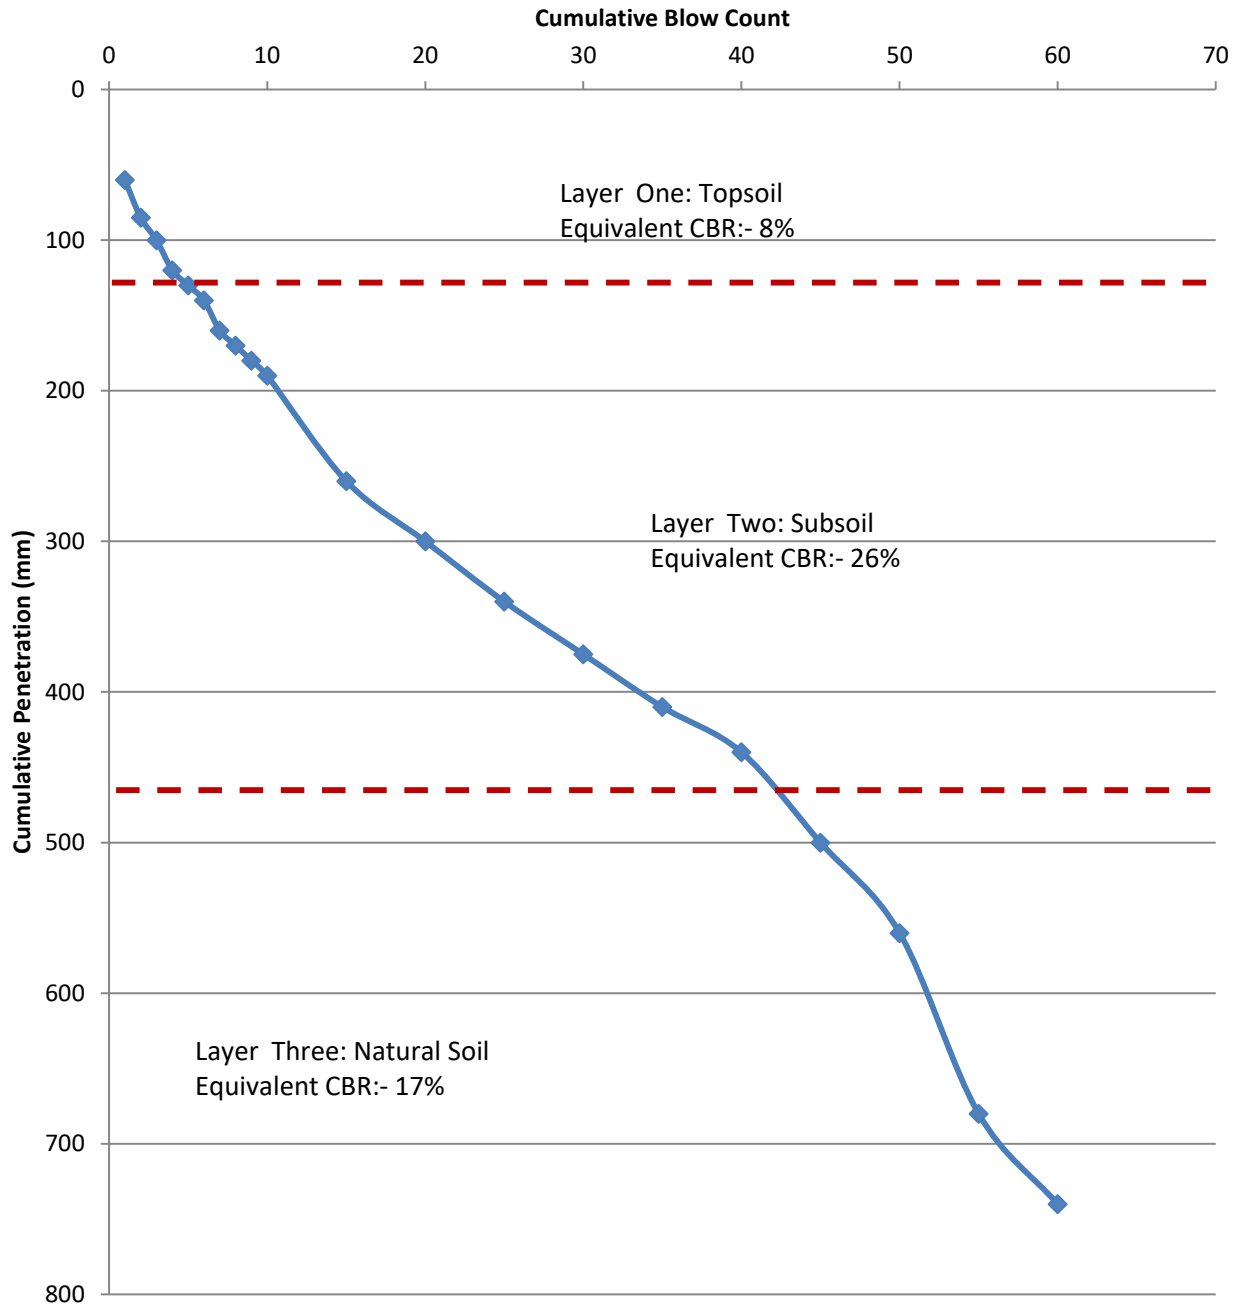
## TRL DYNAMIC CONE PENETROMETER RECORD

Depth below ground level at start of test:- 0.0m

### Cumulative Blows Vs Penetration (mm)
