**Geotechnical and Geo-Environmental Report**

**Land Adj. Park Lane**

**Charvil**

**Report No: 25-07-12**

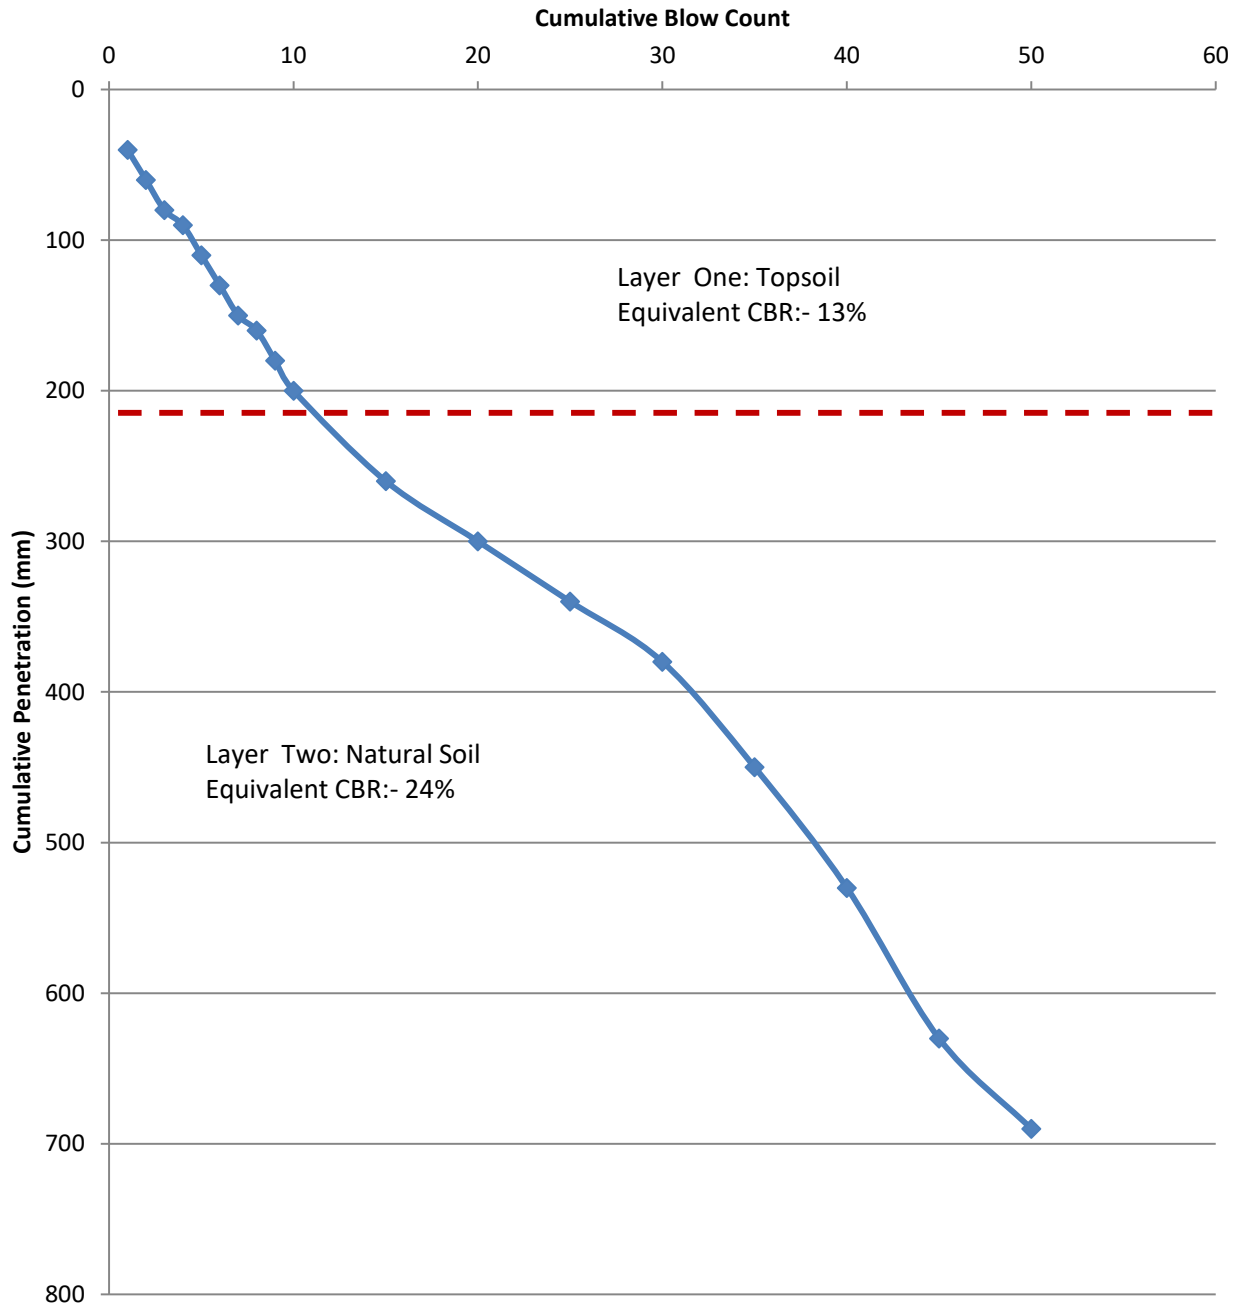
## TRL DYNAMIC CONE PENETROMETER RECORD

Depth below ground level at start of test:- 0.0m

### Cumulative Blows Vs Penetration (mm)

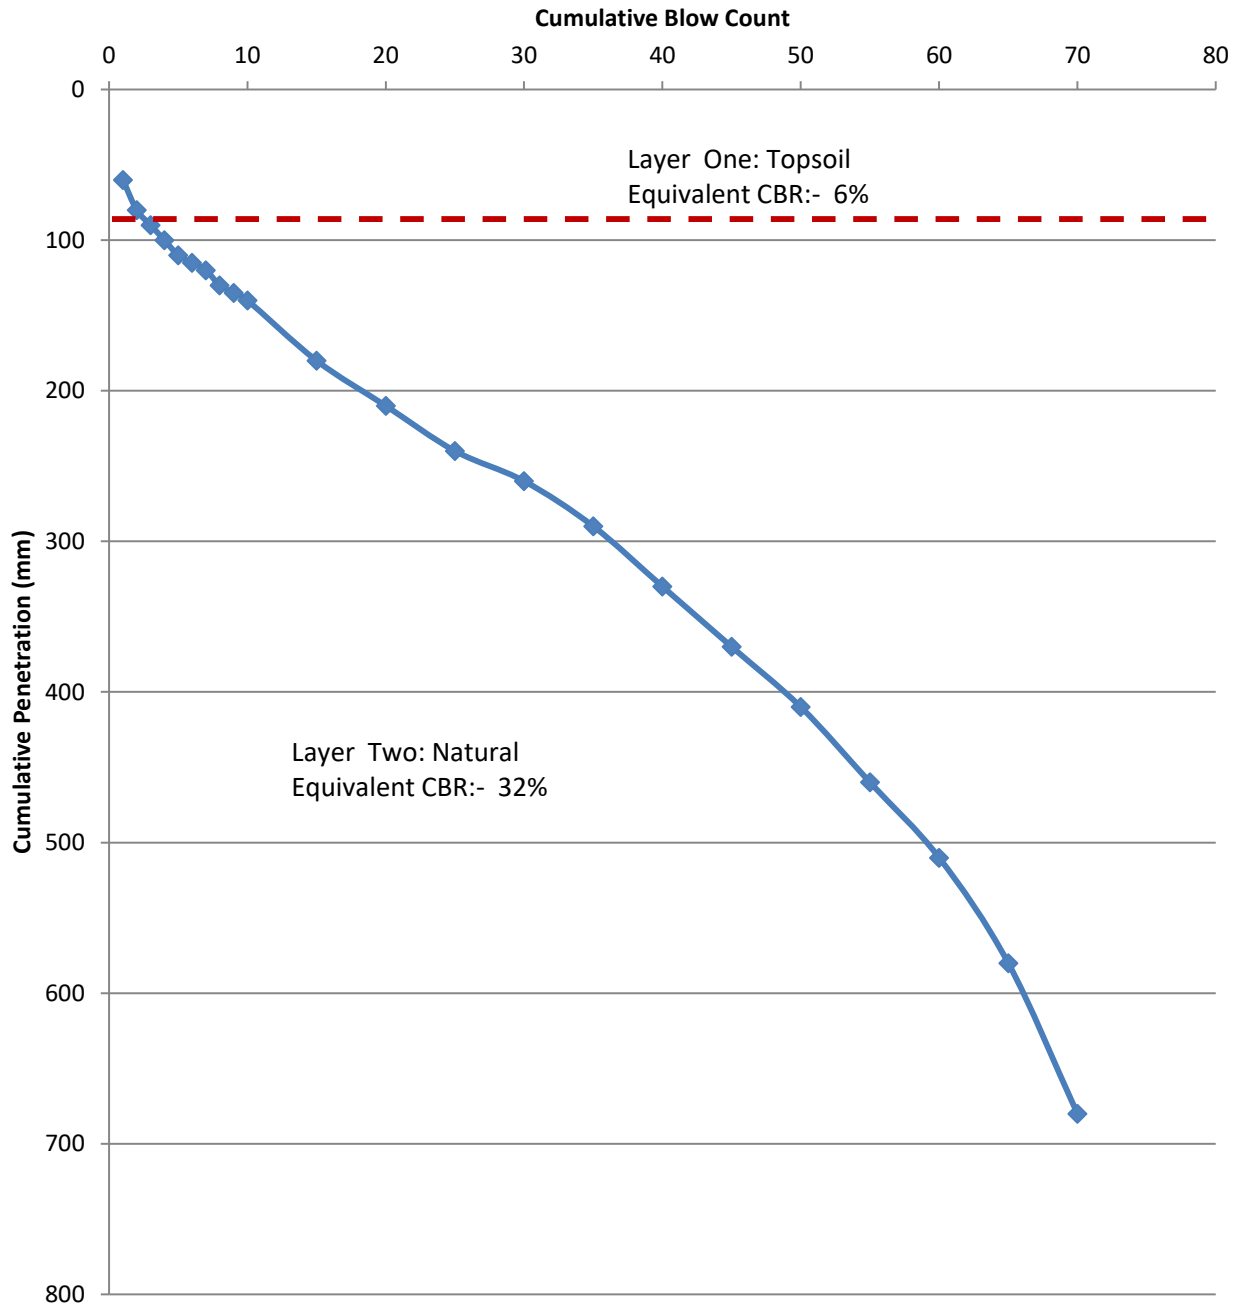
## TRL DYNAMIC CONE PENETROMETER RECORD

Depth below ground level at start of test:- 0.0m

### Cumulative Blows Vs Penetration (mm)

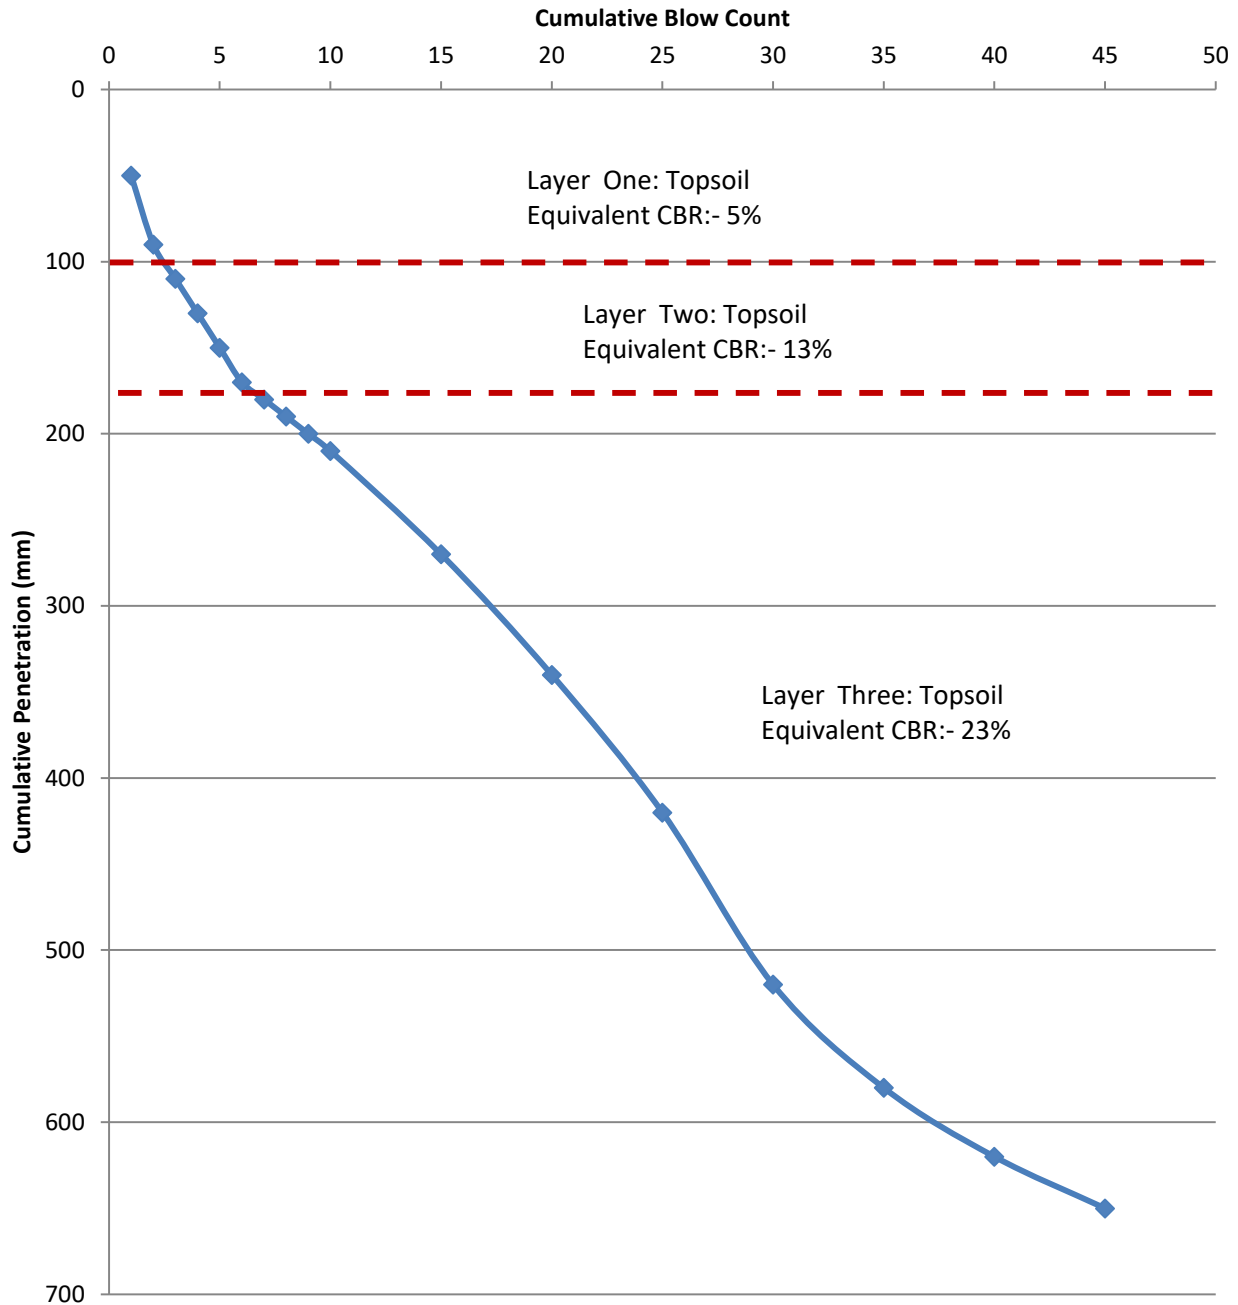
## TRL DYNAMIC CONE PENETROMETER RECORD

Depth below ground level at start of test:- 0.0m

### Cumulative Blows Vs Penetration (mm)

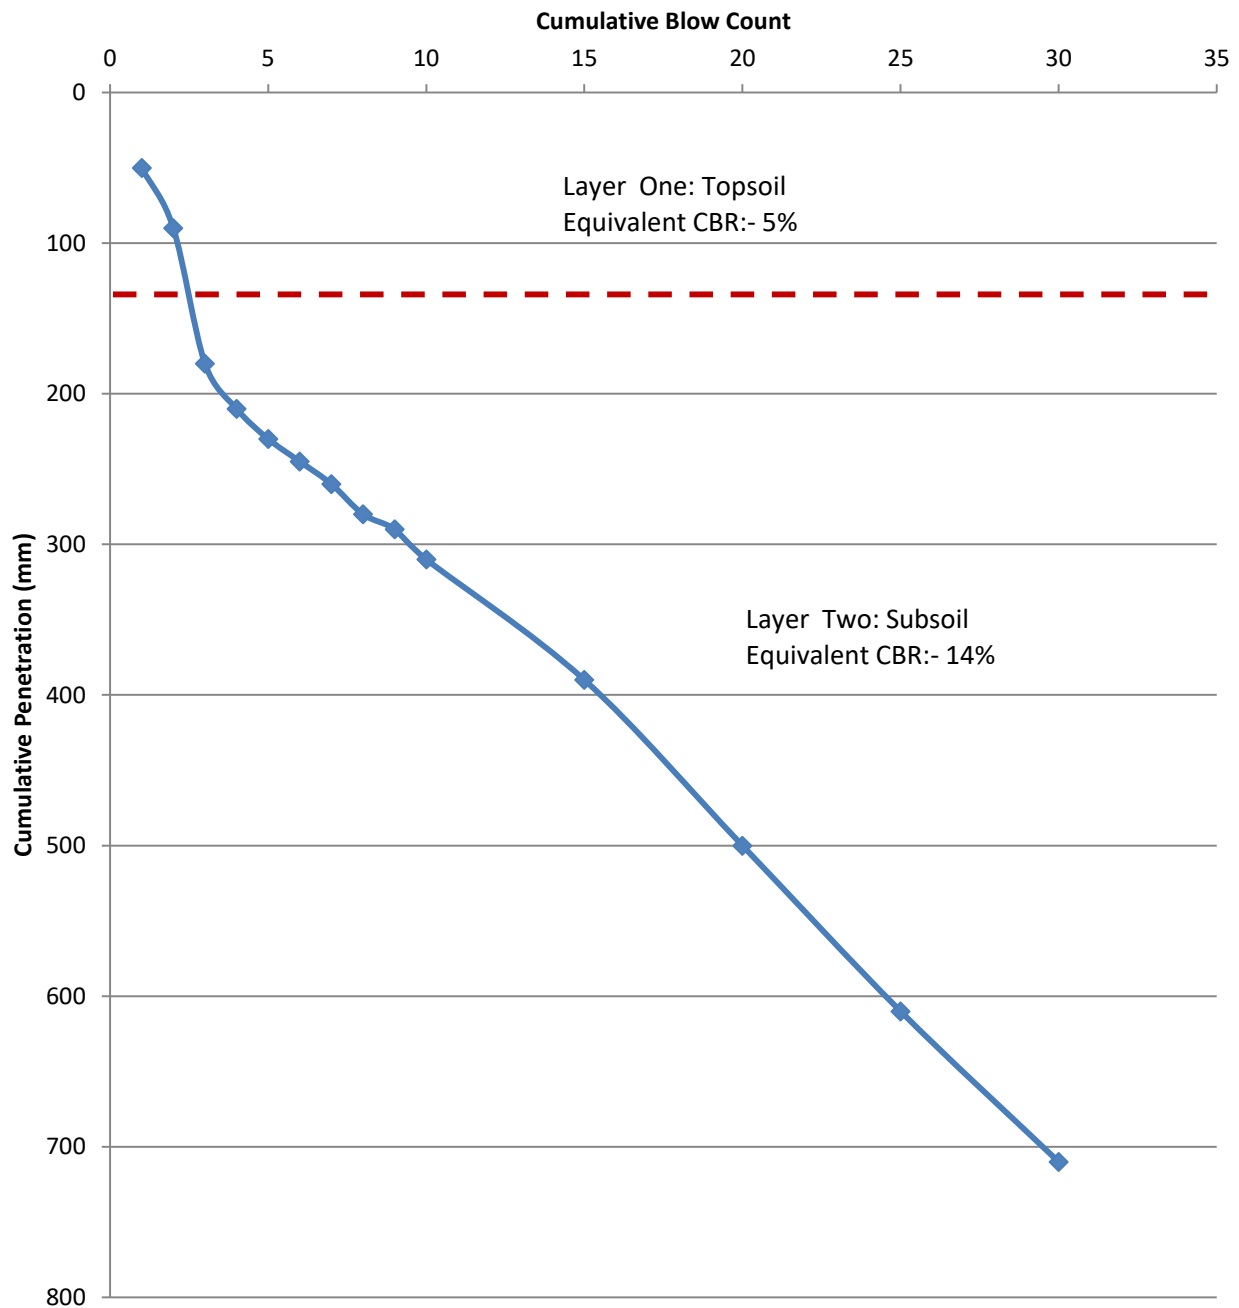
## TRL DYNAMIC CONE PENETROMETER RECORD

Depth below ground level at start of test:- 0.0m

### Cumulative Blows Vs Penetration (mm)

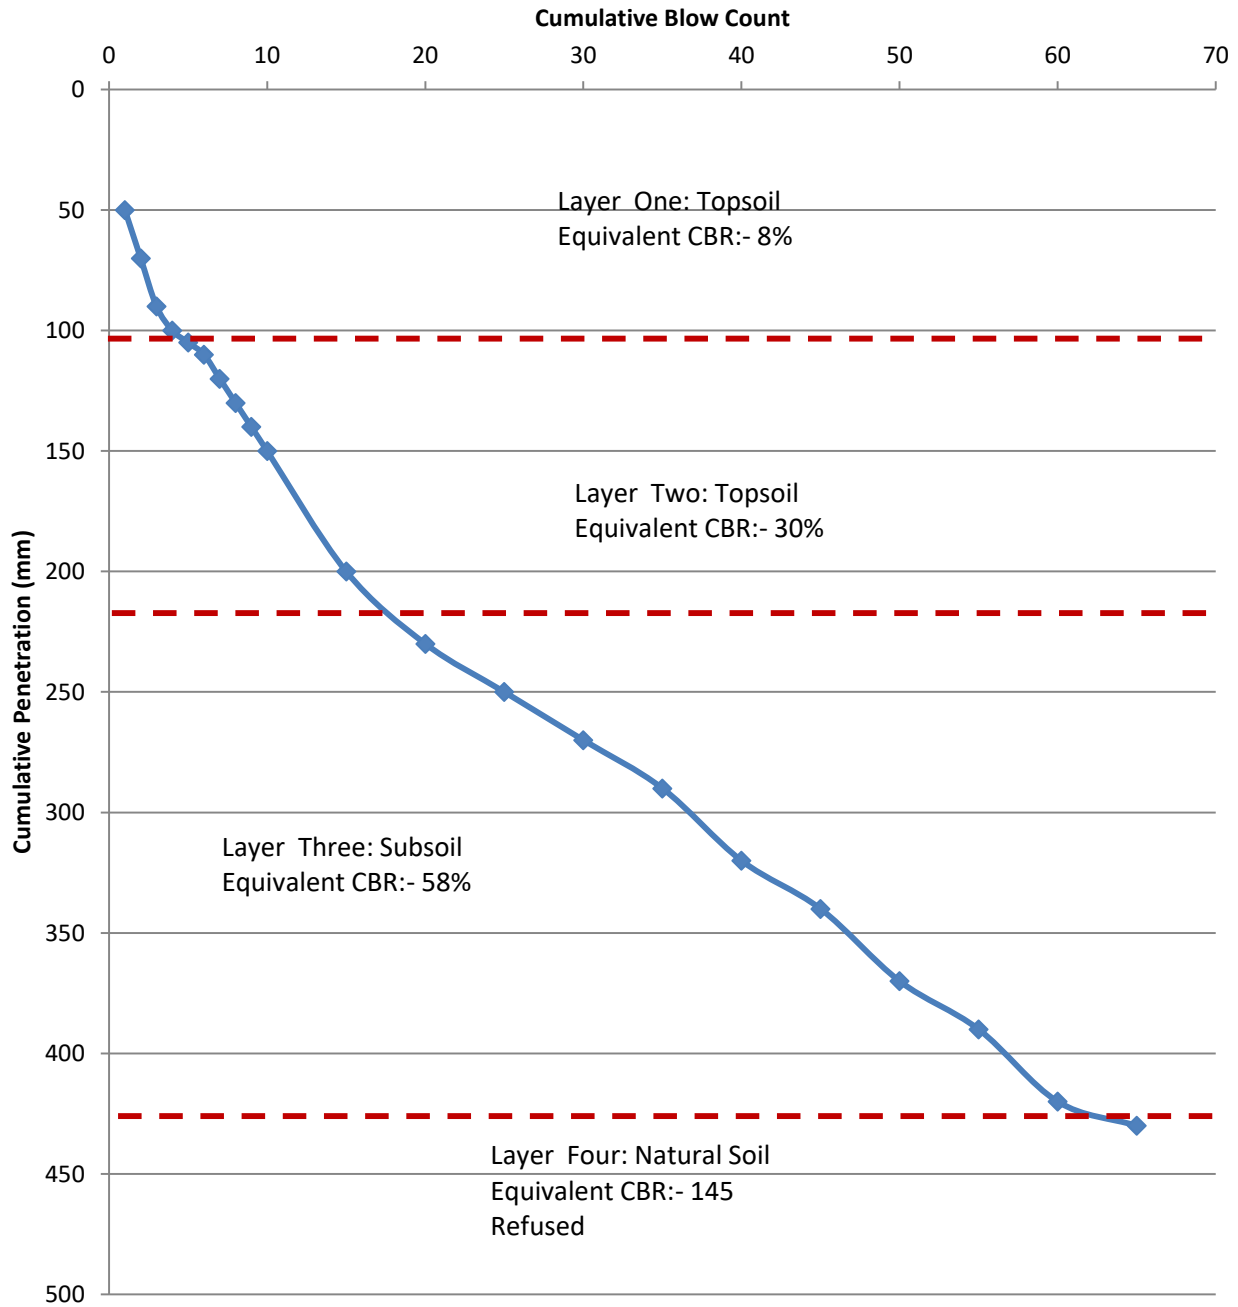
## TRL DYNAMIC CONE PENETROMETER RECORD

Depth below ground level at start of test:- 0.0m

### Cumulative Blows Vs Penetration (mm)
