## 242152 Tree Protection Information

**11/09/2024: Email from Jake Russell – CPC Planning Consultants.**

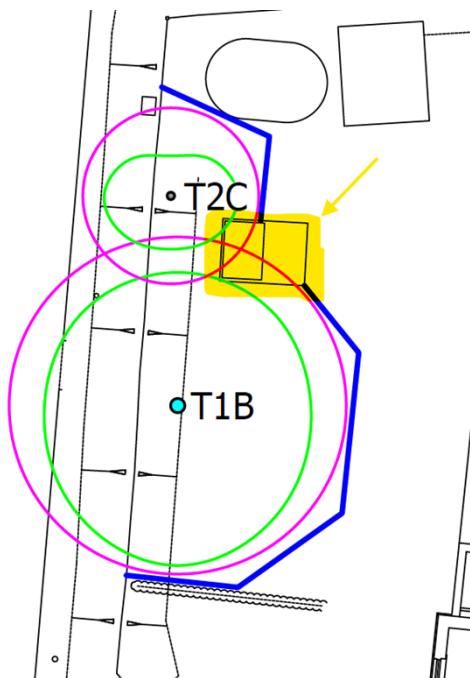
Image indicating location of existing concrete slab (highlighted yellow):

Tree T1's root protection area (RPA) measures 33.91 sqm in area, and the proposed building extends within this RPA by 3.87 sqm, resulting in an 11.41% incursion on the overall RPA. As you'll know the relevant British Standard advises that where a slab for a minor structure (such as a shed, or in this case pool house) is to be formed within the RPA it should be on the existing ground level and should not exceed an area greater than 20% of the existing unsurfaced ground. Clearly at 11.41% we fall well below this maximum threshold.

Firstly, there is an existing concrete slab within the RPA of tree T1 – I have highlighted it in yellow on the image below which is taken from the tree survey. The proposed building will partially reuse this existing slab, proportionately reducing the amount of works within the RPA than if this existing slab were not there. Furthermore, the leftover slab which is not proposed to be used as part of the erection of the pool house, which strays within the RPA of tree T1 (which is cat. B), will be removed resulting in a net benefit to this tree.
